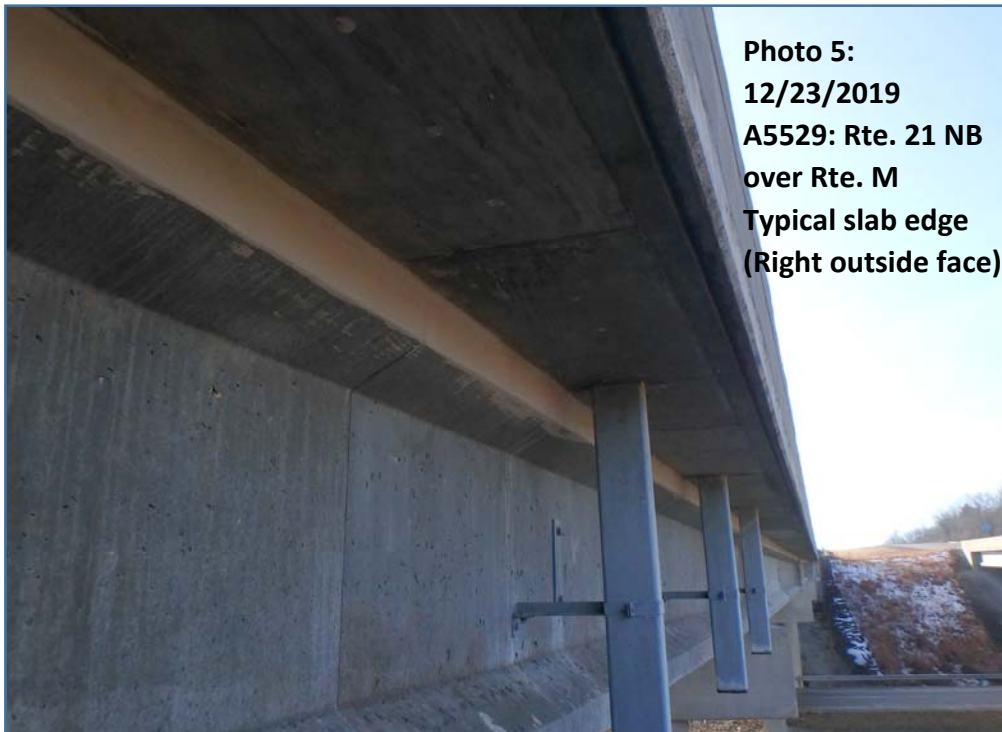
Photo 5:
12/23/2019
A5529: Rte. 21 NB
over Rte. M
Typical slab edge
(Right outside face)

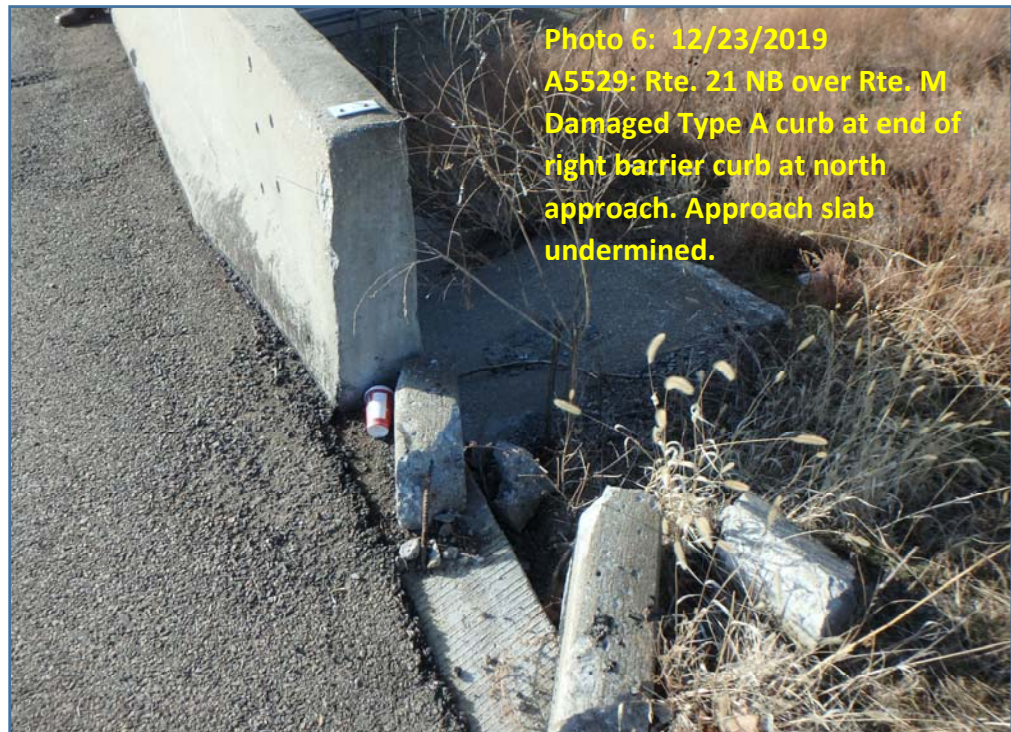
Photo 6: 12/23/2019
A5529: Rte. 21 NB over Rte. M
Damaged Type A curb at end of
right barrier curb at north
approach. Approach slab
undermined.

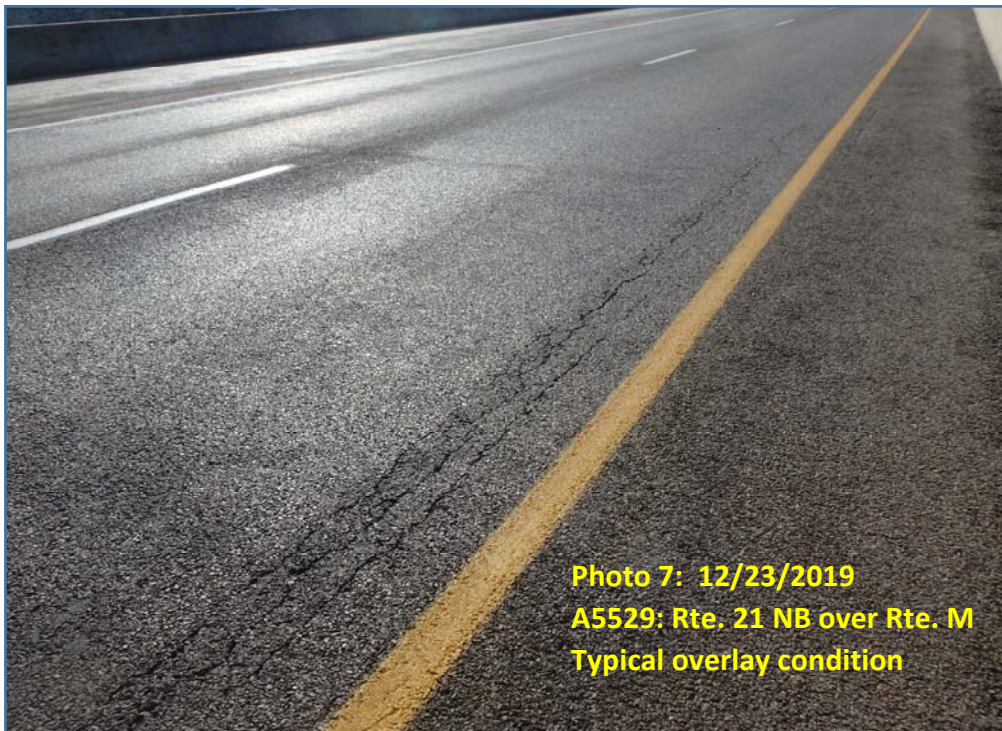
Photo 7: 12/23/2019
A5529: Rte. 21 NB over Rte. M
Typical overlay condition

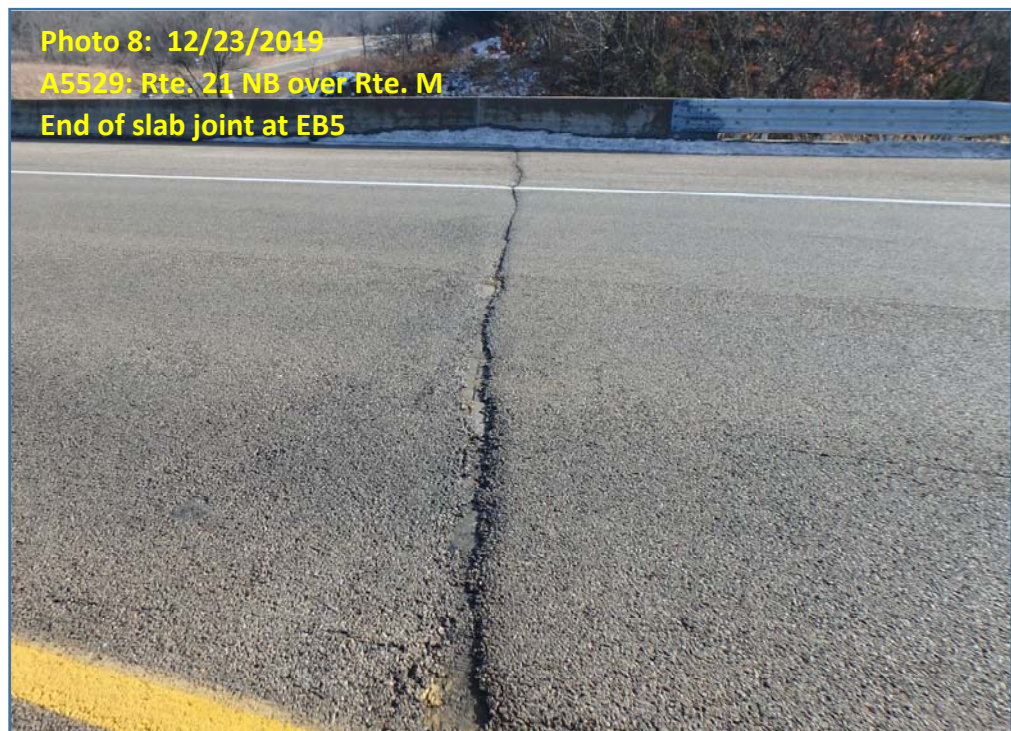
Photo 8: 12/23/2019
A5529: Rte. 21 NB over Rte. M
End of slab joint at EB5

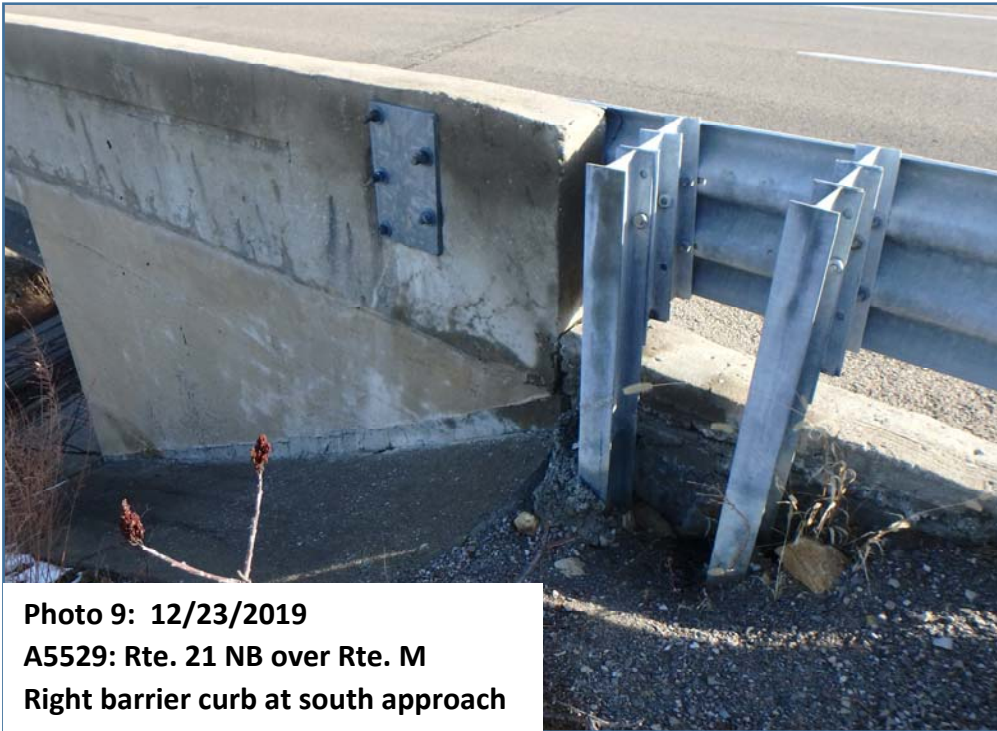
Photo 9: 12/23/2019
A5529: Rte. 21 NB over Rte. M
Right barrier curb at south approach

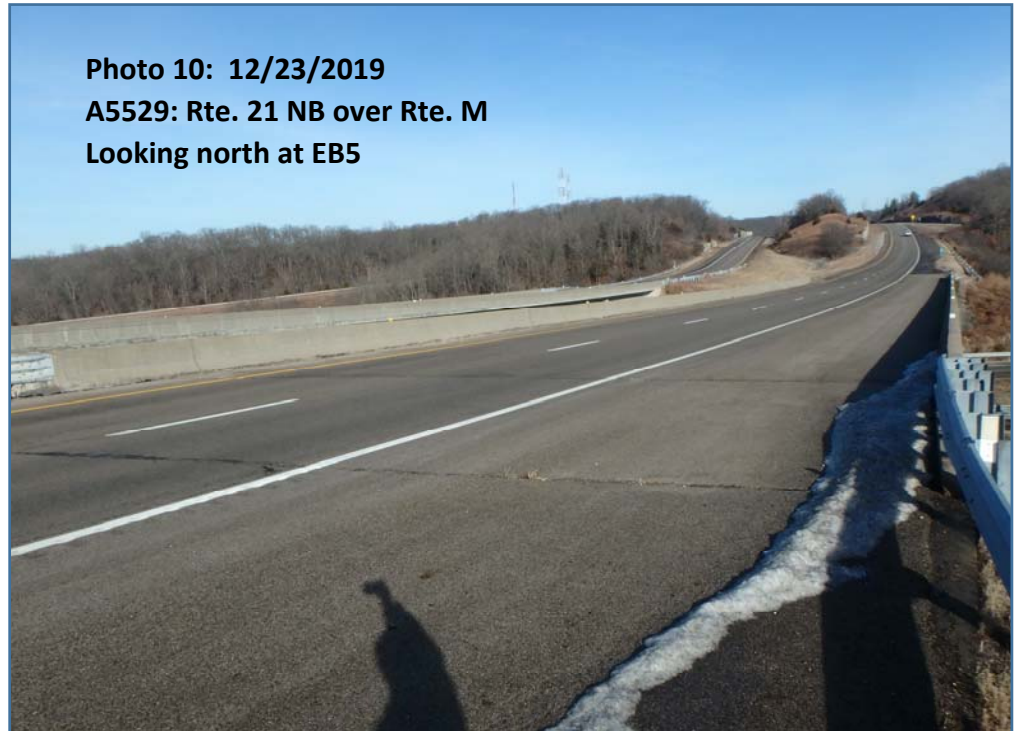
Photo 10: 12/23/2019
A5529: Rte. 21 NB over Rte. M
Looking north at EB5

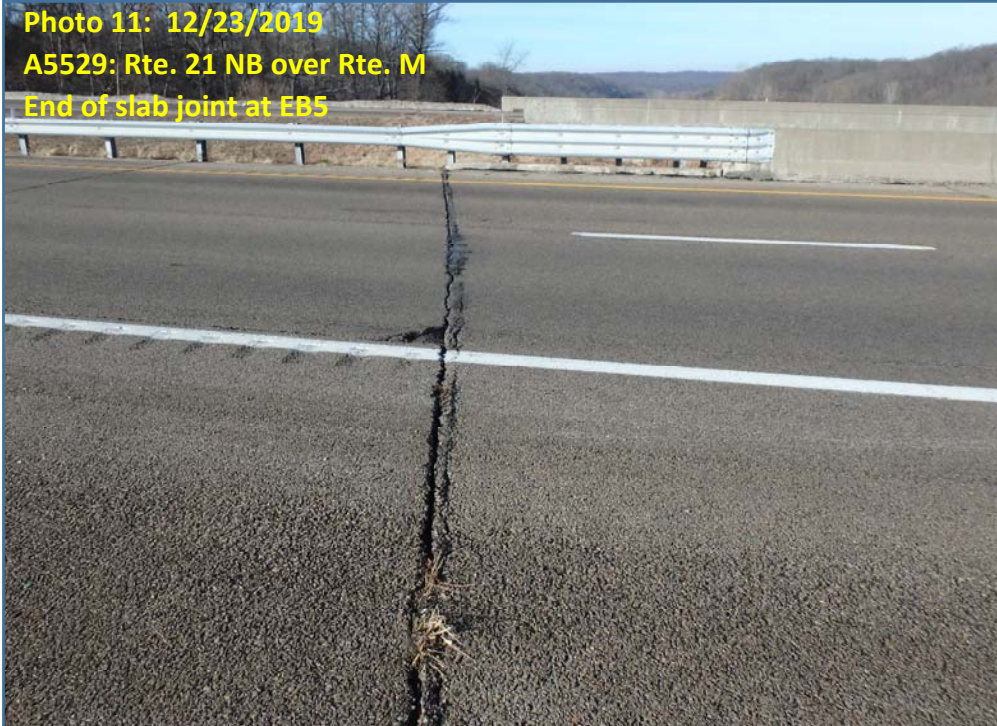
Photo 11: 12/23/2019
A5529: Rte. 21 NB over Rte. M
End of slab joint at EB5

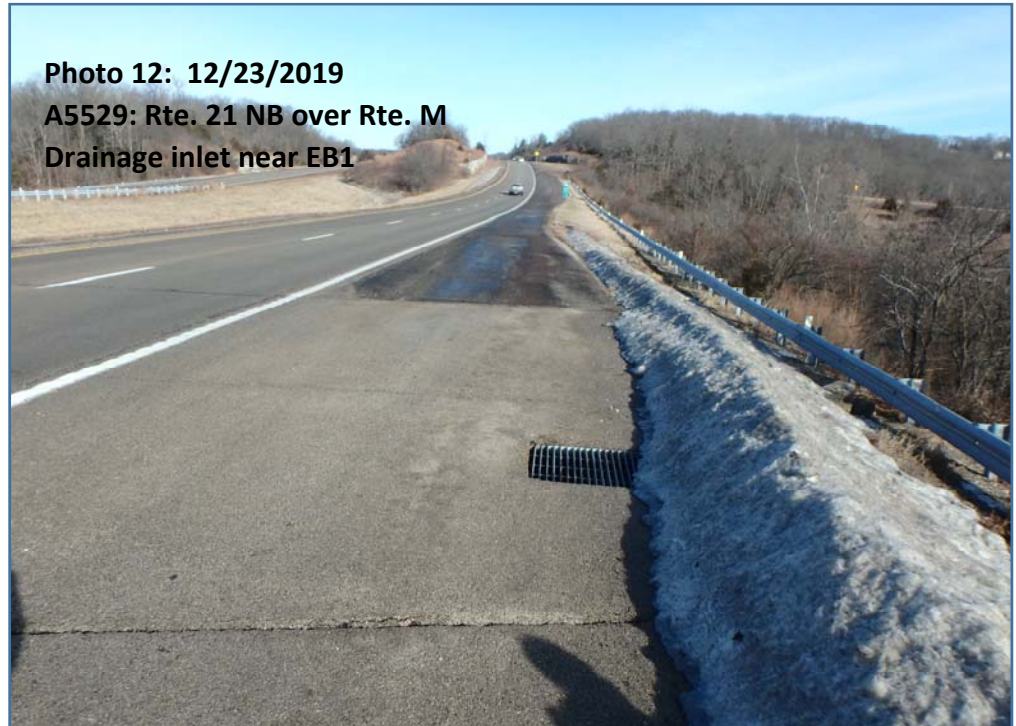
Photo 12: 12/23/2019
A5529: Rte. 21 NB over Rte. M
Drainage inlet near EB1

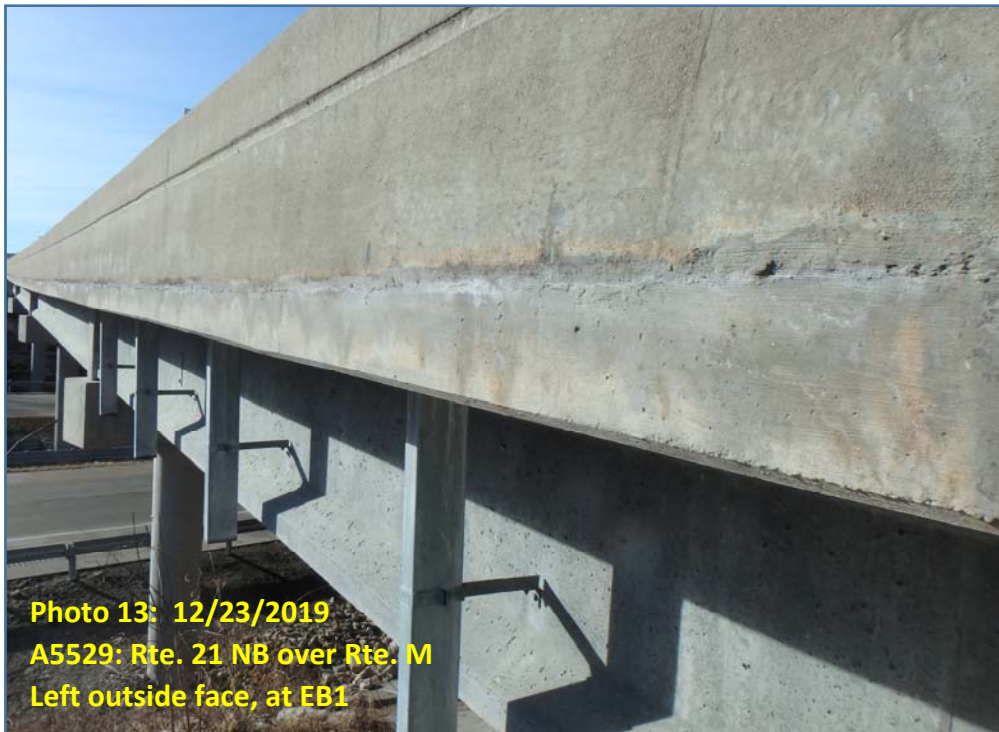
Photo 13: 12/23/2019
A5529: Rte. 21 NB over Rte. M
Left outside face, at EB1

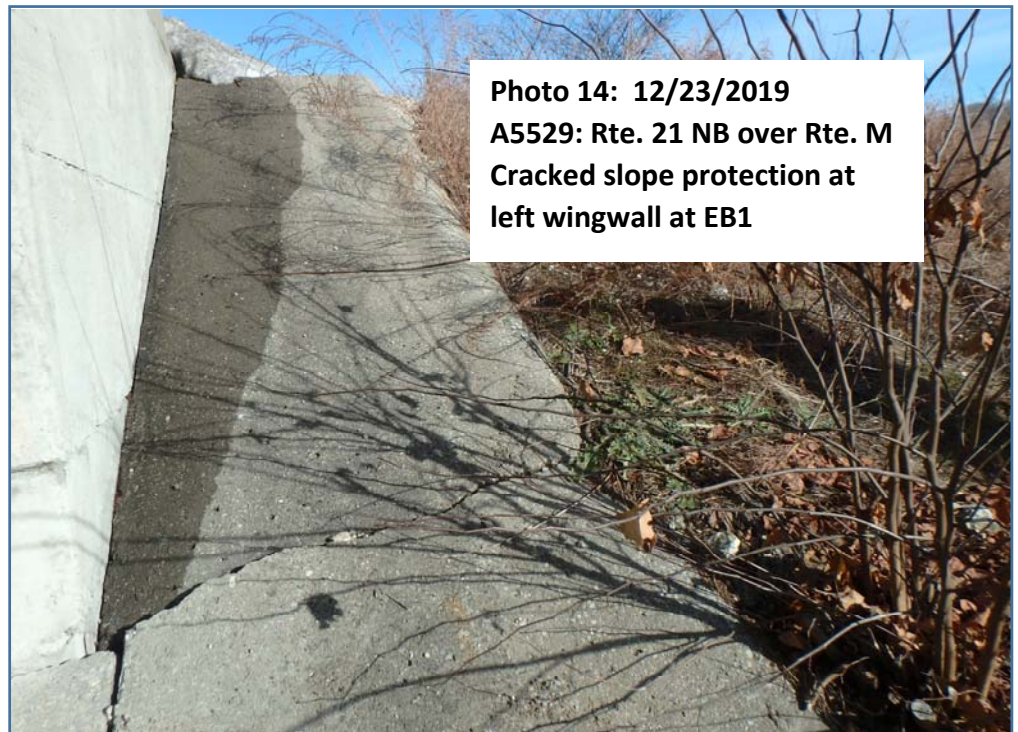
Photo 14: 12/23/2019
A5529: Rte. 21 NB over Rte. M
Cracked slope protection at
left wingwall at EB1

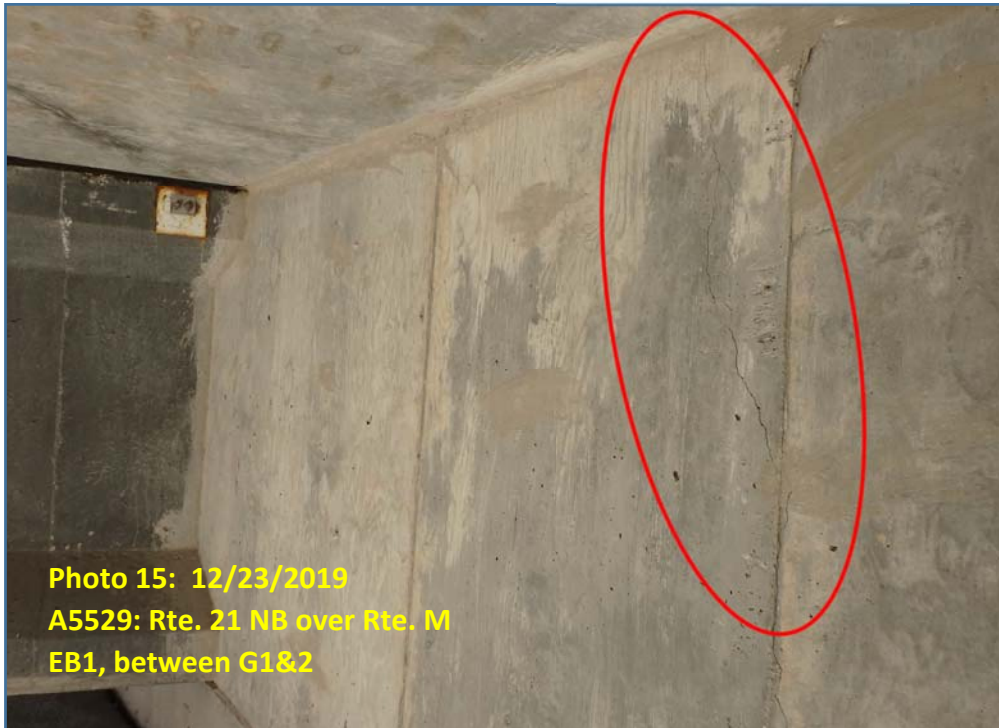
Photo 15: 12/23/2019
A5529: Rte. 21 NB over Rte. M
EB1, between G1&2

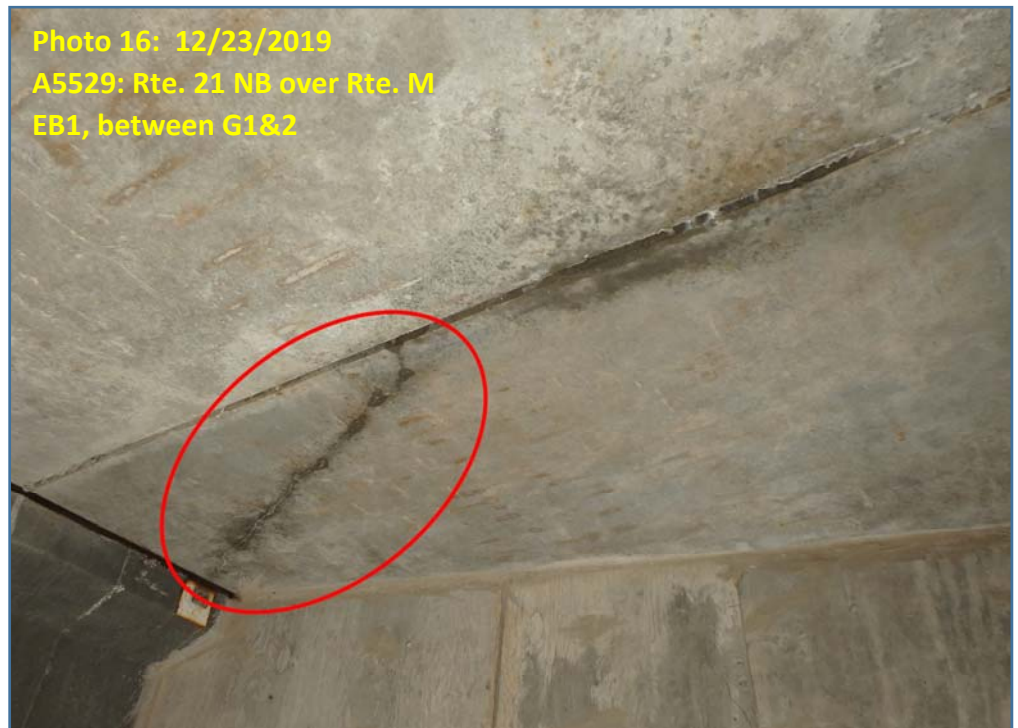
Photo 16: 12/23/2019
A5529: Rte. 21 NB over Rte. M
EB1, between G1&2

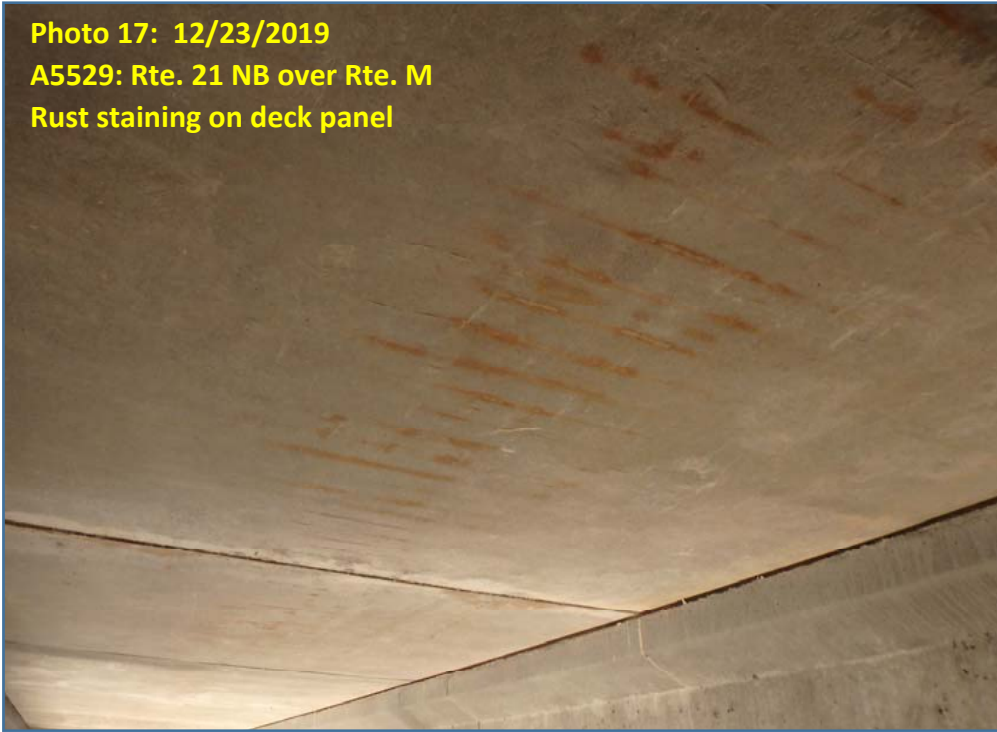
Photo 17: 12/23/2019
A5529: Rte. 21 NB over Rte. M
Rust staining on deck panel

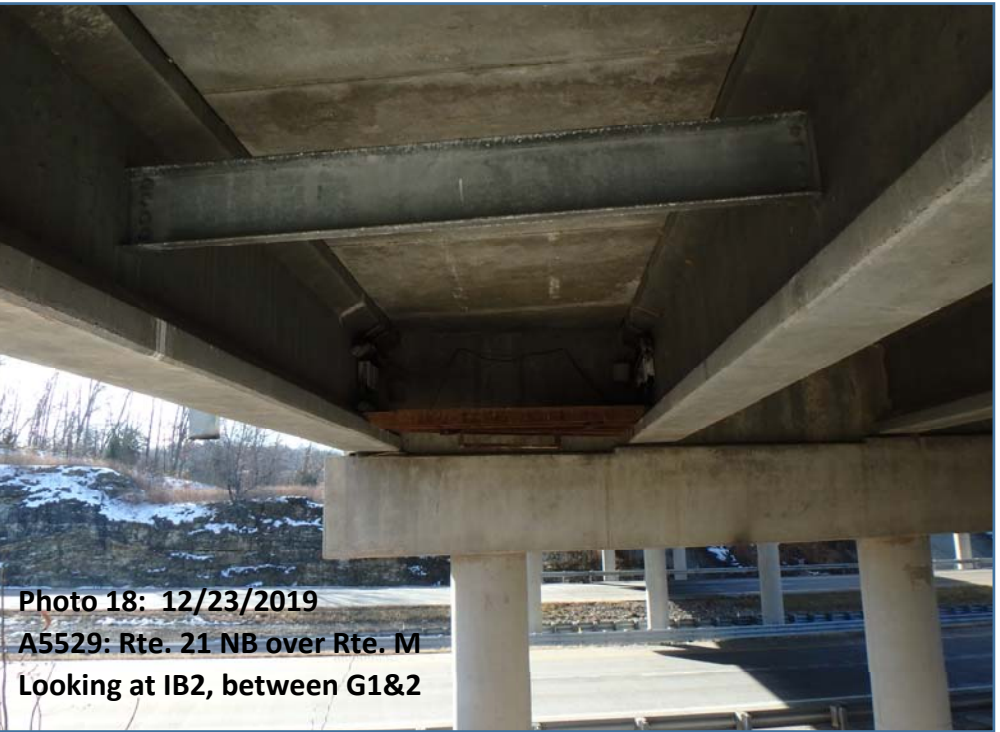
Photo 18: 12/23/2019
A5529: Rte. 21 NB over Rte. M
Looking at IB2, between G1&2

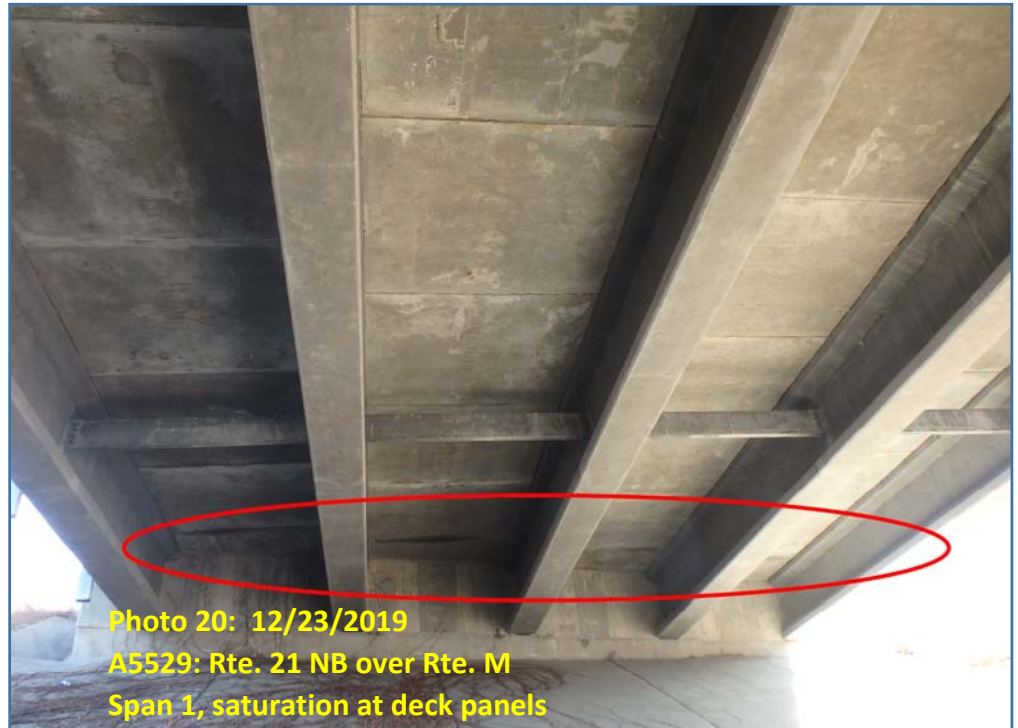
Photo 20: 12/23/2019
A5529: Rte. 21 NB over Rte. M
Span 1, saturation at deck panels

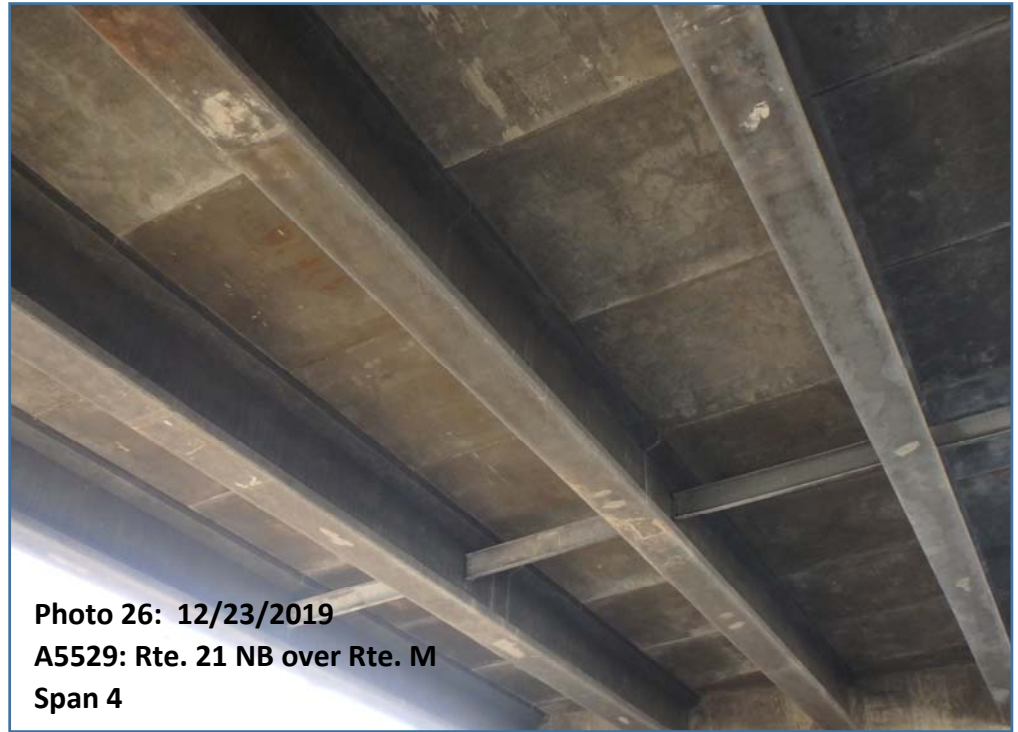
Photo 26: 12/23/2019
A5529: Rte. 21 NB over Rte. M
Span 4

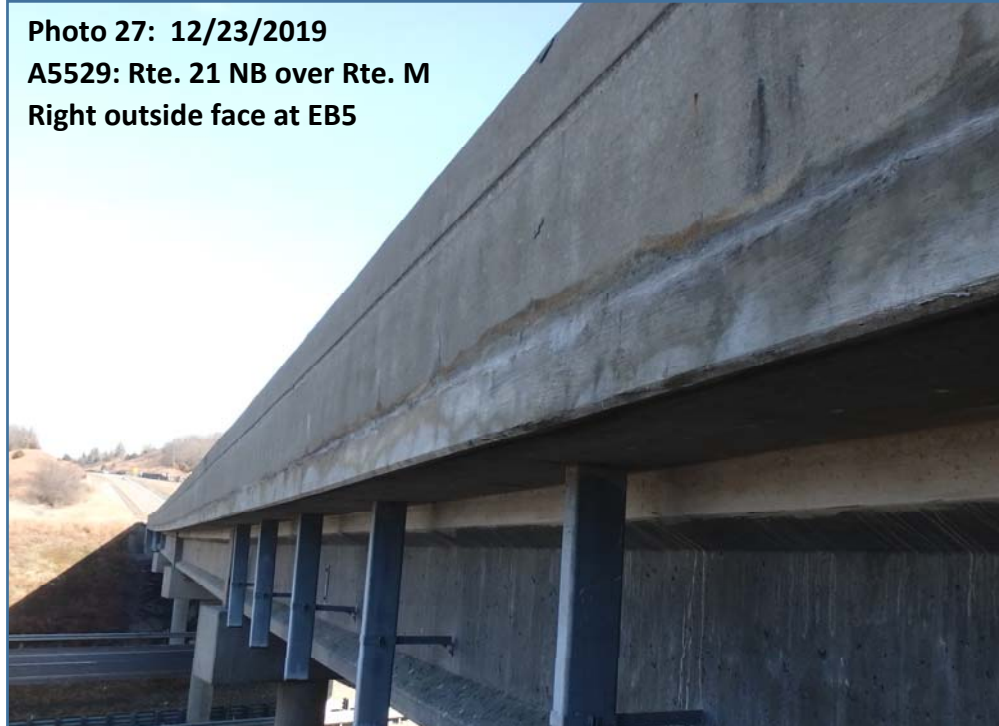
Photo 27: 12/23/2019
A5529: Rte. 21 NB over Rte. M
Right outside face at EB5

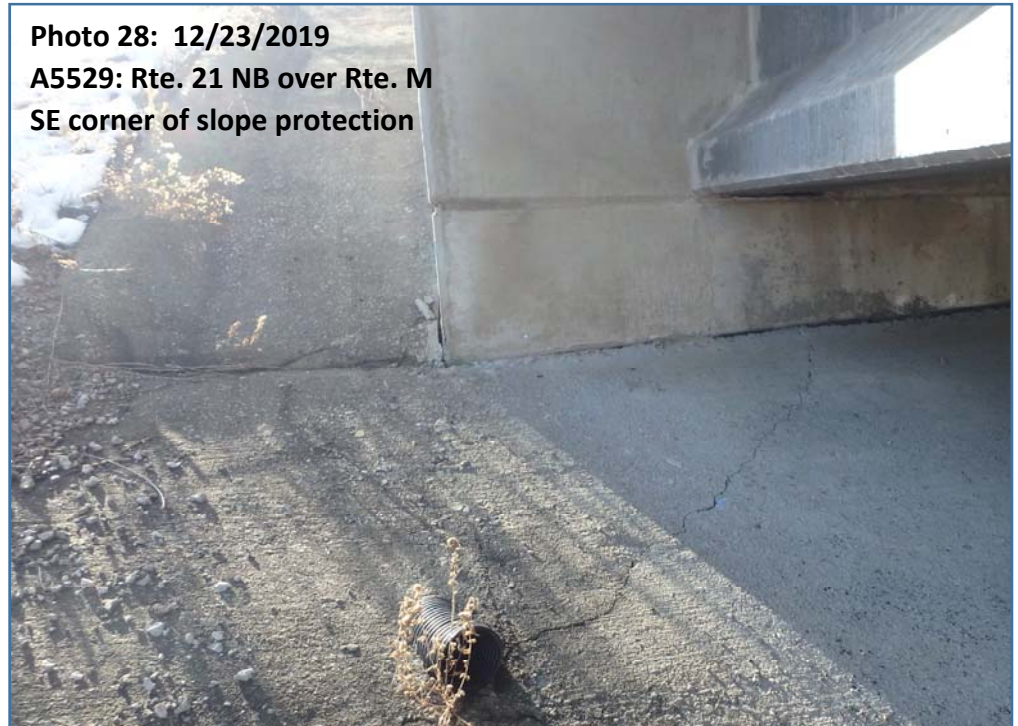
Photo 28: 12/23/2019
A5529: Rte. 21 NB over Rte. M
SE corner of slope protection

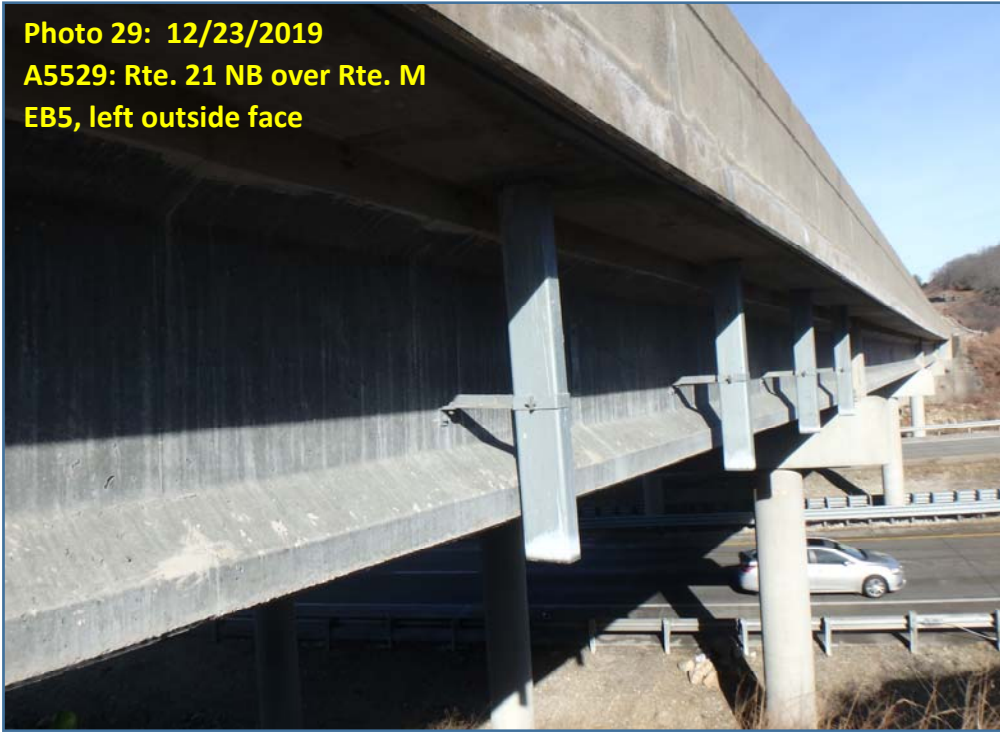
Photo 29: 12/23/2019
A5529: Rte. 21 NB over Rte. M
EB5, left outside face
