Photo 1: 11/19/19
A2945: MO 21 N over Heads
Creek Rd.
North end of slab joint

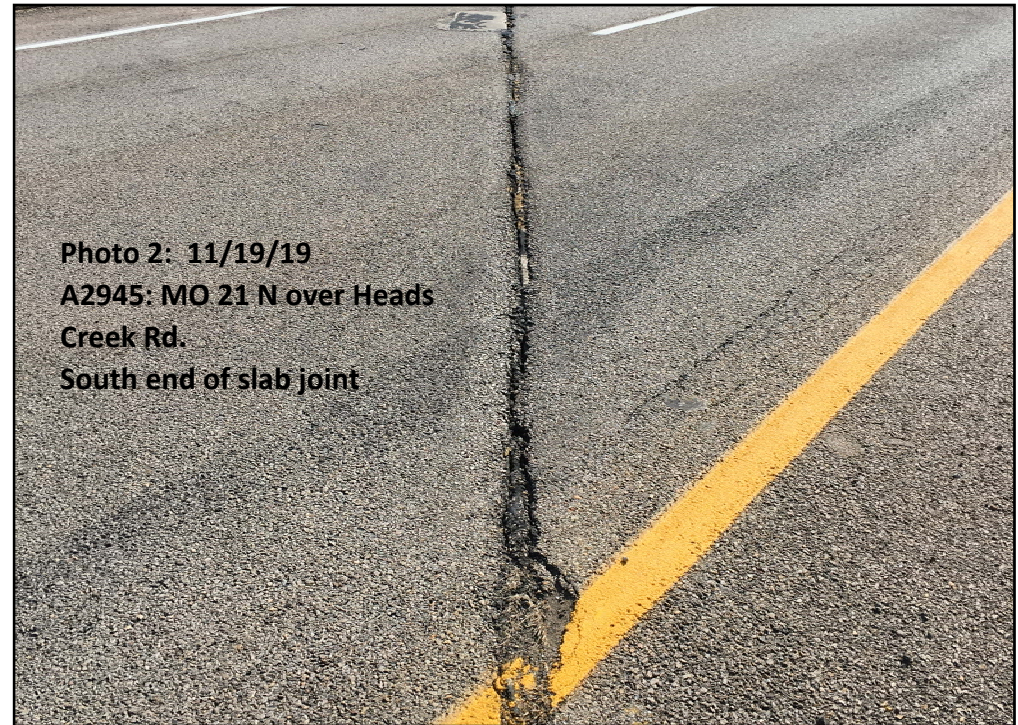
Photo 2: 11/19/19
A2945: MO 21 N over Heads
Creek Rd.
South end of slab joint

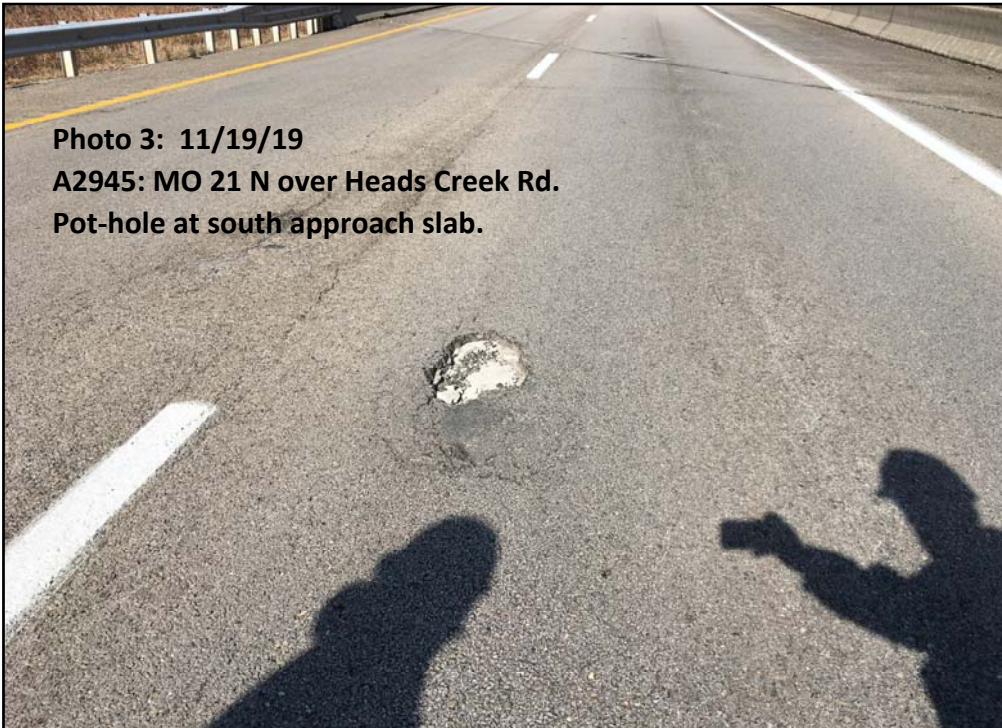
Photo 3: 11/19/19
A2945: MO 21 N over Heads Creek Rd.
Pot-hole at south approach slab.

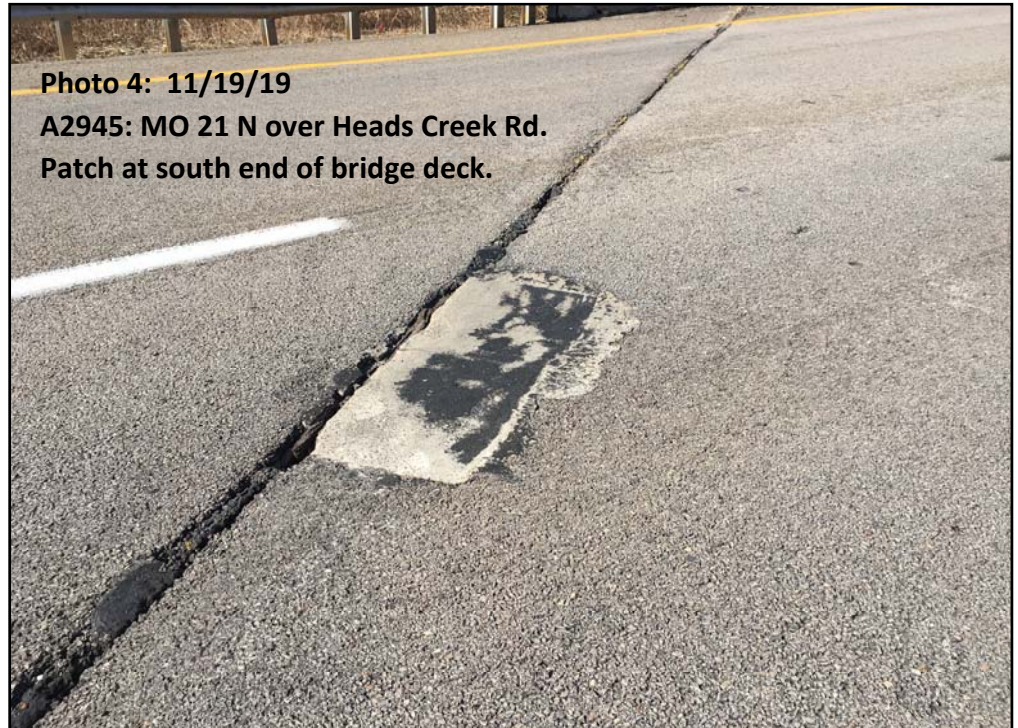
Photo 4: 11/19/19
A2945: MO 21 N over Heads Creek Rd.
Patch at south end of bridge deck.

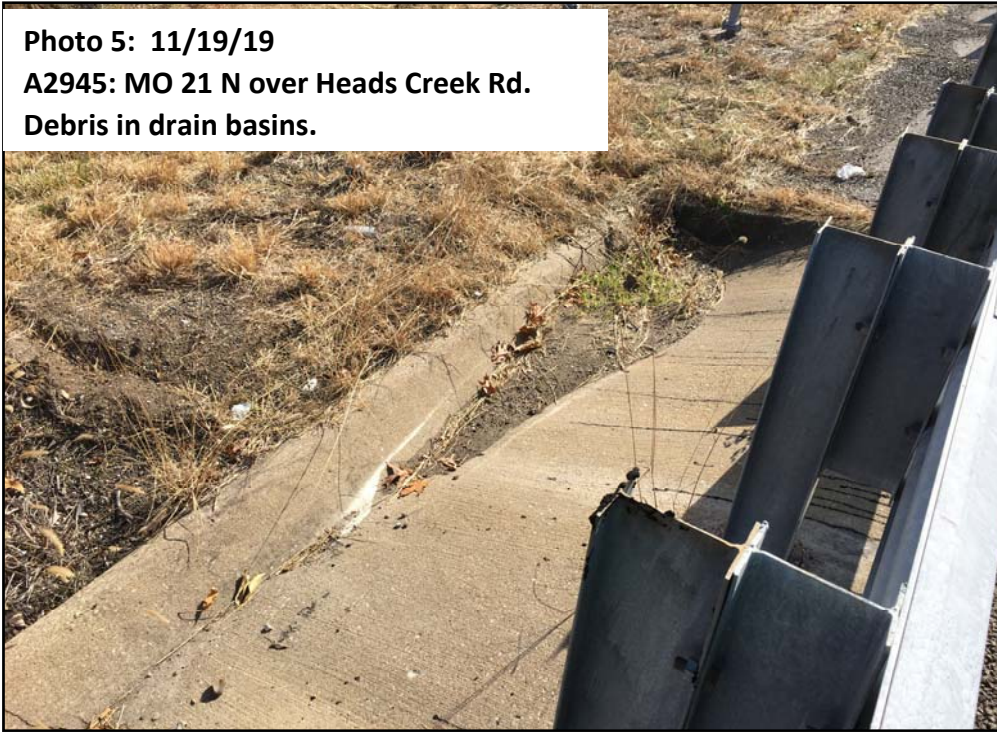
Photo 5: 11/19/19

**A2945: MO 21 N over Heads Creek Rd.
Debris in drain basins.**

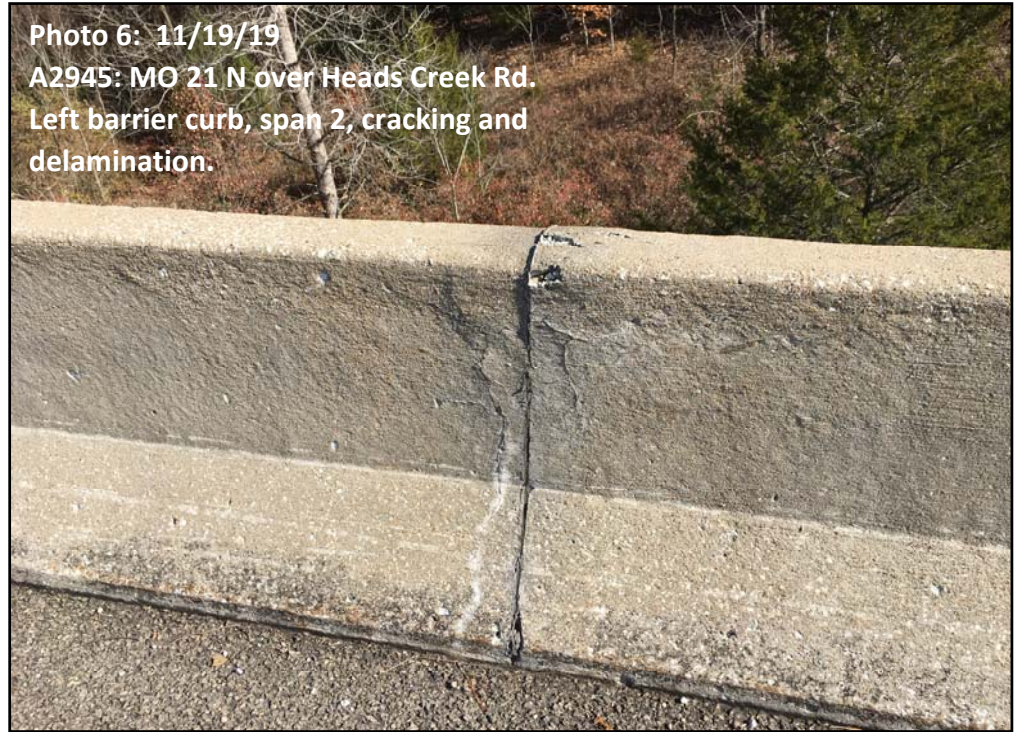
Photo 6: 11/19/19

**A2945: MO 21 N over Heads Creek Rd.
Left barrier curb, span 2, cracking and delamination.**

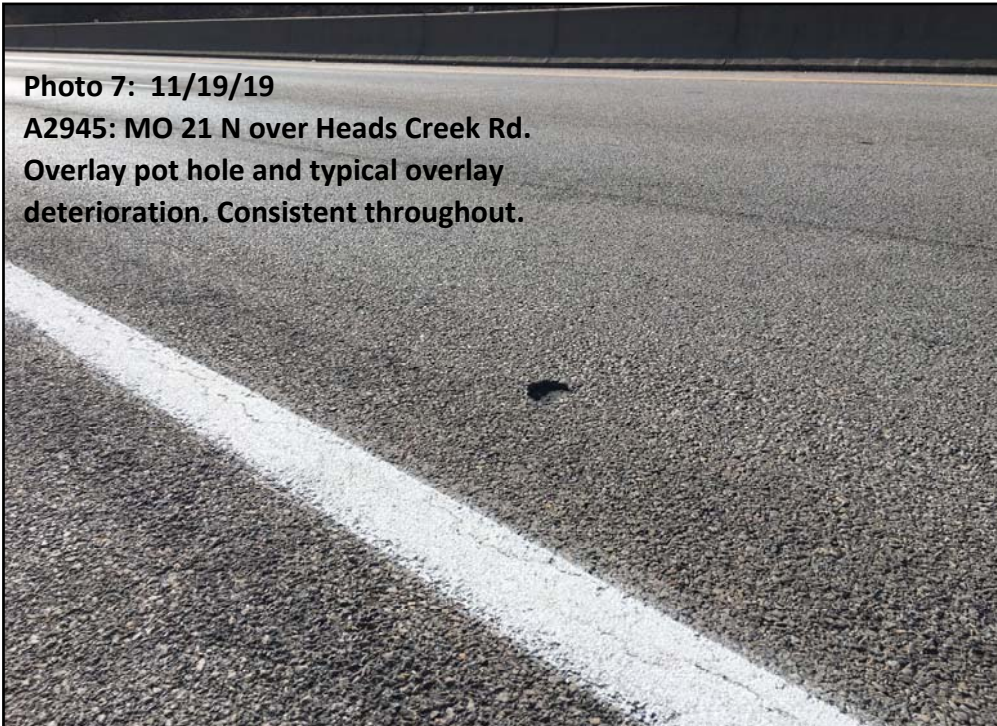
Photo 7: 11/19/19

**A2945: MO 21 N over Heads Creek Rd.
Overlay pot hole and typical overlay
deterioration. Consistent throughout.**

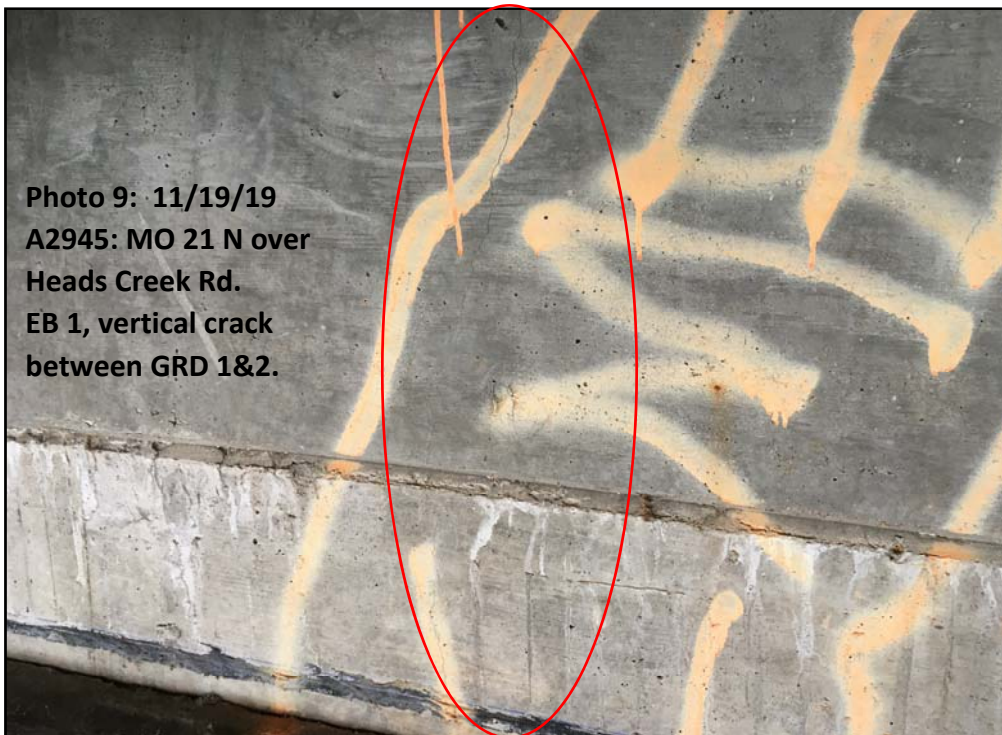
Photo 9: 11/19/19
A2945: MO 21 N over
Heads Creek Rd.
EB 1, vertical crack
between GRD 1&2.

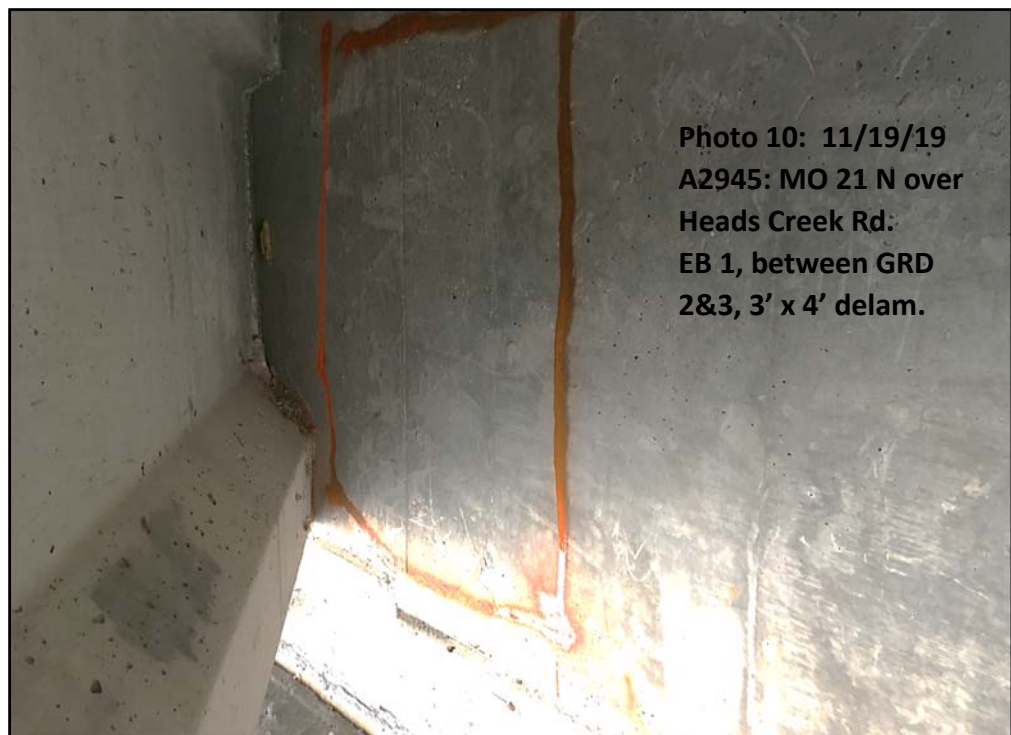
Photo 10: 11/19/19
A2945: MO 21 N over
Heads Creek Rd:
EB 1, between GRD
2&3, 3' x 4' delam.

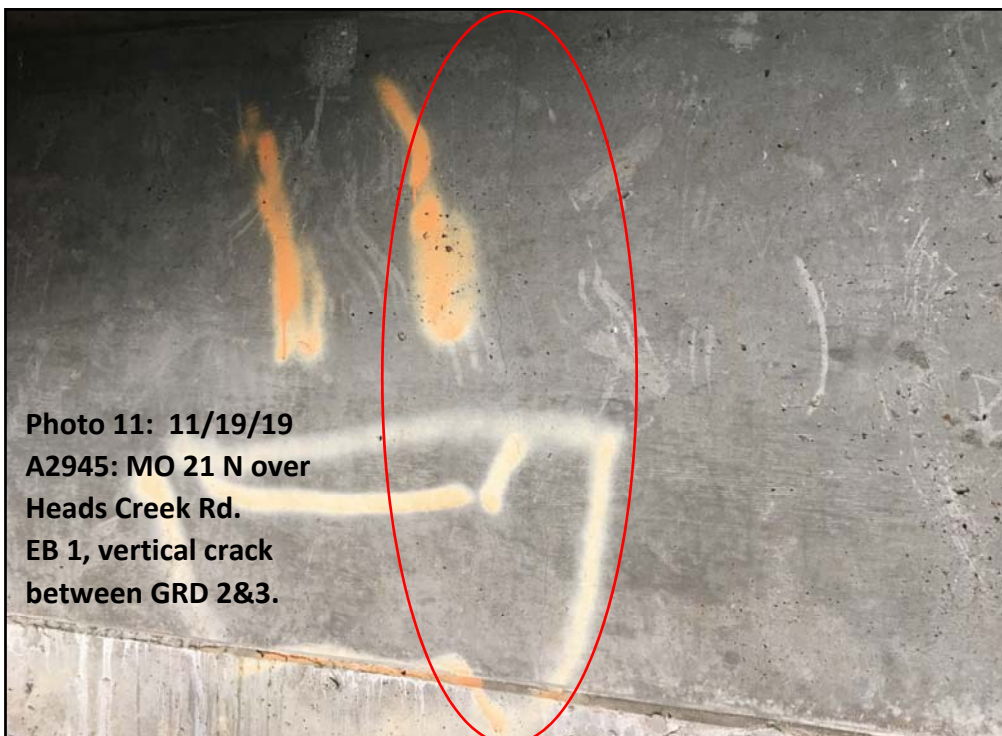
Photo 11: 11/19/19
A2945: MO 21 N over
Heads Creek Rd.
EB 1, vertical crack
between GRD 2&3.

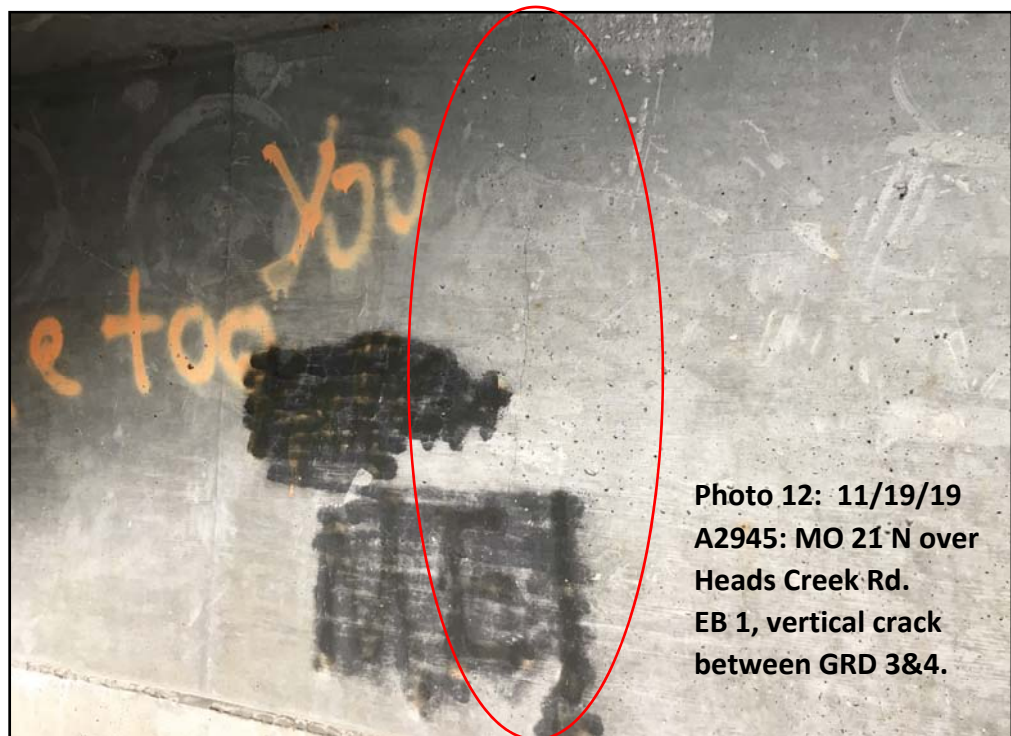
Photo 12: 11/19/19
A2945: MO 21 N over
Heads Creek Rd.
EB 1, vertical crack
between GRD 3&4.

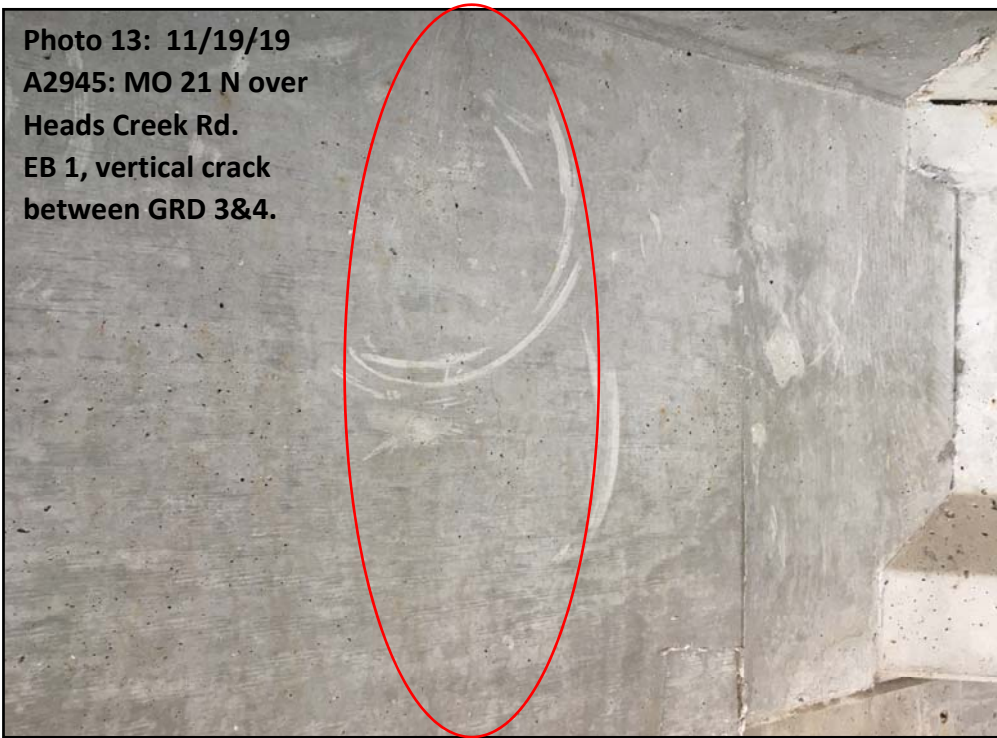
Photo 13: 11/19/19
A2945: MO 21 N over
Heads Creek Rd.
EB 1, vertical crack
between GRD 3&4.

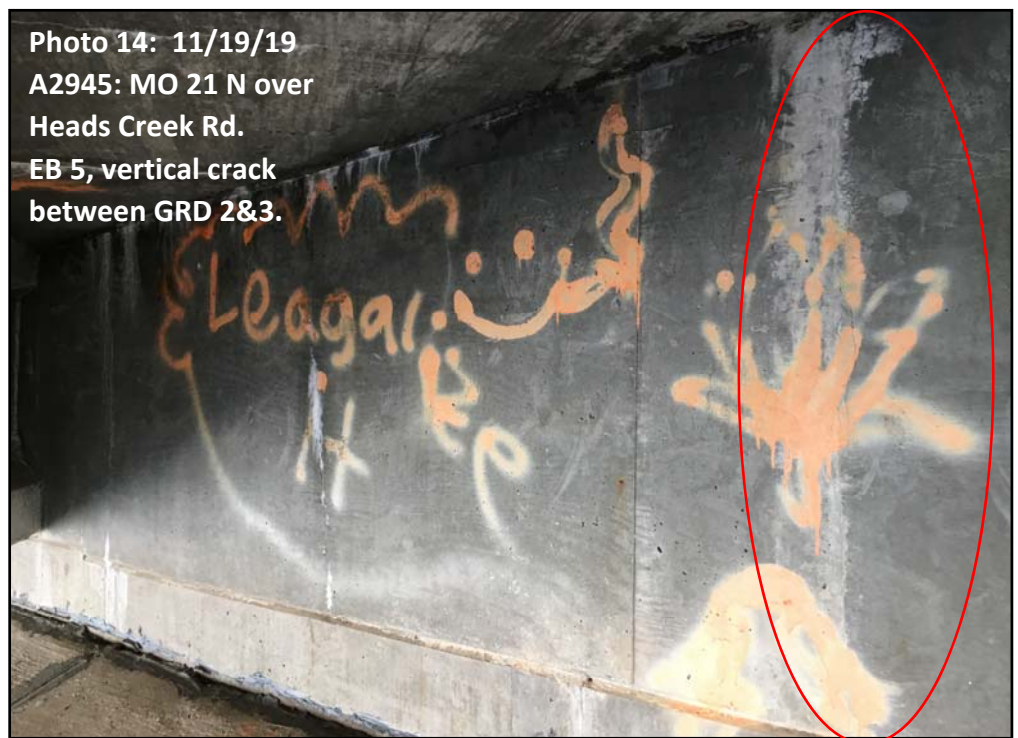
Photo 14: 11/19/19
A2945: MO 21 N over
Heads Creek Rd.
EB 5, vertical crack
between GRD 2&3.

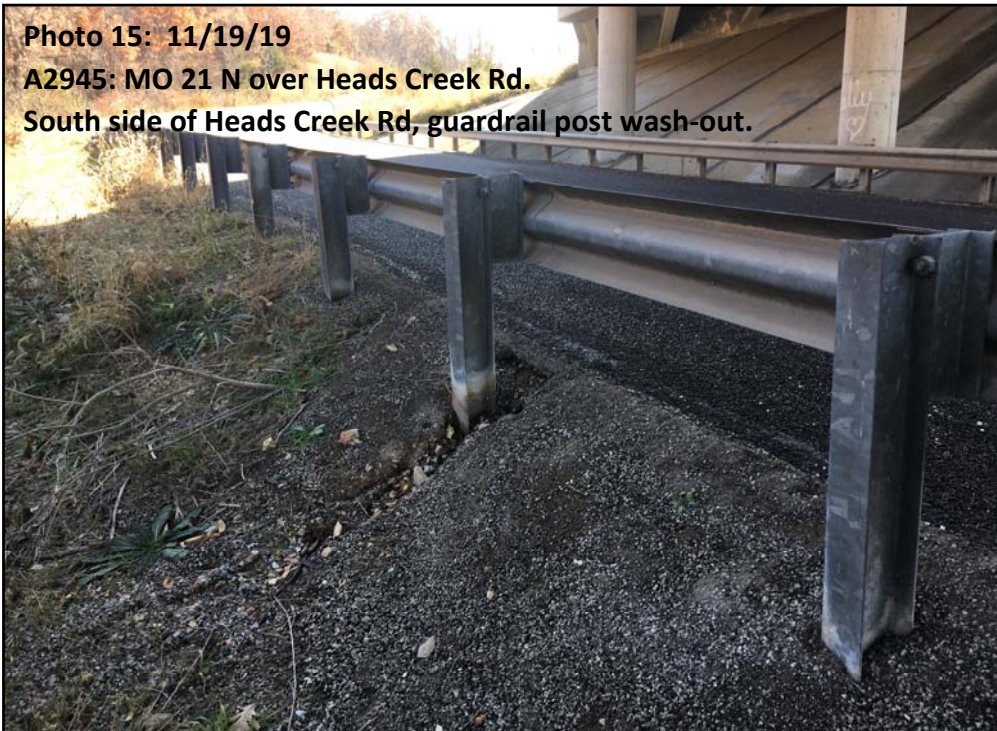
Photo 15: 11/19/19
A2945: MO 21 N over Heads Creek Rd.
South side of Heads Creek Rd, guardrail post wash-out.

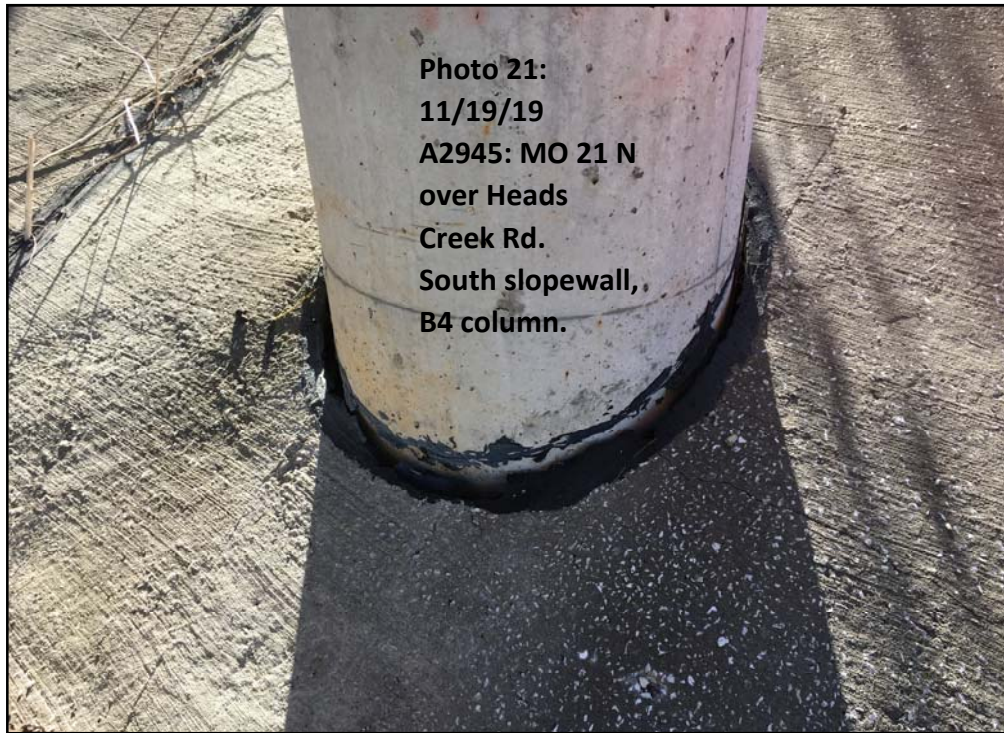
Photo 21:
11/19/19
A2945: MO 21 N
over Heads
Creek Rd.
South slopewall,
B4 column.
