Photo 1: 12/23/2019
A5530: Rte. 21 SB over Rte. M
Gen. view looking South

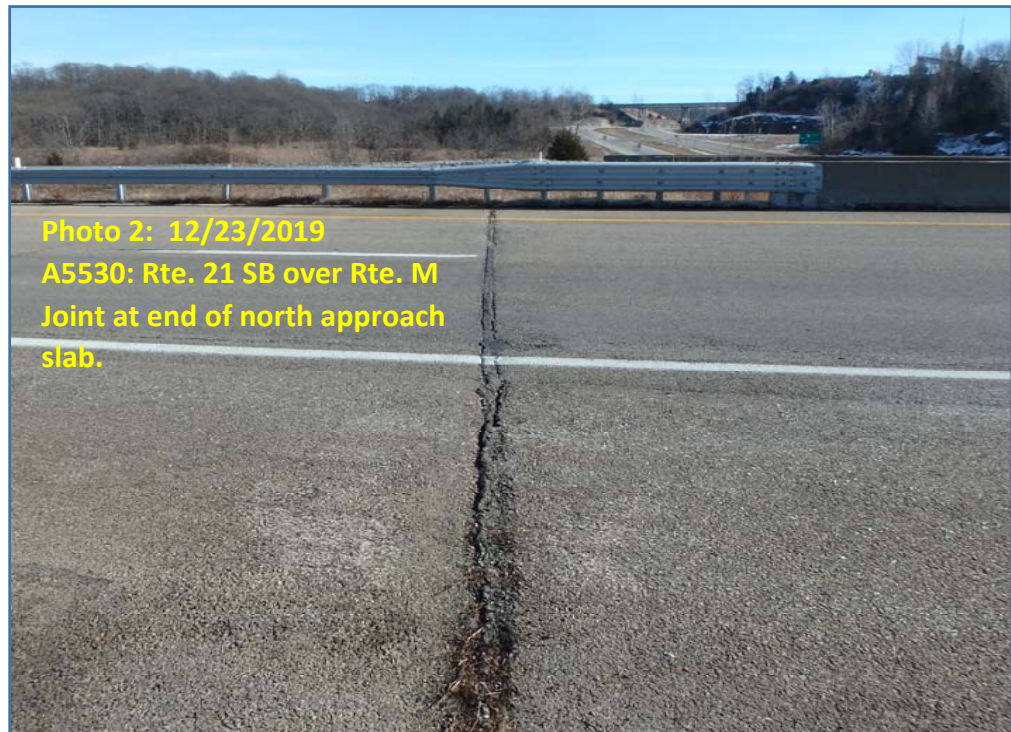
Photo 2: 12/23/2019
A5530: Rte. 21 SB over Rte. M
Joint at end of north approach
slab.

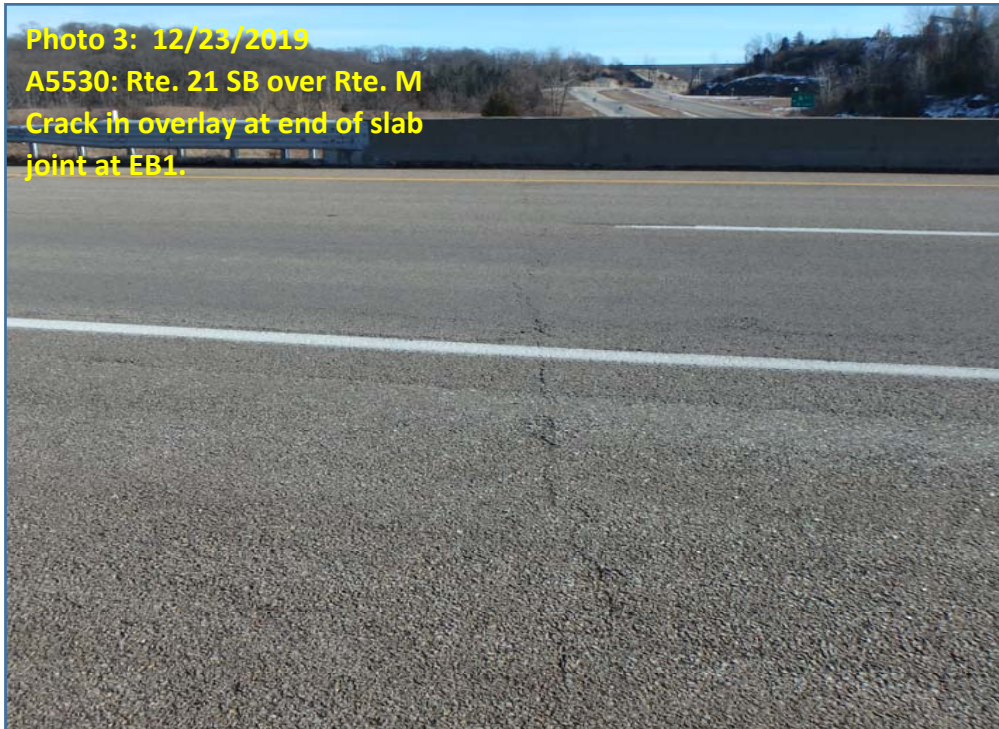
Photo 3: 12/23/2019
A5530: Rte. 21 SB over Rte. M
Crack in overlay at end of slab
joint at EB1.

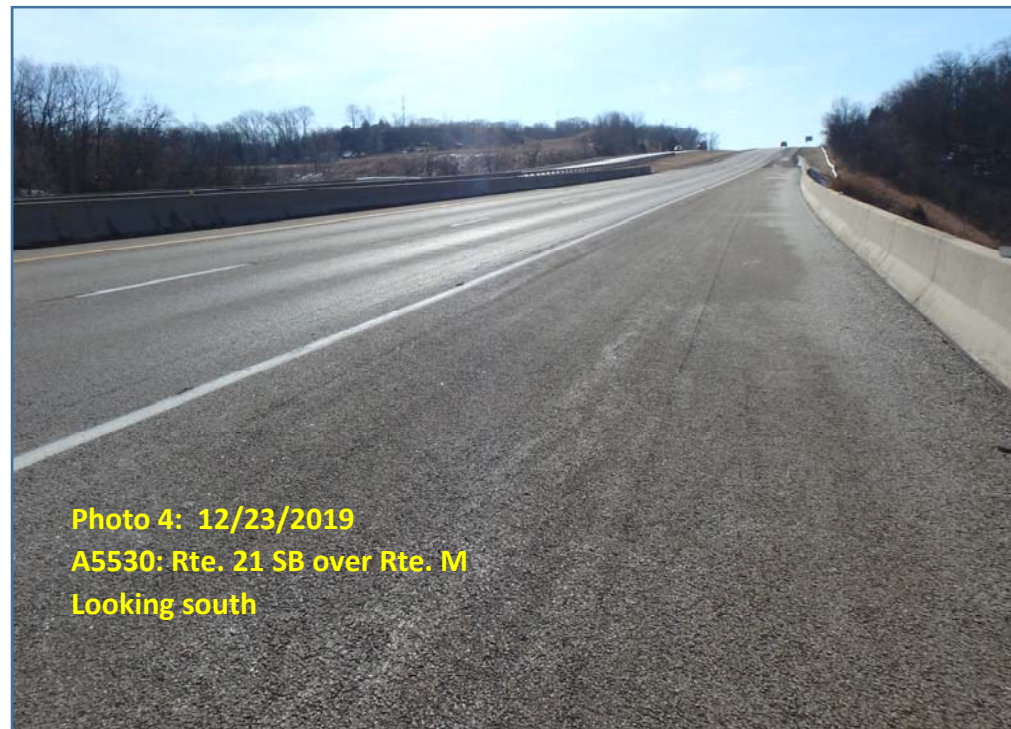
Photo 4: 12/23/2019
A5530: Rte. 21 SB over Rte. M
Looking south

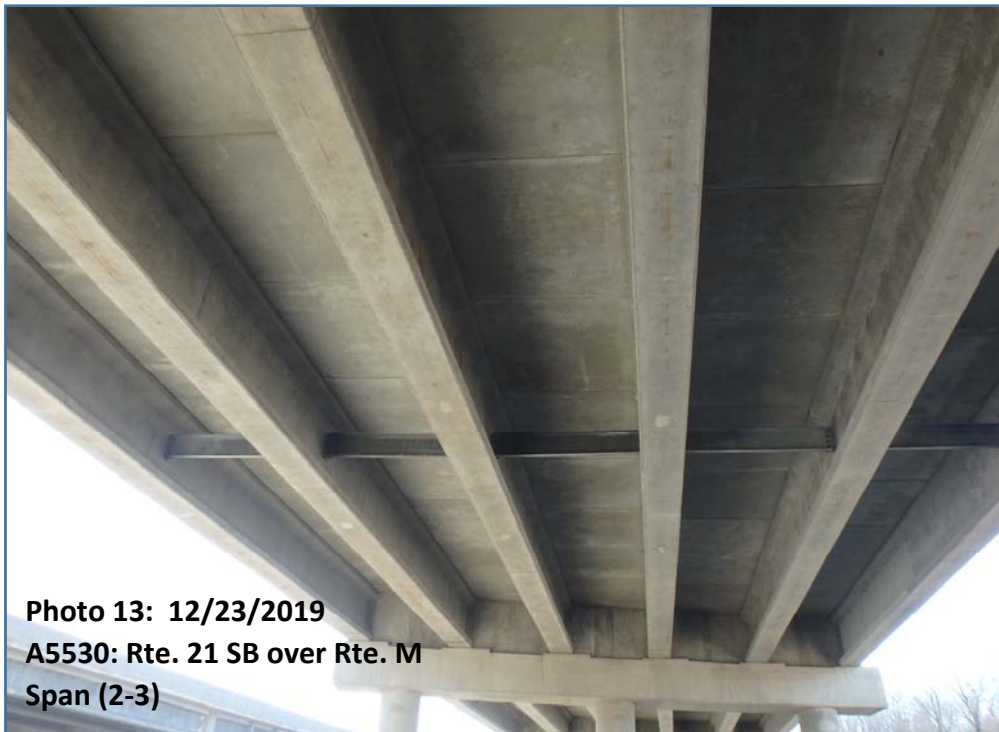
Photo 13: 12/23/2019
A5530: Rte. 21 SB over Rte. M
Span (2-3)

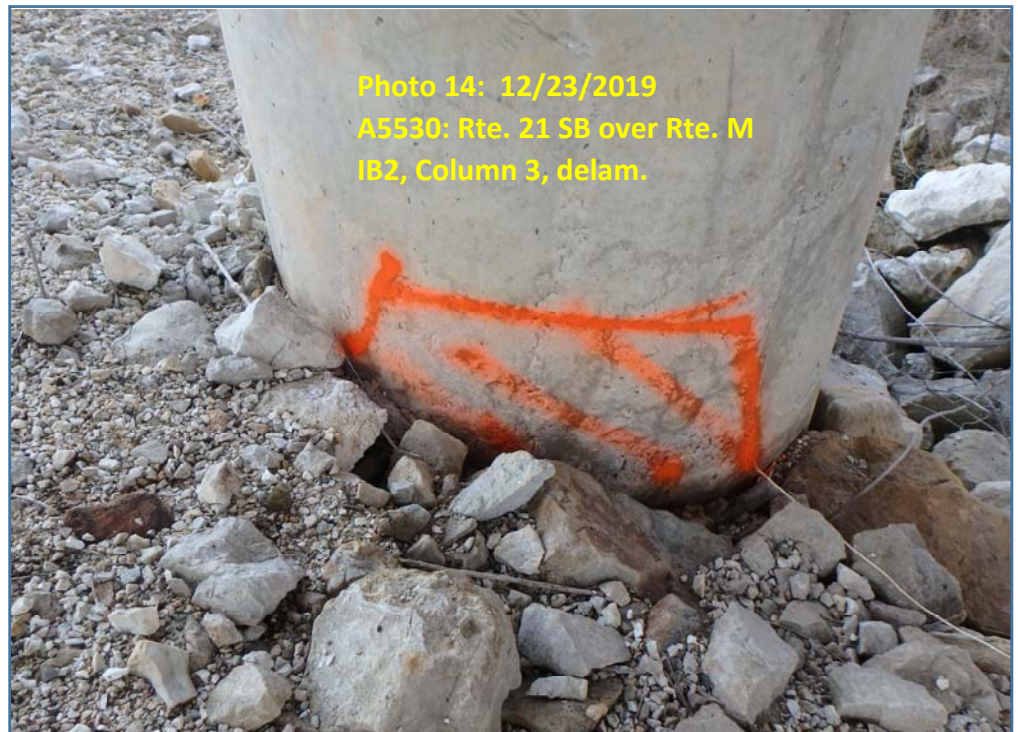
Photo 14: 12/23/2019
A5530: Rte. 21 SB over Rte. M
IB2, Column 3, delam.

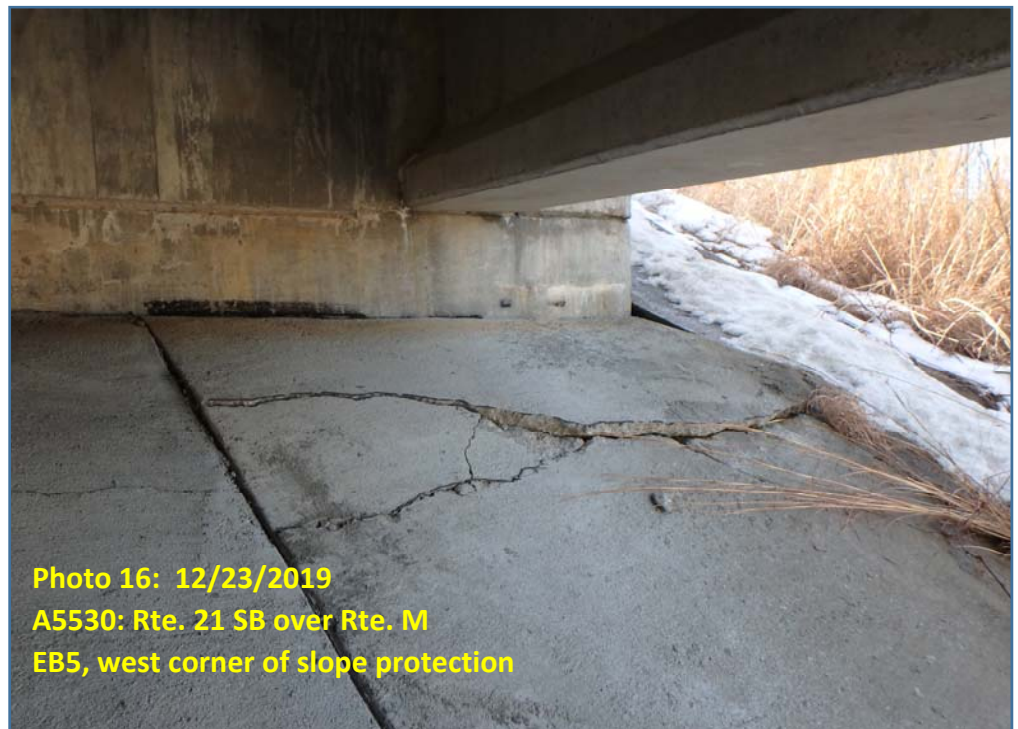
Photo 16: 12/23/2019
A5530: Rte. 21 SB over Rte. M
EB5, west corner of slope protection

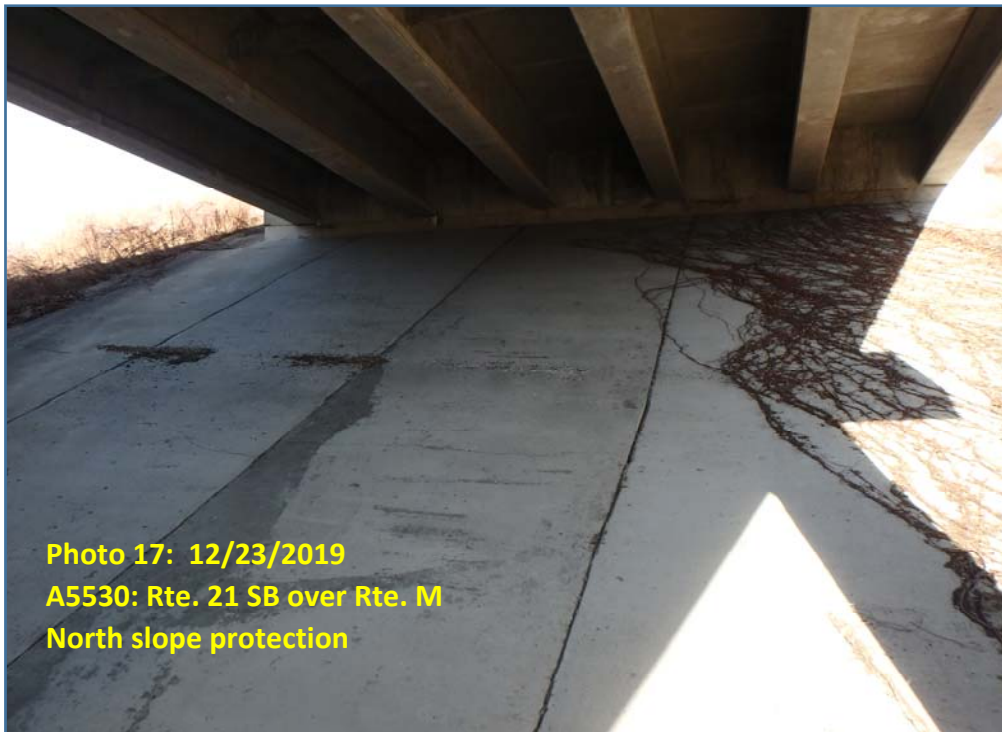
Photo 17: 12/23/2019
A5530: Rte. 21 SB over Rte. M
North slope protection

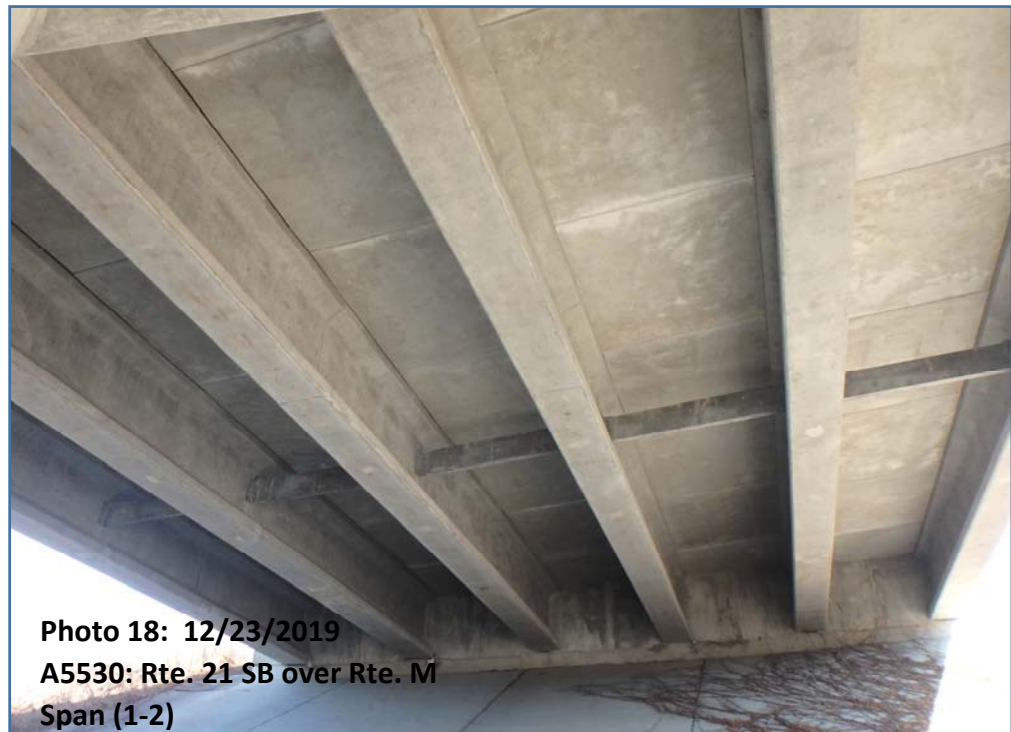
Photo 18: 12/23/2019
A5530: Rte. 21 SB over Rte. M
Span (1-2)

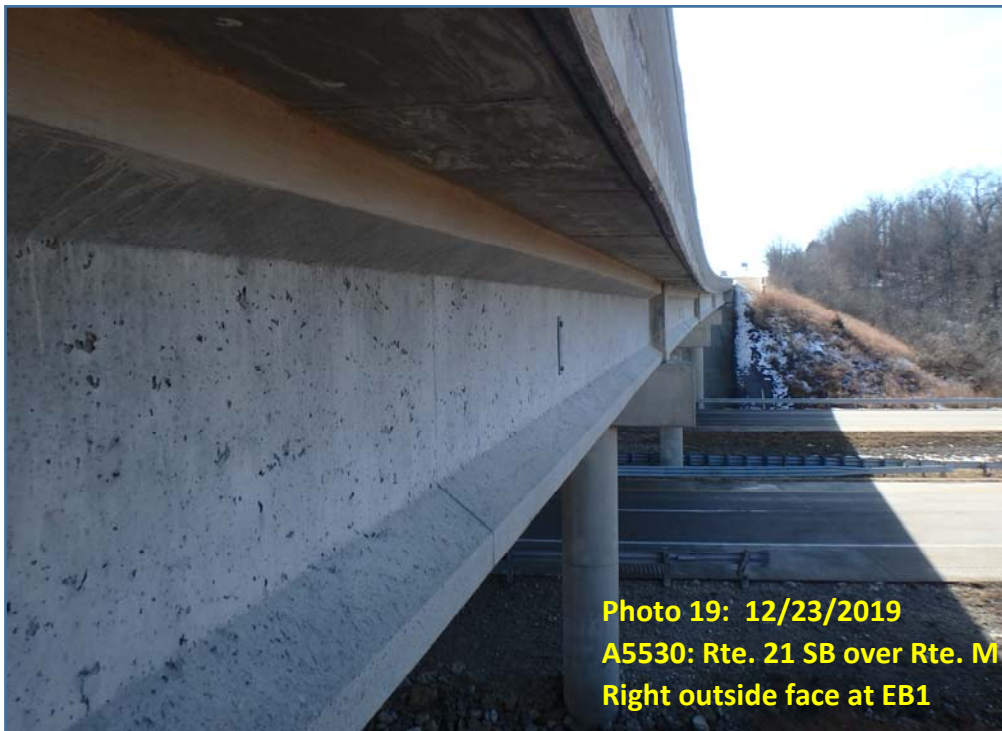
Photo 19: 12/23/2019
A5530: Rte. 21 SB over Rte. M
Right outside face at EB1

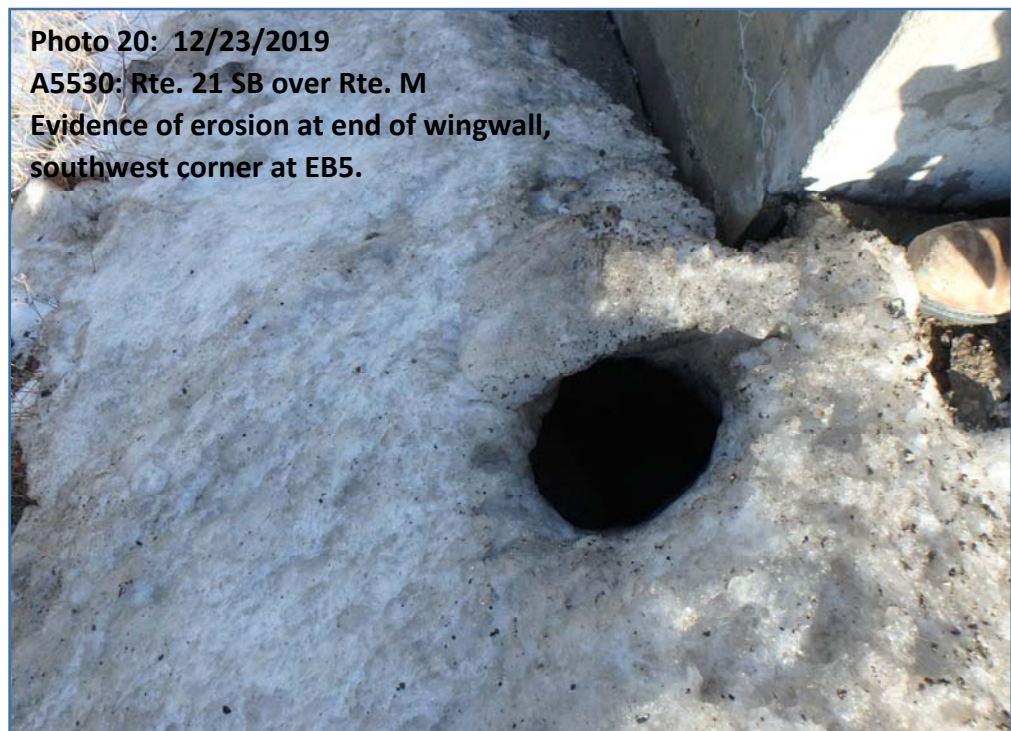
Photo 20: 12/23/2019
A5530: Rte. 21 SB over Rte. M
Evidence of erosion at end of wingwall,
southwest corner at EB5.
