Photo 1: 11/19/19
A2944: MO 21 over Heads
Creek Rd.
General view

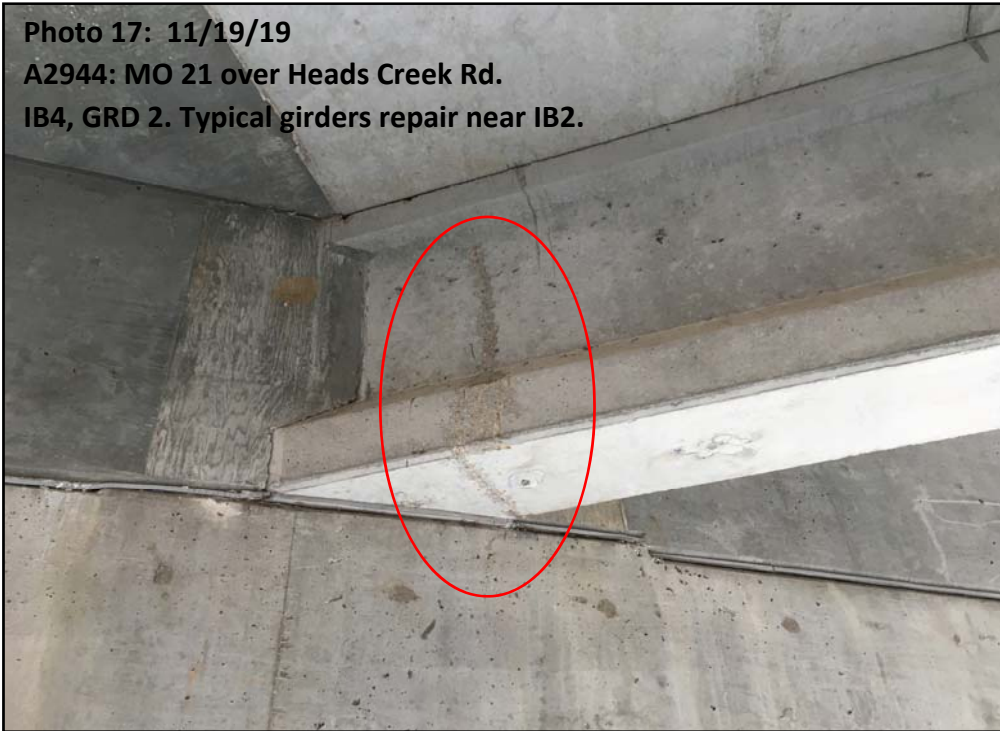
Photo 17: 11/19/19
A2944: MO 21 over Heads Creek Rd.
IB4, GRD 2. Typical girders repair near IB2.

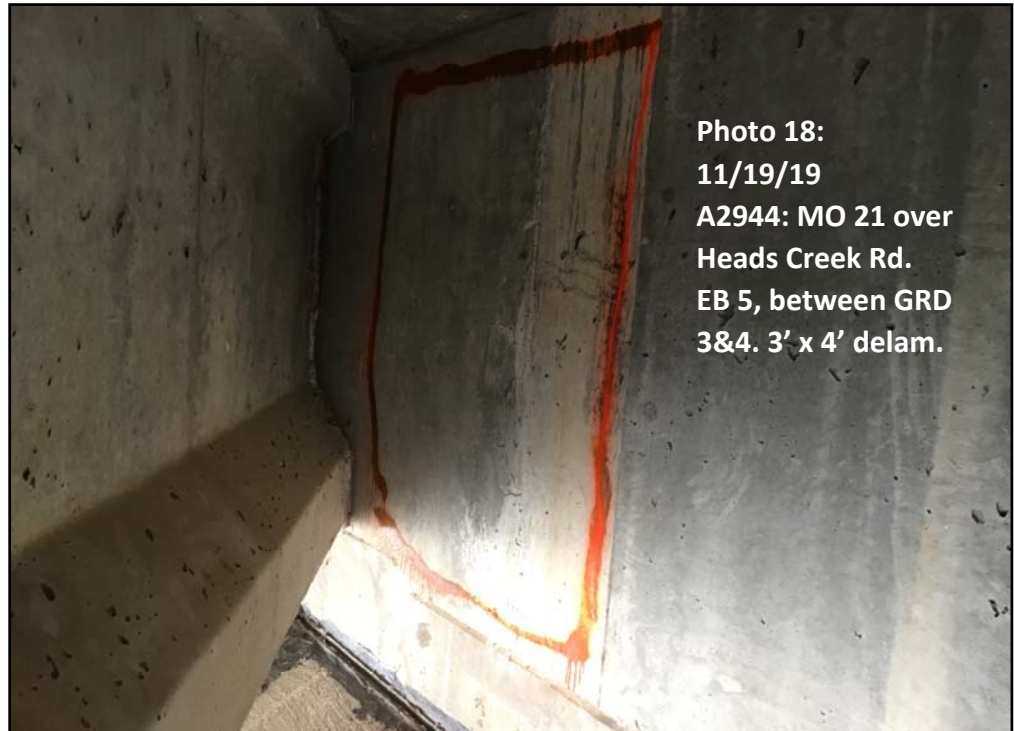
Photo 18:
11/19/19
A2944: MO 21 over
Heads Creek Rd.
EB 5, between GRD
3&4. 3' x 4' delam.

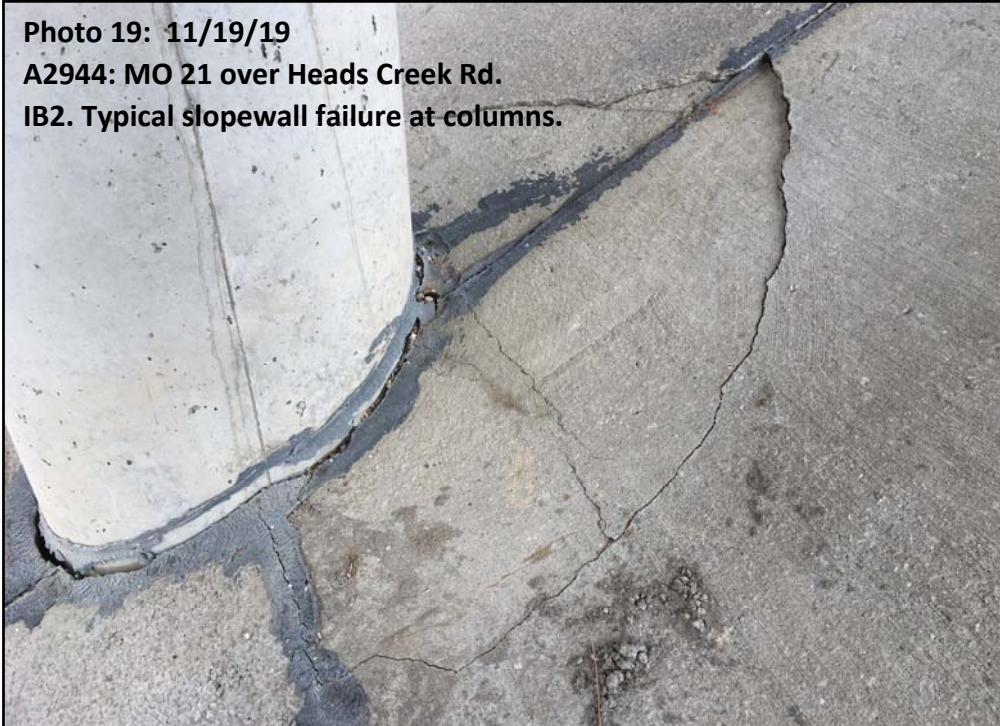
Photo 19: 11/19/19
A2944: MO 21 over Heads Creek Rd.
IB2. Typical slopewall failure at columns.

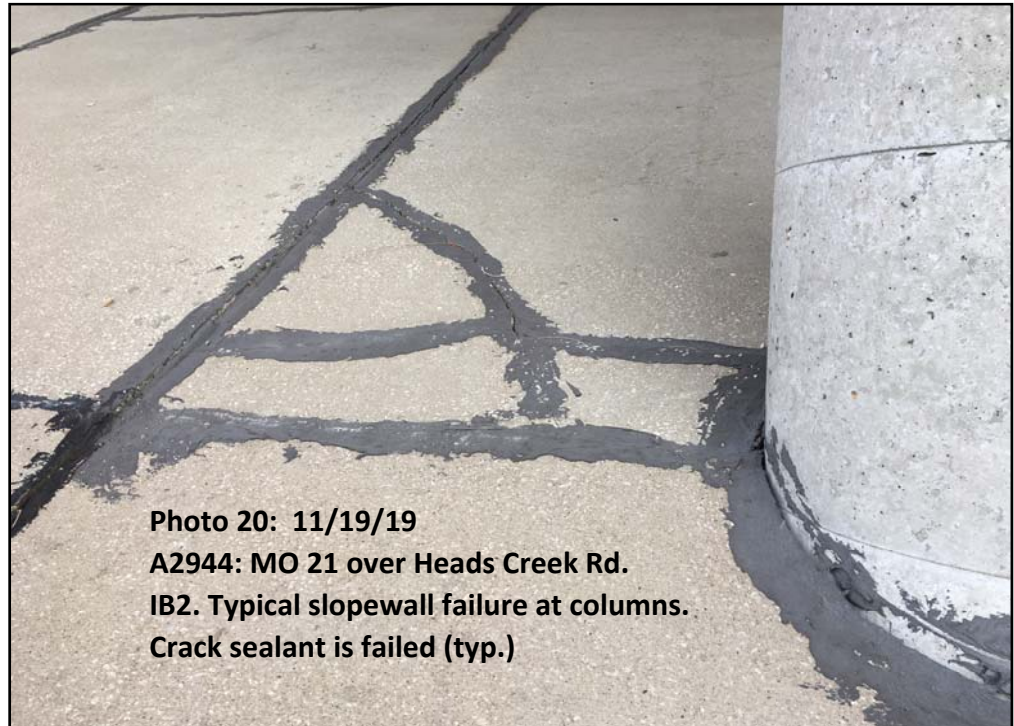
Photo 20: 11/19/19
A2944: MO 21 over Heads Creek Rd.
IB2. Typical slopewall failure at columns.
Crack sealant is failed (typ.)
