Bridge Deck Condition Evaluations

Structures: A4294 & A5045

Job Number: J6S3488

FINAL REPORT

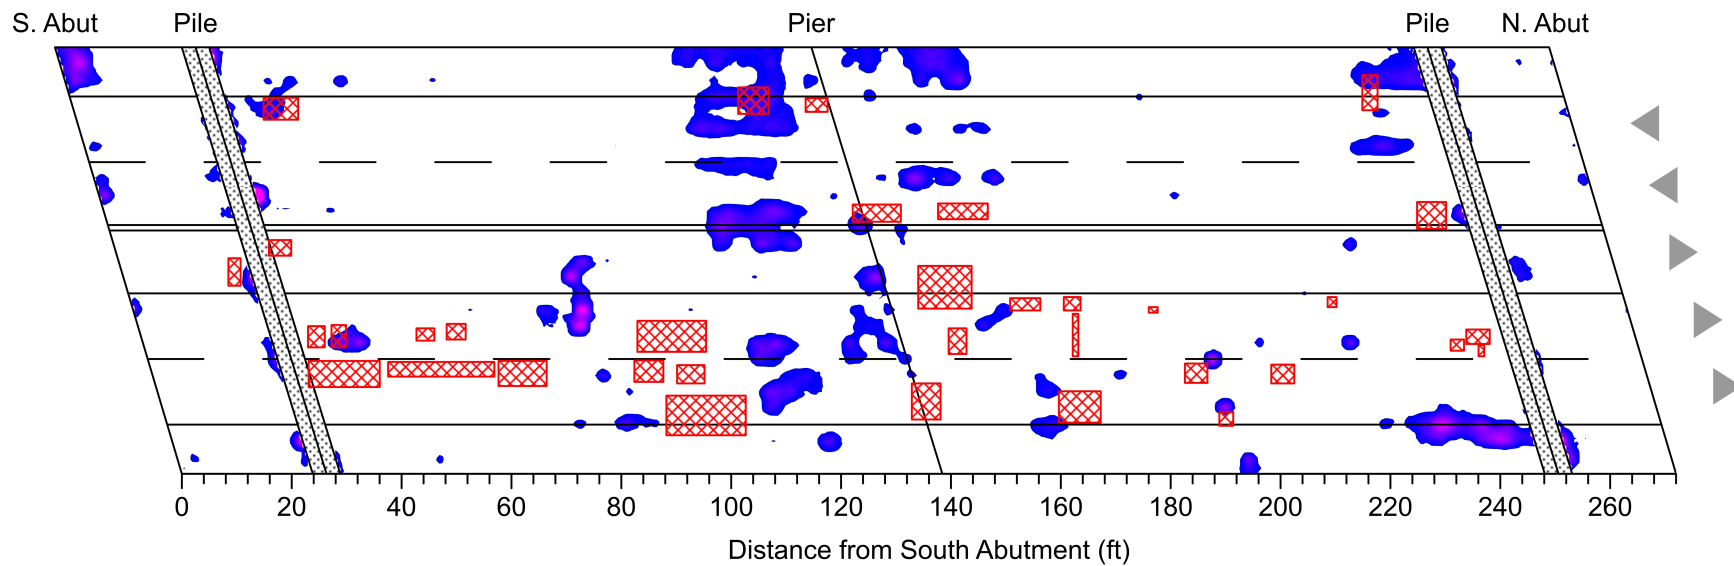
Condition Quantities	sq. ft.	%	Bridge ID: A4294 MO 79 over I-70
Increasing severity -->		GPR Deterioration	1520.0	7.5	Analyzed by: STB Reviewed by: AJC Completed: 7/27/2020

Delamination detected by IR		Delaminations	845.3	4.0	Sheet 1 of 1

Patching		Patching	0.0	0.0

Spalling		Spalling	0.0	0.0

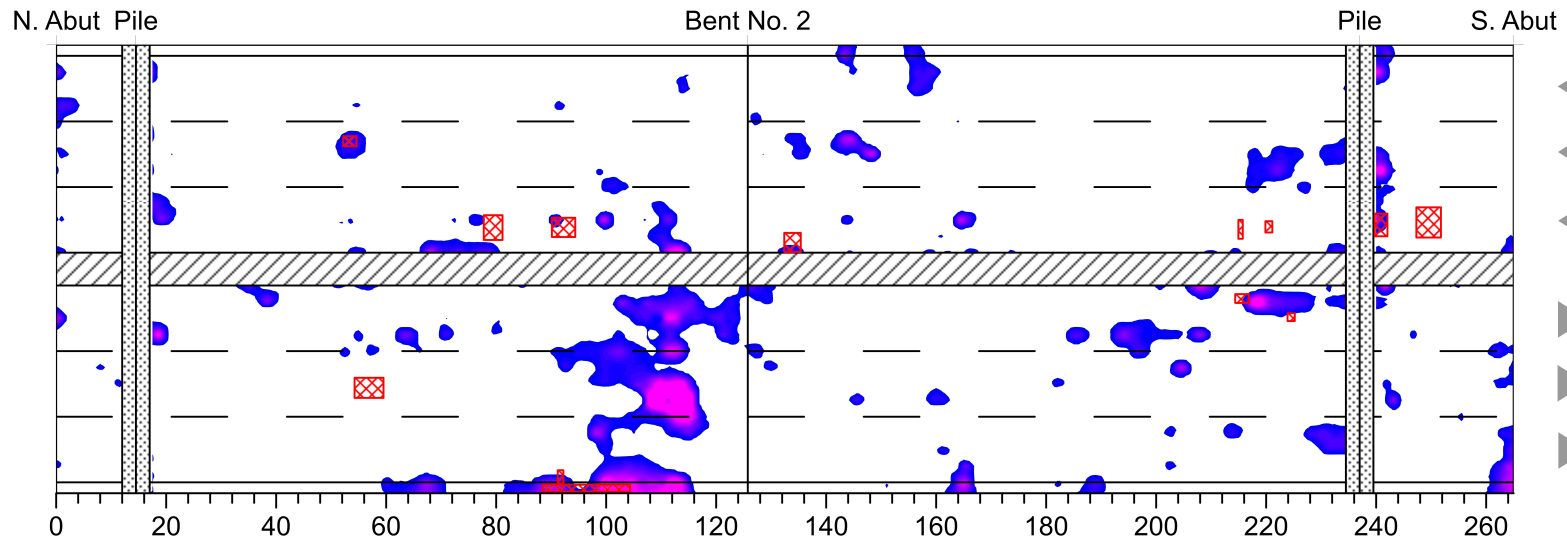
Conditions Legend			Orientation	Quantity Summary			General Information	
<div>Rebar-level deterioration detected by GPR</div> <div>Increasing severity --></div> <div></div> <div>Condition not detectable by GPR</div>	<div></div>	Delamination detected by IR	<div></div> <div>Direction of traffic</div>	Condition Quantities	sq. ft.	%	Bridge ID: A5045 Bryan Rd. over I-70	
	<div></div>	Patching		GPR Deterioration	1531.8	7.9		
	<div></div>	Spalling		Delaminations	132.8	0.6	Analyzed by: STB Reviewed by: AJC Completed: 7/23/2020	
				Patching	0.0	0.0		
				Spalling	0.0	0.0	Sheet 1 of 1
