**Route 19 over Current River (Br. G0804)  
Rehabilitation / Replacement Concept Study  
Report of Field Investigation**

**MoDOT Project No.: J9P3305**

**Route 19 over Spring Valley (Br. J0420)  
Rehabilitation / Replacement Concept Study  
Report of Field Investigation**

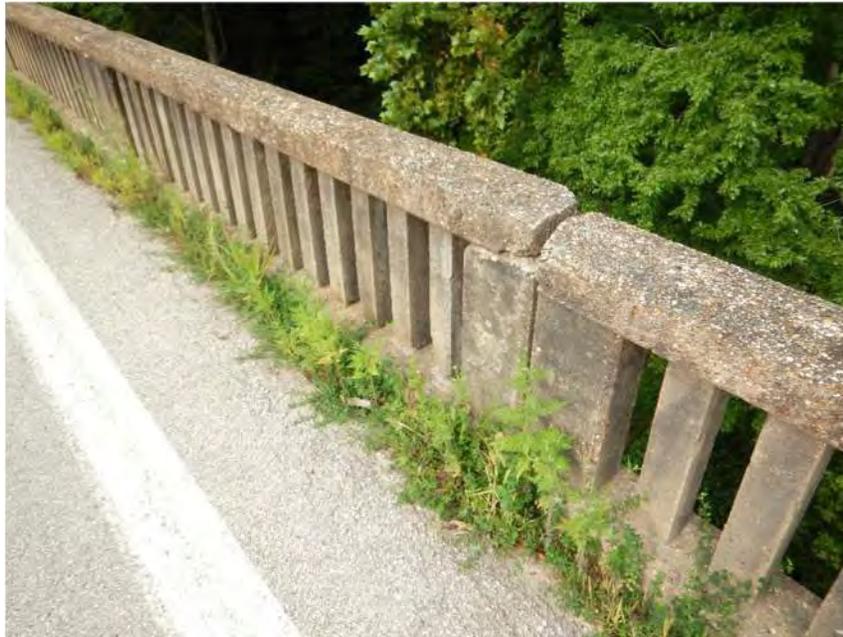
Collision Damage to the Railing

- Replacement of the barrier and the wearing surface.
- Improvement of the drainage system for the arch fill material.
- Replacement of the joint filler in the sidewalls.
- Repair or replacement of the numerous deteriorated brackets.
- Concrete repair and possible chloride remediation at deteriorated concrete areas and areas of high chloride levels in walls, piers and arches.
- Fill and protection of the observed scour holes

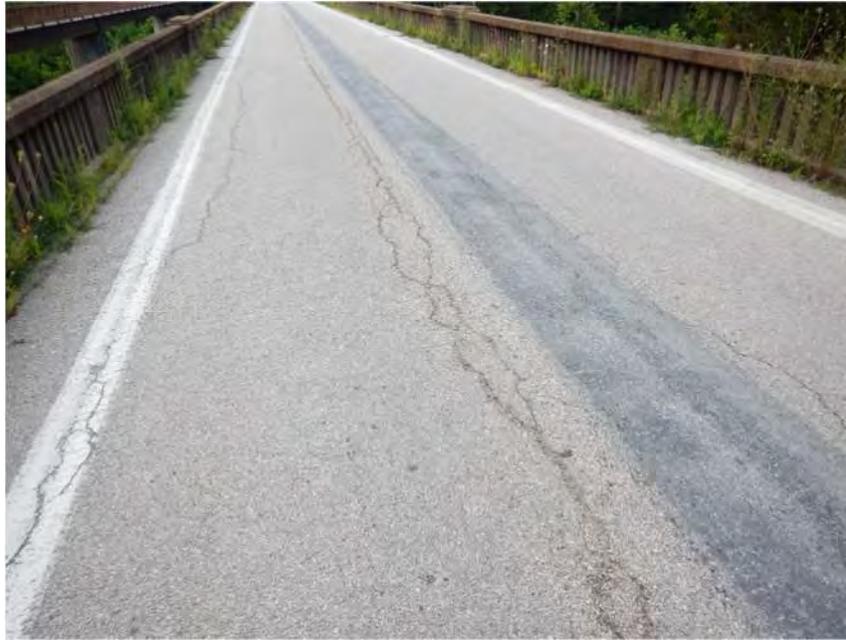
Condition of Wearing Surface

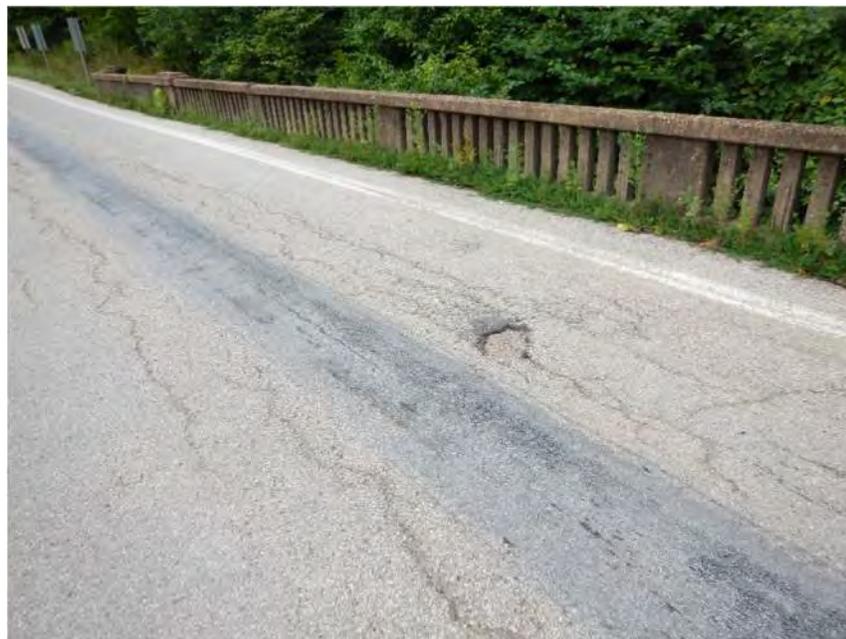
Deck Spall

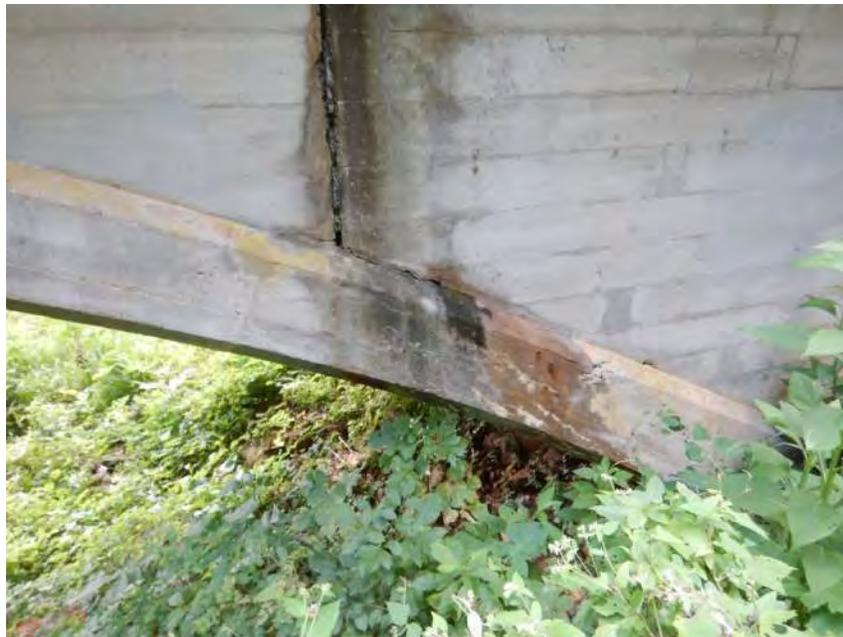
In general the arches are in good condition with areas of spalling and staining, primarily from leakage at the vertical joints in the sidewalls and the brackets. This leakage appears to be due in large part to the failure of the joint material between sections of the sidewall. The brackets supporting the deck cantilevers are heavily deteriorated throughout the structure. Several locations exhibit loss of up to 40% of the bracket area under the deck. Heavy spalling with exposed reinforcing steel is also prevalent.

Spalling and Staining on Arch Ring

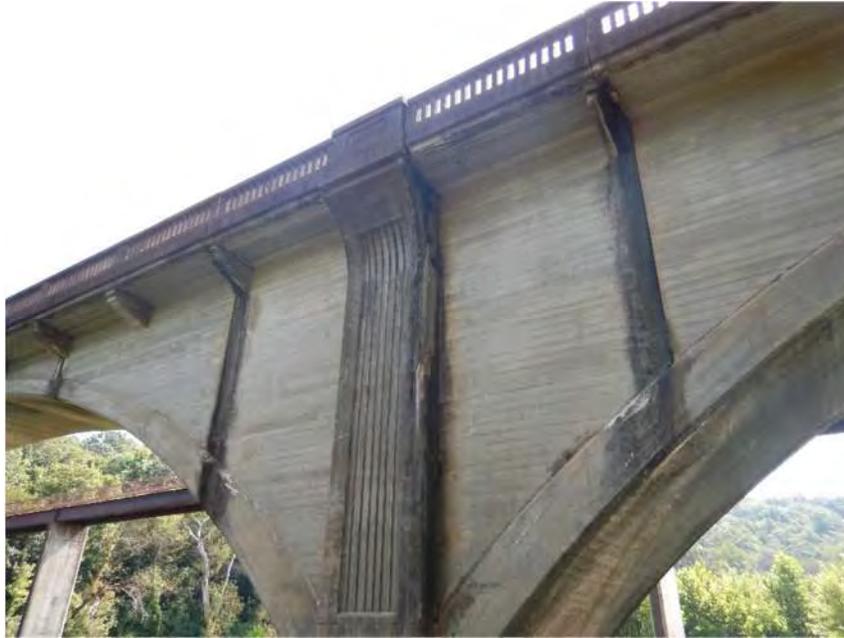
Leakage from Sidewall Joints

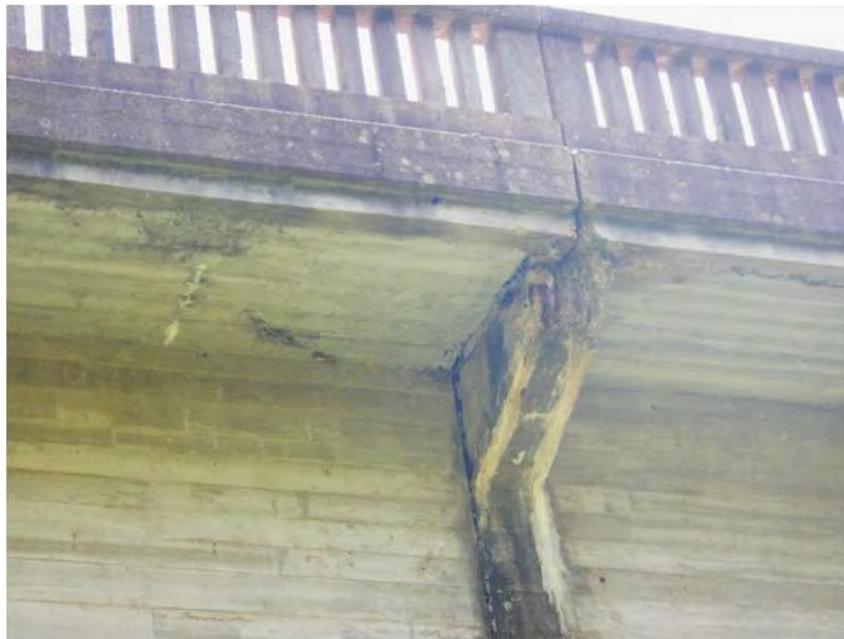
Heavy Deterioration with Loss of Bracket Support Area

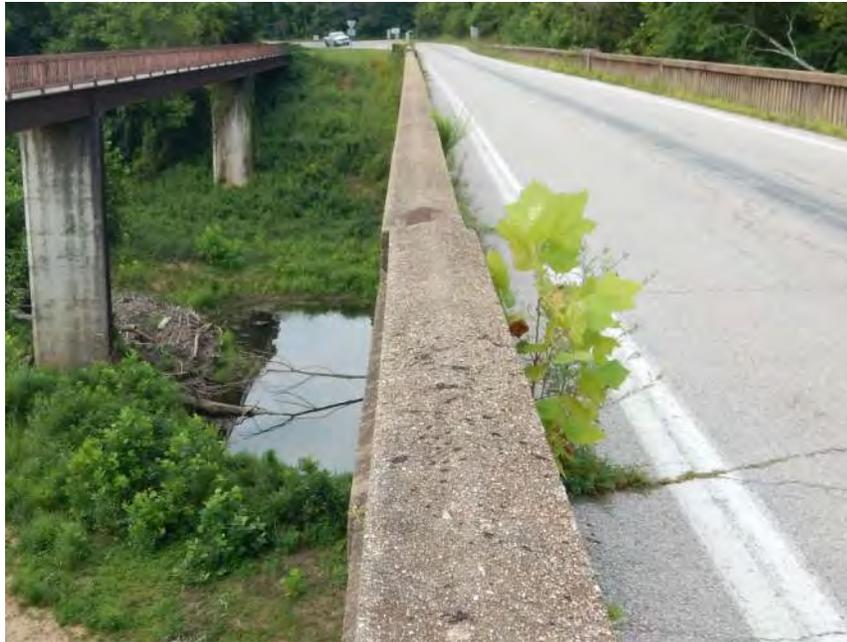
One additional observation on the superstructure was the differential lateral movement between the sidewall sections. The section of sidewall over the pier that extends to each joint is either connected from side to side with a floor beam or there are counterforts on the pier side of the joint. The wall that is on the opposite side of the joint is not likewise supported and appears to have deflected outward on the order of  $\frac{3}{4}$ " per side. This results in a face of barrier dimension approximate  $1\frac{1}{2}$ " wider than over the pier.

Differential Alignment of Barrier at Joints Adjacent to Pier

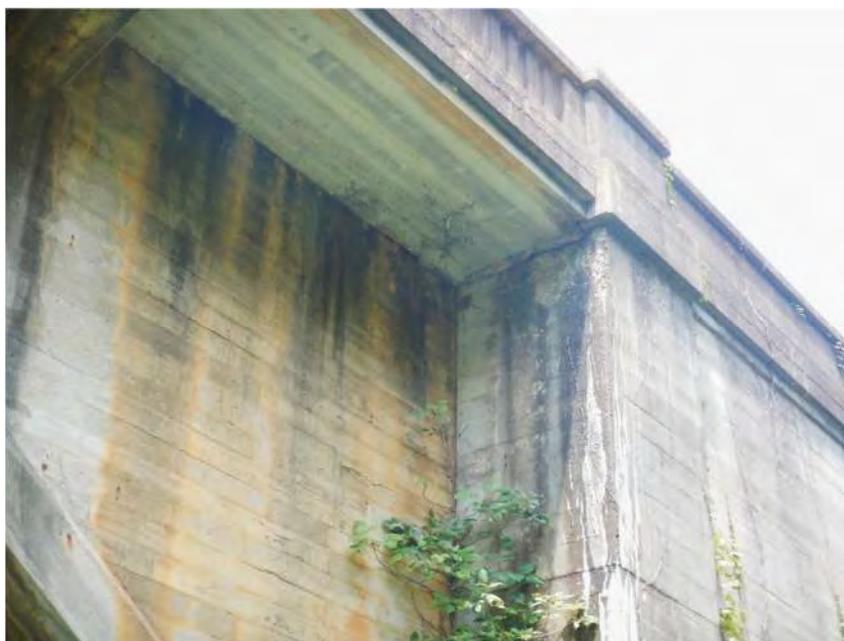
Typical Spalling at Abutment Corners

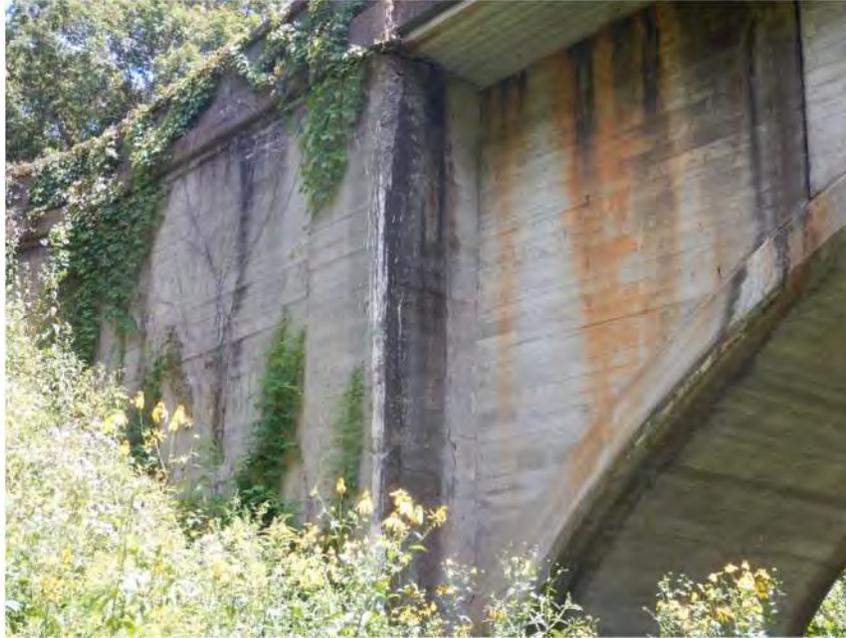
Cracking and Delamination at Abutments

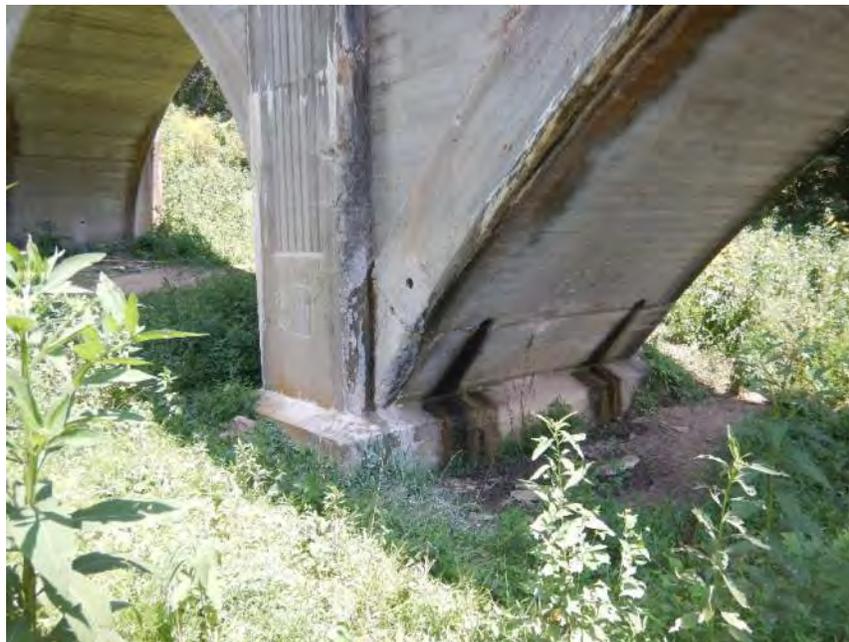
Scaling Along Pier Foundations

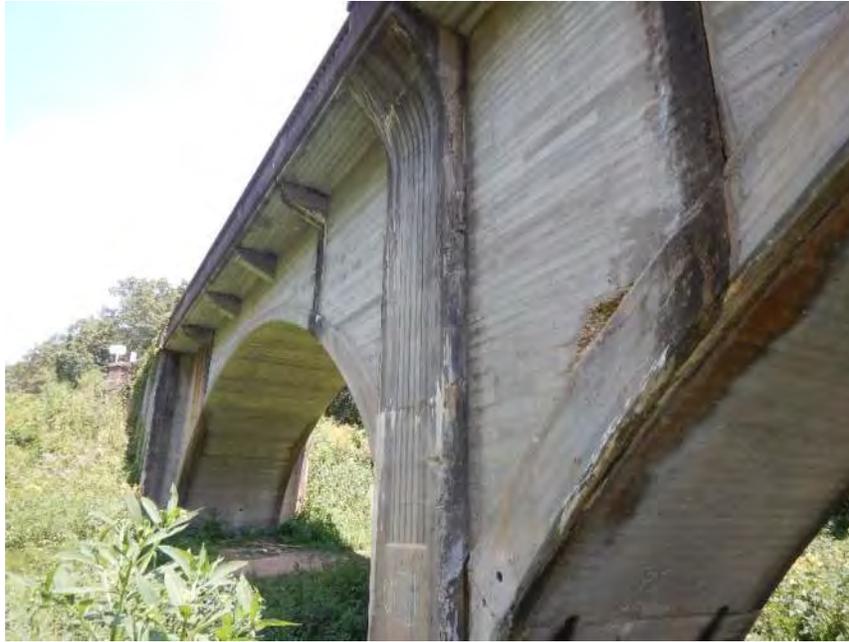
Spalling on Pier Surfaces

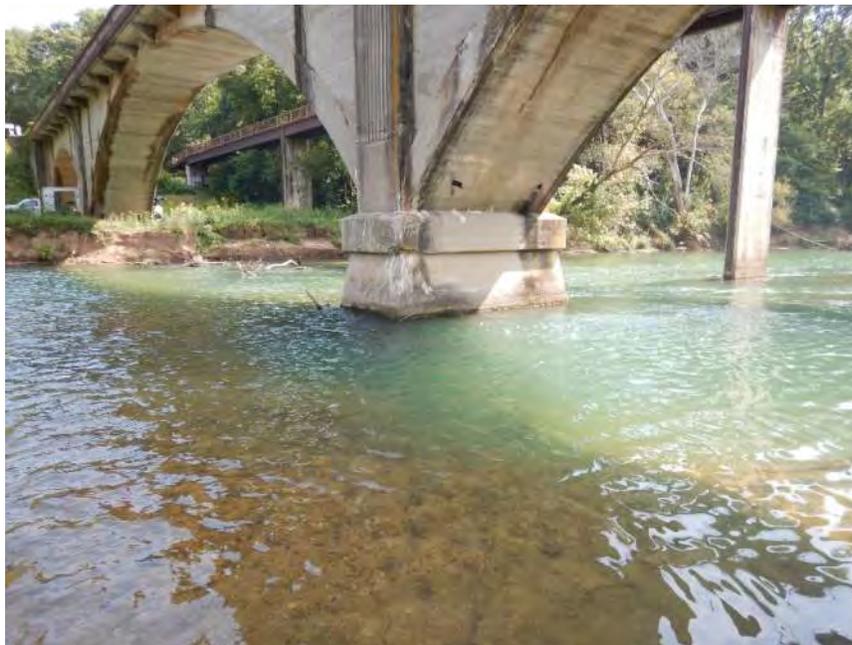
Scour Hole at Pier 3

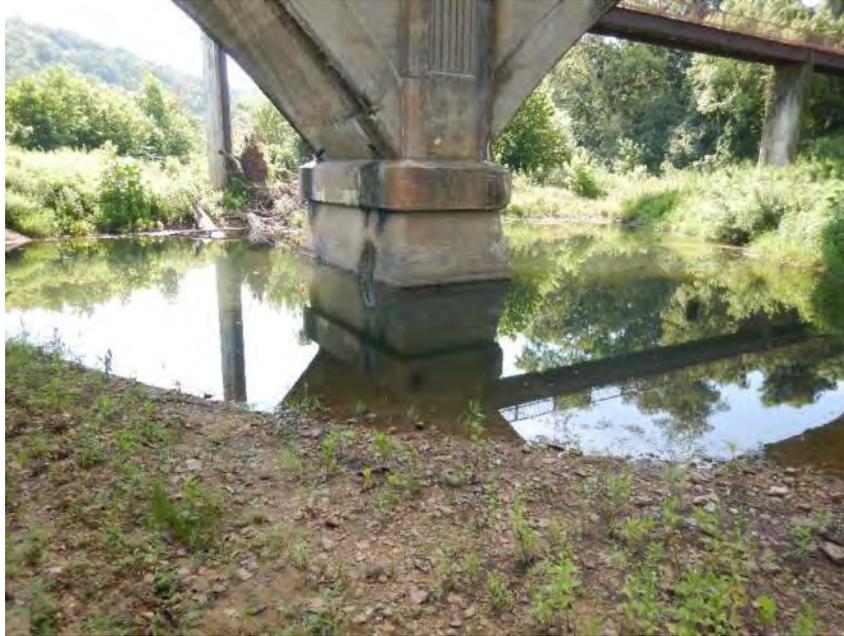
Scour Hole at Pier 4

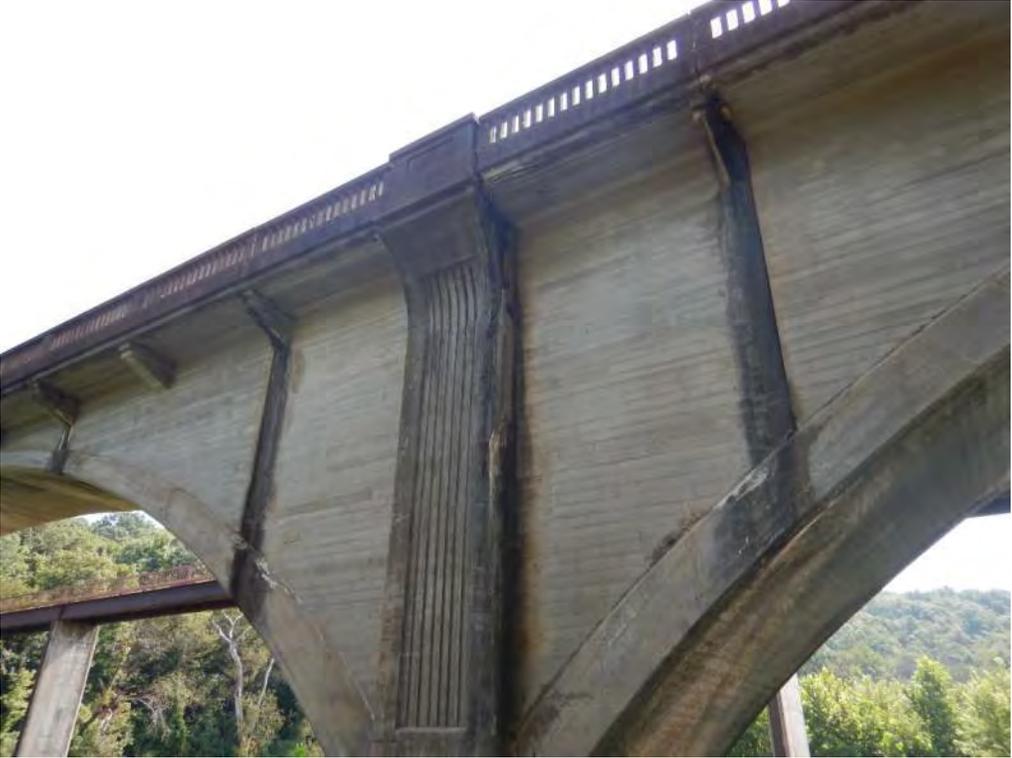
Pic. 002: Typical leakage from sidewall joints

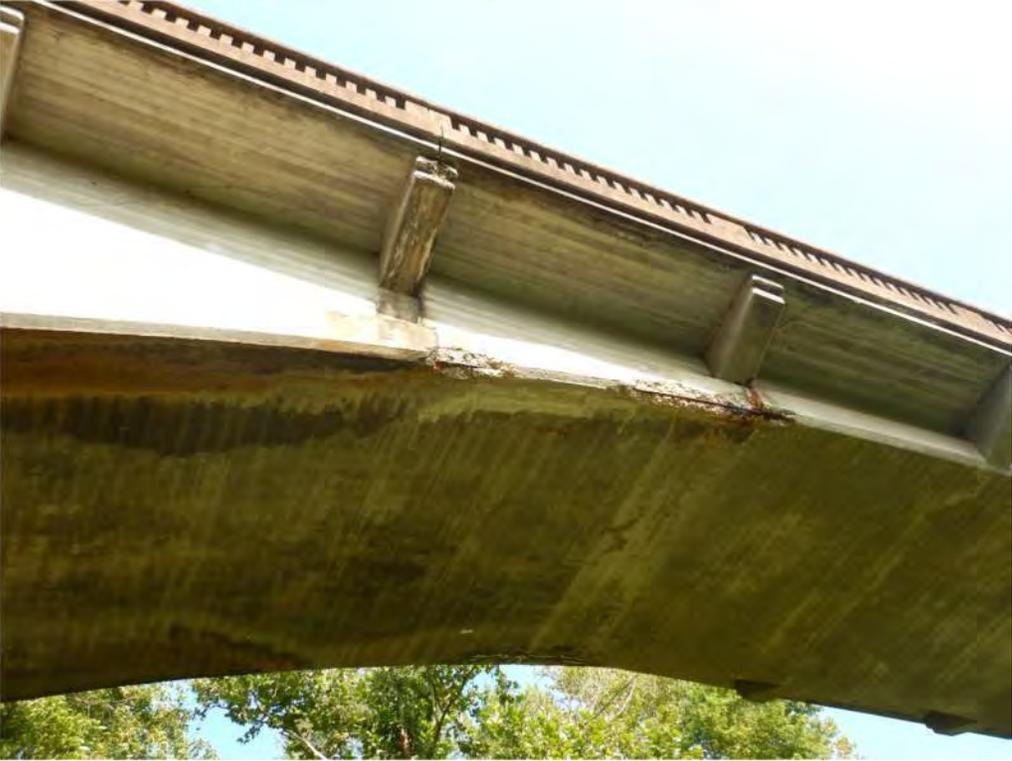
Pic. 005: Spalling along corner of arch ring, Span (4-5) east face

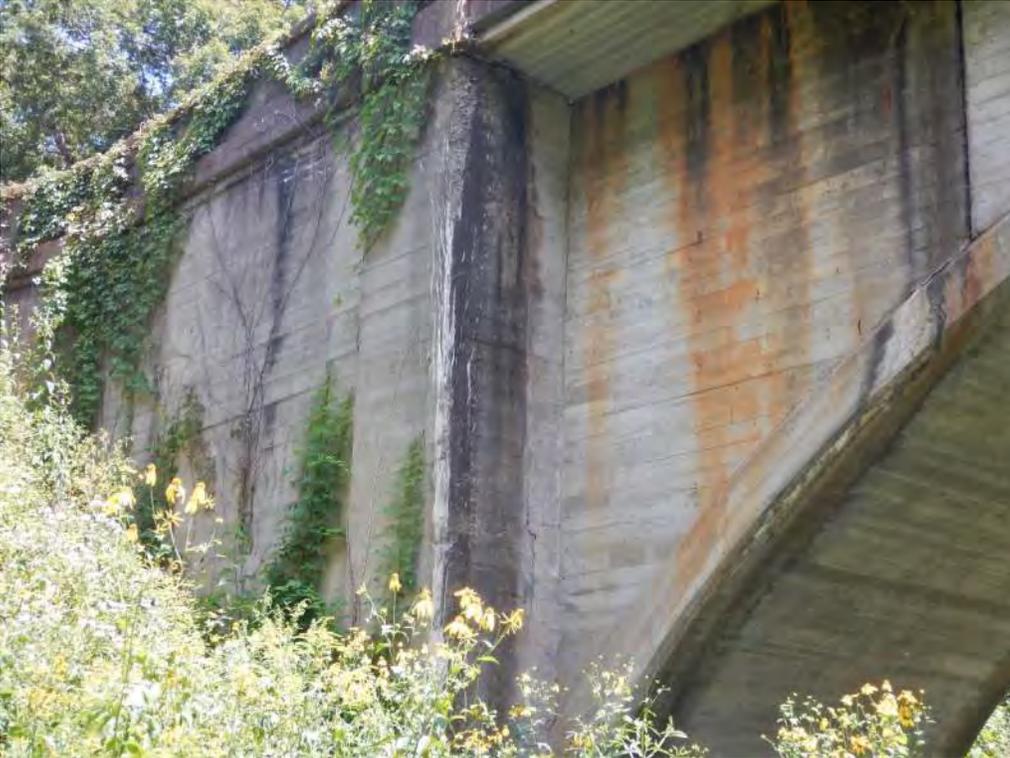
Pic. 007: Cracking and delamination, Abutment 1 west side

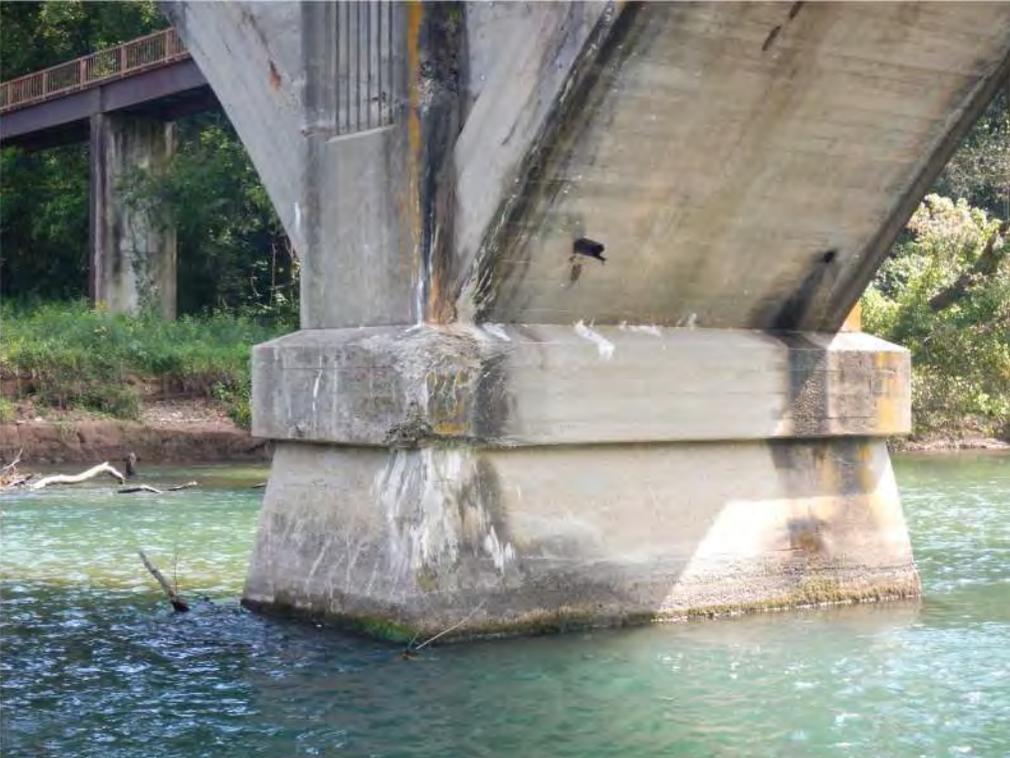
Pic. 008: Spalled and deteriorated concrete, Pier 3 west face

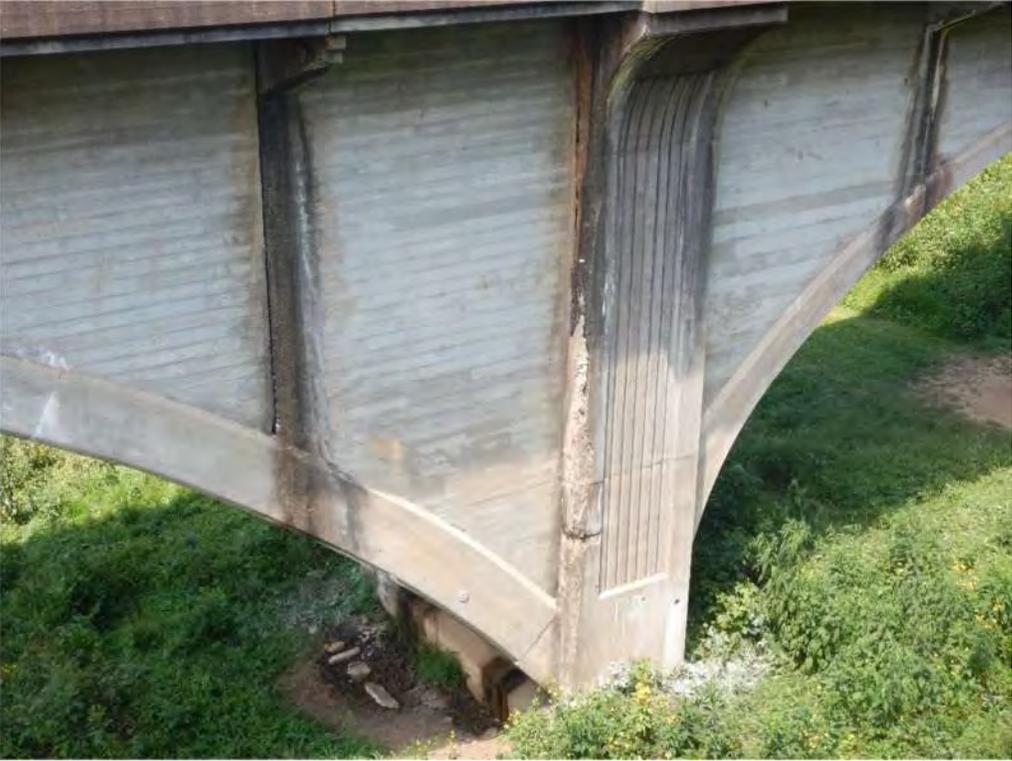
Pic. 009: Spalling and delamination on pilaster, Pier 2 east side

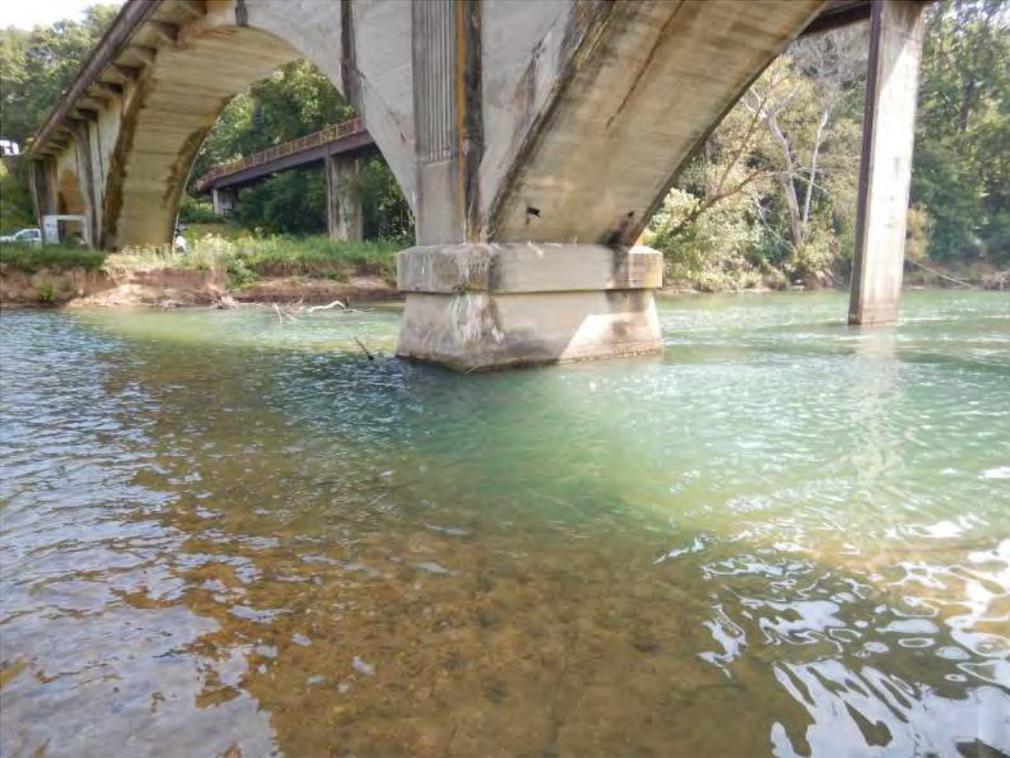
Pic. 011: Scour hole at Pier 3

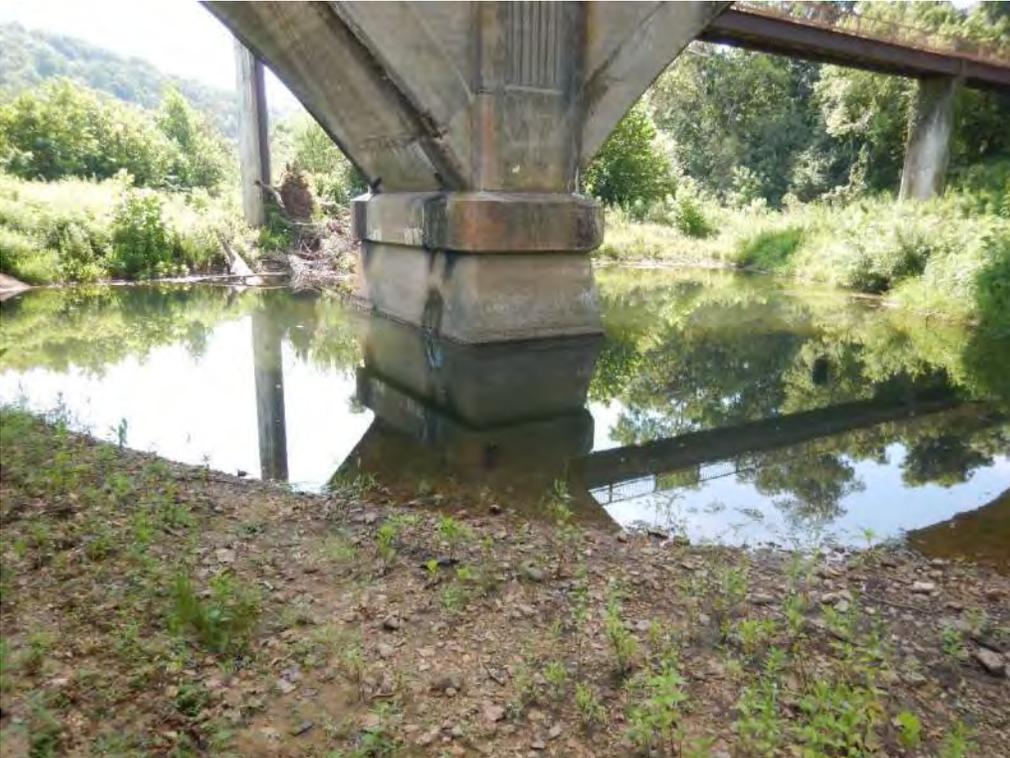
Pic. 012: Scour hole at Pier 4

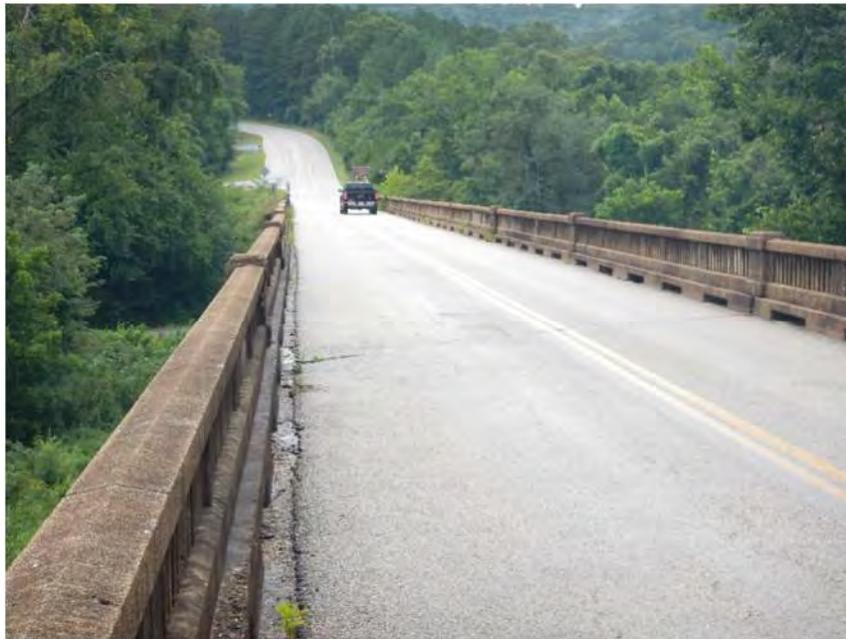
Collision Damage to the Railing

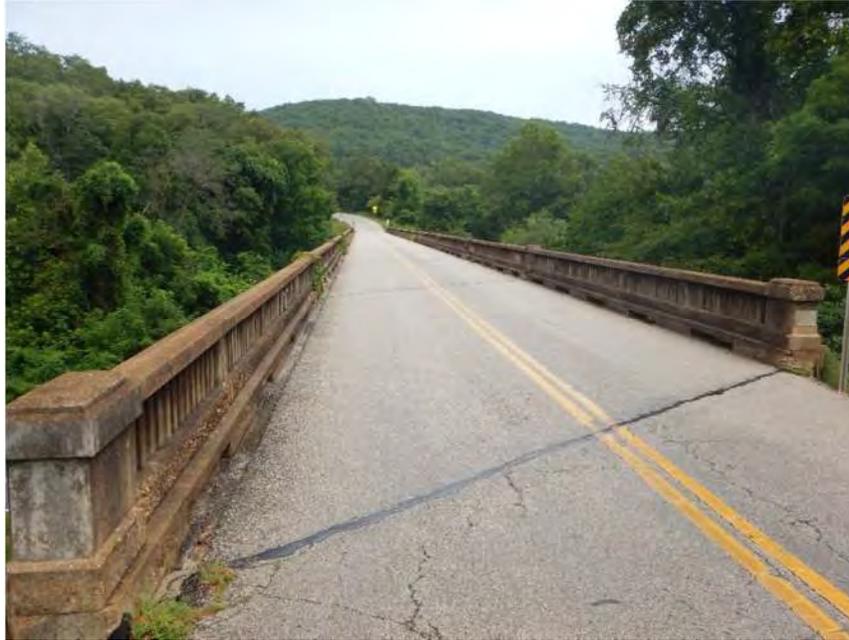
Condition of Wearing Surface

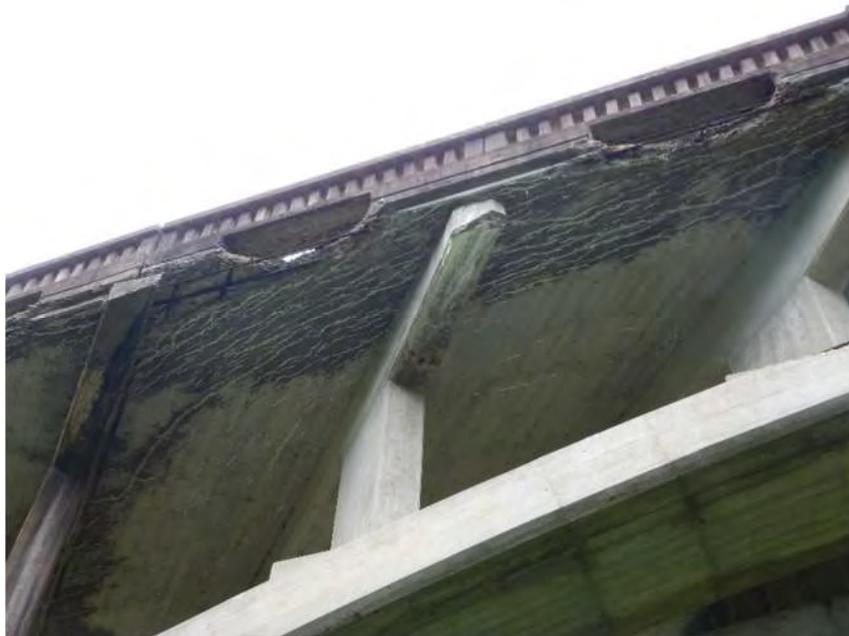
Heavy Deterioration of the Deck at Existing Drains

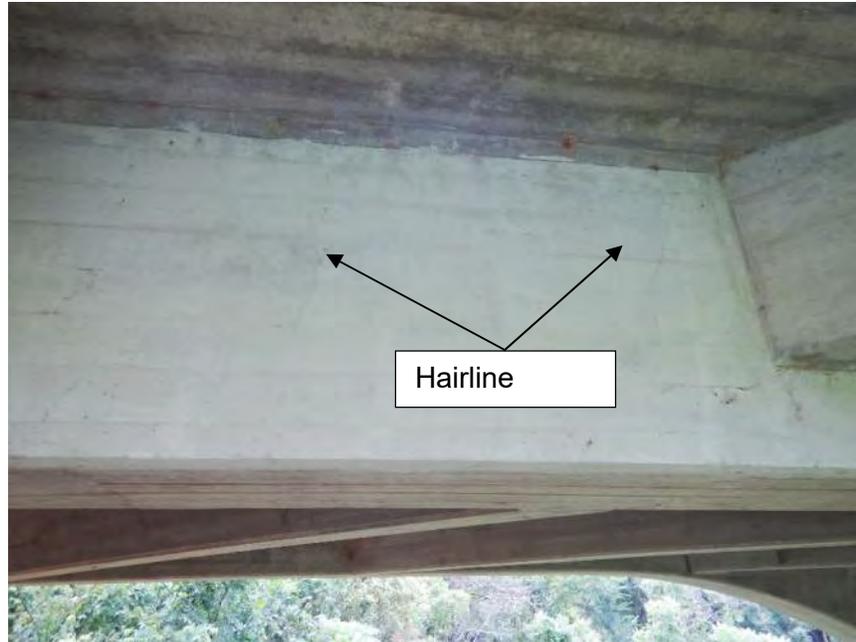
Typical Hairline Cracks in Girders

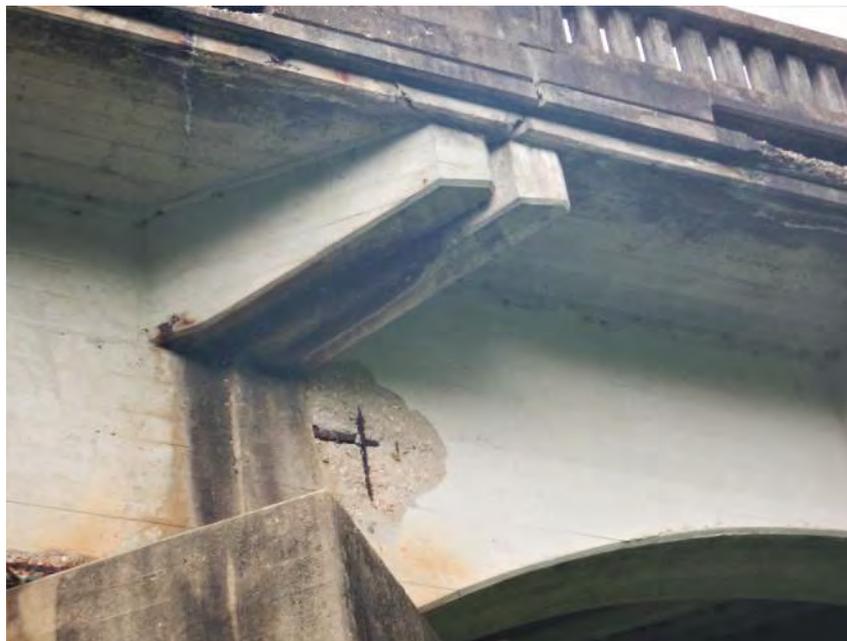
Typical Delamination on Girders

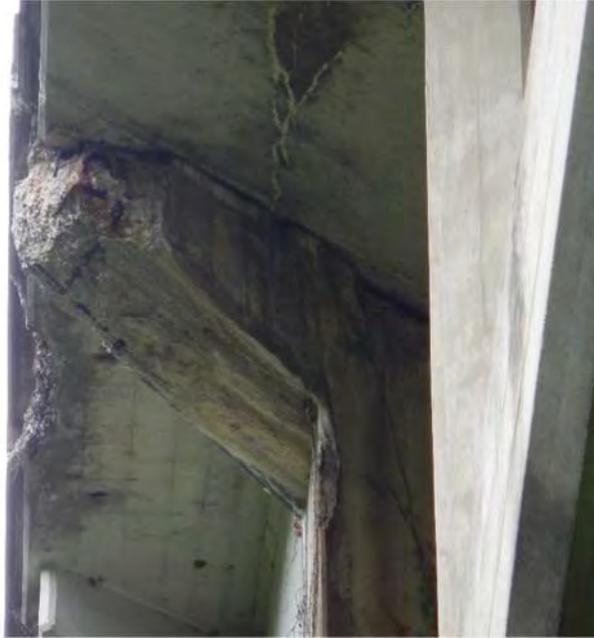
In general the concrete girders of Units 1 and 3 and the arch ribs of Unit 2 are in good condition with areas of spalling, hairline cracking, delamination and staining, primarily from drainage from the deck. The brackets supporting the deck cantilevers are deteriorated throughout the structure.

Typical Deterioration of Brackets

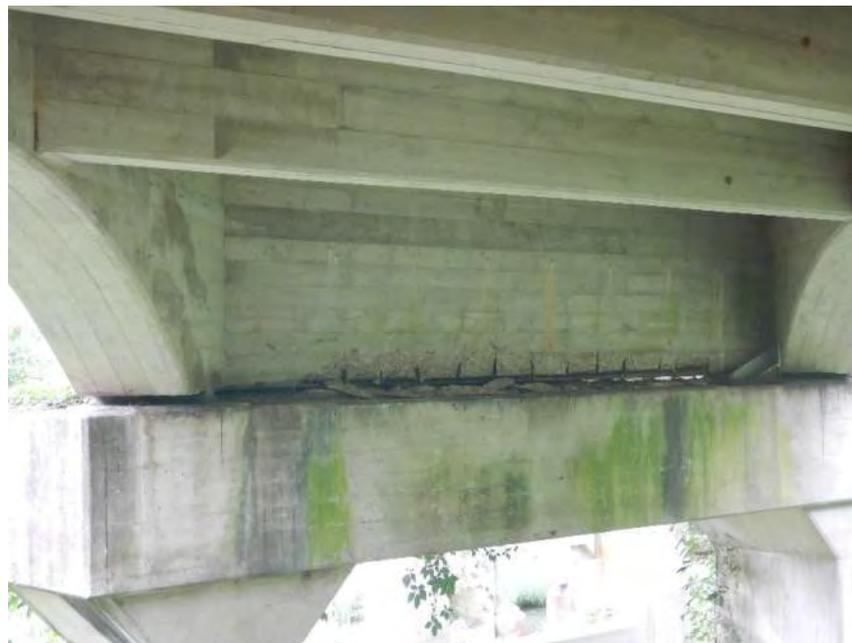
Deterioration of Floorbeams at Intermediate Bents

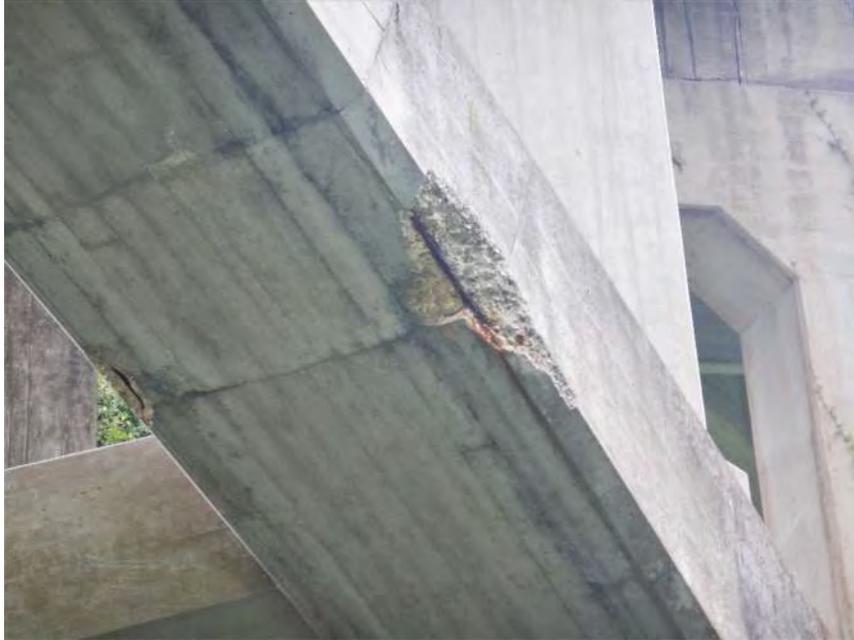
Spalling and Delamination of Arch Ribs

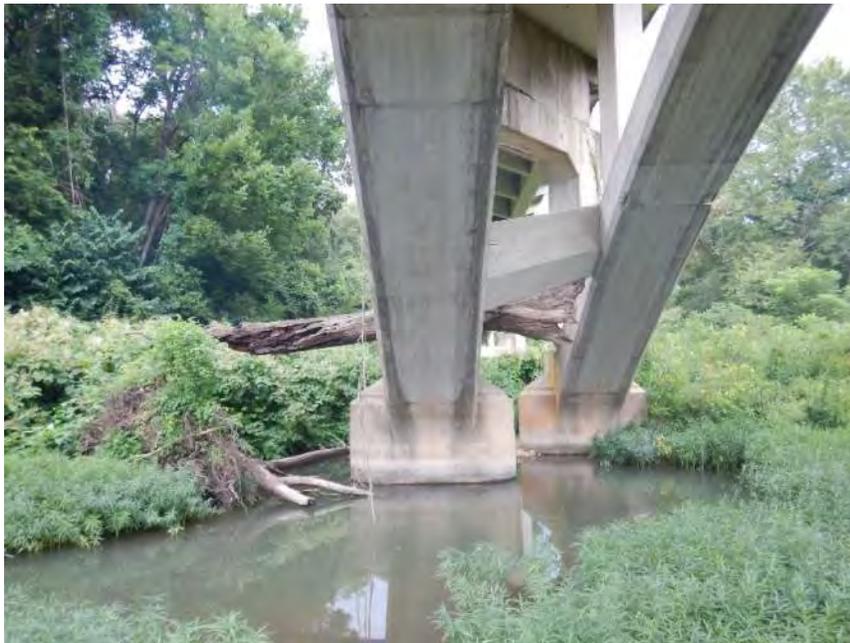
Drift in Structure

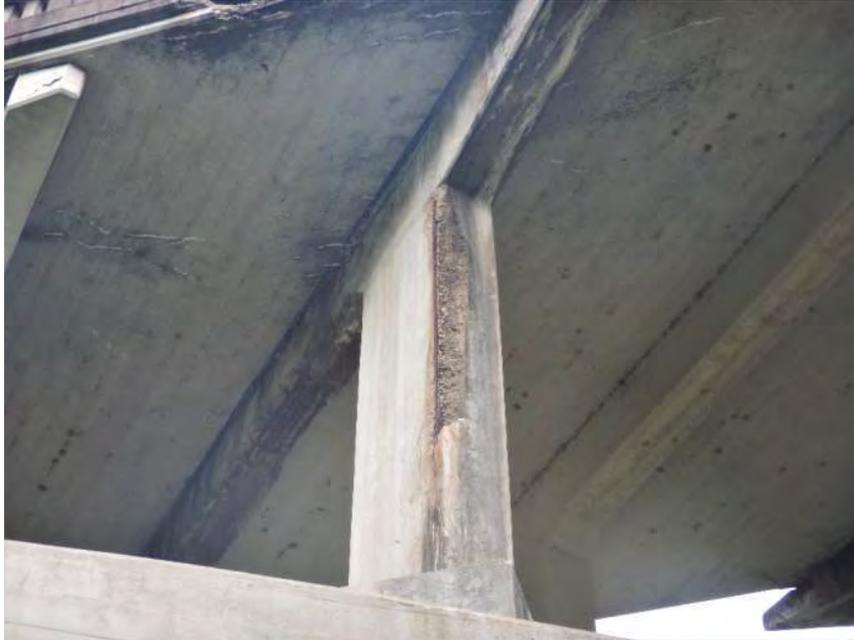
Typical Deterioration on Spandrel Columns

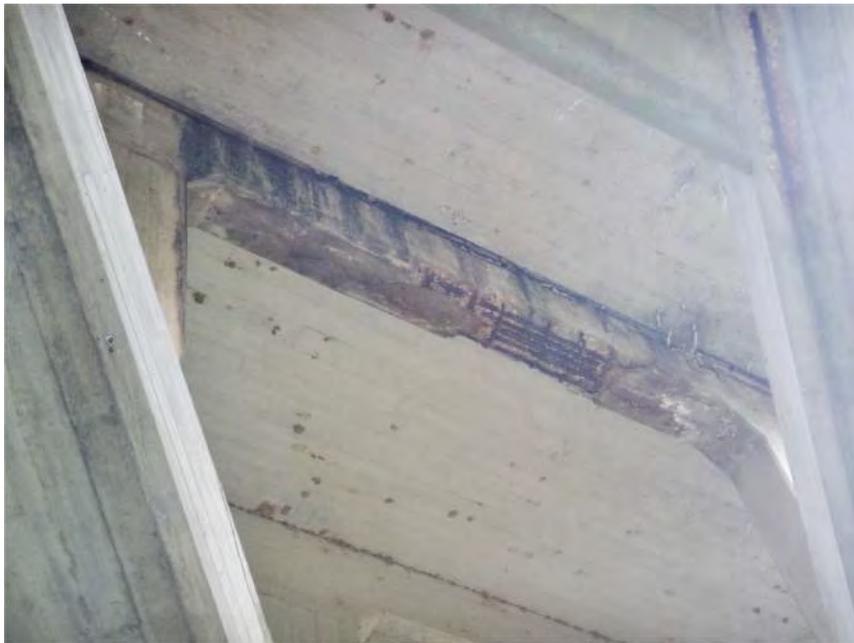
Typical Deterioration on Spandrel Capbeams

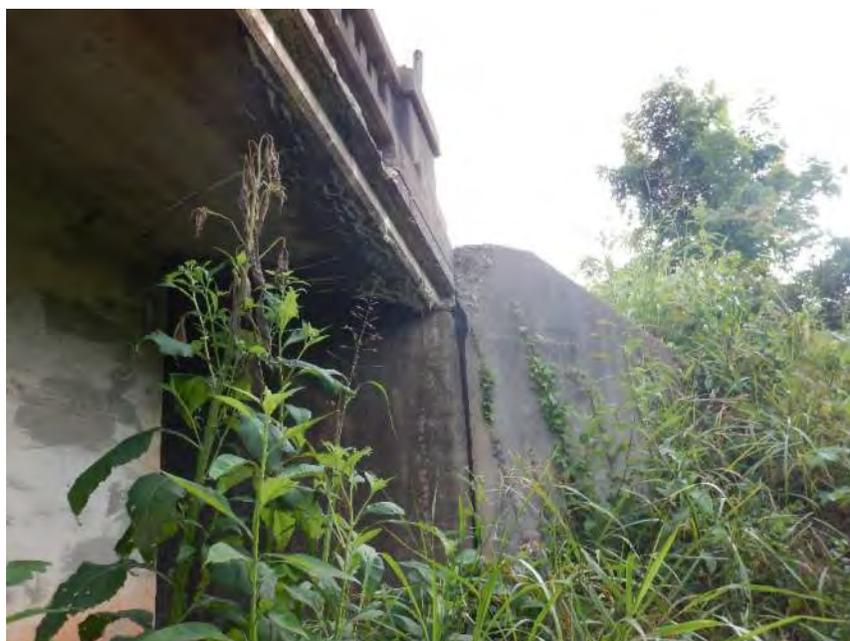
Typical Spalling at Abutment

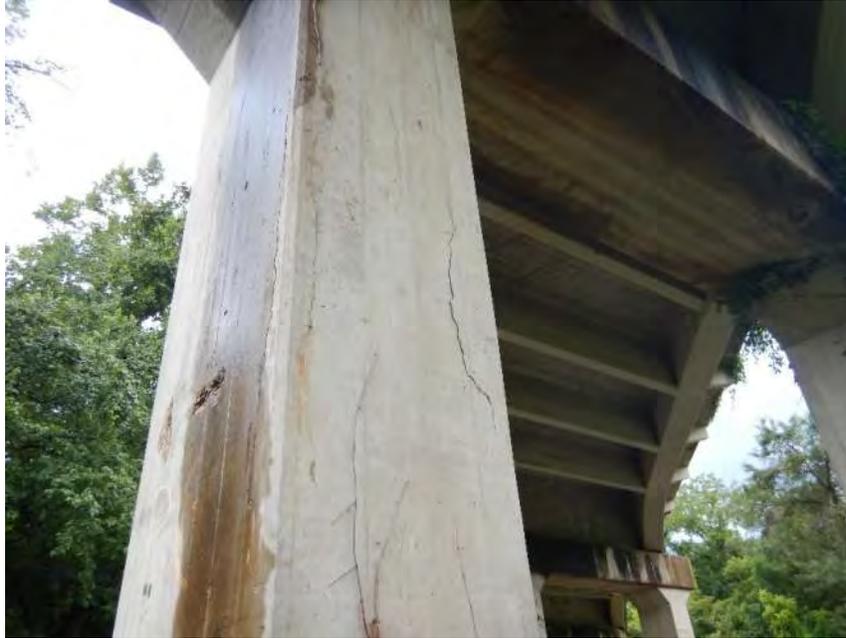
Deterioration of Intermediate Bent Columns

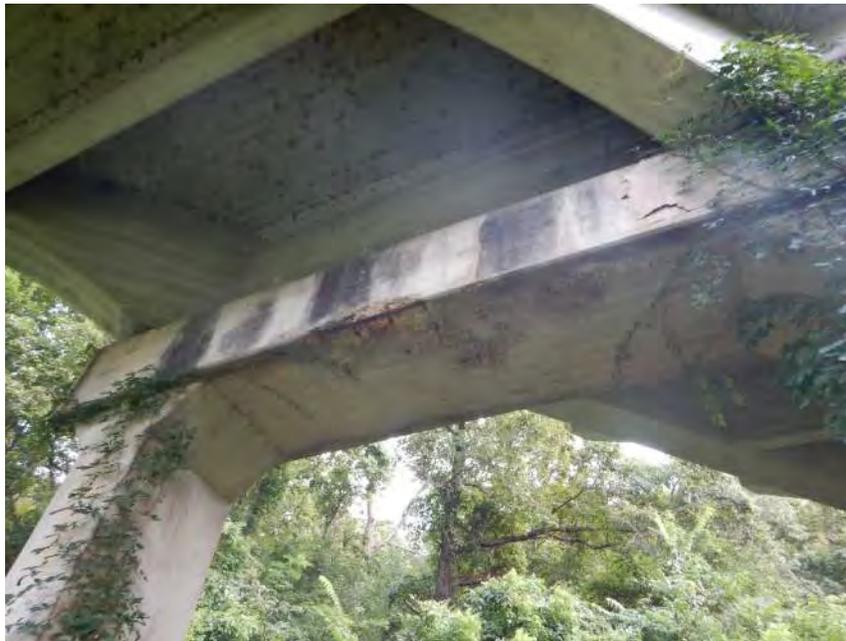
Deterioration of Intermediate Bent Cap Beams

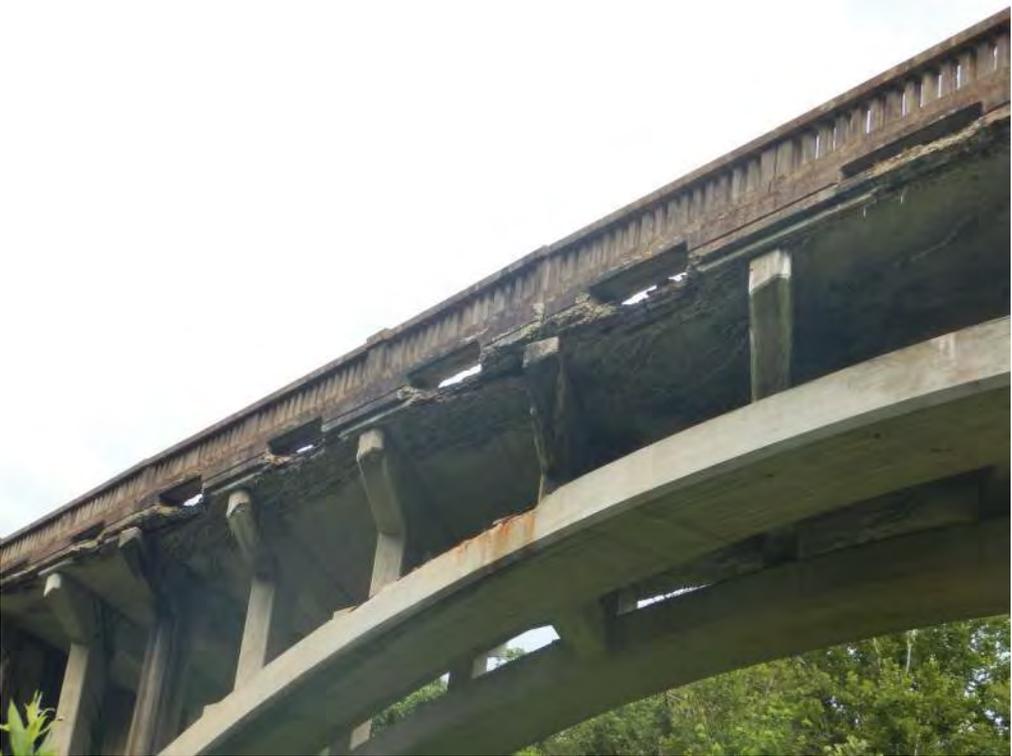
Pic. 002: Typical deck condition below curb openings

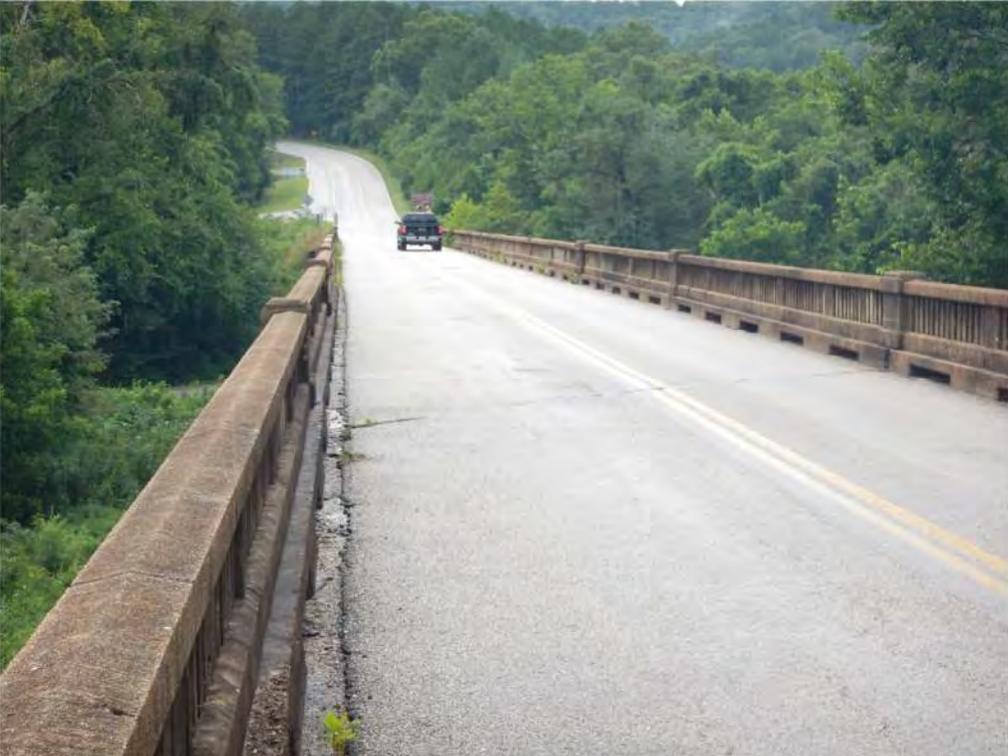
Pic. 003: Bridge barrier rail with misalignment

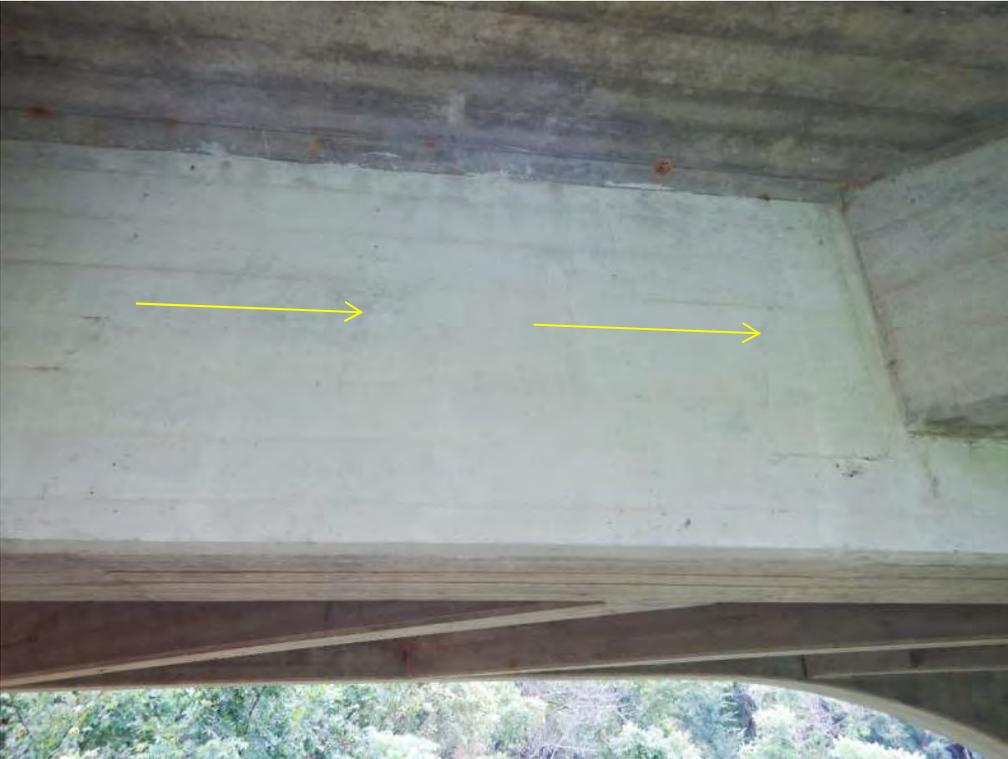
Pic. 004: Hairline cracks in girder, Span )1-2) west girder shown
