**Route 19 over Current River (Br. G0804)  
Rehabilitation / Replacement Concept Study  
Report of Field Investigation**

**MoDOT Project No.: J9P3305**

**Route 19 over Spring Valley (Br. J0420)  
Rehabilitation / Replacement Concept Study  
Report of Field Investigation**

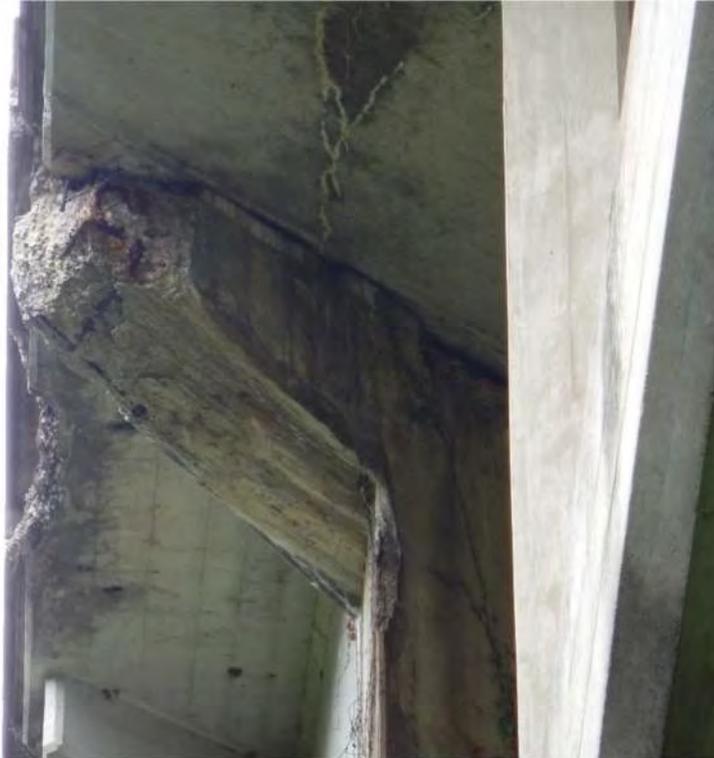
Pic. 005: Deterioration of cap beam cantilever

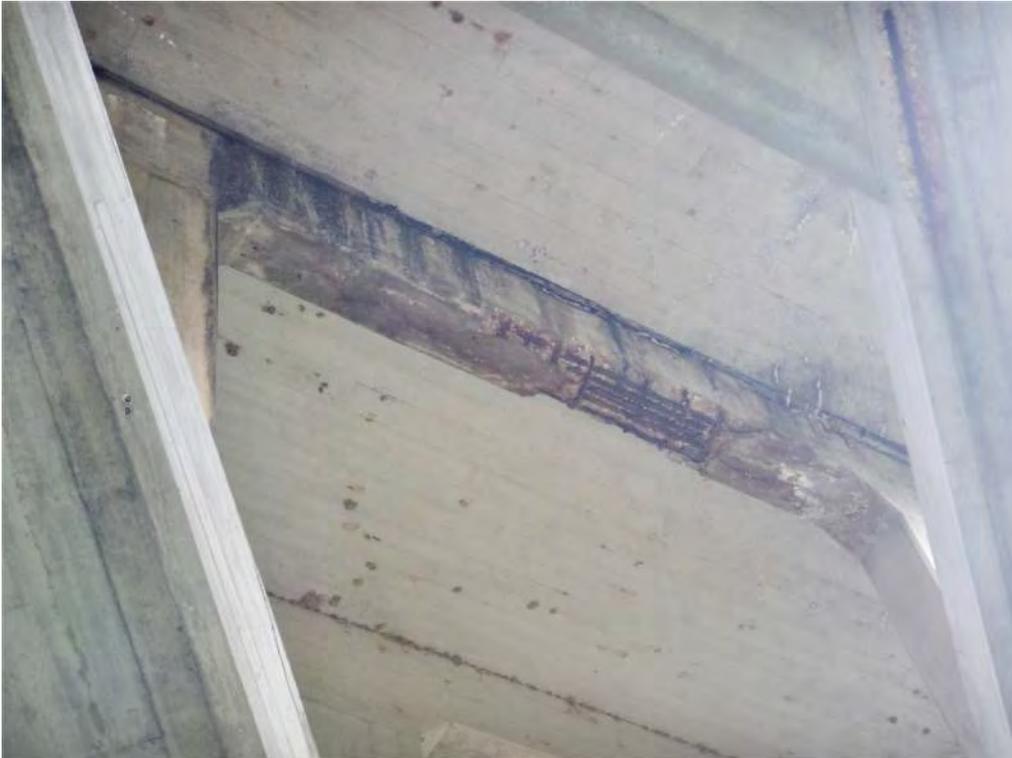
Pic. 006: Typical deterioration of spandrel capbeams

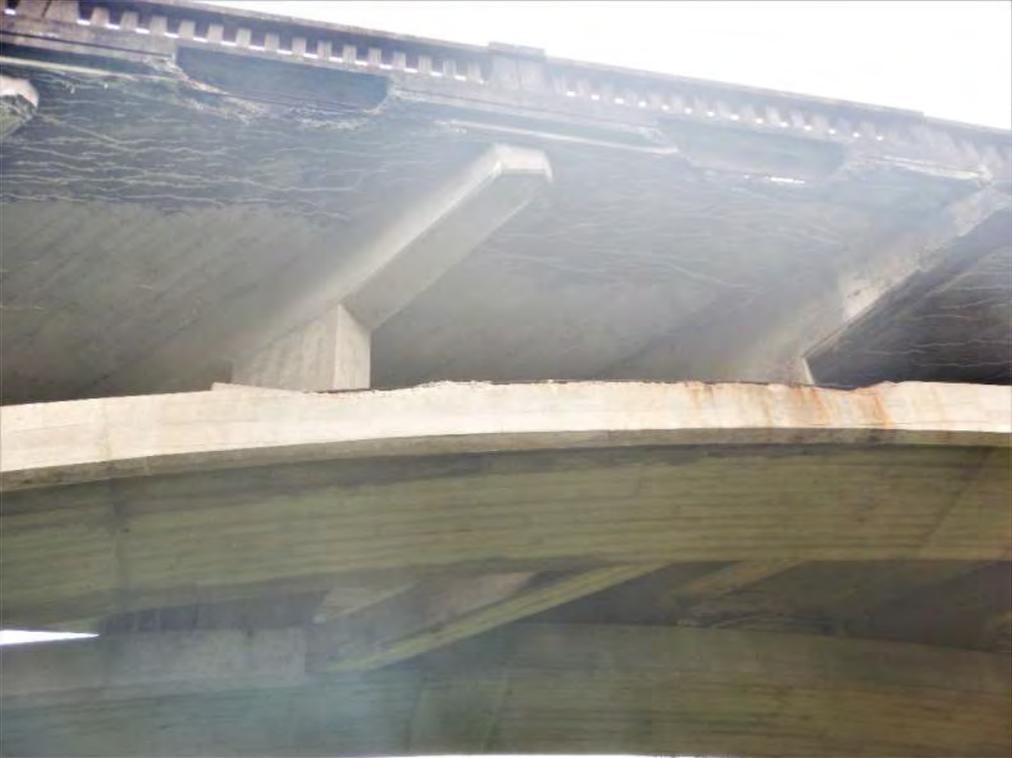
Pic. 007: Spalling near center of arch rib, east rib

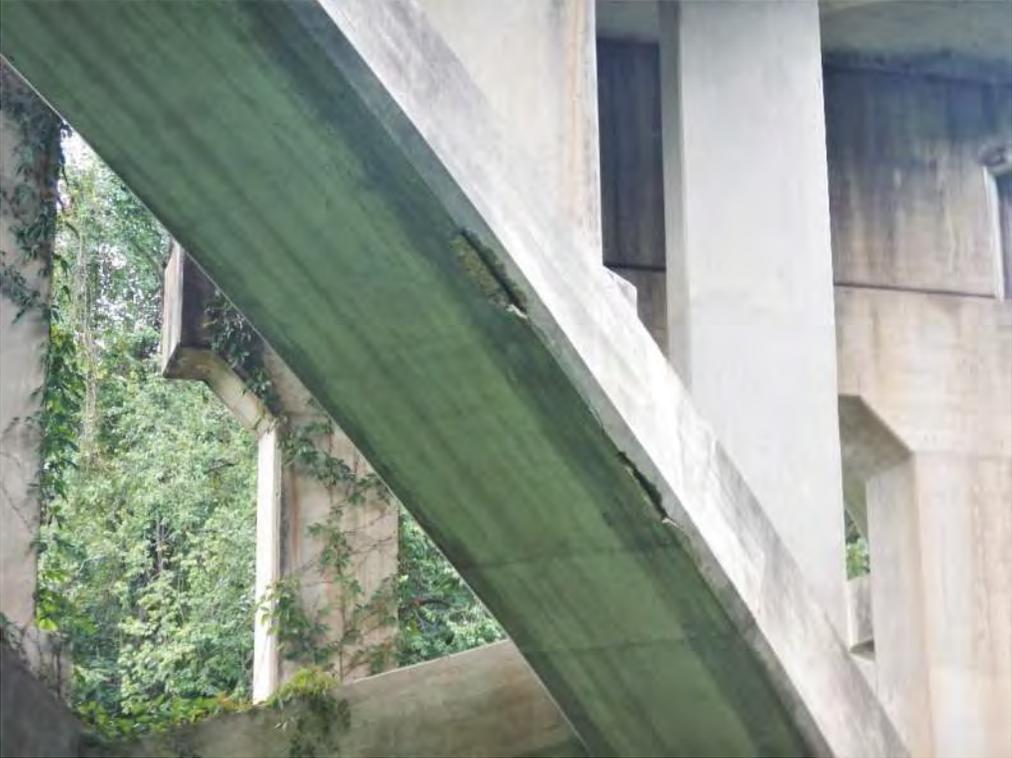
Pic. 008: Spalling of arch rib, west rib near south thrust block

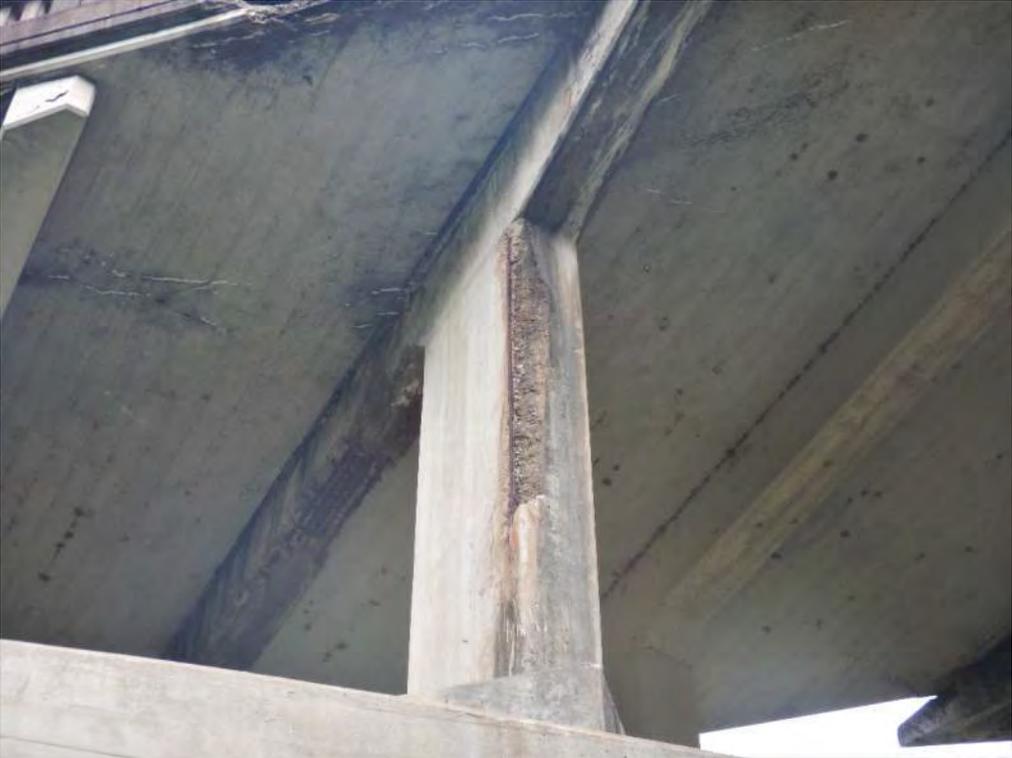
Pic. 009: Typical deterioration of spandrel column

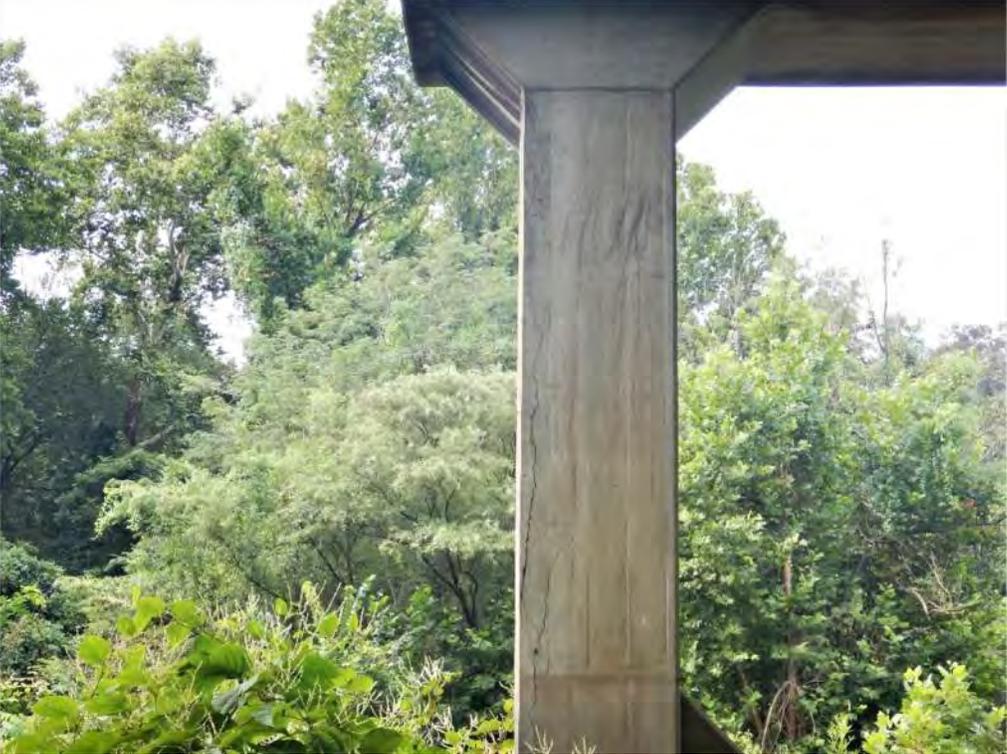
Pic. 010: Vertical cracking in column, Bent 3 shown

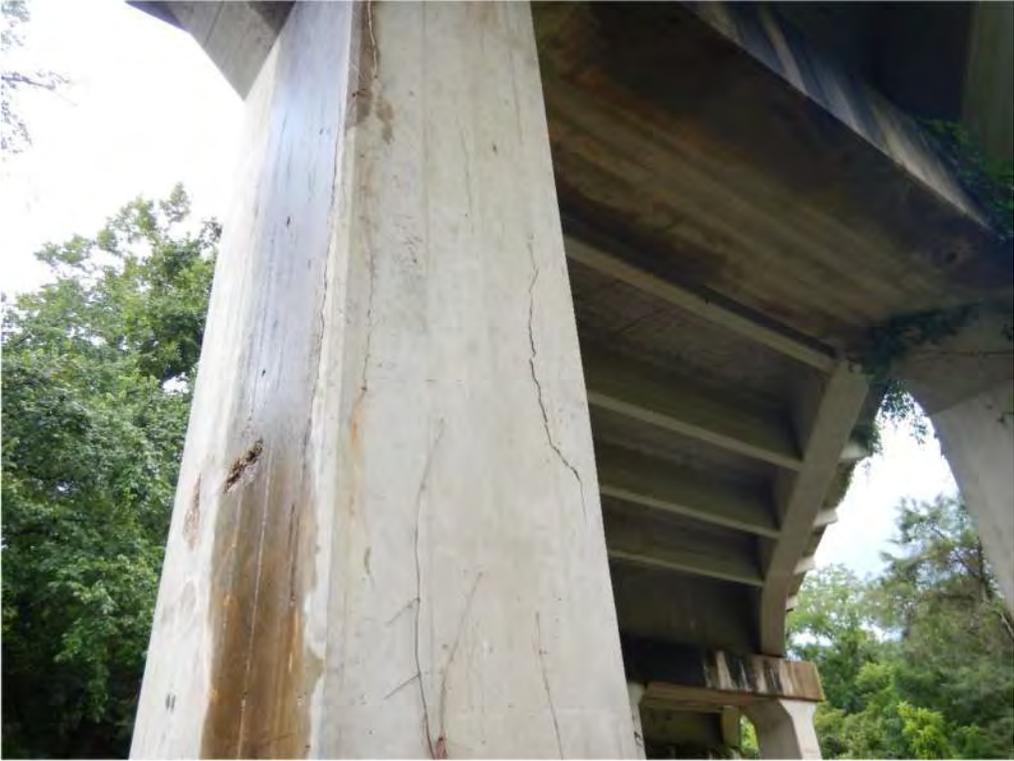
Pic. 011: Spalling and cracking on column, Bent 6 shown

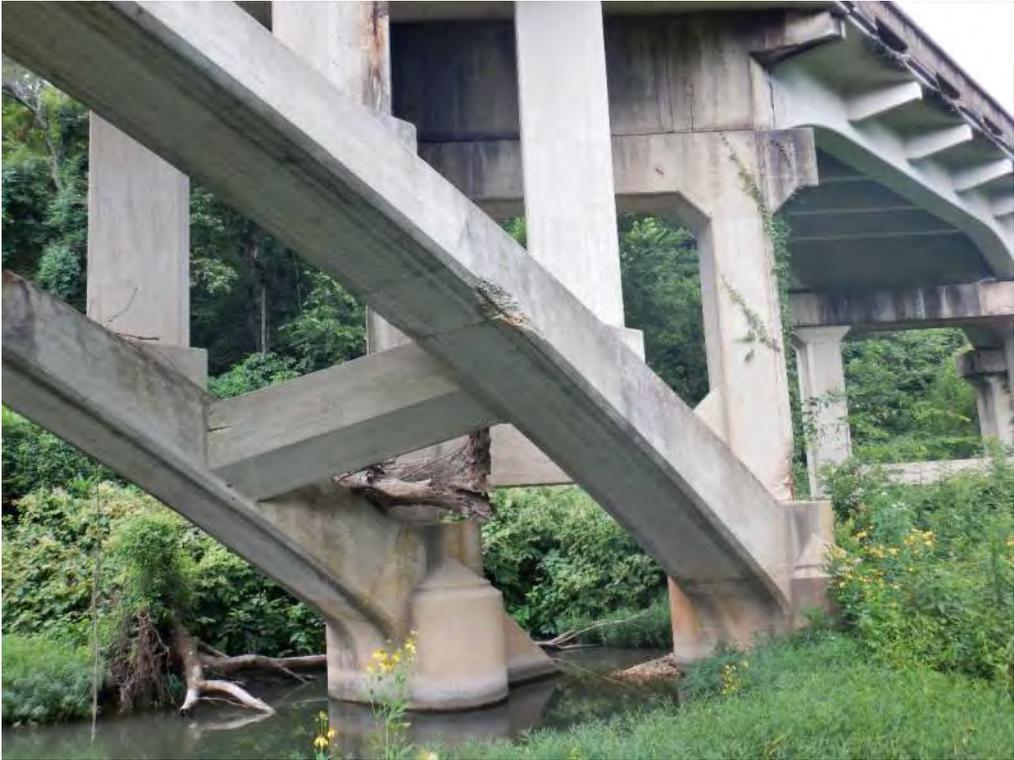
Pic. 012: Scour hole at Pier 4

- Replacement of the deck, barrier and the wearing surface. Replacement of the deck will require replacement of the concrete deck girders and possibly the floorbeams over the spandrel arch.
- Include a drainage system in the rehabilitation or replacement.
- Repair or replace of the numerous deteriorated brackets.
- Repair the numerous areas of cracking, spalling and delamination in the superstructure and substructure.
- Concrete repair and possible chloride remediation at deteriorated concrete areas and areas of high chloride levels.
- Stabilization of the lateral displacement of the girders due to the 45 degree skew.
- Fill observed scour hole and provide protection for the pier.
