Substructure Evaluation

Route 19 Bridges over Current River and Spring Valley

MoDOT Structure Nos.: G0804 / J0420

Inspection Report

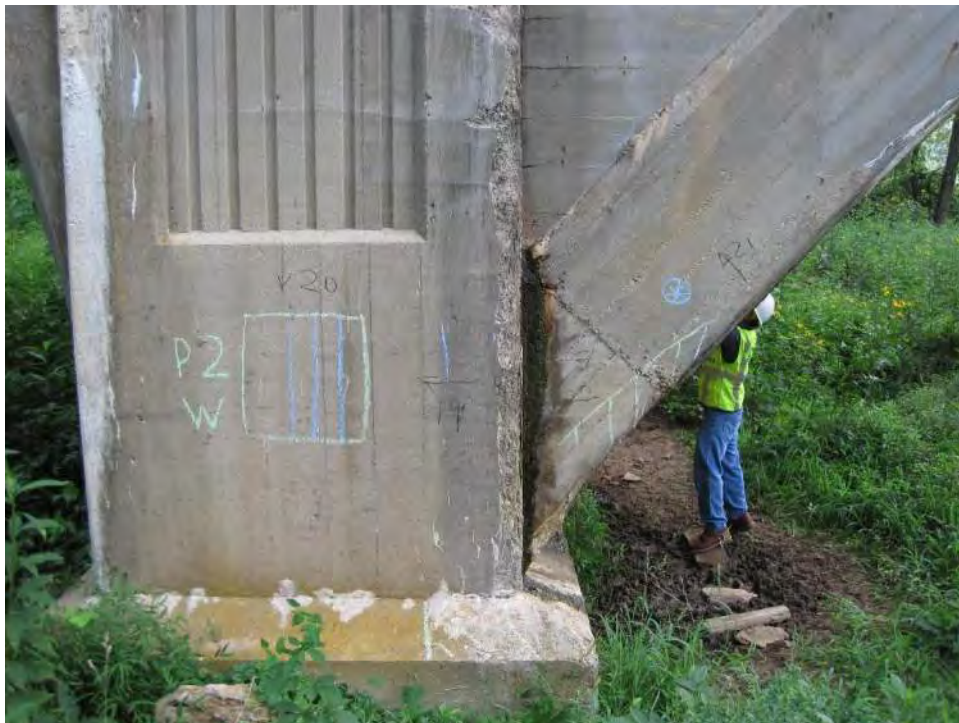
In general the arches and piers of the Current River bridge are in fair condition with moderate cracking and spalling along the vertical corners of the pier pilasters and abutments and moderate cracking and spalling along the edges of the arches, see photo 2. Significant leakage was observed from the vertical joints in the fascia walls and the drains located near the base of the arches, as shown in Photos 3 and 4.

Photo 2: CRB, Typical spalling and deterioration along vertical corners of pier and edge of arch, West Face, pier 2 shown.

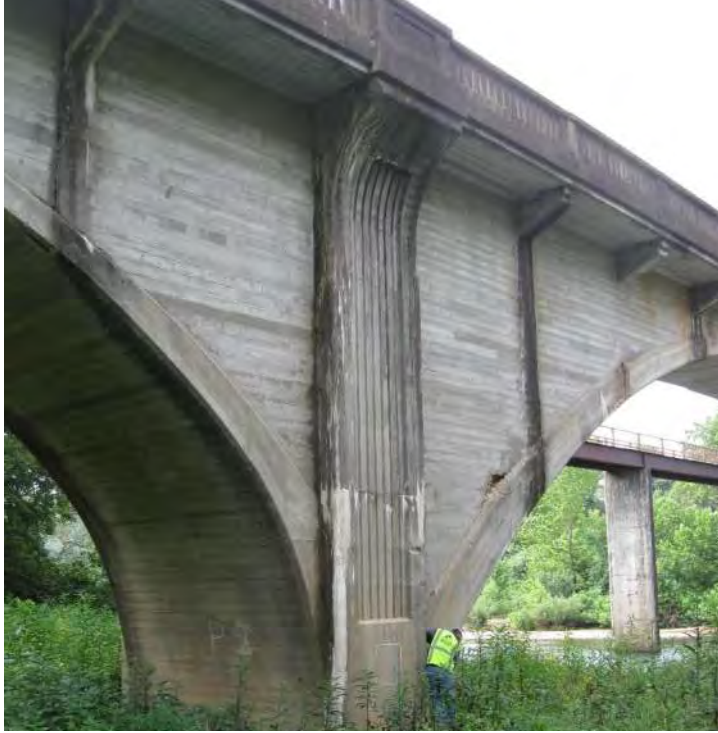
Photo 3: CRB, Typical Leakage from vertical joints in fascia walls

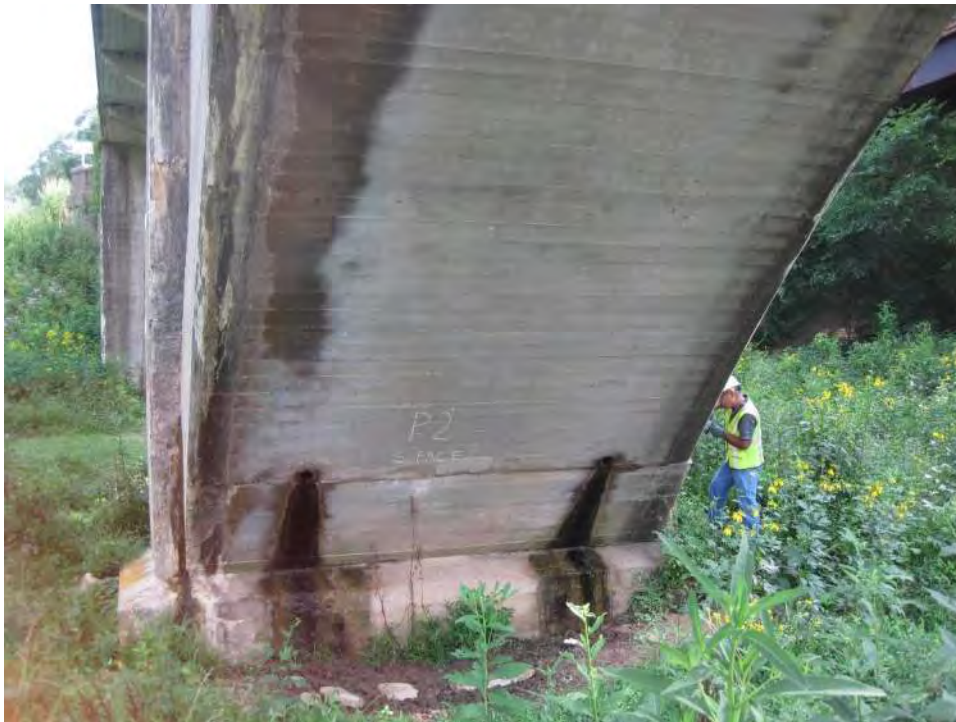
Photo 4: CRB, Typical leakage from drains at base of arch

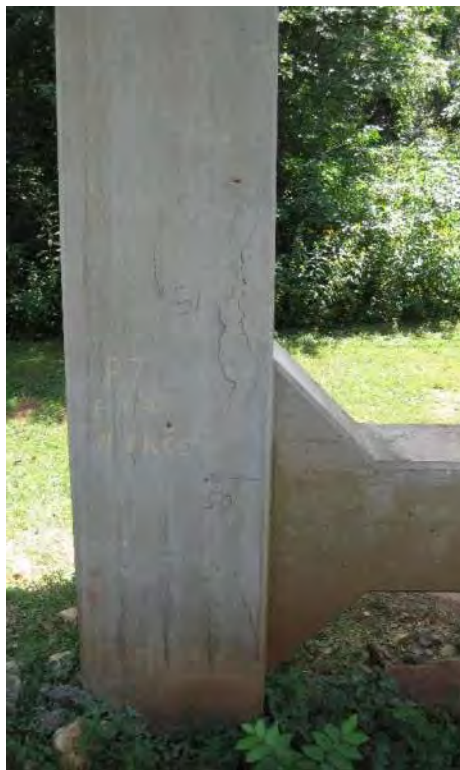
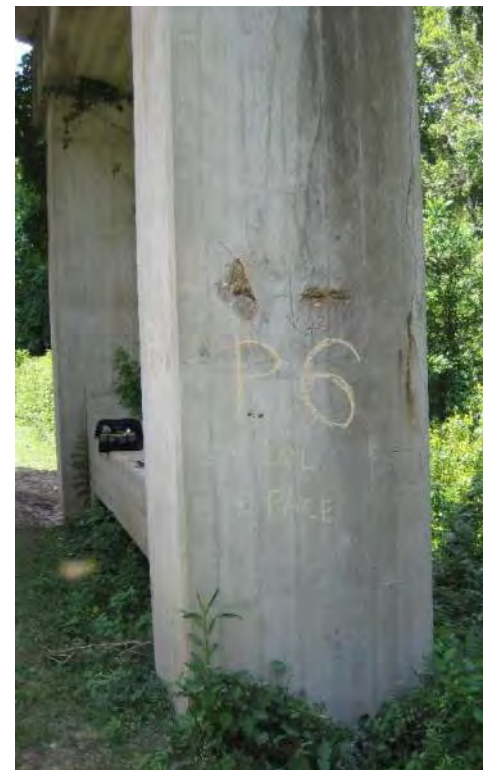
The arches and piers of the Spring Valley Bridge (SVB) are in good condition, with isolated areas of delaminated concrete and limited cracking observed in the pier columns, Photo 6

Photo 6: SVB, Typical Cracking and exposed reinforcement, Pier 7, North Face, east column and Pier 6, East Face, east column shown

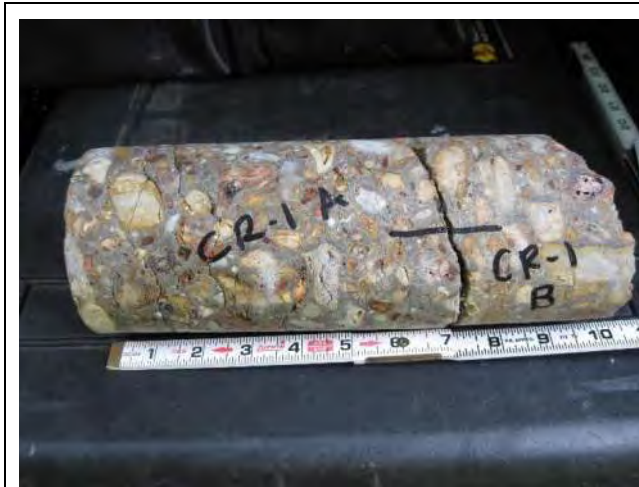
Core CR-1

- Edge of Arch, Span B @ Pier 2
- West Exposure
- 4 x 10, extracted in two pieces
- Several delaminations noted in core and core hole
- Cracks through and around aggregate with cracks in aggregate

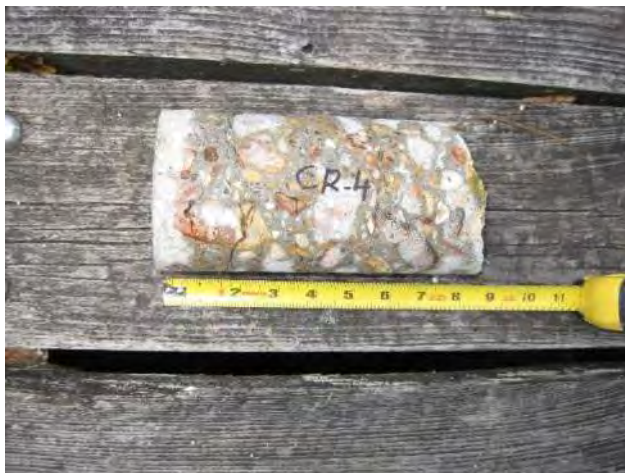
Core CR-4

- Edge of Arch, Span A @ Abut. 6
- East Exposure
- Drilled 4 x 10, extracted length ~ 7 inch.
- Several delaminations noted in core and core hole
- Cracks through and around aggregate with cracks in aggregate

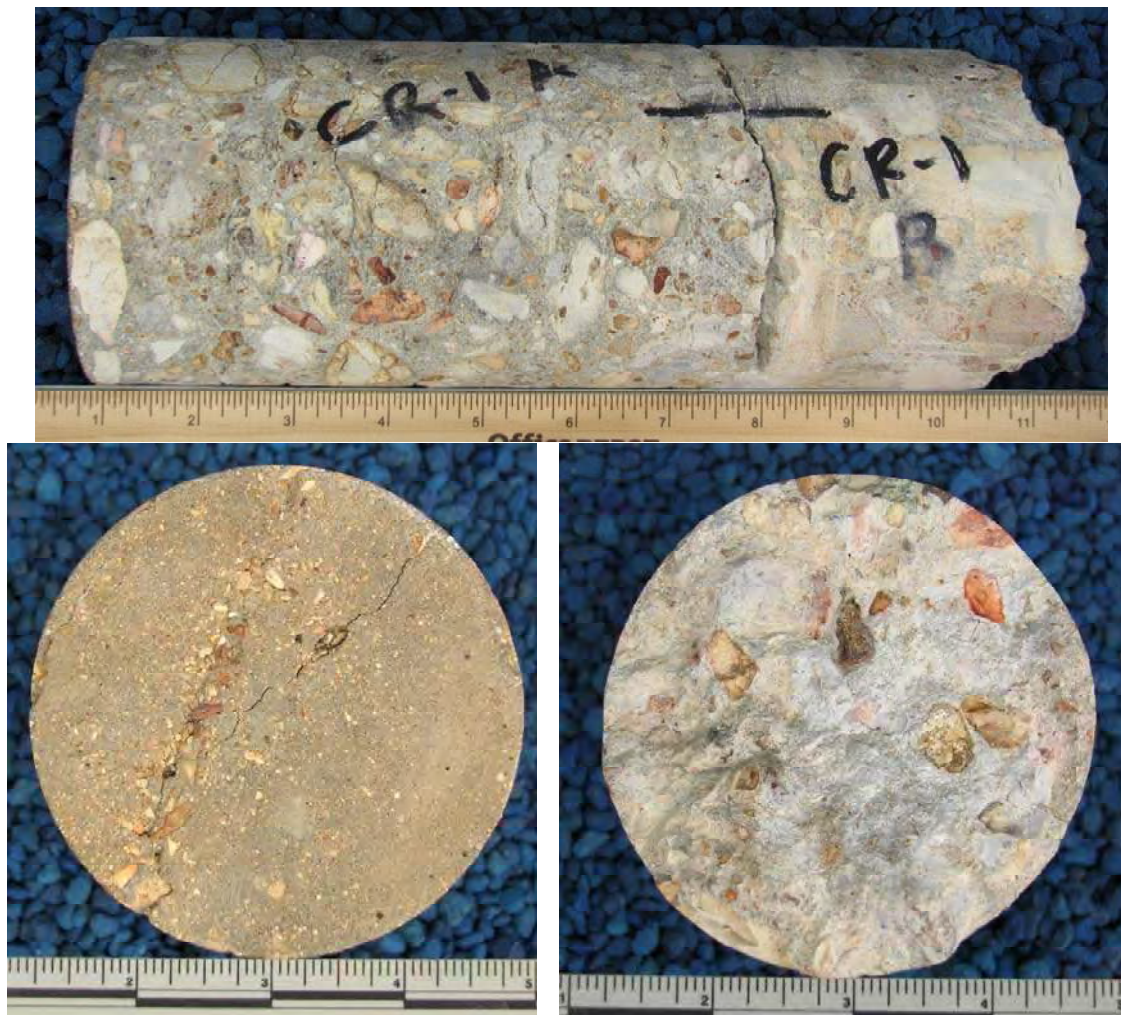
Figure 1: Top: Core CR-1 (outer surface oriented to the left). Bottom: Outer (left) and inner (right) surfaces of the Core CR-1.

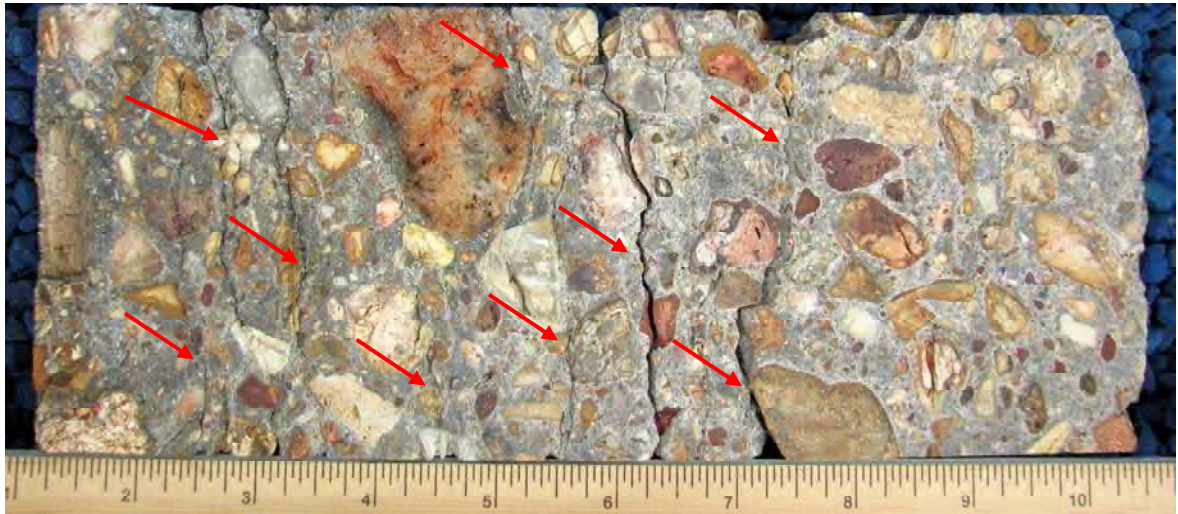
The lack of an intentionally developed air-void system imparted by intentional air-entrainment has rendered this concrete highly susceptible to freeze-thaw damage. Cracking oriented subparallel to the outer surface of the concrete and in the outer regions of the concrete members in cores CR-1 and CR-4 is characteristic of bulk freeze-thaw damage that usually occurs in a non-air-entrained concrete subjected to saturated service exposure. Therefore, bulk freeze-thaw damage is the most likely cause of the cracking in Core CR-1 and CR-4.

Multiple, interlaced cracks, oriented subparallel to the outer surface of the core, are present through the length of the core and have a range of widths from 0.1 to 6.0 mm. The cracks pass around and through aggregate particles. Cracks are depicted in Figure 2 below (red arrows).

Figure 2: Photograph showing the cracks in Core CR-1. The outer surface is to the left. Scale in inches.

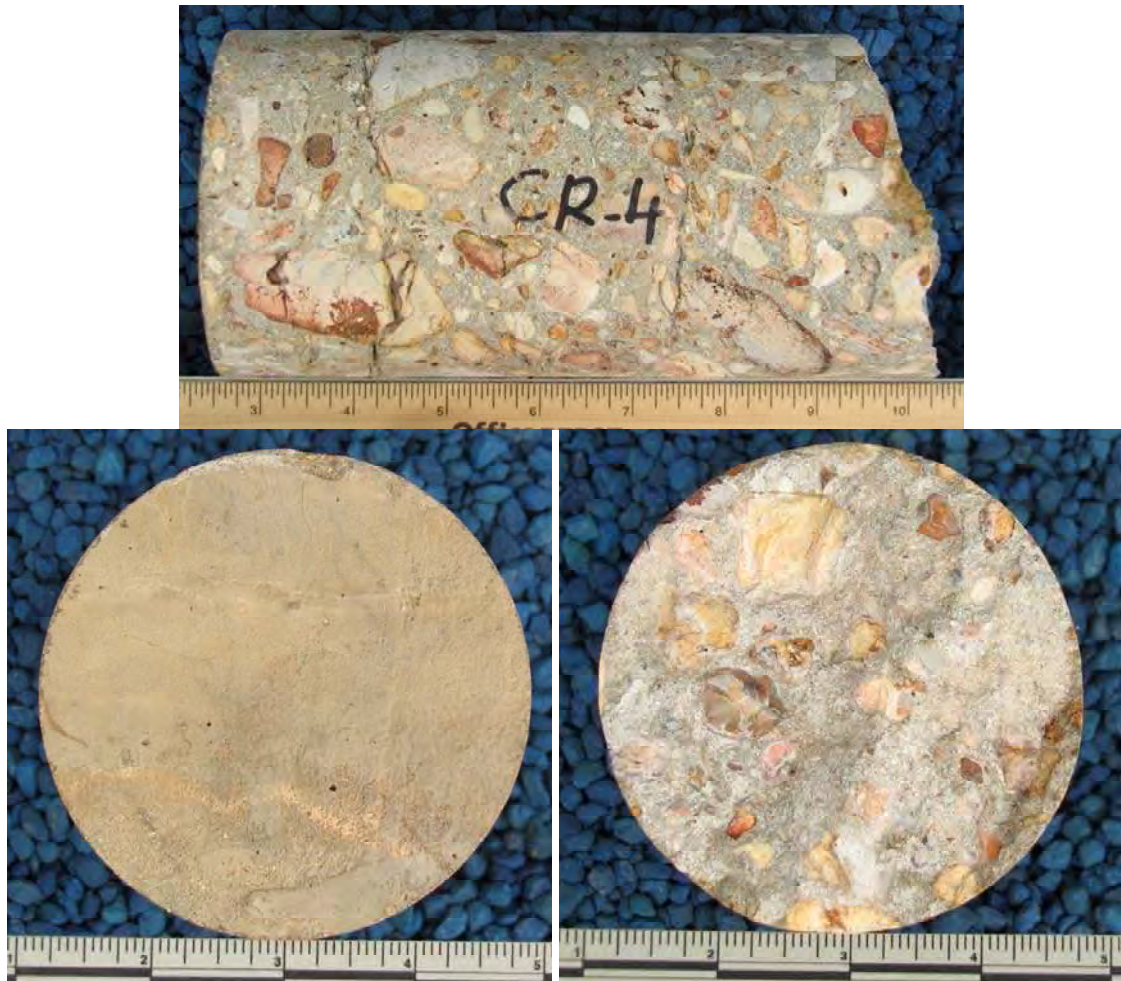
Figure 3: *Top:* Core CR-4 (outer surface oriented to the left). *Bottom:* Outer (left) and inner (right) surfaces of Core CR-4.

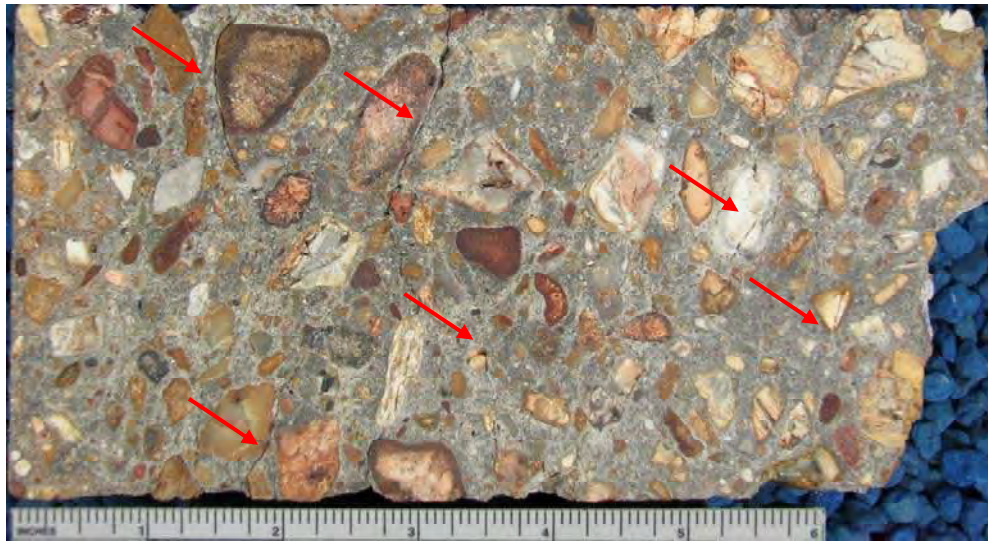
Multiple, interlaced cracks, oriented subparallel to the outer surface of the core, are present through the length of the core and have a range of widths from 0.1 to 1.0-mm. The cracks pass around and through aggregate particles. Cracks are depicted in Figure 4 below (red arrows).

Figure 4: Photograph showing the cracks in Core CR-4. The outer surface is to the left. Scale in inches.

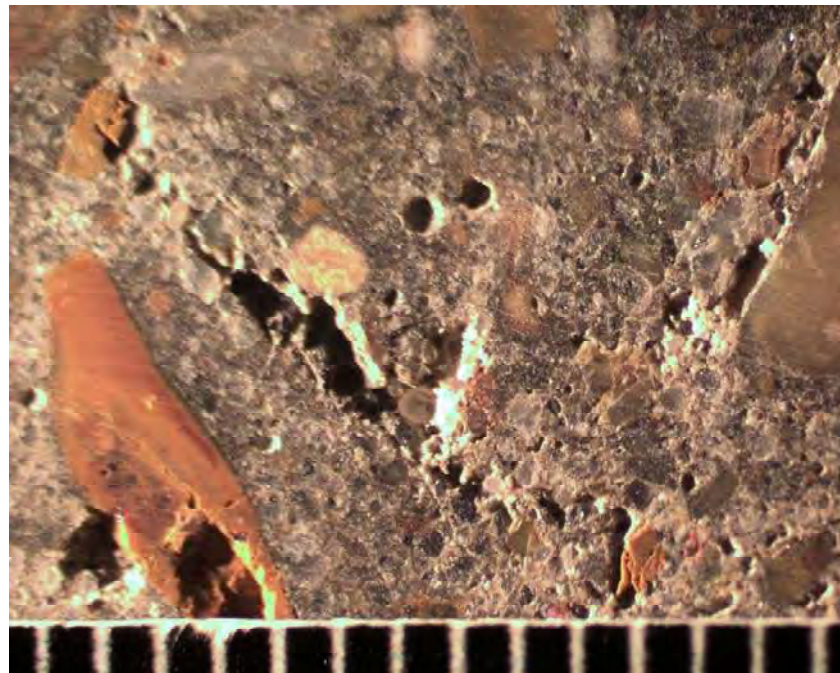
The cores are not air-entrained, as air-entrained admixtures were not discovered until about 20 or more years after this concrete was cast. Therefore, the samples contain low estimated air contents, significantly lower than the 4% recommended by ACI 318 for air-entrained concrete to protect against freeze-thaw damage.

The concrete has an estimated air content between **2.0 and 3.0%**. Figure 5 is a photomicrograph depicting the low air content.

Figure 5: Photomicrograph showing the low air content in Sample CR-4. Scale in millimeters.

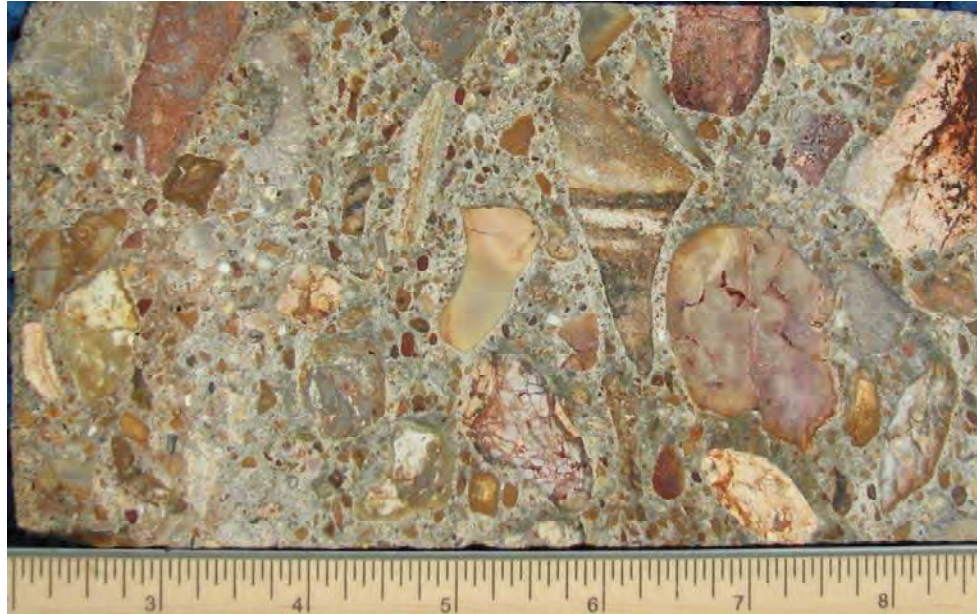
No cracks or microcracks are present in the core, as shown in Figure 7 below.

Figure 7: Photograph showing the good condition of Core SV-3. The outer surface is to the left. Scale in inches.
