# I-44 at I-270 bridges over the Meramec

## Eastbound Bridge

## Westbound Bridge

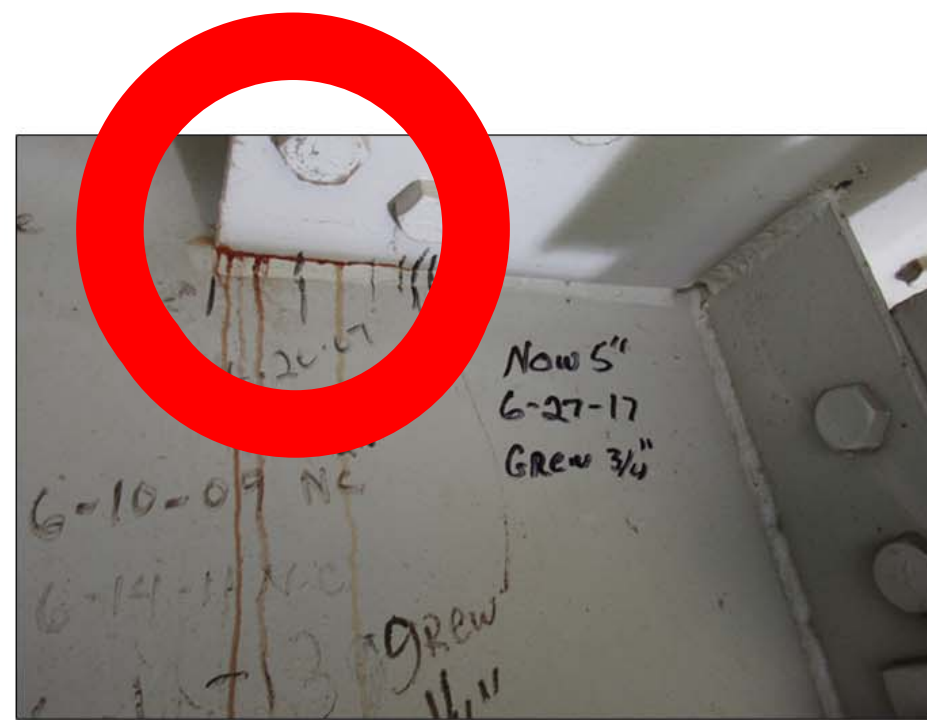
Some of the steel connections are cracking apart.

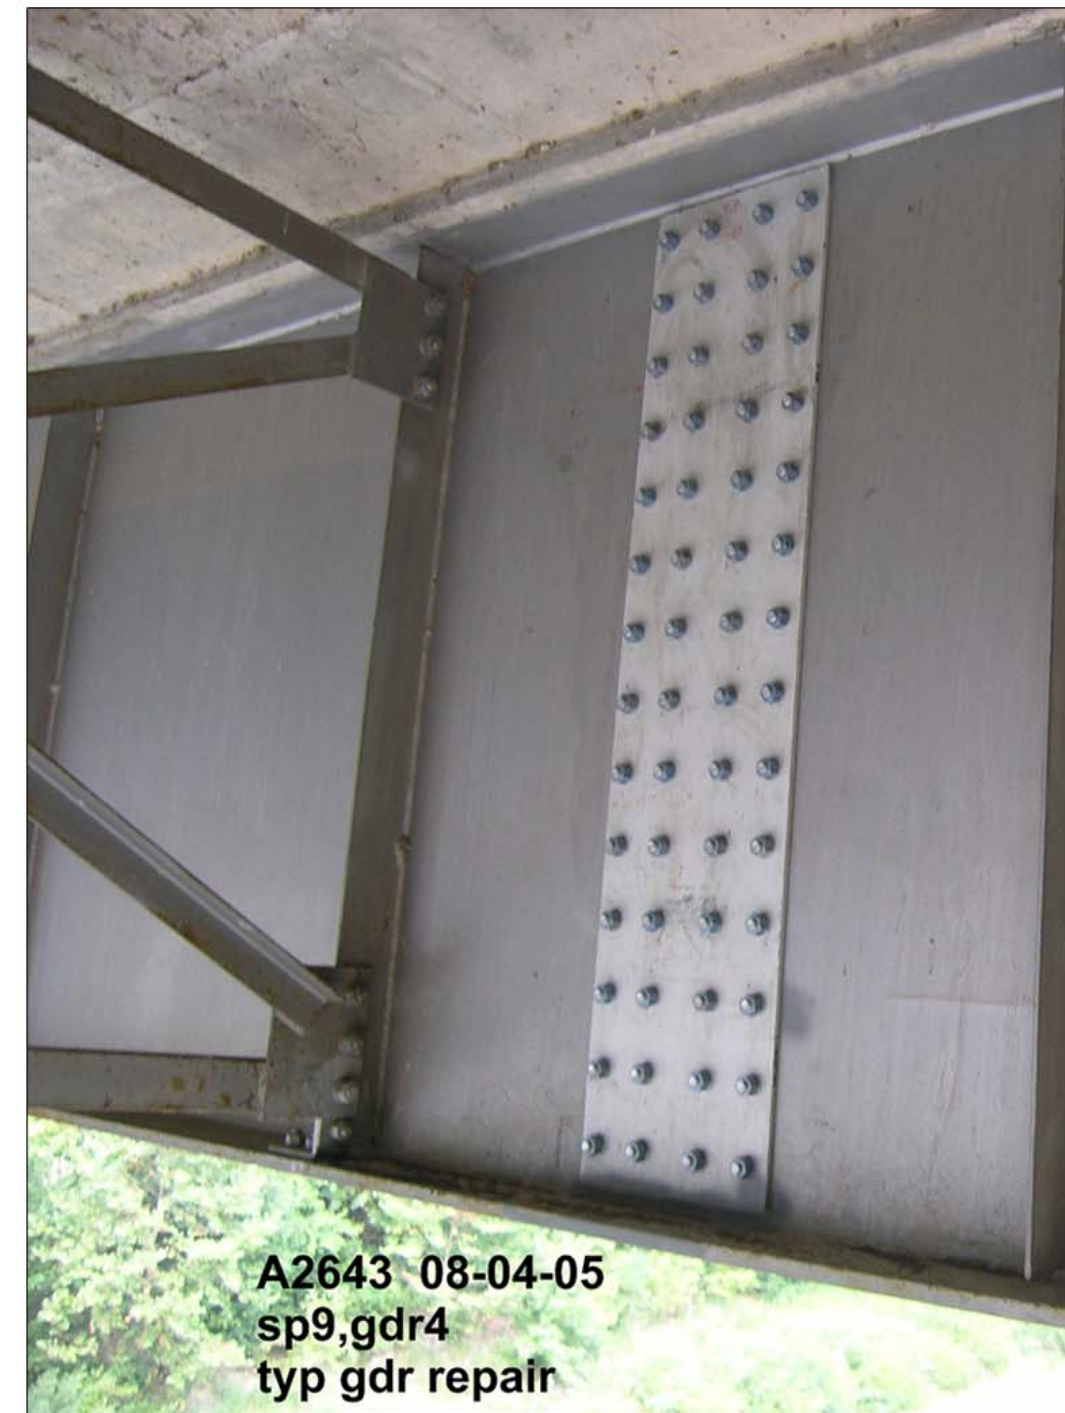
The plate here helps strengthen an area where the girder is weaker.

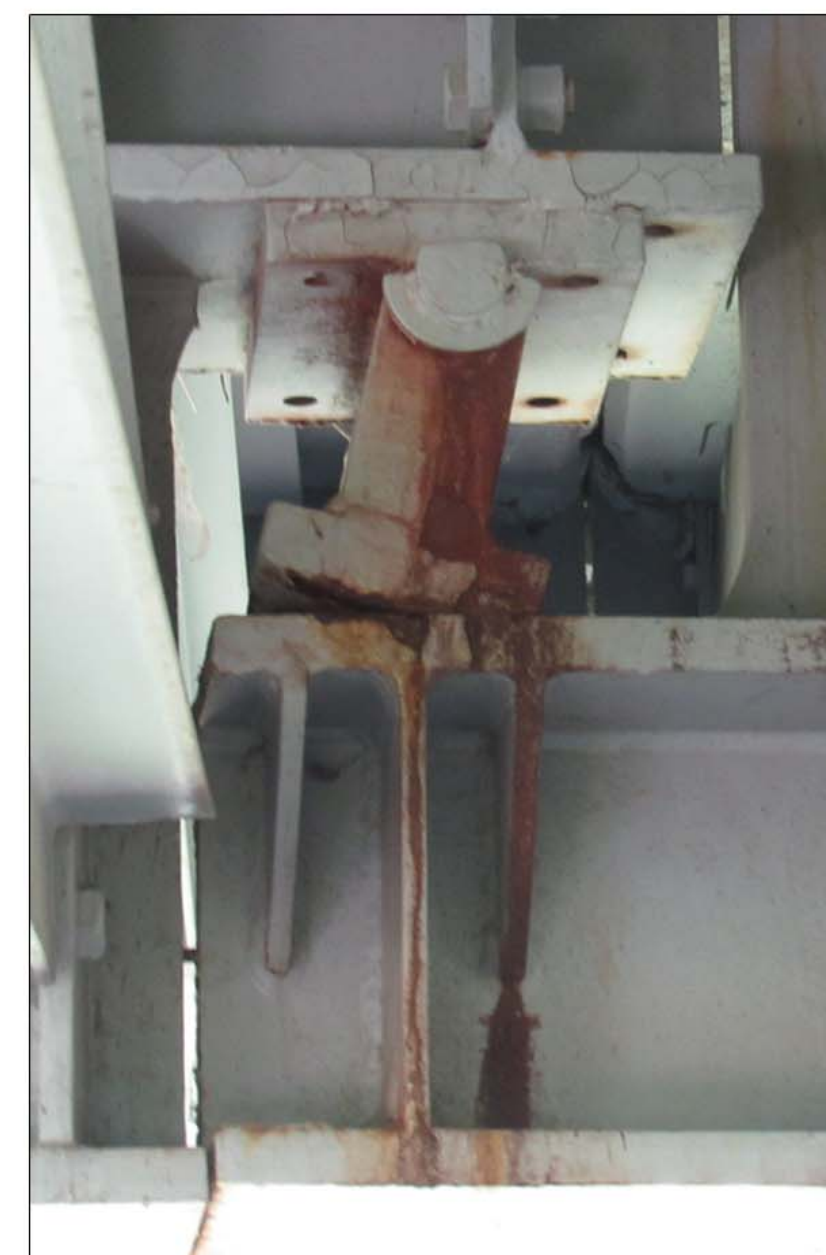
This piece helps ensure the bridge can move as the bridge heats and cools. It is rusted and stuck.

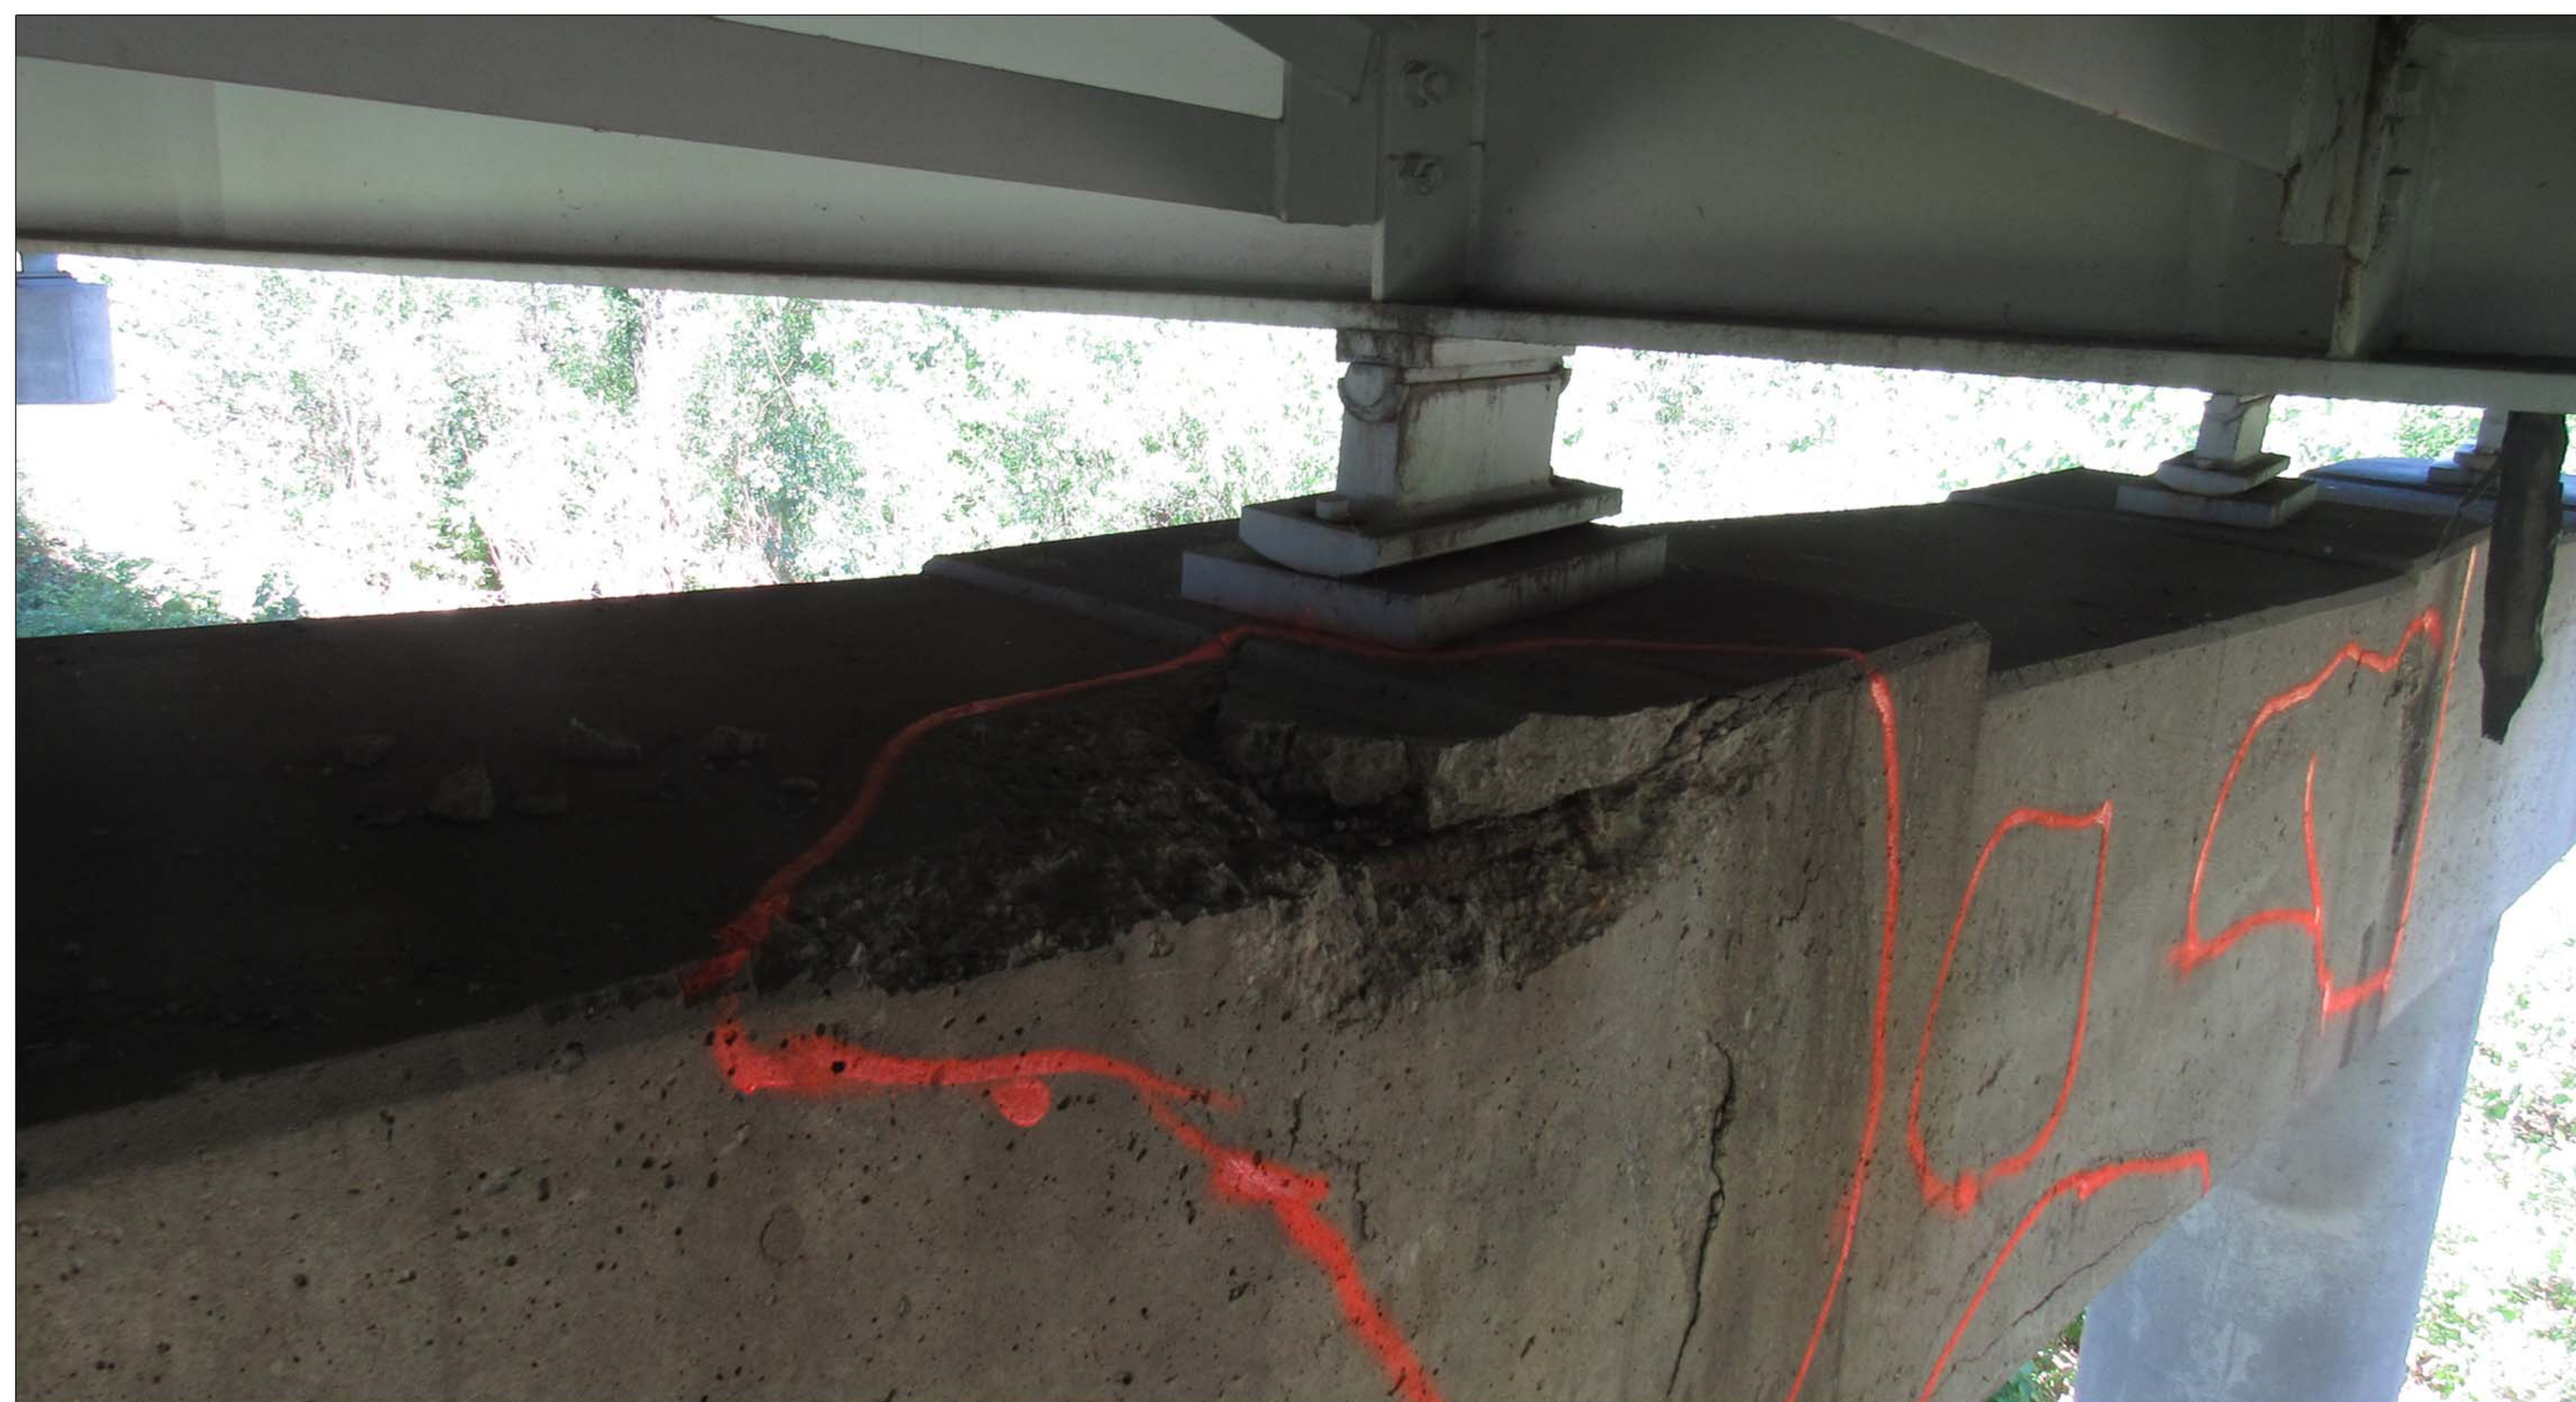
The concrete foundations are cracking and crumbling.

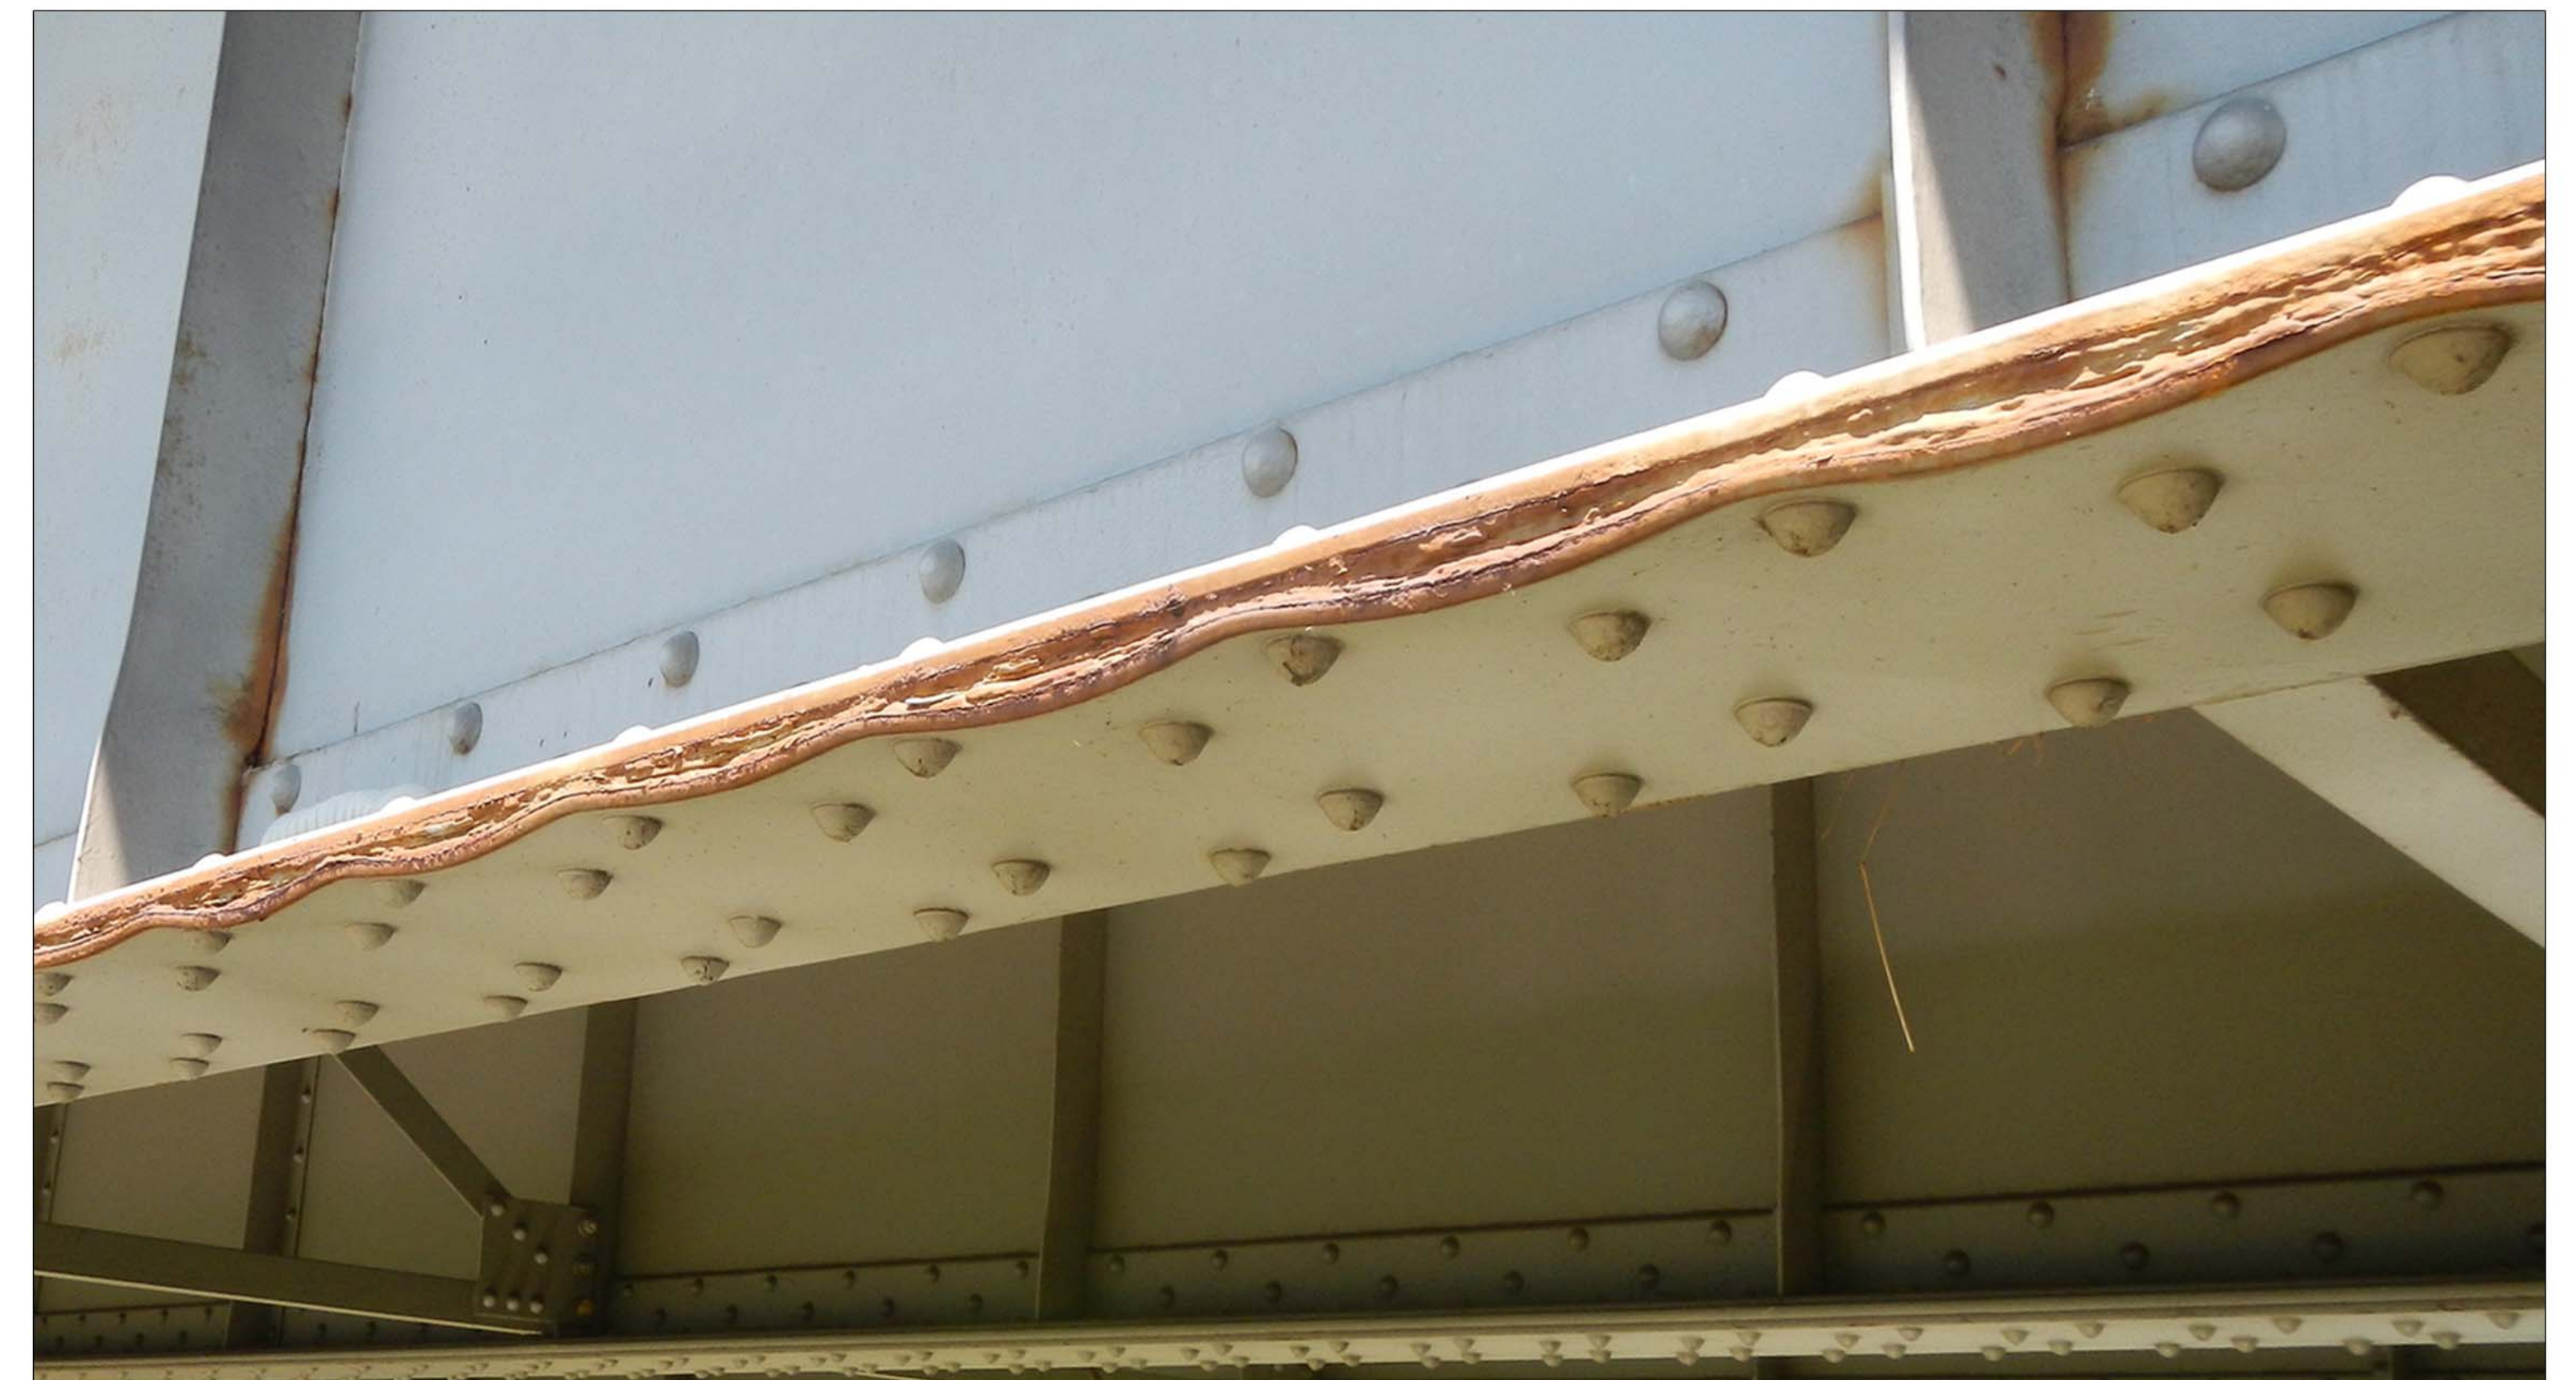
Bridge girders are starting to rust and deteriorate.

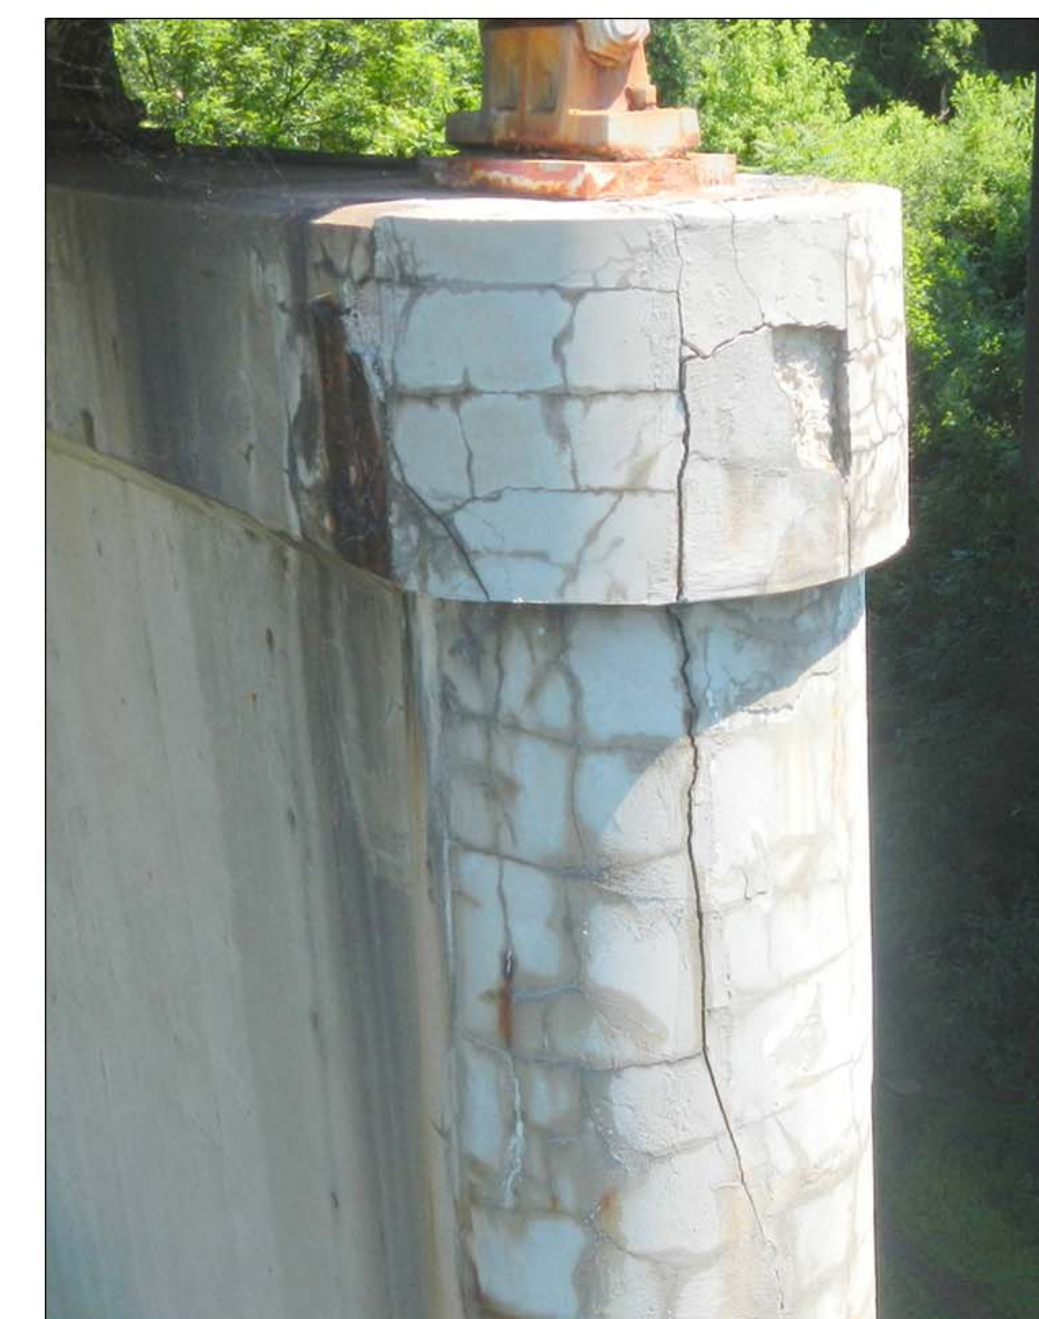
Concrete in the foundation is starting to wear out and crumble.

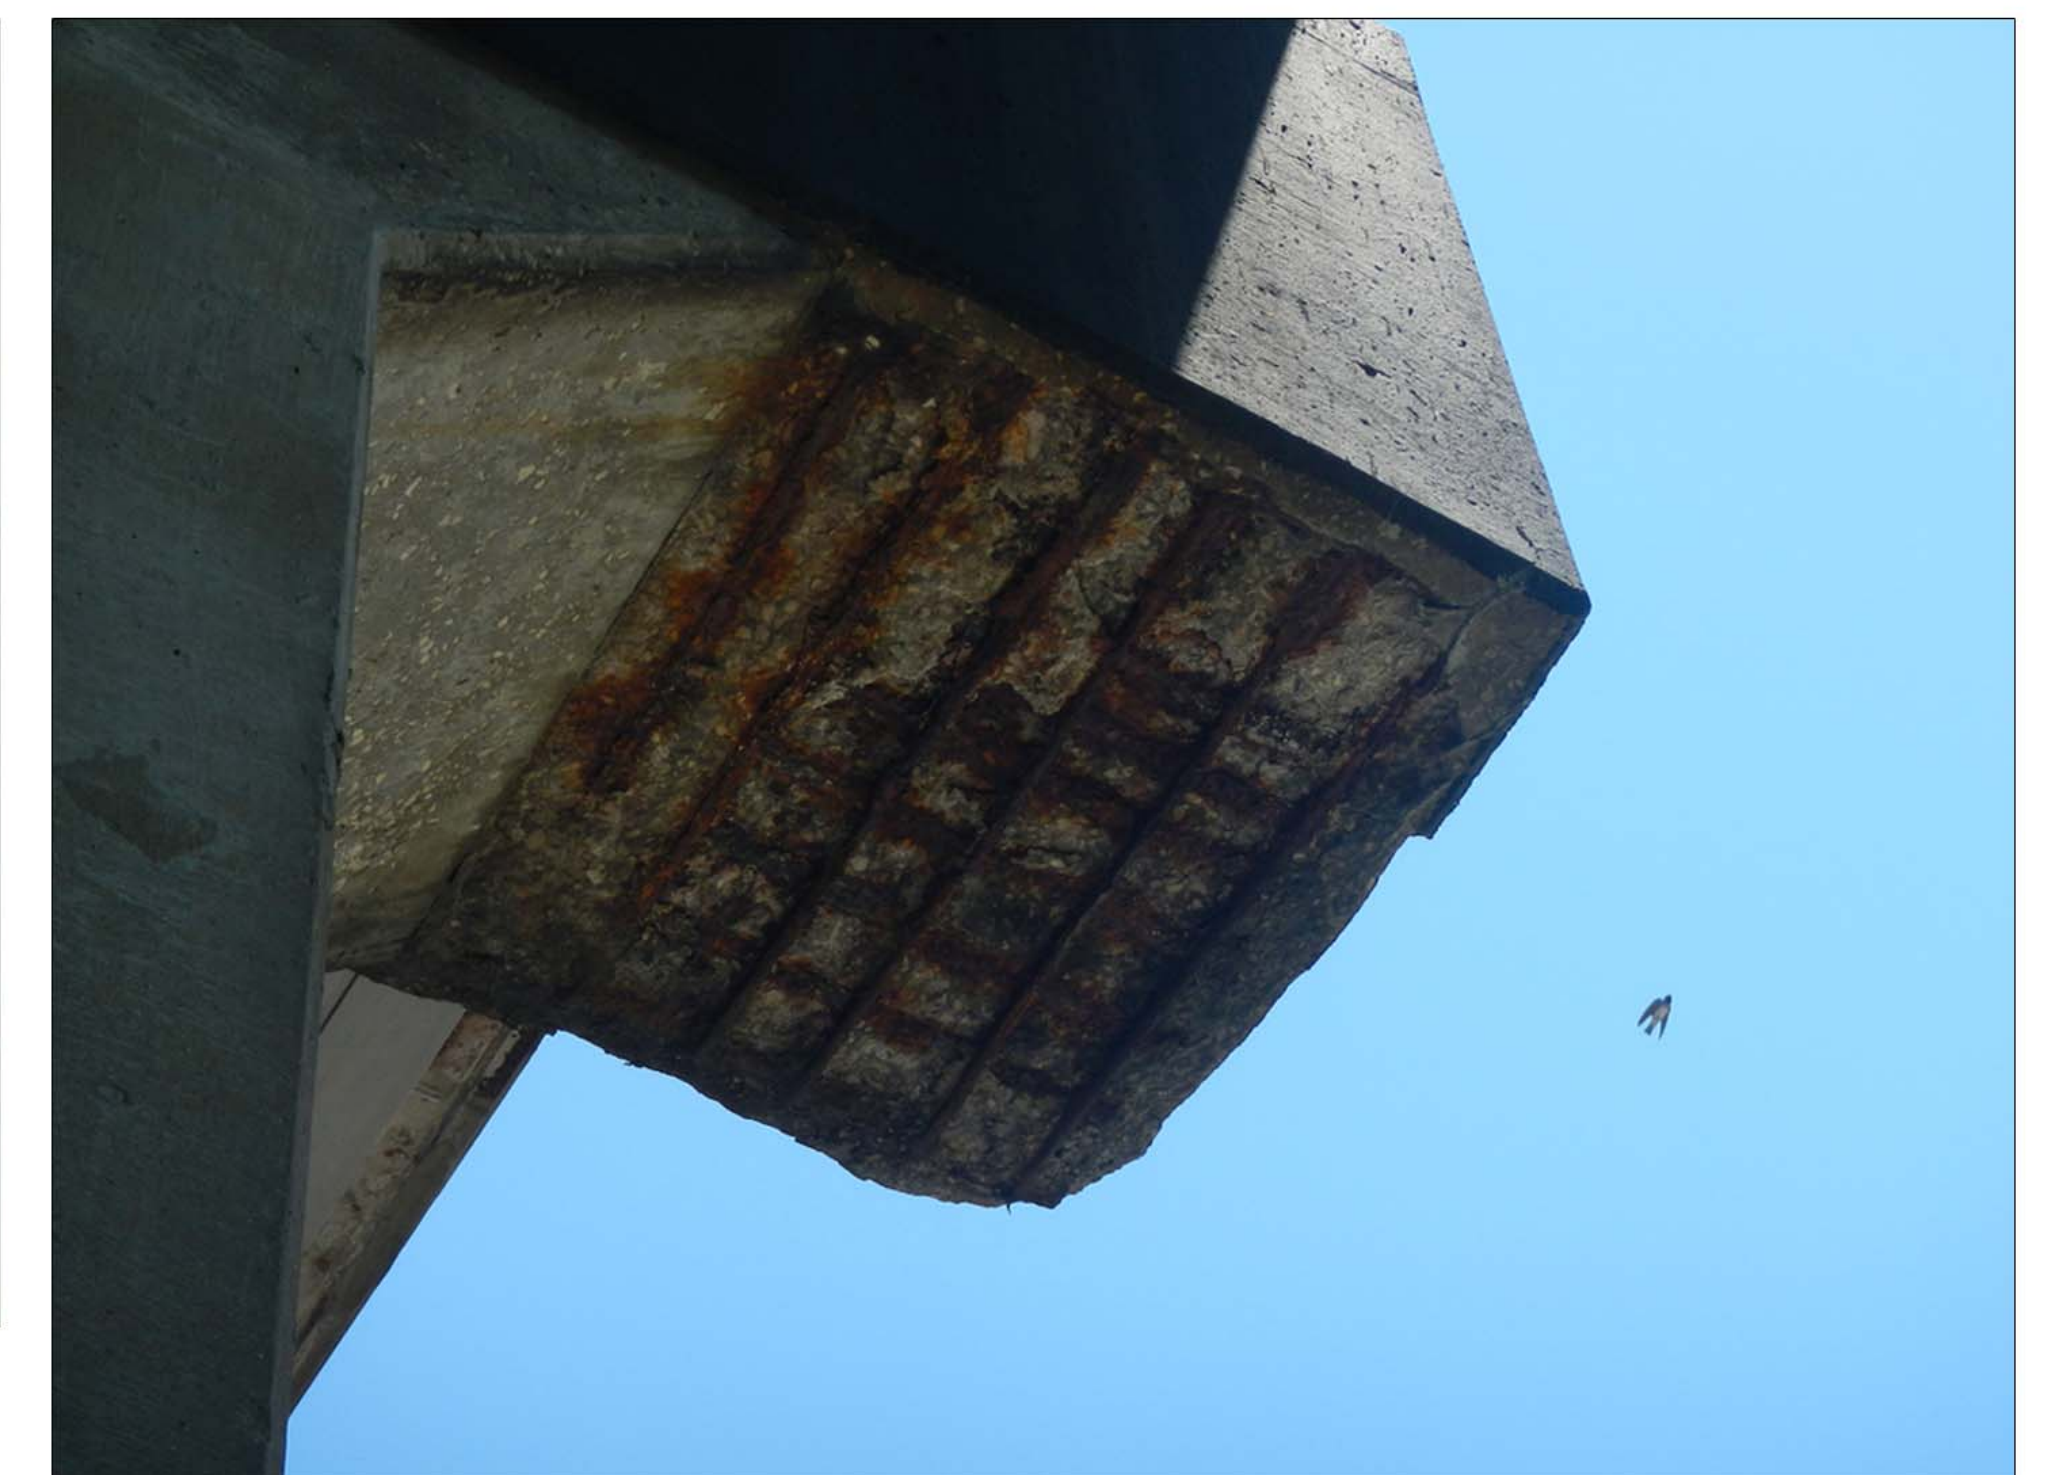
Portions of the reinforcing steel are exposed and rusting.
