Soil Evaluation Report

Project Number: 15-J073

580 N. Service Road (St. Peters, MO)

Soil Evaluation Report 580 N. Service Road (St. Peters, MO) St. Charles County, Missouri

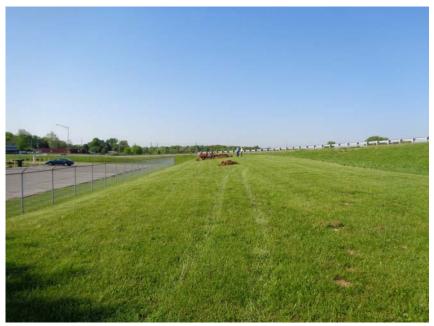
PHOTO # 1 Overview of Site 2 & far Site 3 (Backhoe) near east/west fence looking south.

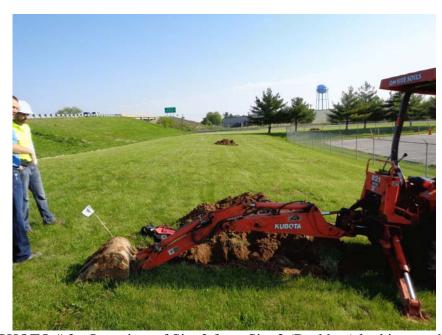
PHOTO # 2 Overview of Site 2 from Site 3 (Backhoe) looking north.
