# Proposed New Franklin Route 5 Improvements

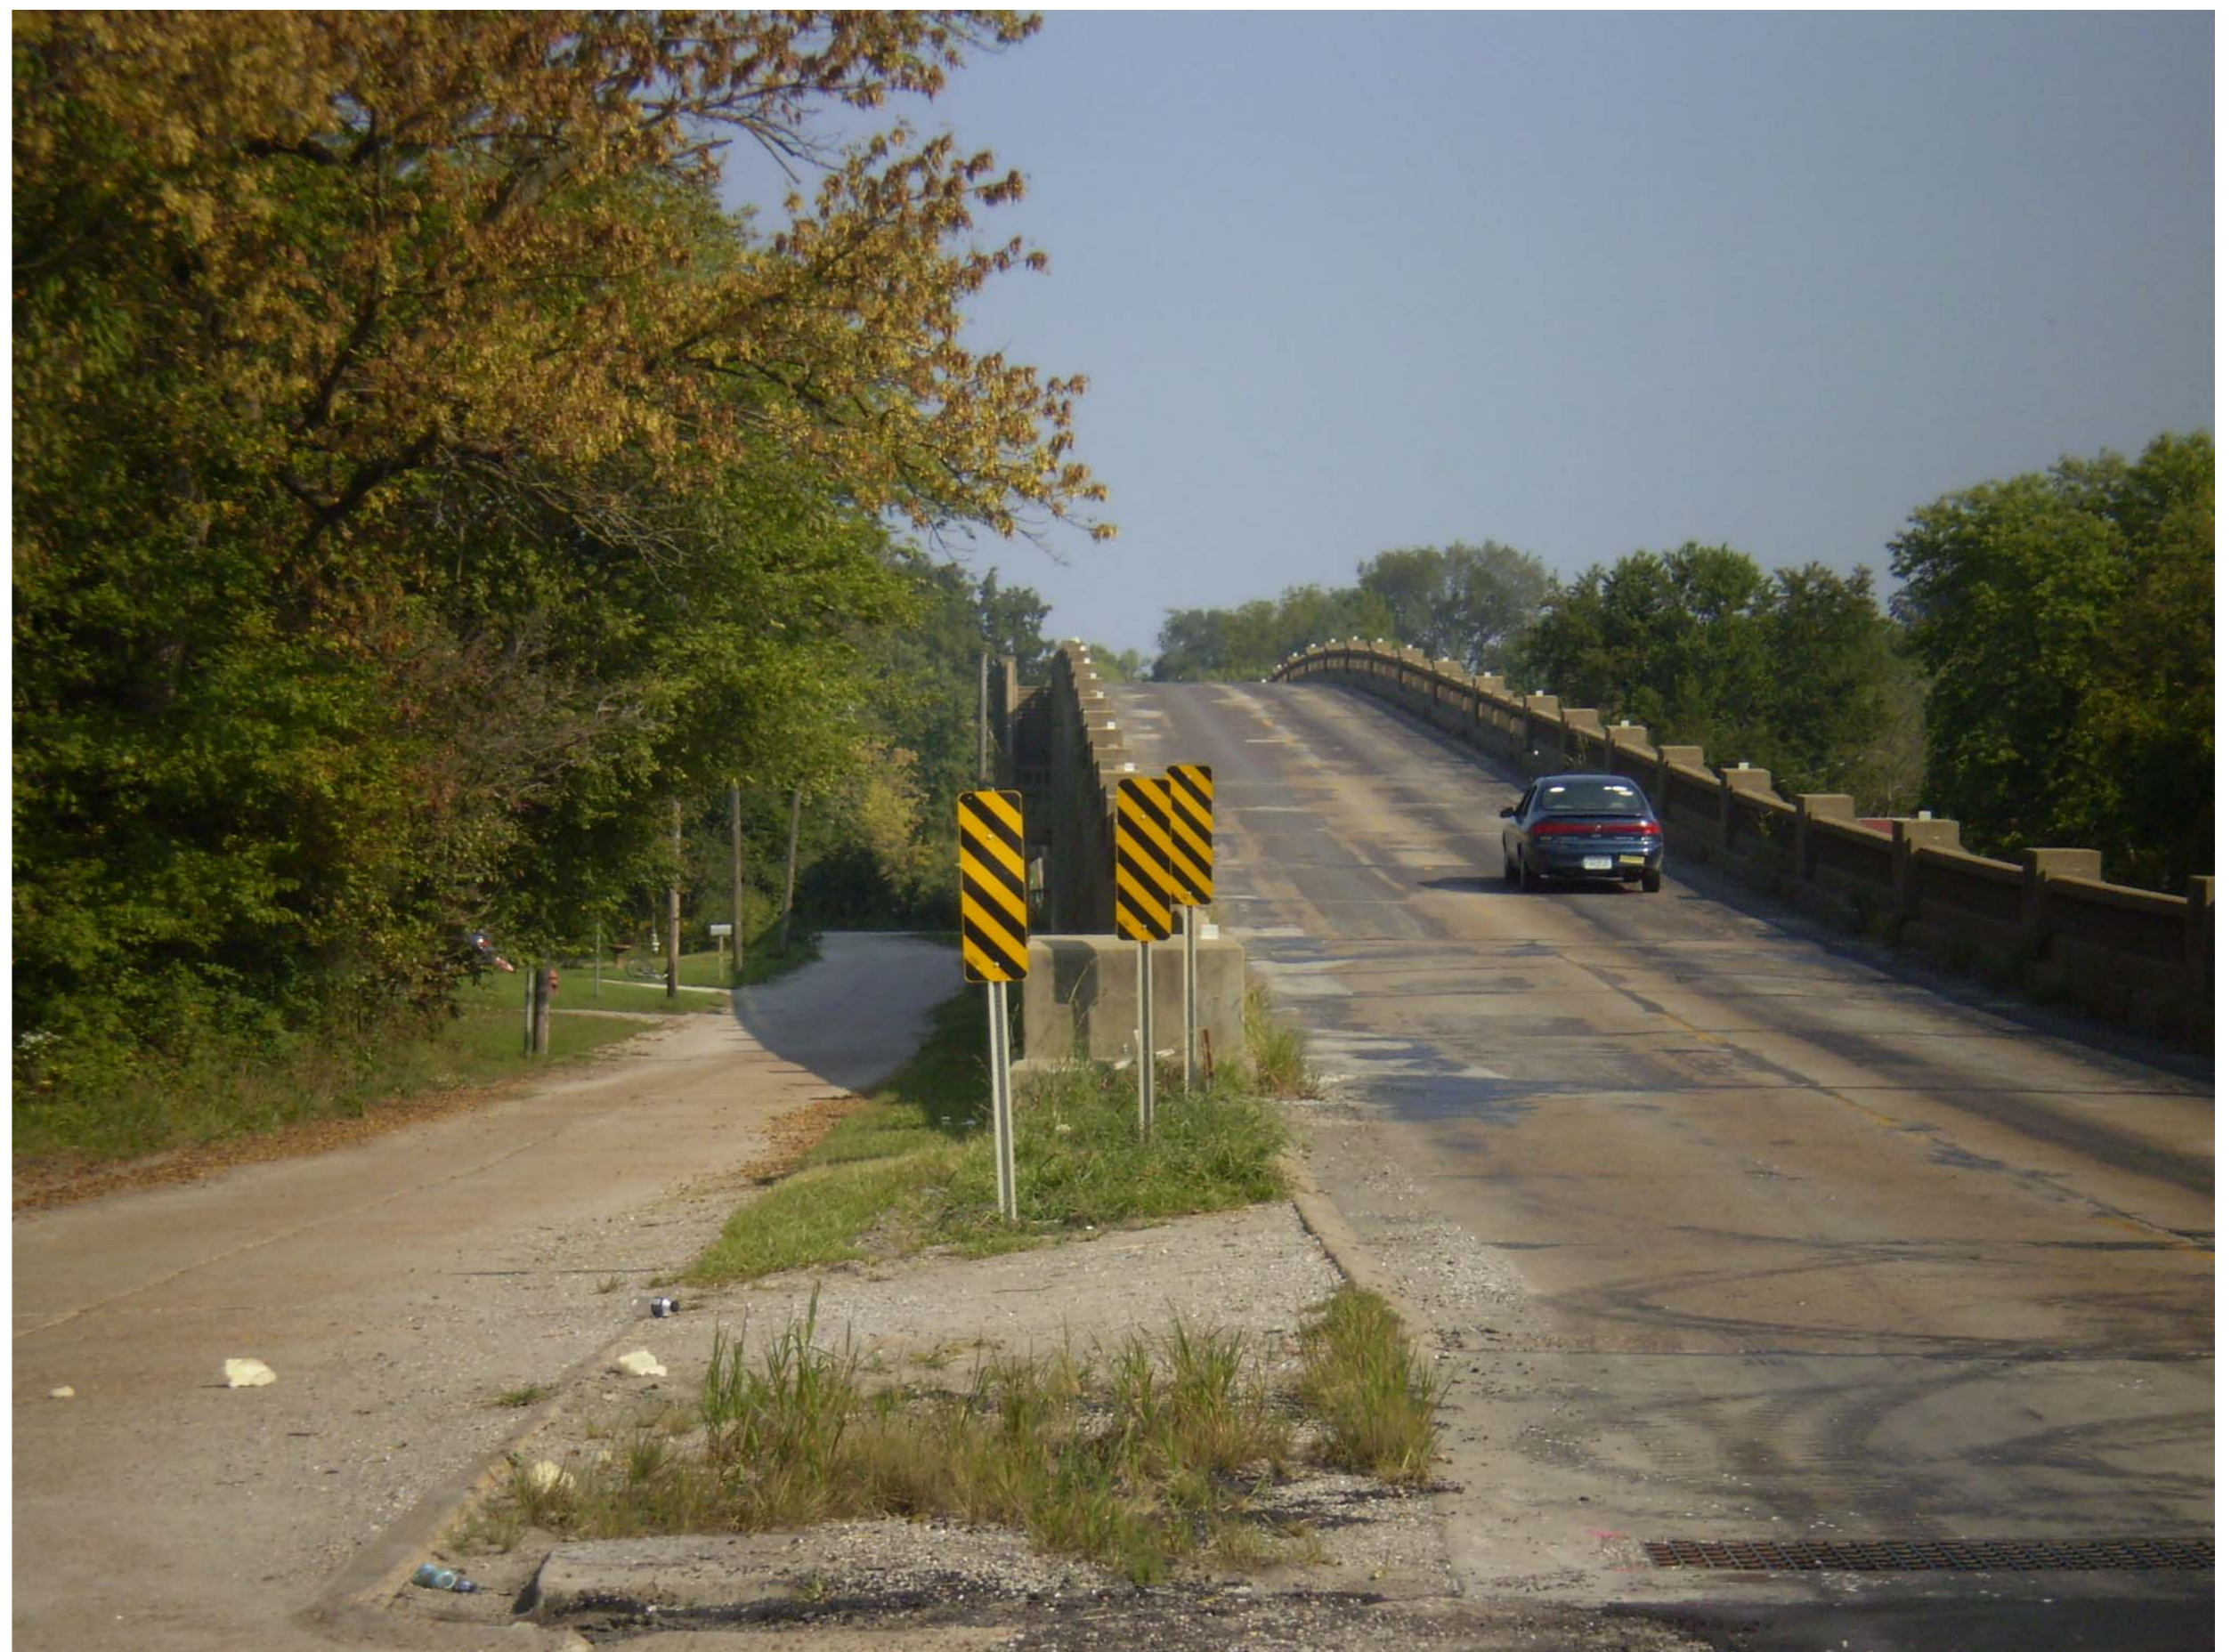
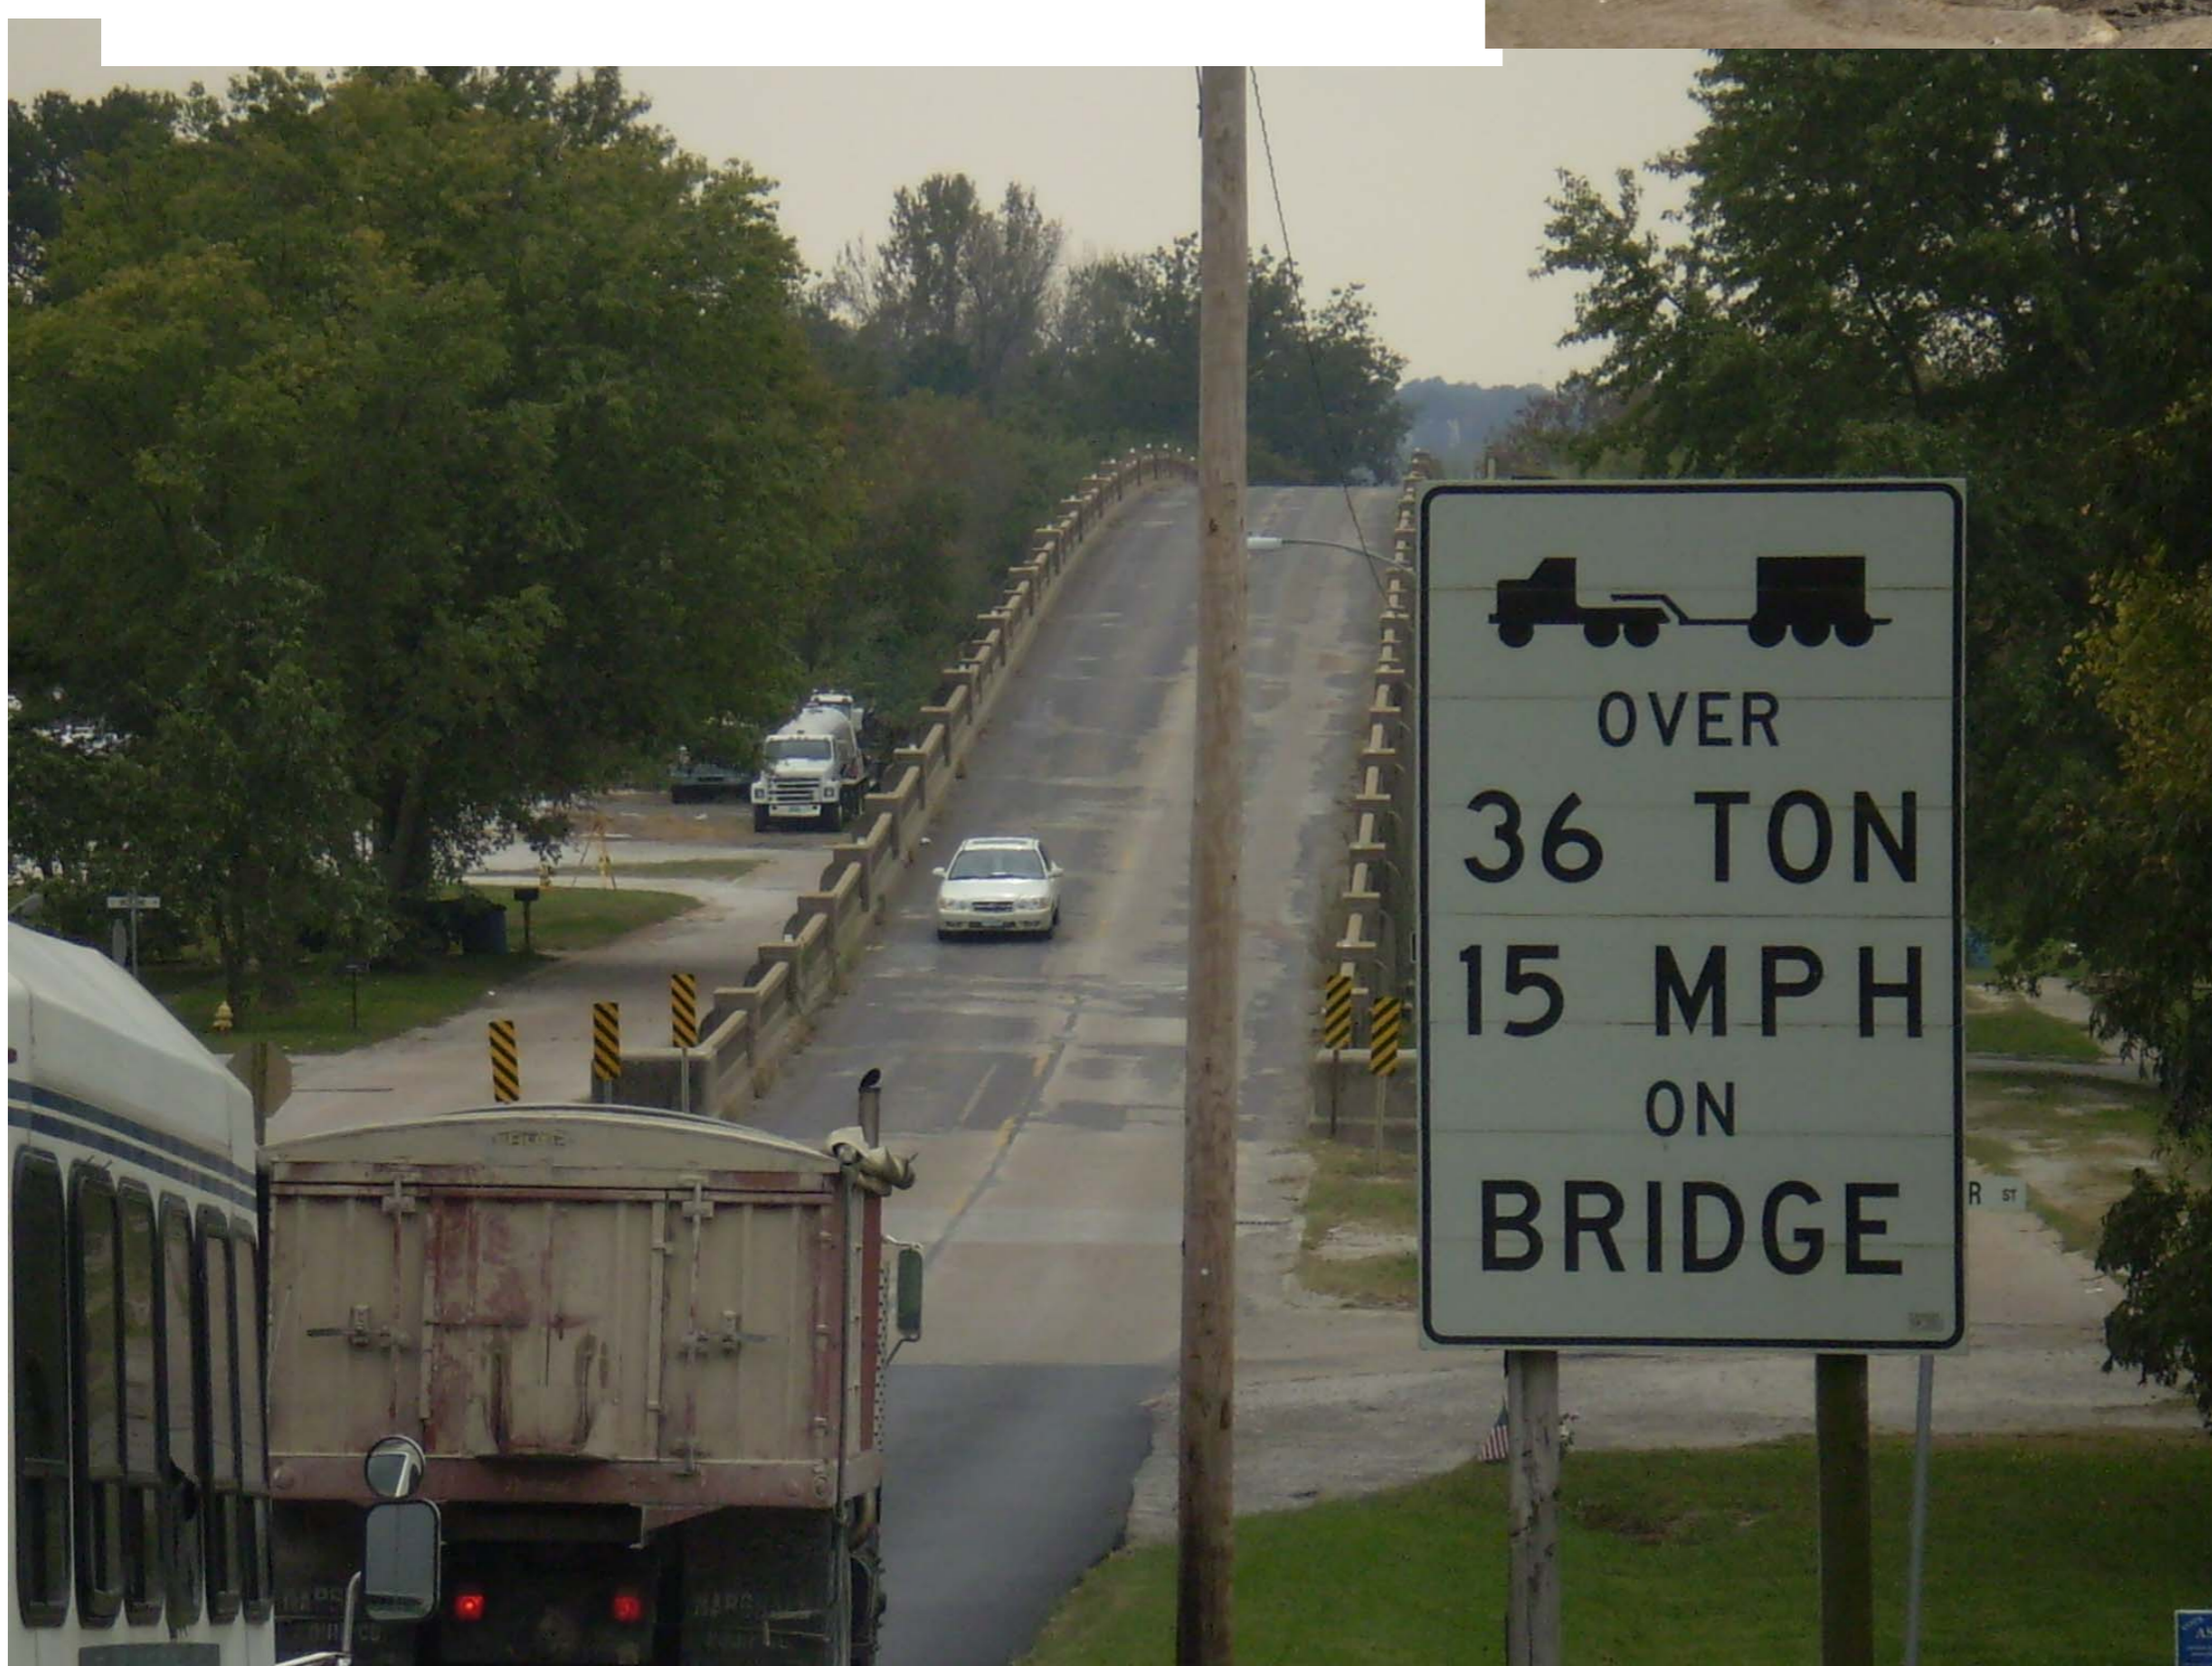
- The blunt ends of the bridge create a impact hazard.
- The narrow width causes drivers to crowd the centerline.
- The poor sight distance requires drivers to guess what is over the bridge.
