Missouri Department of Transportation Construction & Materials Central Office

- TO: Bret Davidson-nw/cm
- FROM: Lydia Brownell Geotechnical Engineer
- DATE: September 10, 2018
- SUBJECT: Slide Investigation Slide No S2498 Job No. R35G Hwy 59, Holt County

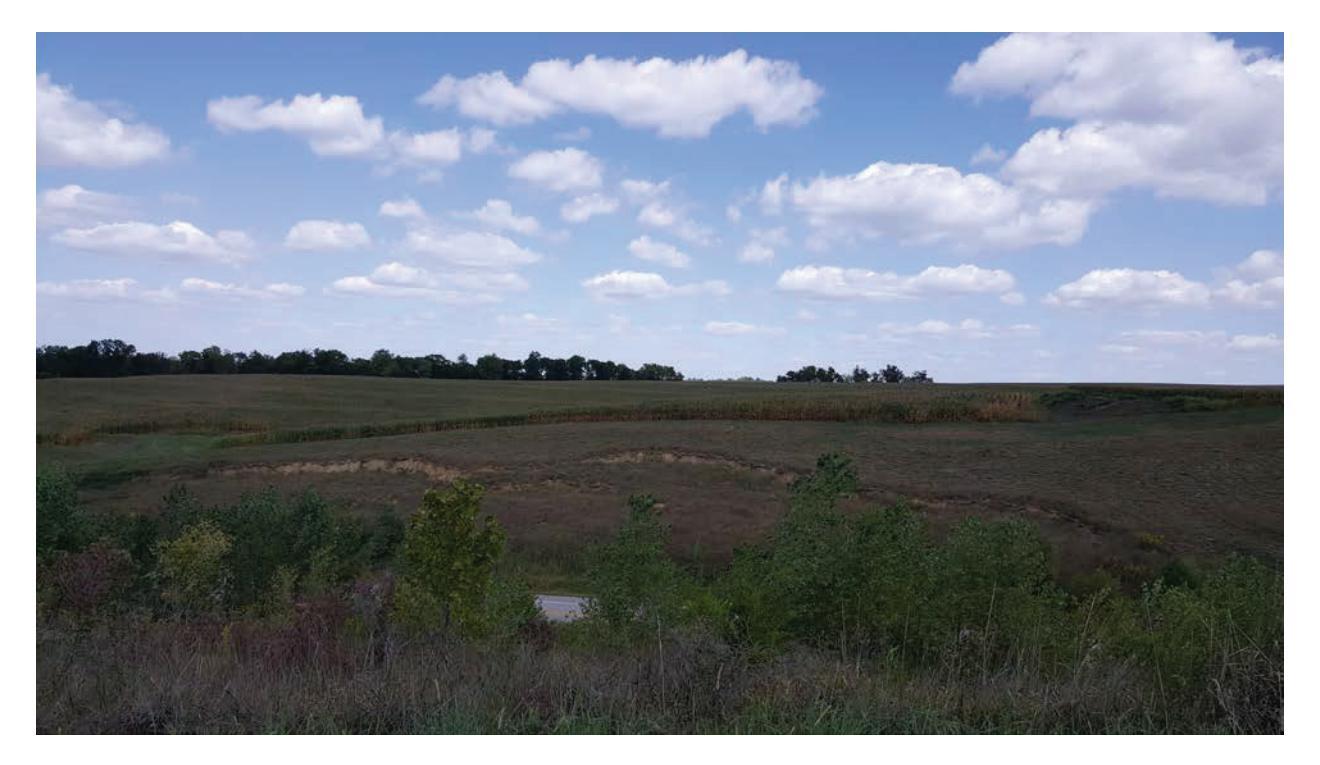
Northern slope looking north.

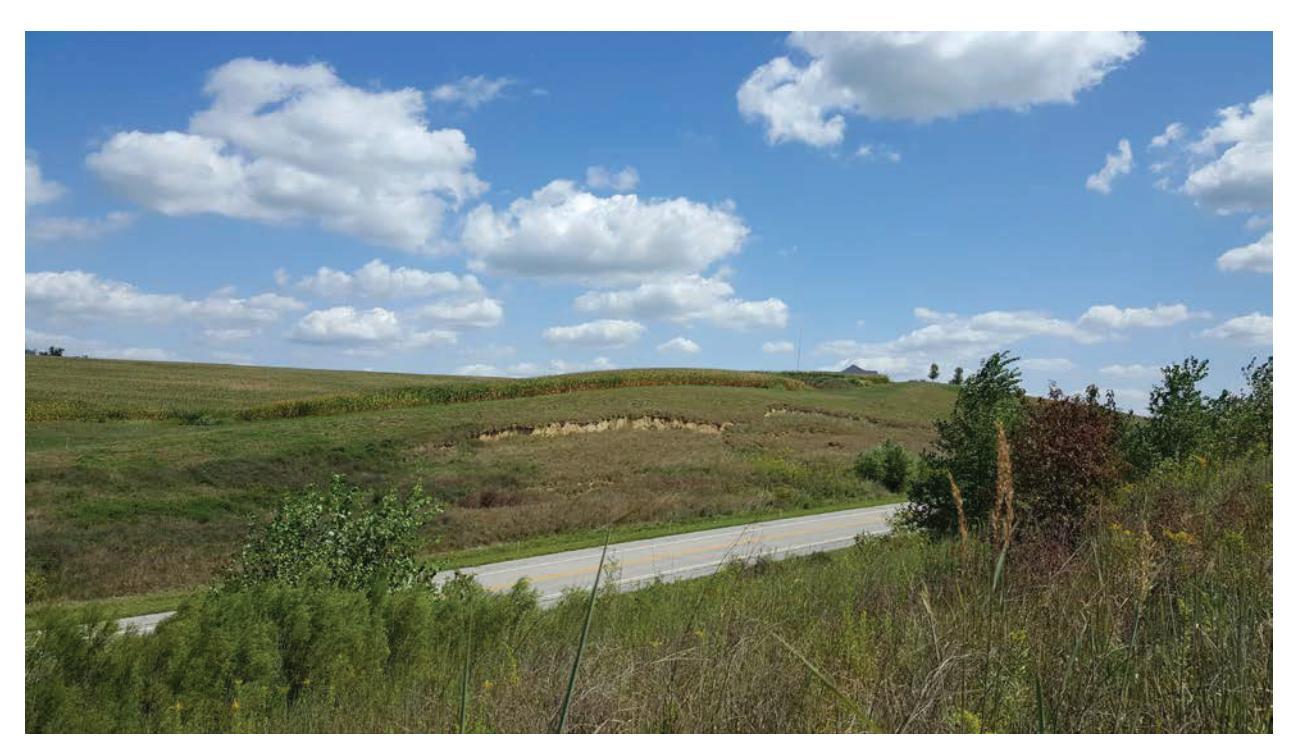
Northern slope looking northeast.

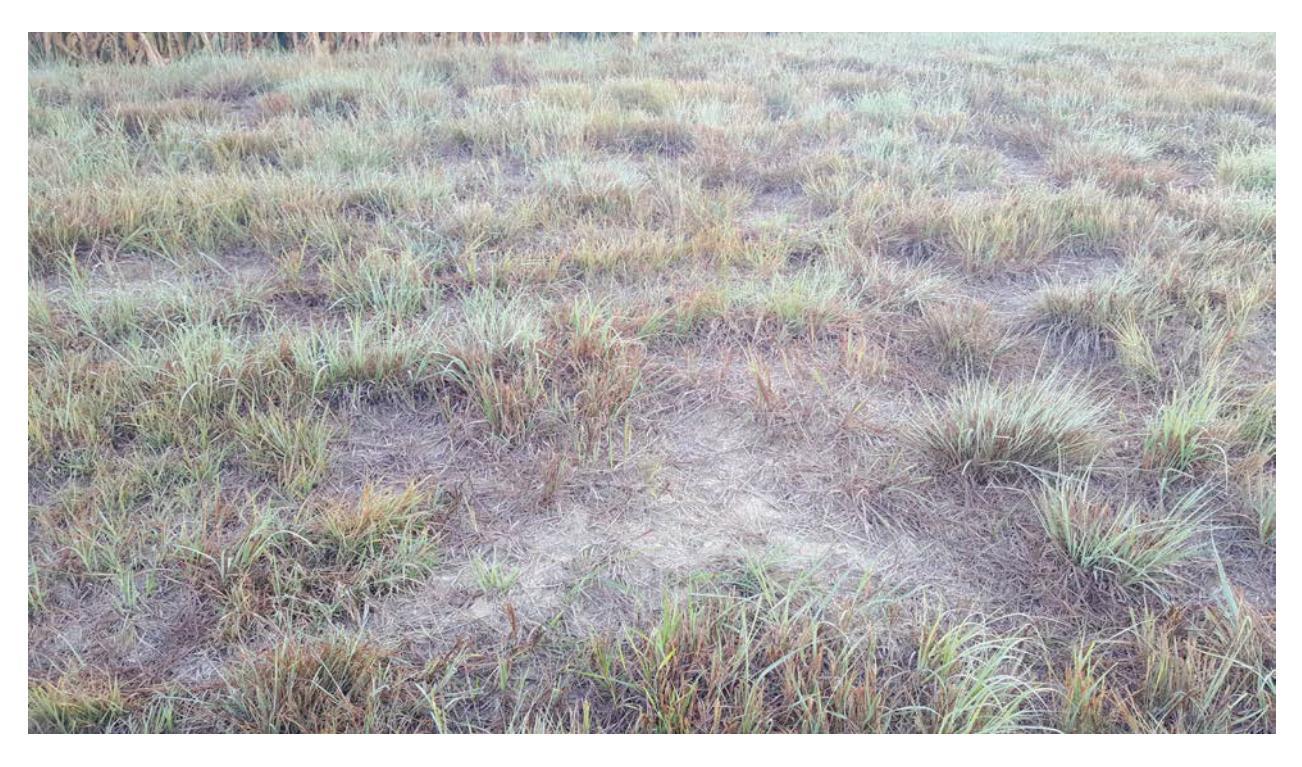
Present guidelines in the EPG 321.1 would require slopes no steeper than 2.5H:1V for this material and old plan sheets show a 3H:1V slope was designed for this location. Both of these slides appear to be caused by water seepage into the silt material, most likely caused by sparse vegetation along the slope in addition to a water table that appears to be either perched in the silt or slowly draining at the toe of the slope. This drainage is creating a permanently saturated condition at the toe of the slope.

Sparse vegetation along northern slope.

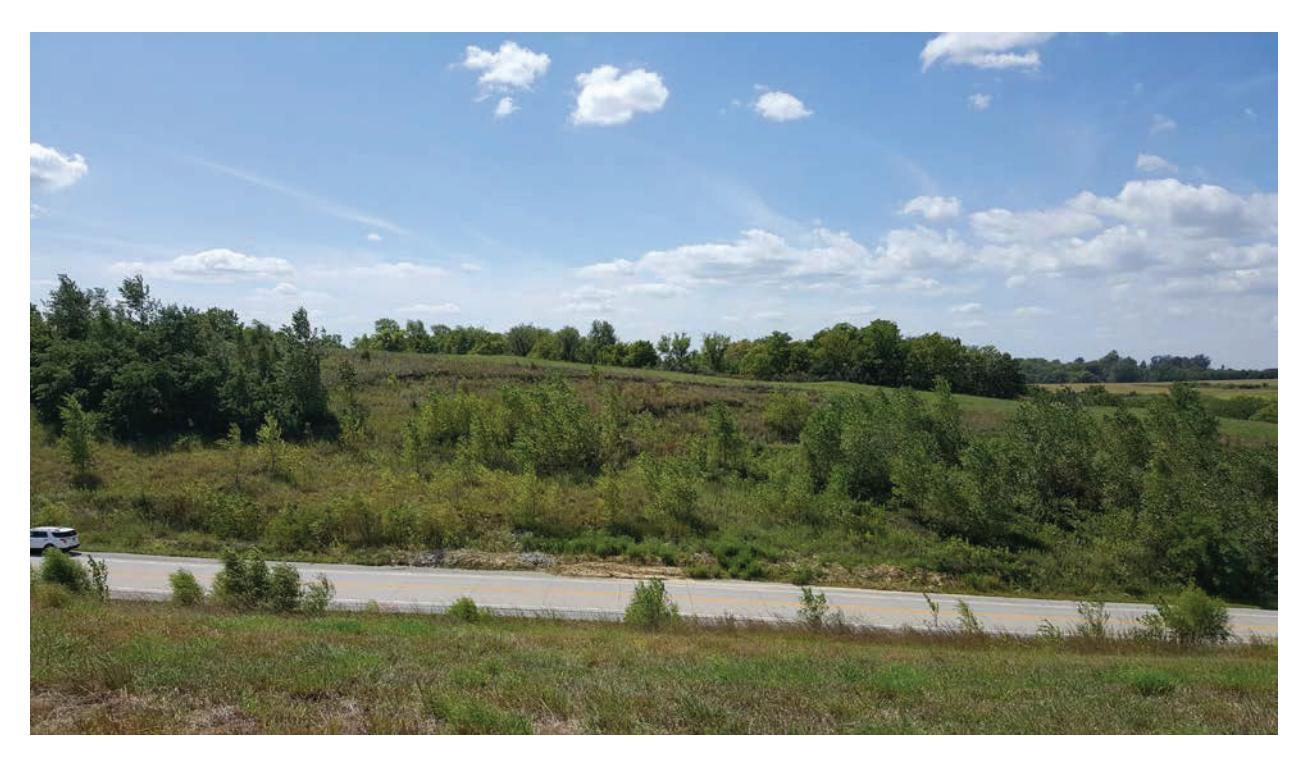
Southern Slope

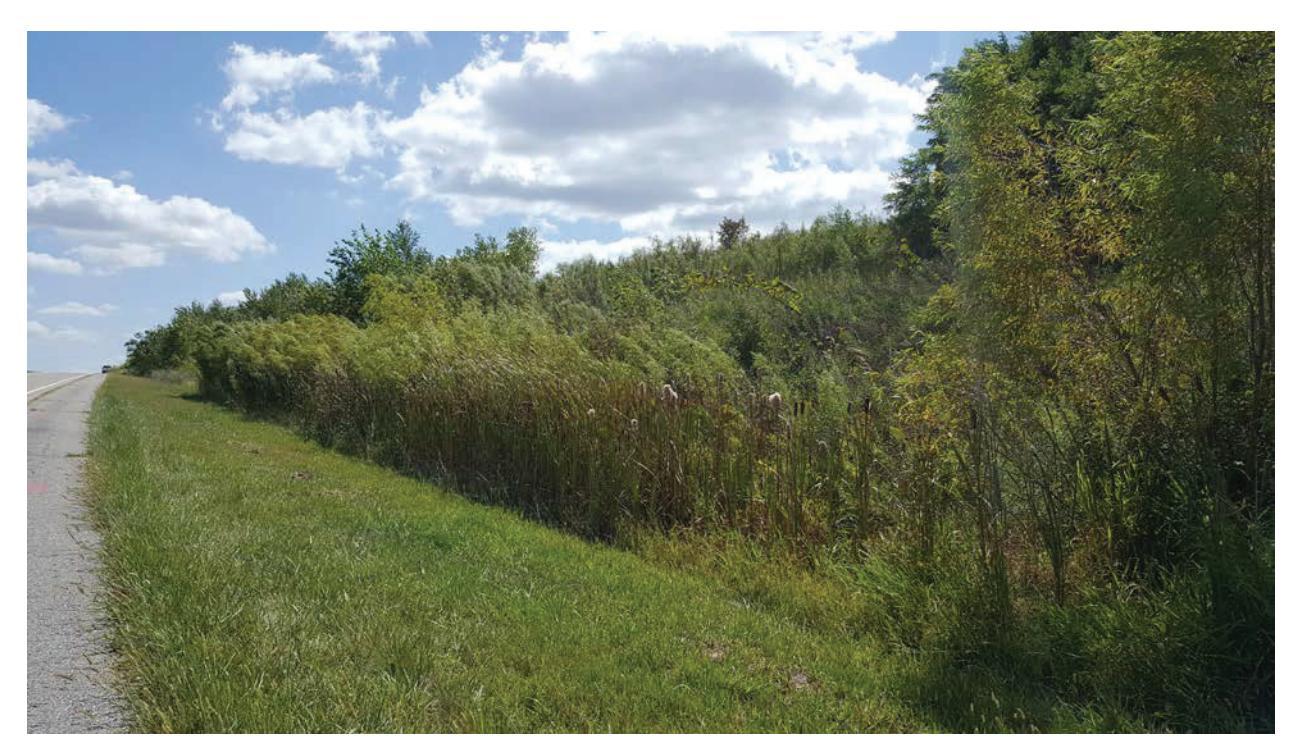
of sand and shale, which is visible in the ditch. The silt and lean clay classify as ML, ML-CL, and CL material by ASTM classification methods. Along the southern slope, the back fill height is about 47 feet at the highest point, with the back fill cut on a slope of about 2H to 2.5H:1V. The southern slope consists of silt, overlying lean clay on top of shale which is visible in the ditch. The silt and lean clay classify as ML, ML-CL, and CL material by ASTM classification methods. The ditches along both sides of the roadway are filled with cattails, a wetland plant that thrives in a wet environment.

Cattails in southern ditch line.

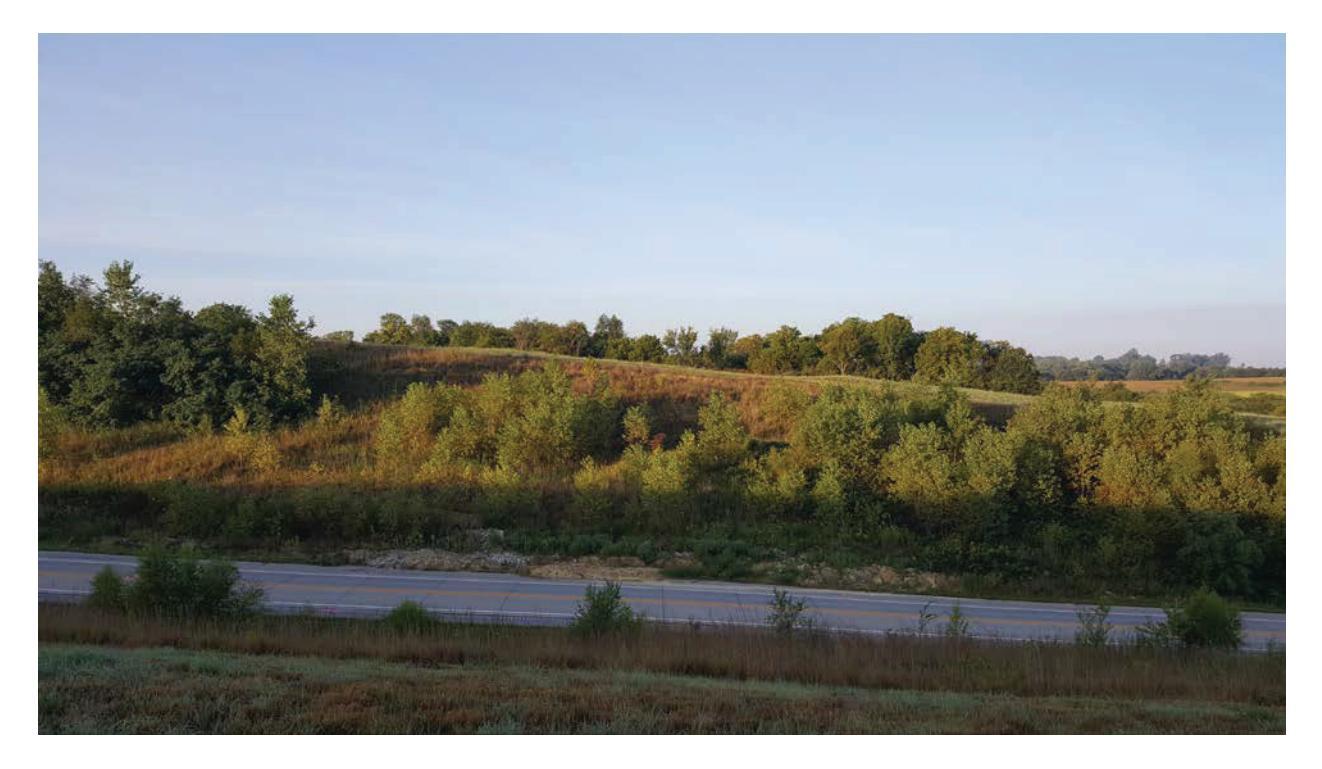
Southern Slope

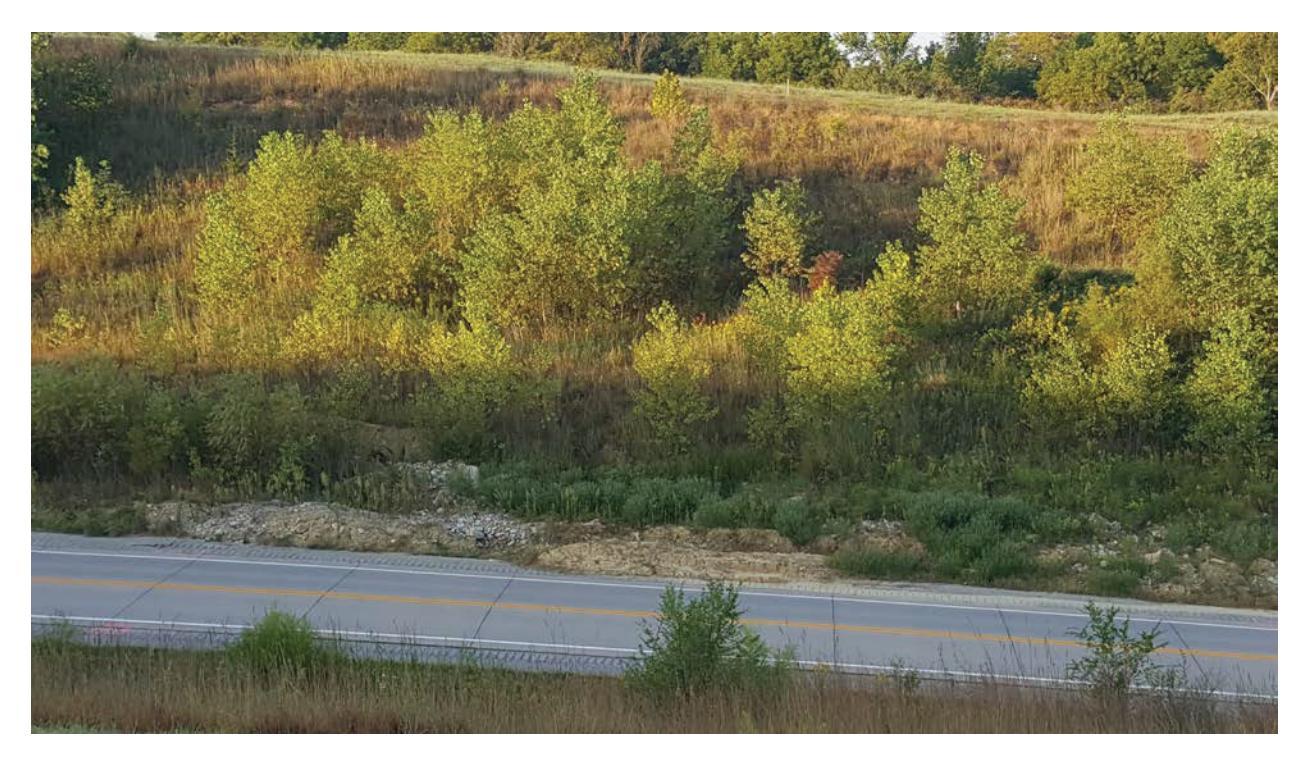
Filled ditch beneath southern slope.

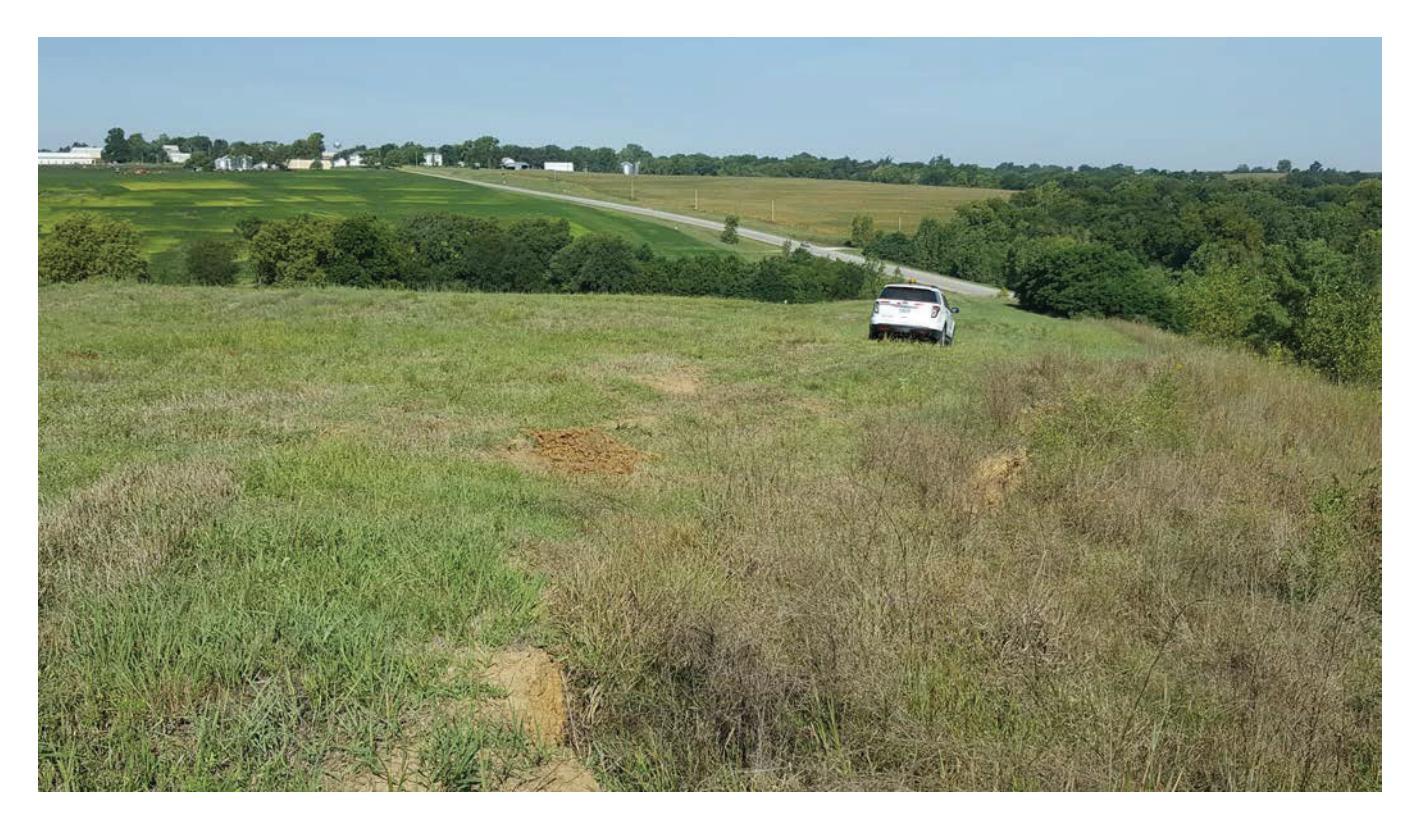
Cracks along upper surface of southern slope.

Drain material should consist of MoDOT Aggregate for Drainage in accordance with 1009.3.5 Grade 5. Pipes and separation fabric are not required in the drains. Once the drains are installed, the slope should be re-graded and any cracks in the ground surface, above the slide, should be sealed to prevent surface water from entering the slide. This can be accomplished by blading and tracking over cracks with a small dozer. Vegetation should be established as quickly as possible. The use of coconut fabric is recommended to promote vegetation growth.
