Central Laboratory

- DATE: September 20, 2022
- SUBJECT: Geotechnical Section Slide Investigation Slide No. S2967 Job No. R35G Route U, Warren County

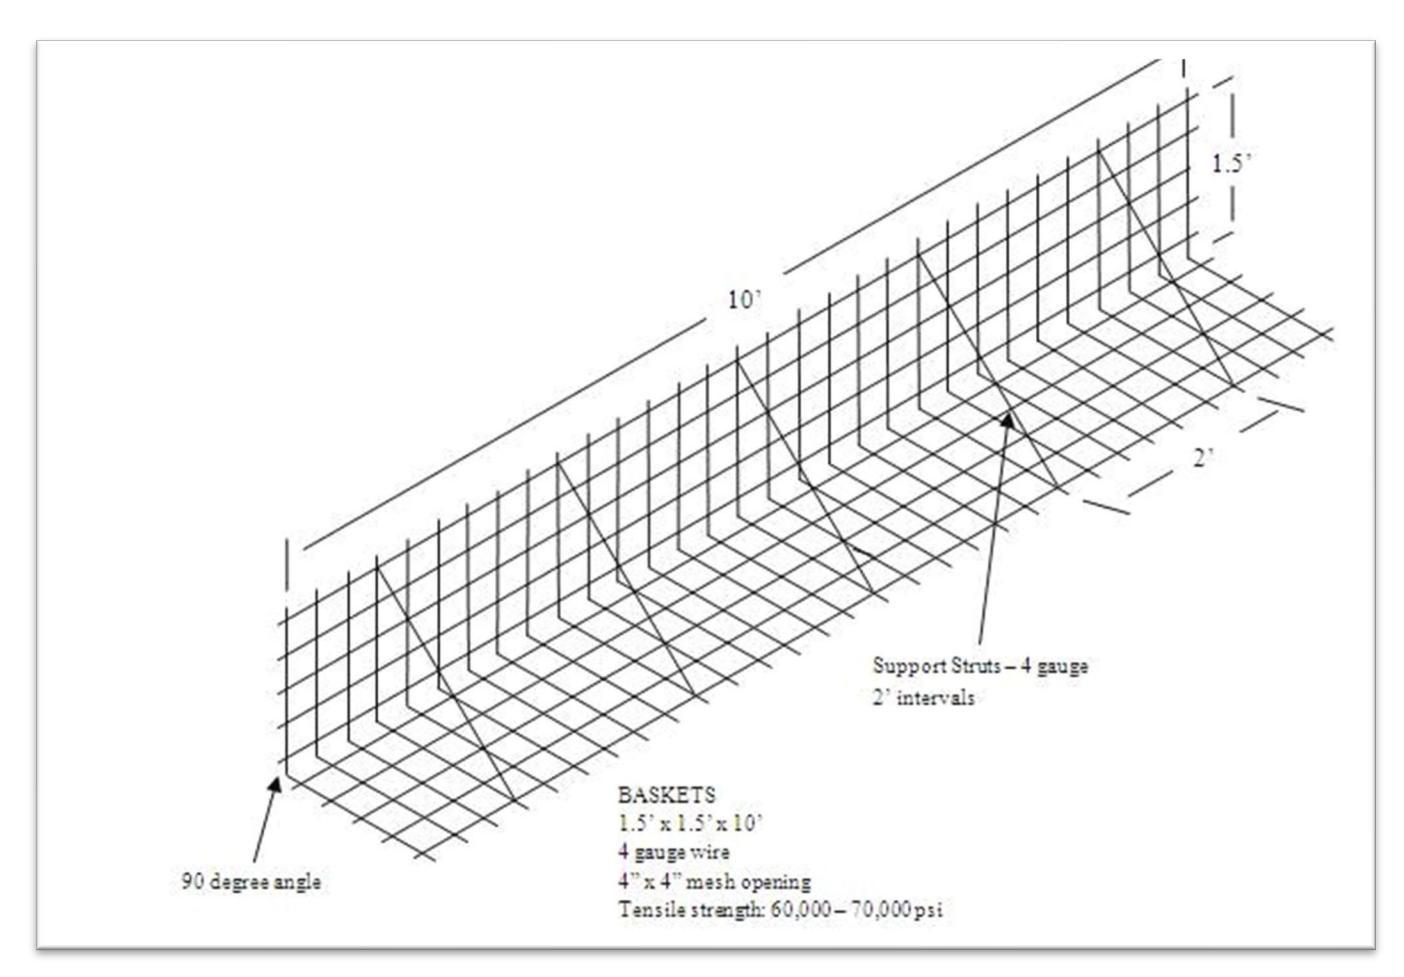
Image 1 - Welded Wire Facing Units, Taken From US Fabrics, <u>www.usfabricsinc.com</u>

Welded Wire Frame such as US Fabric's Welded Wire Facing Unit, or equivalent, see Image 1 below. The final slope will have a stepped finish.

This system should incorporate geogrid reinforcement placed horizontally from the back of the new fill to the face of each L-shaped Welded Wire Form. The L-shaped forms should be placed horizontally and be faced with a non-degradable/UV resistant mesh to retain fine materials. For a concept of the design, we anticipate the design will incorporate a polymer mesh facing similar to US Fabric's Startamesh and geogrid reinforcement similar to US Fabrics SGU 80 or SGU 100.

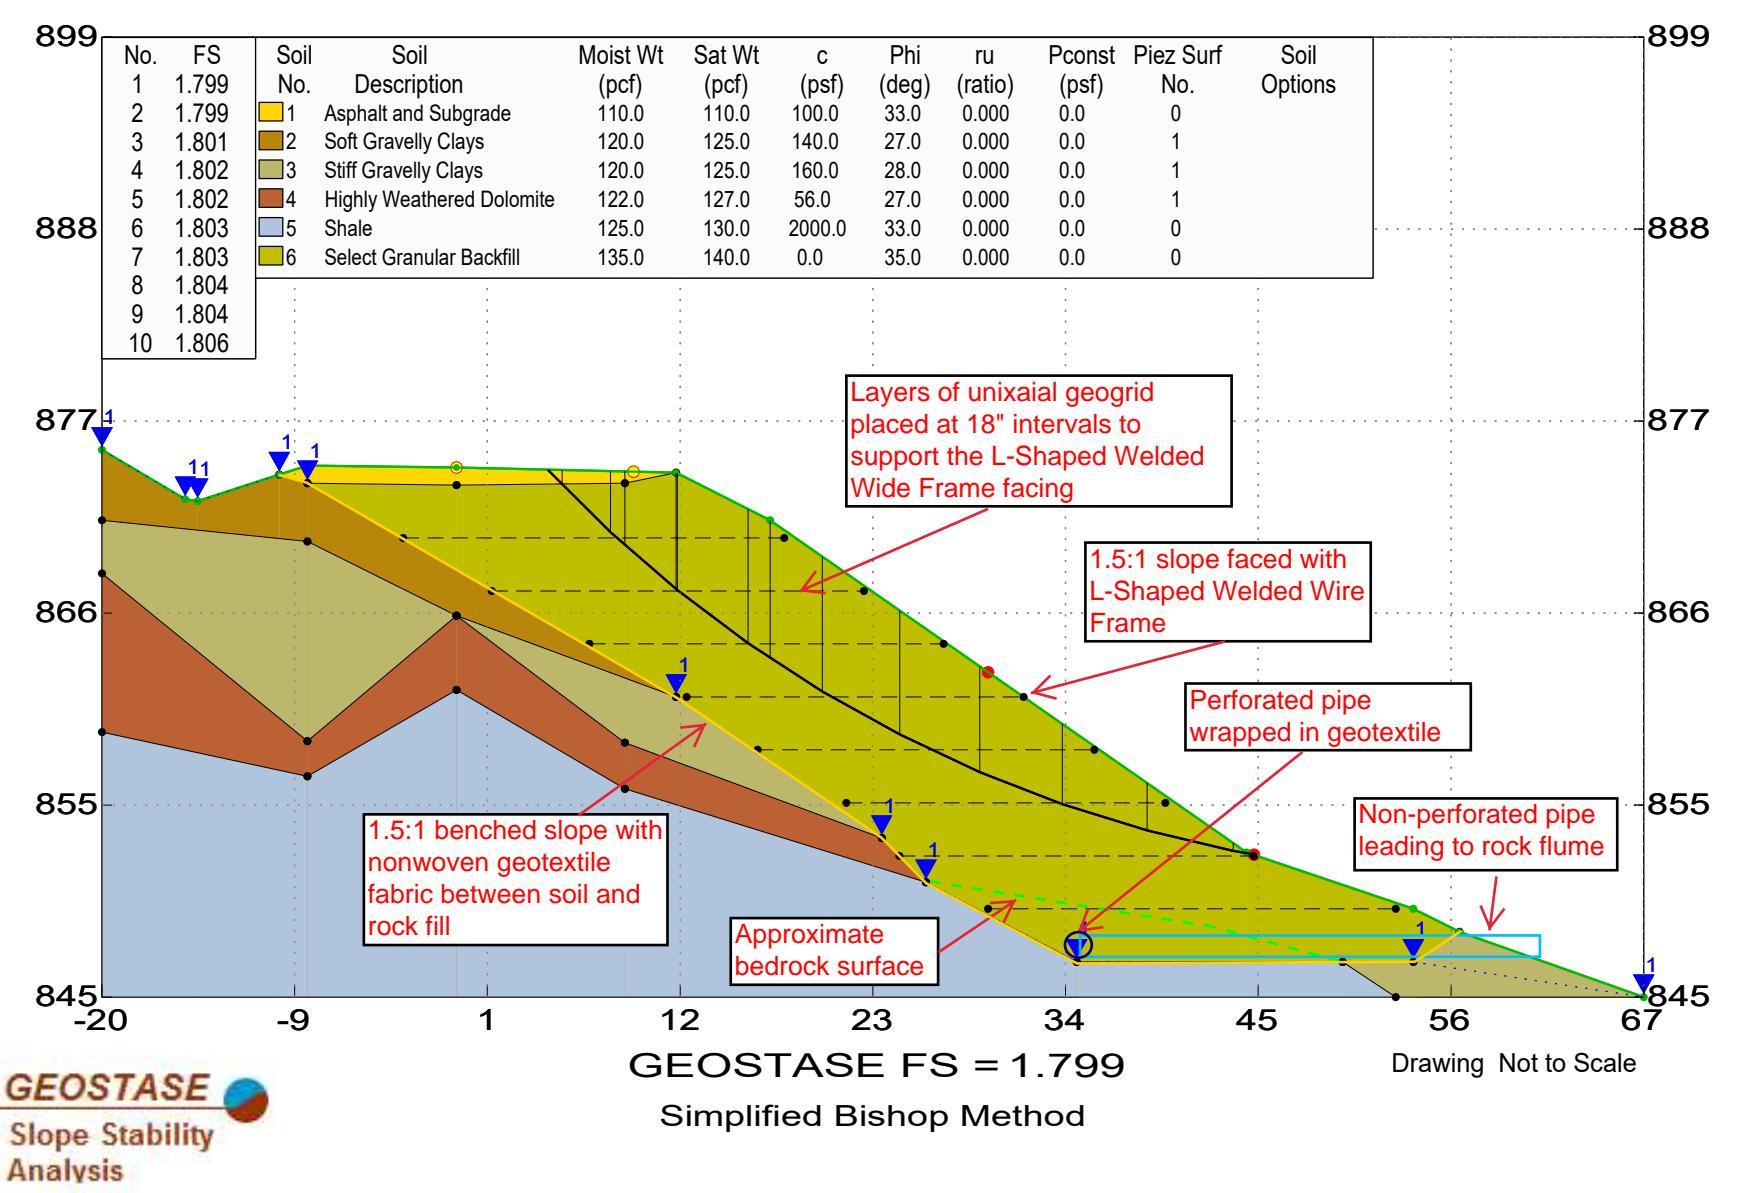
Figure 1

Though there could be additional reasons not discovered by the field investigation, it is believed that Slide 1 likely occurred due to the over saturation of the upper layer of gravelly lean clay resulting in a loss of shear strength. This combined with the very steep nature of the embankment allowed the layer to begin sliding along the surface of the lower clay layer resulting in the settling and cracking in the pavement. Slide 2 is a result of poorly placed fill that became saturated resulting a loss of shear strength.

Warren County - Rte U R35G - Station 109+48 Slide 1 (North Slide)

Slide 1 - Reinforced L-Shaped Welded Wire Facing

Recommendations for Slide 1 (Sta 108+50 to 110+00) Reinforced L-Basket Slope Repair (Figure 1)

Global stability modeling was completed for a slope reconstructed to follow a similar geometry to the existing slope prior to failure. Our initial repair model consisted of a rock wedge with an embankment slope of 1.5:1. However, this system has a very low factor of safety (FOS~1.1) and is not recommended. We then modeled a repair consisting of a reinforced rock wedge fill. This system has a suitable factor of safety for global stability and incorporates a slope facing product and horizontal geogrid reinforcement as outlined below.

Beginning at the edge of the western shoulder, make a temporary benched excavation no steeper than 1.5H:1V. The excavation should be embedded a minimum of 4 feet into shale at the toe of the slope or excavator refusal if shallower. We recommend the shale surface at the base of the repair be excavated such that it's slope is no steeper than 10 percent in any direction. We also recommend a representative from the geotechnical section be on site during excavation of the toe of the slope to verify these recommendations are valid based upon actual subsurface conditions.

We recommend an 8oz non-woven geotextile (such as US Fabrics US 205NW or Mirafi 180N) be laid down to separate existing soil from the new rock fill. The fabric should be lapped at the edges a minimum of 18-inches. The embankment should be reconstructed with Select Granular Backfill (SGB) in accordance with Specification Section 1010 with a final embankment slope no steeper than 1.5:1. The SGB should be faced with L-Shaped

We recommend using an 8oz non-woven geotextile to separate the existing soil from the new rock fill. The fabric also needs to be lapped at the edges a minimum of 18 inches. We also recommend installing a 4-inch perforated pipe bedded in 1-inch clean rock and wrapped with an 8 oz non-woven geotextile, such as US Fabrics US 205NW or equivalent, at the back of the base of the repair. If the base of the repair dips toward the toe, a perforated pipe bedded in in 1-inch clean rock and wrapped with an 8-oz non-woven geotextile should also be placed along the toe of the repair. The perforated drainage pipe(s) should be connected to solid 4-inch drainage pipes spaced every 50 feet along the repair. The solid pipes should be routed to daylight and drain on a rock flume pad.

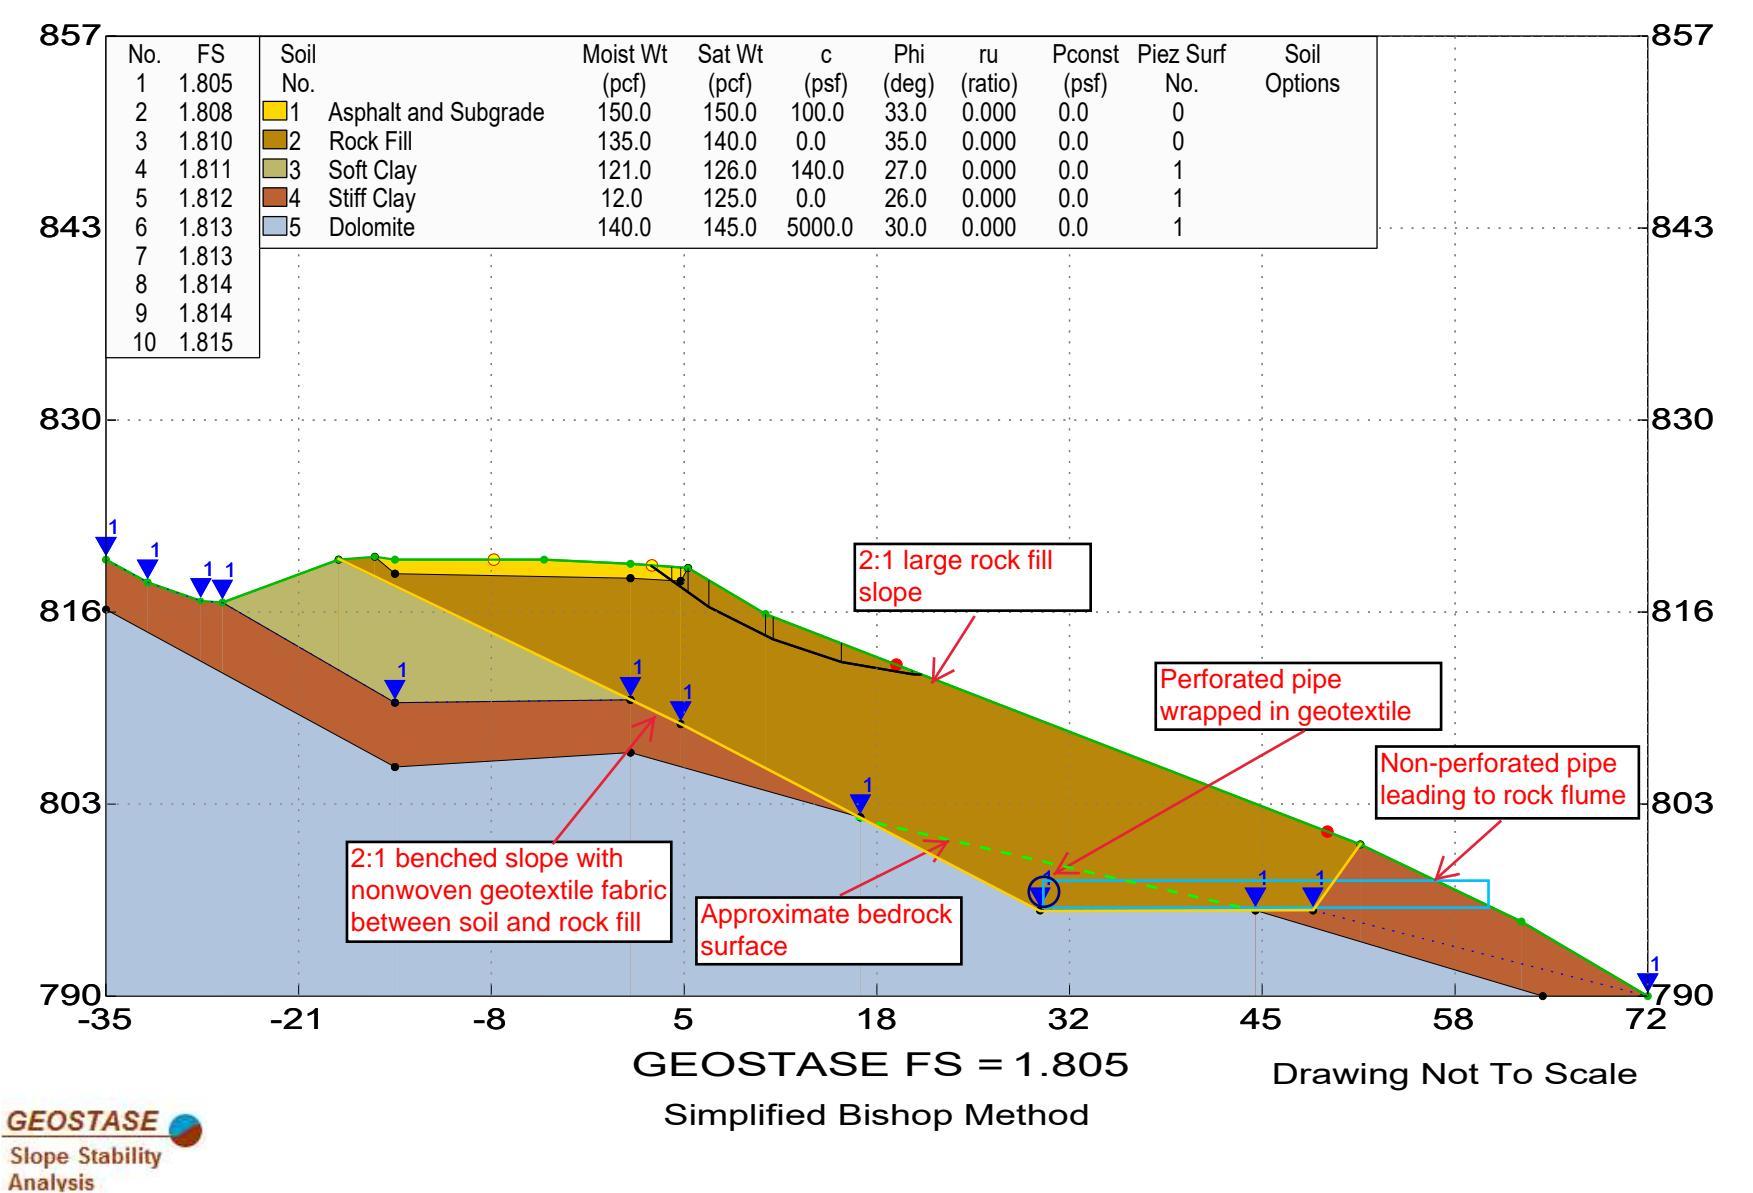
Figure 2

Warren County - Rte U S2967 - Station 104+98 Slide 2 (South Slide)

Slide 2 - Large rock Fill Slope

Recommendations for Slide 2 (Sta 104+50 to 105+80) Rock Wedge Repair (Figure 2)

Global stability modeling was completed for a slope reconstructed to follow a similar geometry to the existing slope prior to failure. Our repair model consisted of a rock wedge with an embankment slope of 2:1. A suitable factor of safety was achieved and recommendations for constructing the slope are provided below.

Beginning at the edge of the western shoulder, make a temporary benched excavation no steeper than 2H:1V. The excavation should be embedded a minimum of 4 ft into weathered dolomite or excavator refusal, whichever comes first. We recommend the dolomite surface at the base of the repair be excavated such that it is no steeper than 10 percent in any direction. We also recommend a representative from the geotechnical section be on site during excavation of the toe of the slope to verify these recommendations are valid based upon actual subsurface conditions.

It is recommended that a slope no steeper than 2H:1V be constructed utilizing large rock fill meeting the following:

- Predominant top size of 12 inches
- Particle top size should be restricted to 24". If boulders larger than 24" are delivered to the site, they can be removed from the fill and placed near the toe of the slope.
- Up to about 20% passing 6 inches is permissible.
- Fines should not exceed 10%.

We recommend using an 8oz non-woven geotextile to separate the existing soil from the new rock fill. The fabric also needs to be lapped at the edges a minimum of 18 inches. We also recommend installing a 4-inch perforated pipe bedded in 1-inch clean rock and wrapped with an 8 oz non-woven geotextile, such as US Fabrics US 205NW or equivalent, at the back of the base of the repair. If the base of the repair dips toward the toe, a perforated pipe bedded in in 1-inch clean rock and wrapped with an 8-oz non-woven geotextile should also be placed along the toe of the repair. The perforated drainage pipe(s) should be connected to solid 4-inch drainage pipes spaced every 50 feet along the repair. The solid pipes should be routed to daylight and drain on a rock flume pad.
