Preliminary Geotechnical Report

JSE0083 BRIDGE L0210 ROUTE 67 OVER OTTER CREEK WAYNE COUNTY, MISSOURI

January 5, 2024

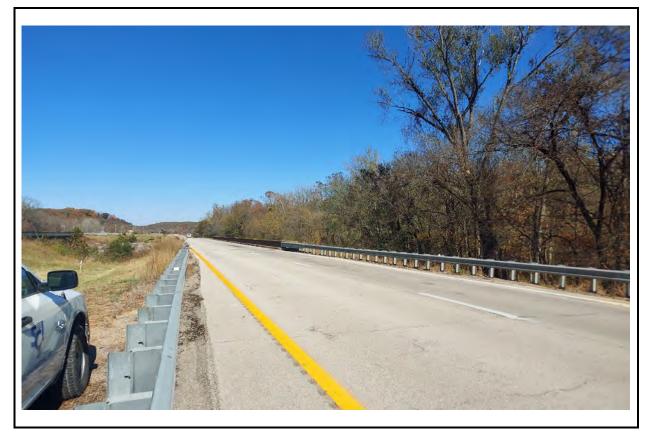
Photo 1. Southeast Bridge Approach

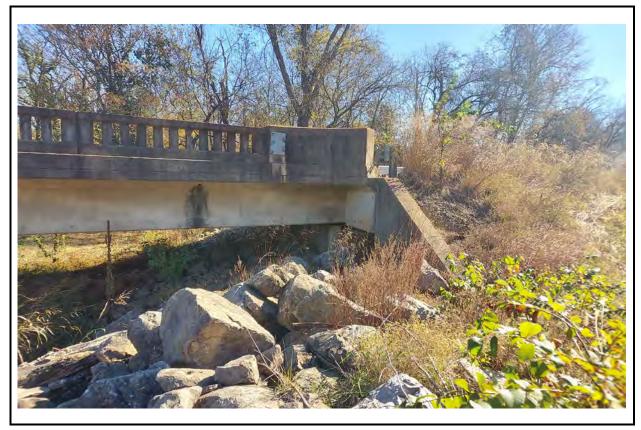
Photo 2. Southeast End Bent

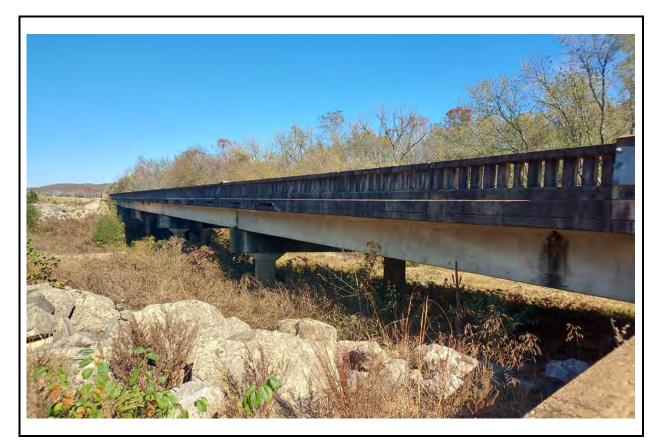
Photo 3. Existing Bridge Deck

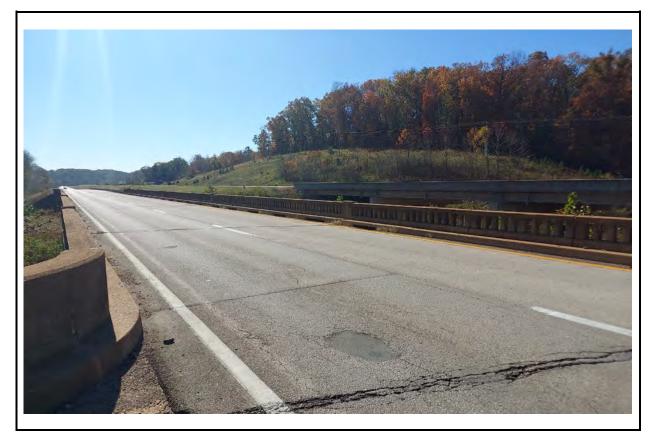
Photo 4. Existing Bridge Pavement

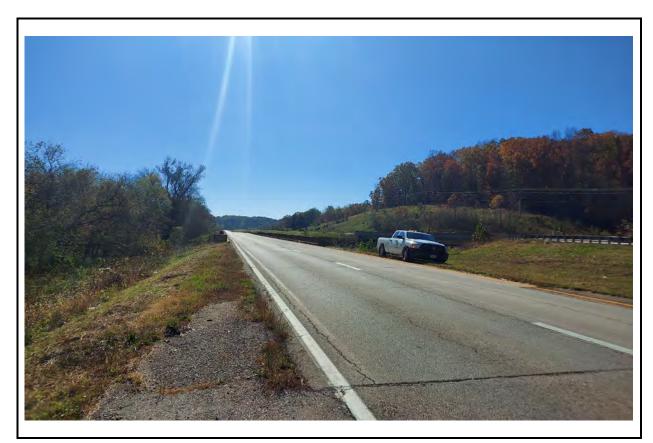
Photo 5. Northwest Bridge Approach

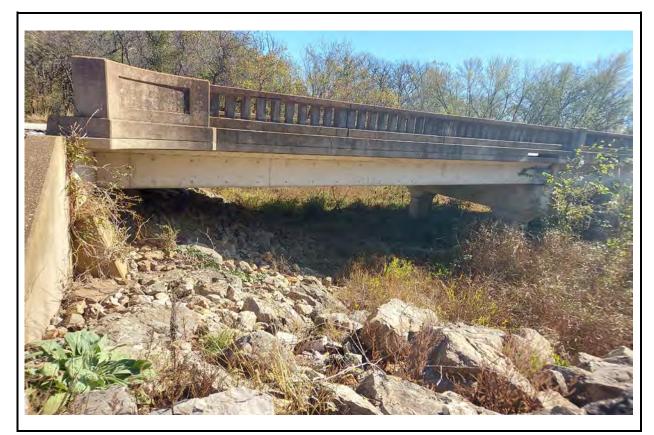
Photo 6. Northwest End Bent

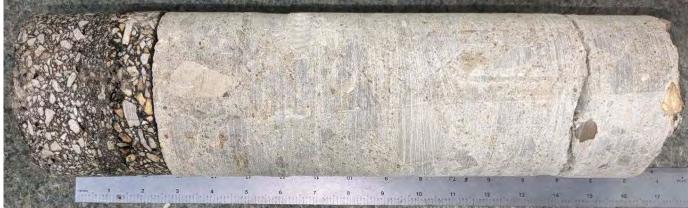
BORING P-1

The existing pavement was cored at both P-1 and P-2 and consisted of 3 inches of asphaltic concrete pavement overlying 13 inches of concrete, for a total thickness of 16 inches, at each location. Photographs of the pavement cores are included in Appendix D. The concrete base was underlain by chert gravel and boulders. No aggregate base was encountered in the pavement borings.

SAMPLE NO.	LENGTH 1	LENGTH 2	LENGTH 3	AVERAGE
1	15.4	15.5	15.7	15.6

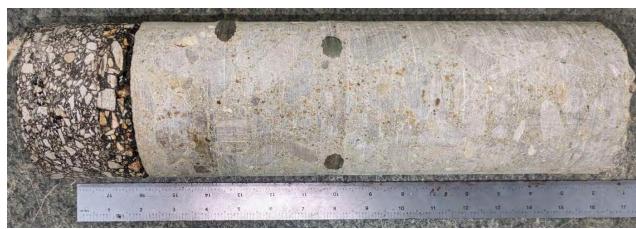
BORING P-2

SAMPLE NO.	LENGTH 1	LENGTH 2	LENGTH 3	AVERAGE
1	15.0	15.2	14.9	15.1
