180216-G08  
LAWRENCE CO

# Project Background

- Unbonded overlay on the driving lanes of I-44
- Remove and replace existing unbonded overlay
- Perform the work as quickly as possible
- Minimize impact to traveling public
- Joplin Project office- Marvin Morris RE

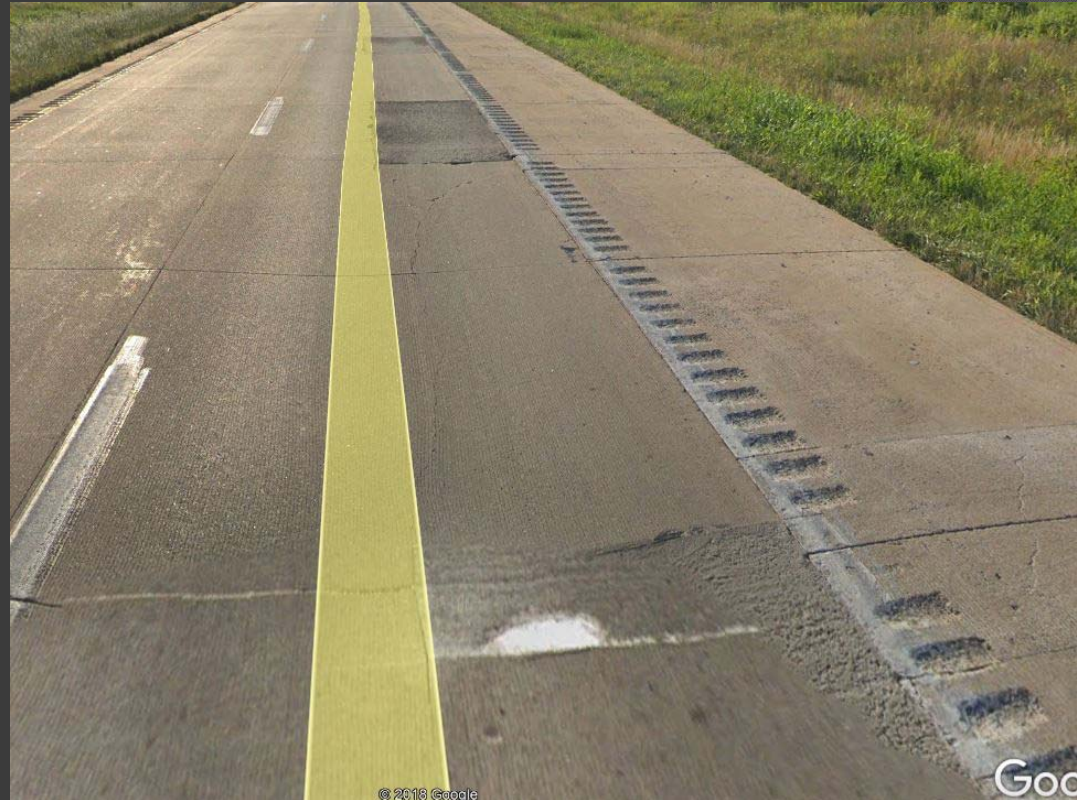
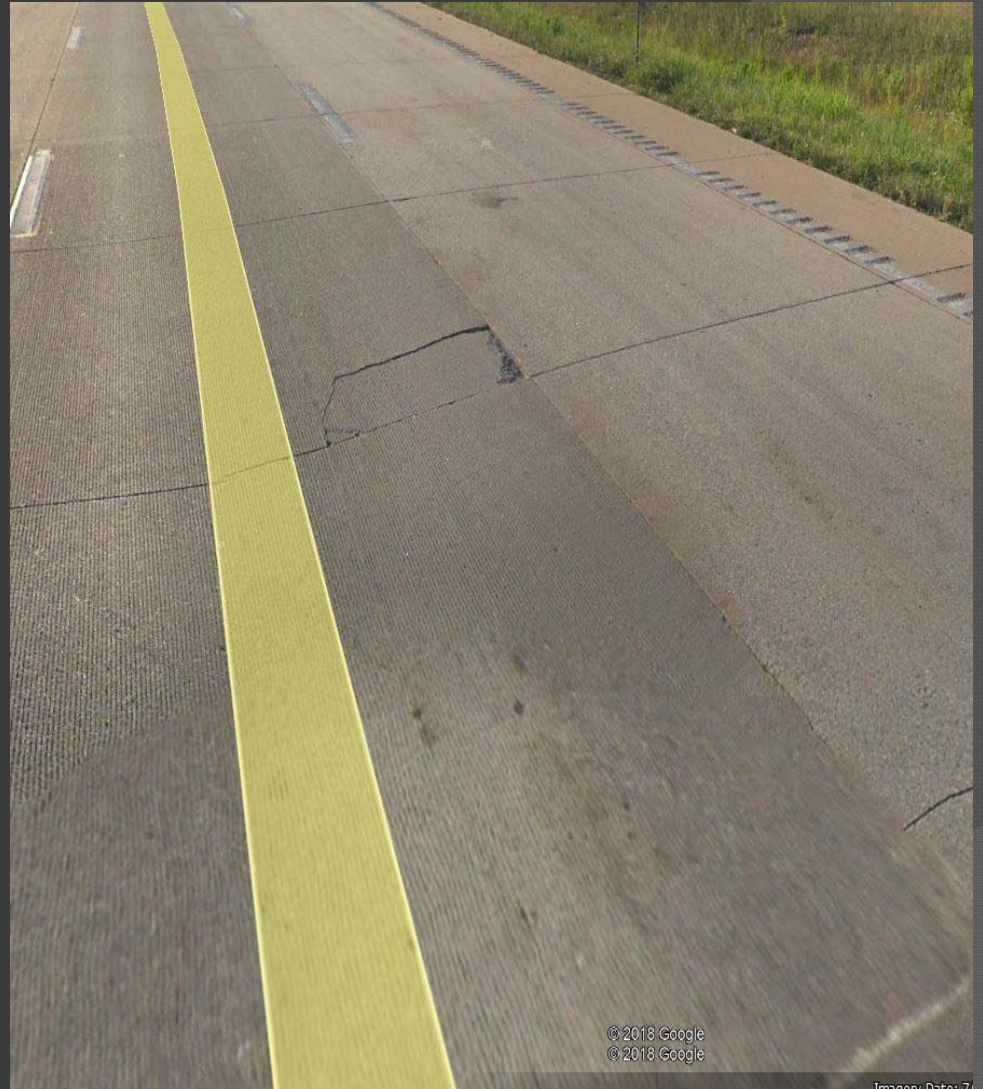
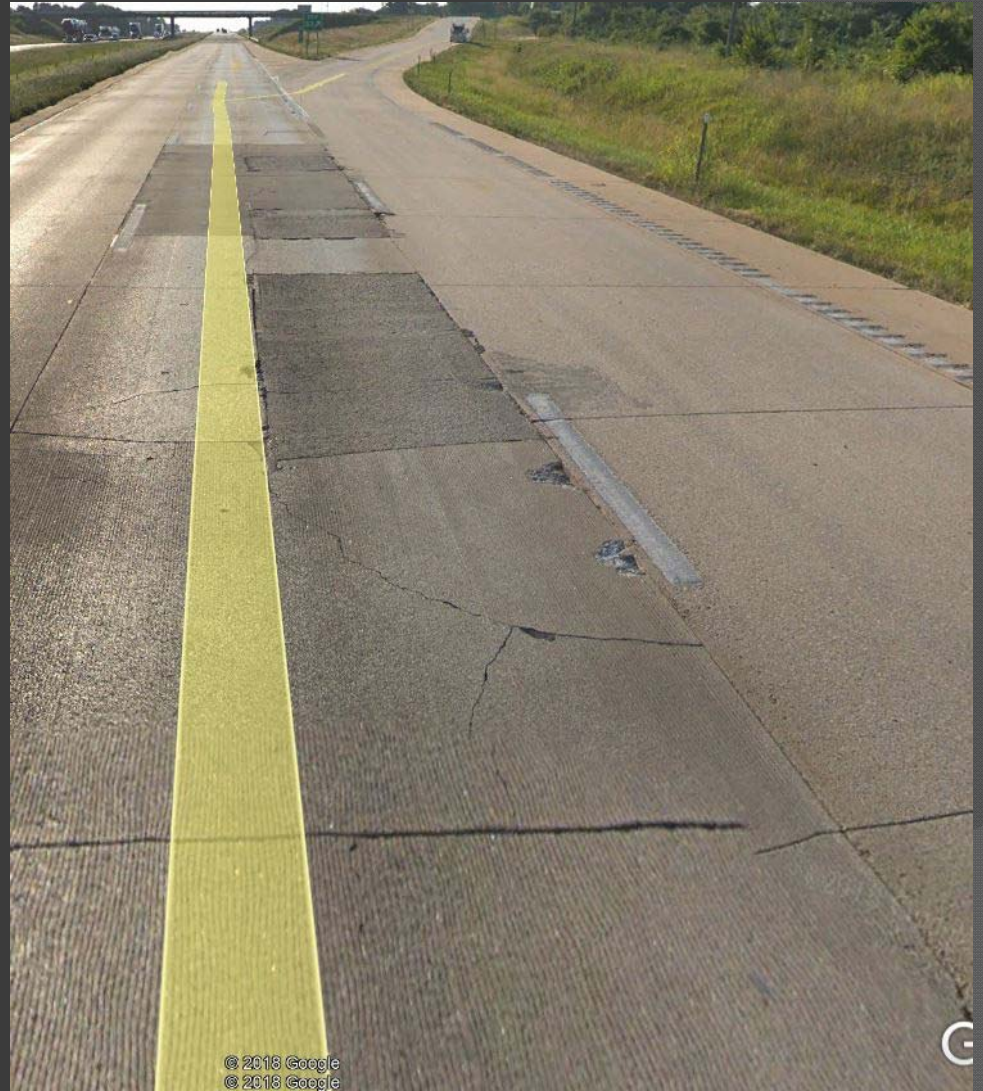
- Driving Lane had previously been ground
- Panels were faulting
- Faulting due to failure of previous bond breaker

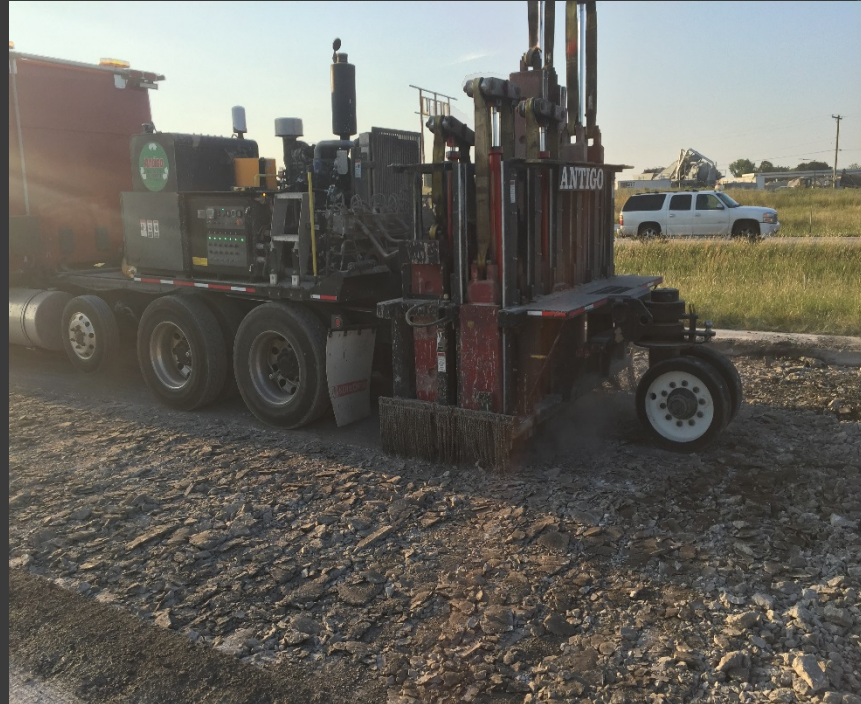
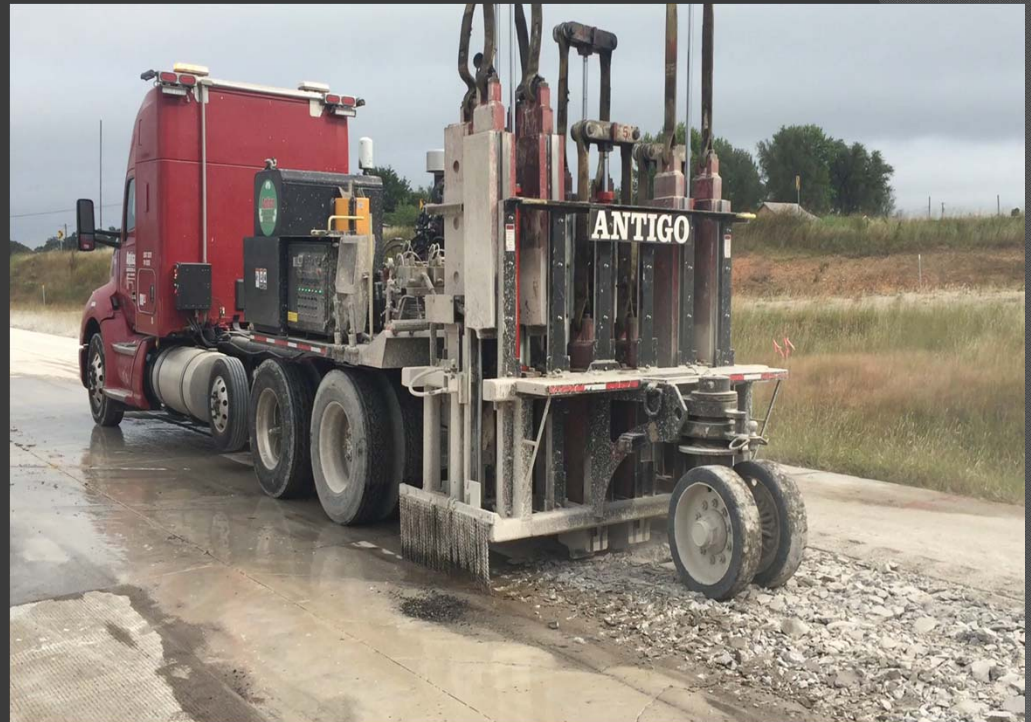
- Antigo performed breaking operations
- Existing bond breaker was no problem
- Had spalling due to expansion of broken concrete and existing slab conditions

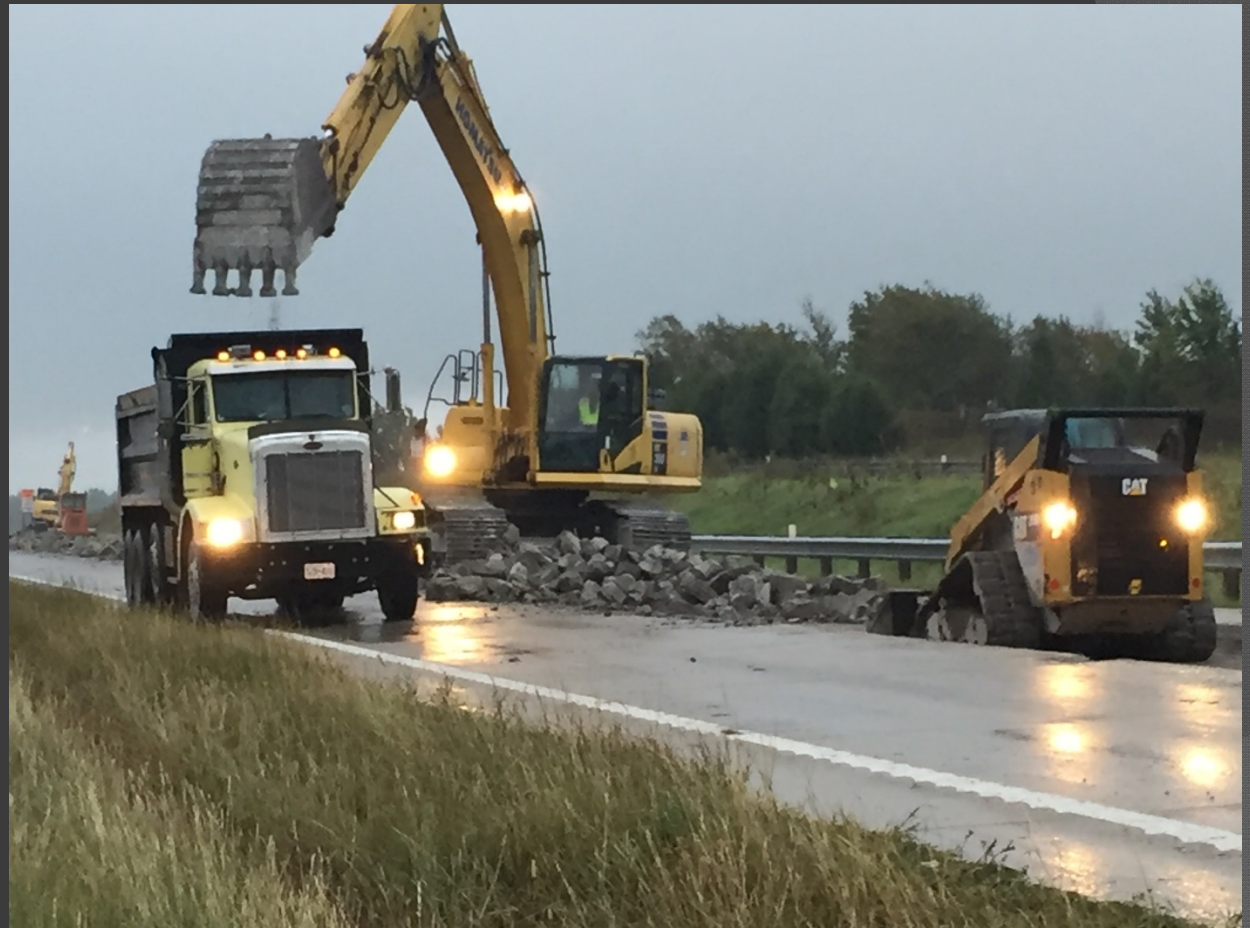
- ◉ Trackhoe to remove bulk of material
- ◉ Skidsteer provided clean up
- ◉ Material hauled back to plant location

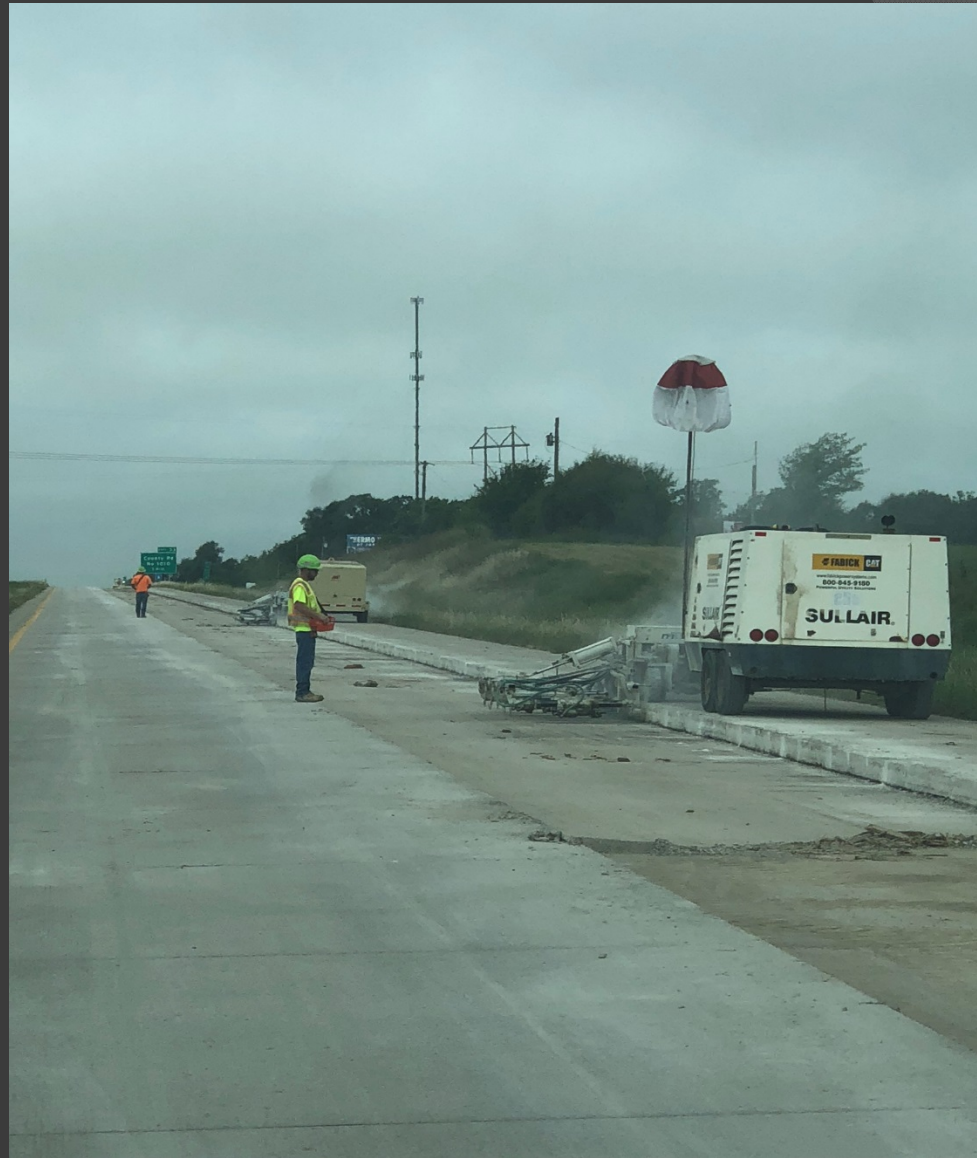
- ◉ Shoulder was drilled
- ◉ Tie-Bars were epoxied into place
- ◉ Dual five gang drills were used

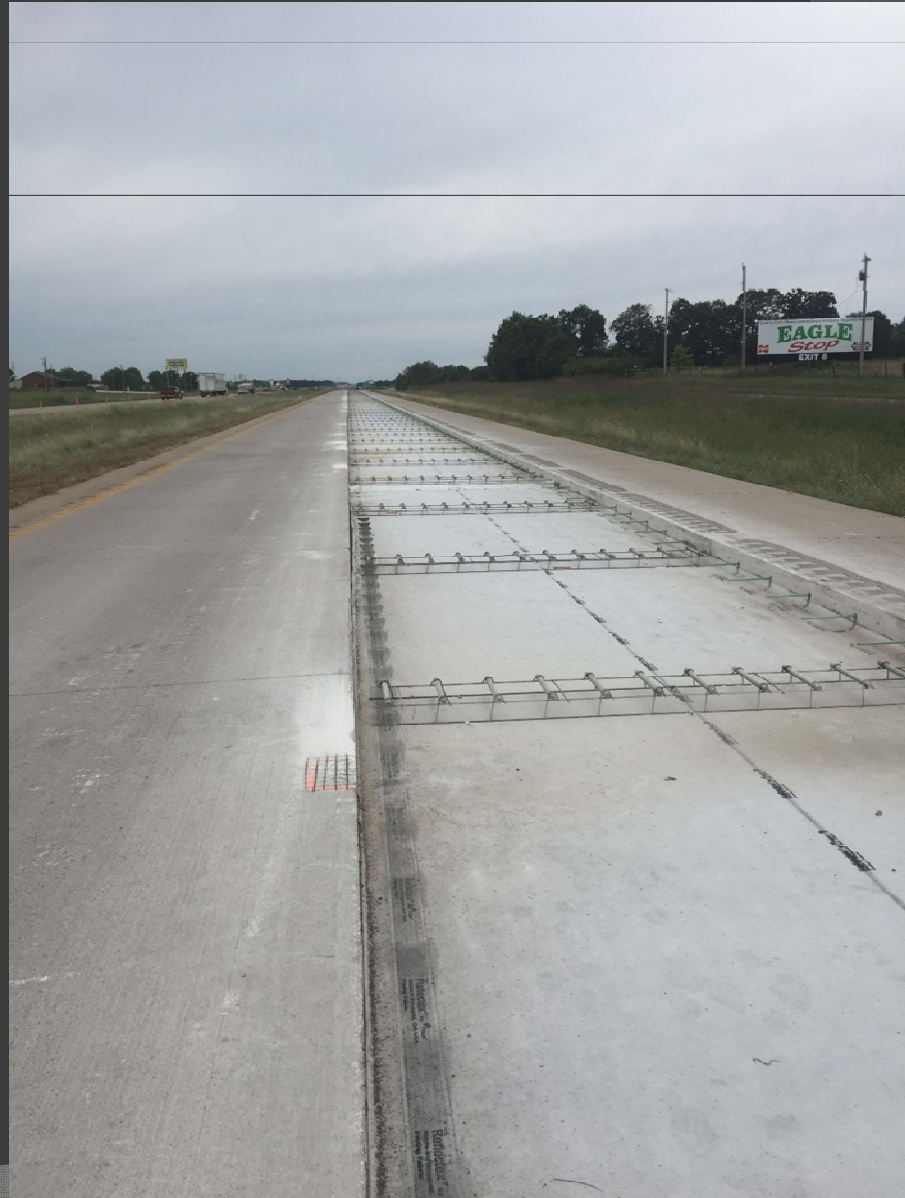
- Geotextile fabric used as bond breaker
- Rolled out very quickly
- Pinned baskets once down

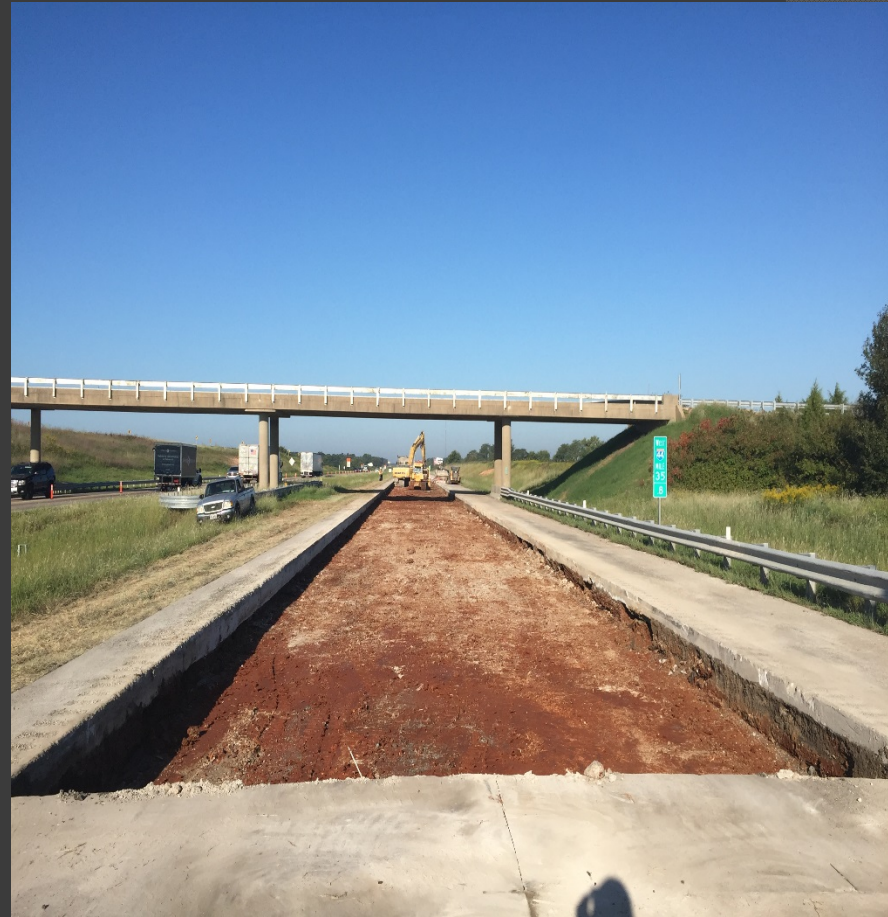
- Under the overpasses MoDOT opted for full depth removal and replace
- Both driving and passing lanes were replaced
- We removed both lanes at once

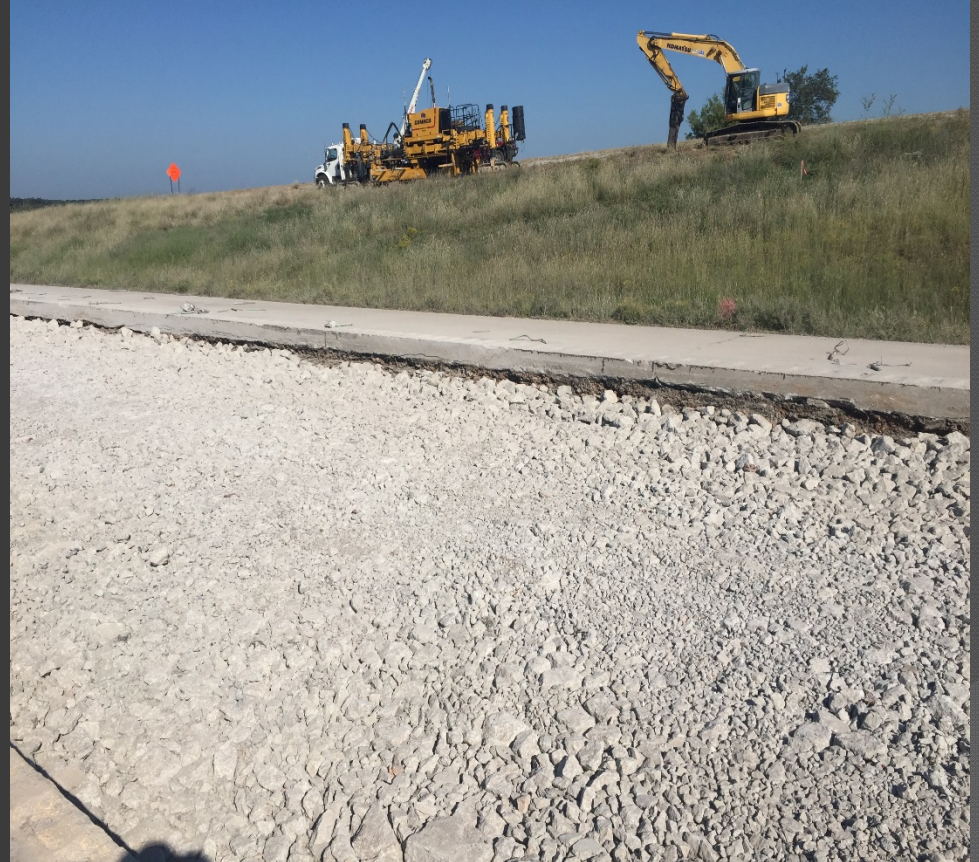
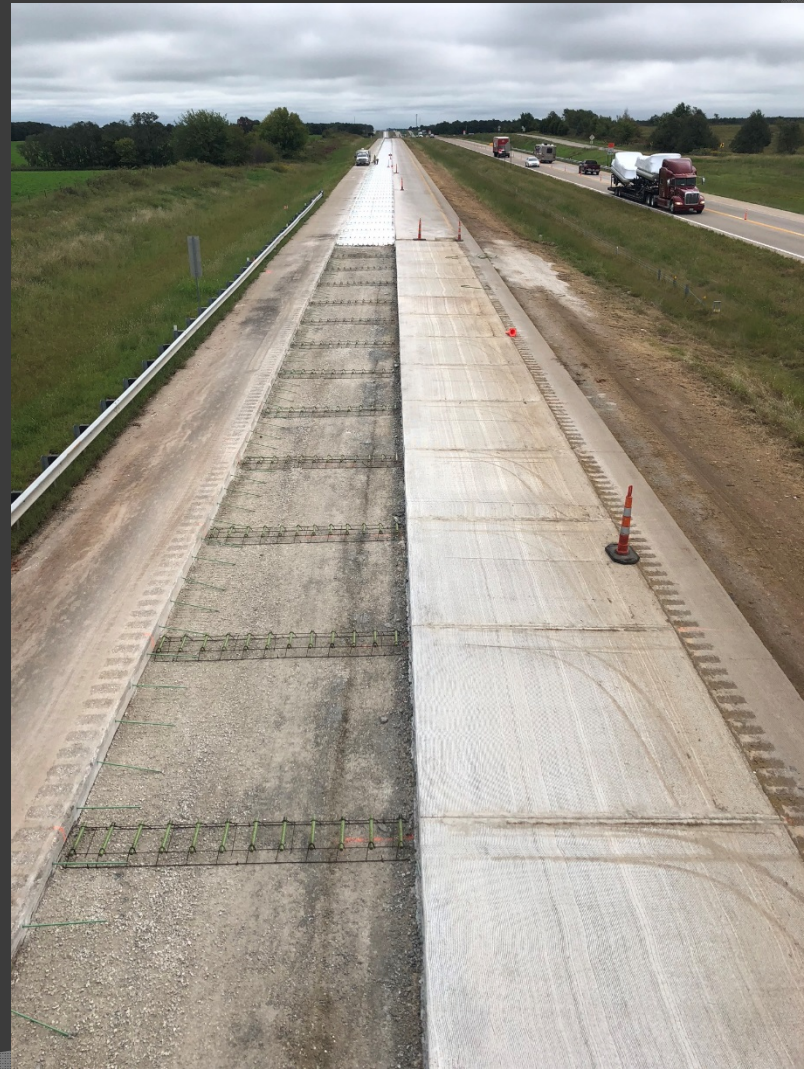
- ① 12" of rock base was installed
- ② We paved the passing lane first
- ③ This allowed us to pave through continuously in the driving lane

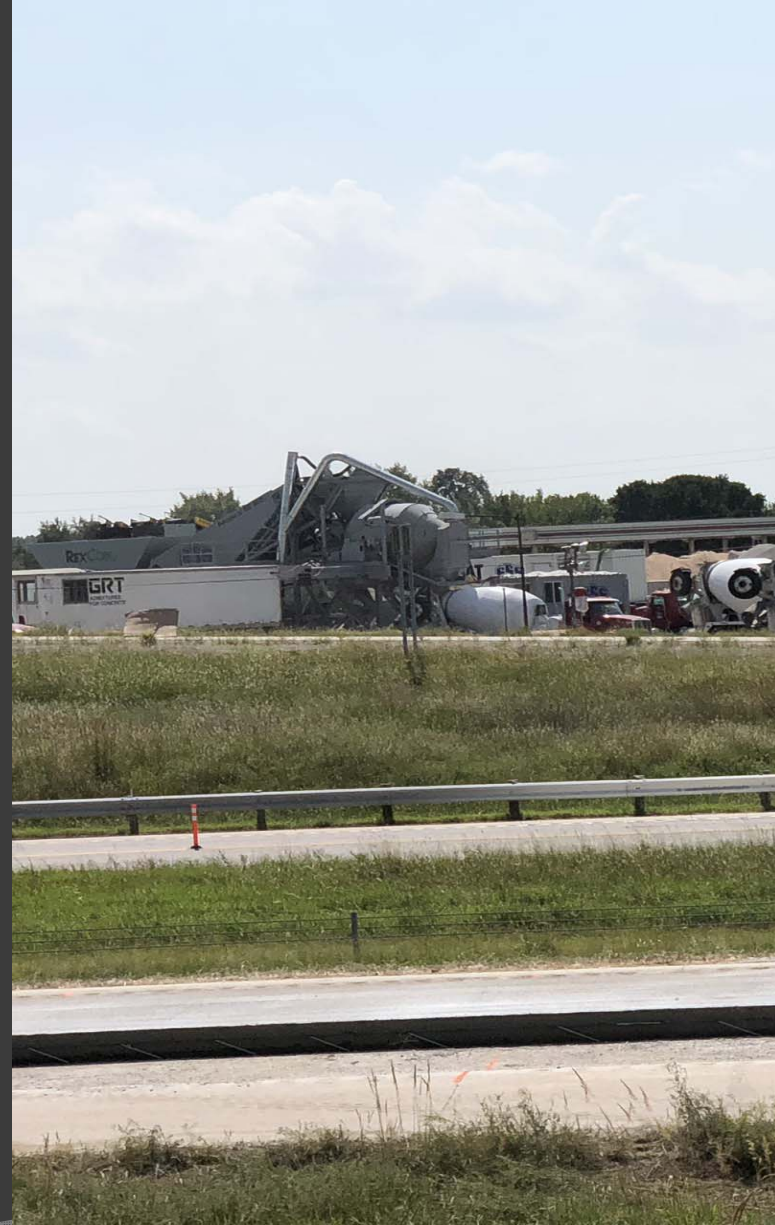
- Averaged roughly 190 yds an hour
- Yds/hr and pace was limited to paver speed
- New RexCon Mobile 12 Self-Erecting Batch Plant
