Gear Box Shaft Bit Attachment

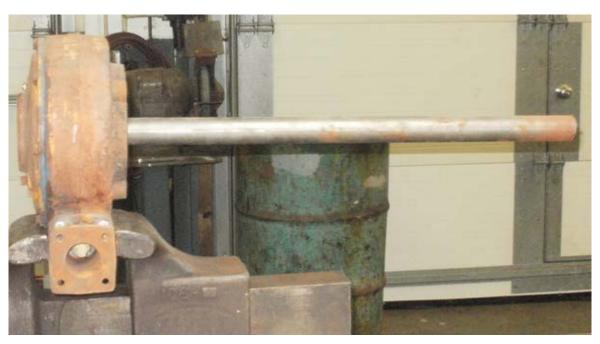
An attachment was added to the gear box shaft to remove broken chains from the gear box shaft.

The Gear Box Shaft Bit Attachment allows crews to back up a bound up cinder bed chain when a link has broken inside the bed. The attachment helps rotate the gearbox in reverse so that a bound up chain can be removed for repair. The tool replaces the pipe wrench method which caused damage to the end of the shaft. This tool is easily attached to a drill to rotate the gear box that loosens the binding chain.

Materials - \$10.00 1- 1" X 8" solid shaft 1- Gear box sleeve with key way One hour of labor
