**Addendum NO 2**

**FOR:**                   **Pike County Bridge Replacement on C.R. 103 & C.R. 318.**

## Geotechnical Engineering Report

Pike County  
County Road 318 Bridge No. 1880029 over Little Creek Replacement  
GRE Project No. 4529

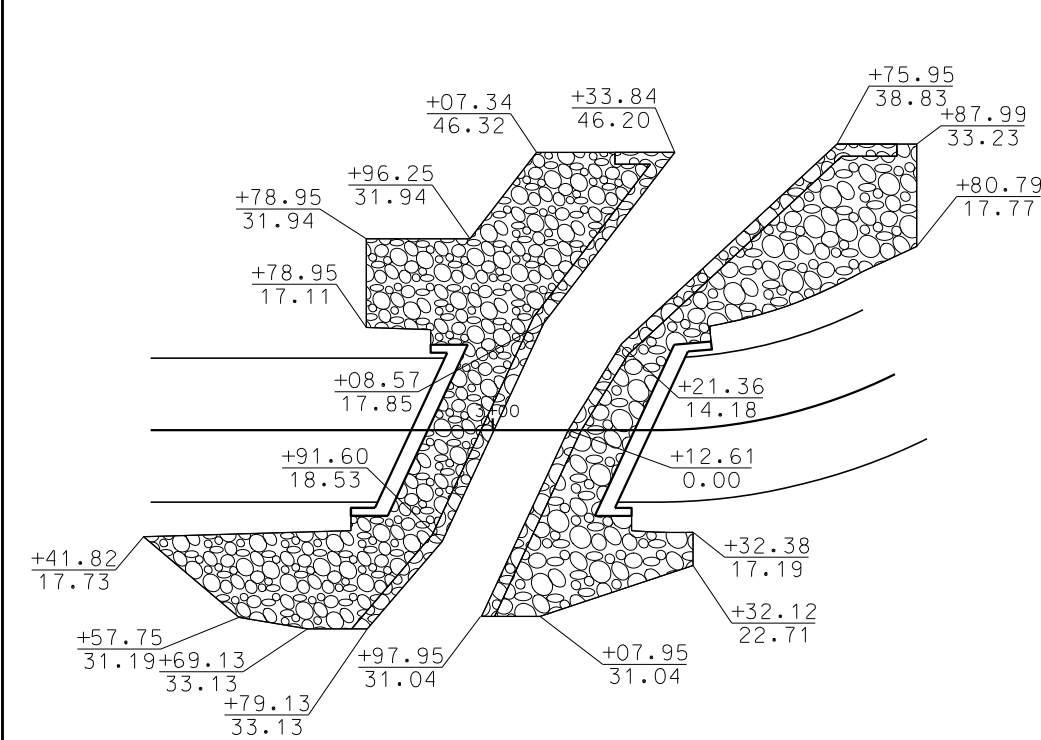
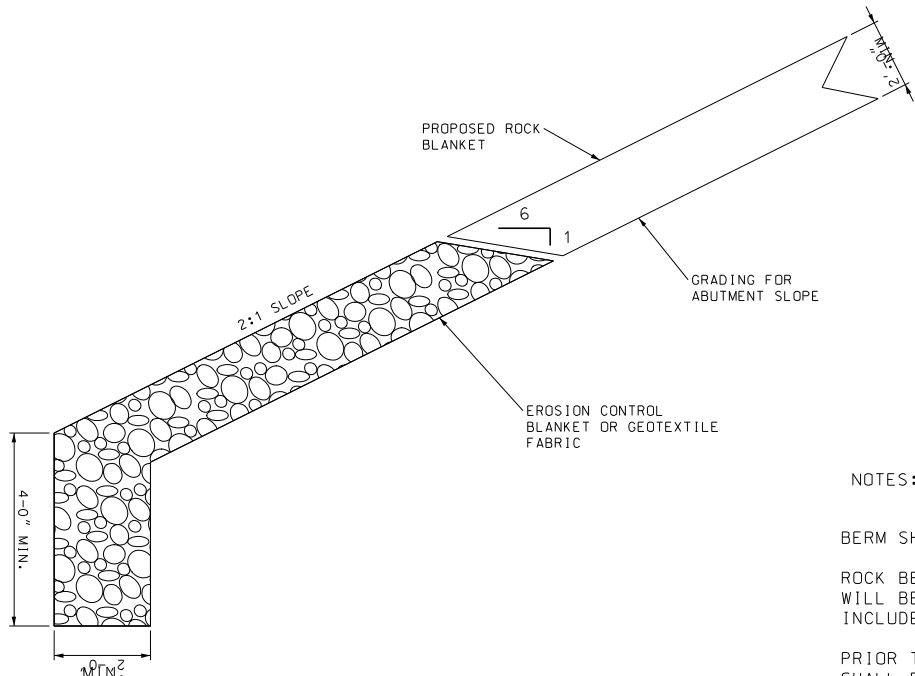
BERM SHALL BE BUILT TO HANDLE SIGNIFICANT RUN-OFF EVENTS.

ROCK BERM SHALL BE PLACED AT THE BEGINNING OF CONSTRUCTION AND WILL BE INCORPORATED INTO THE ROCK BLANKET. COST SHALL BE INCLUDED IN THE UNIT PRICE FOR THE TYPE 2 ROCK BLANKET.

PRIOR TO FINAL PLACEMENT OF TYPE 2 ROCK BLANKET, CONTRACTOR SHALL REMOVE GEOTEXTILE FABRIC AND ANY SILT BUILDUP ALONG TOP OF ROCK BERM. ALL WORK NECESSARY FOR REMOVAL SHALL BE INCIDENTAL TO BID ITEM TYPE 2 ROCK BLANKET.

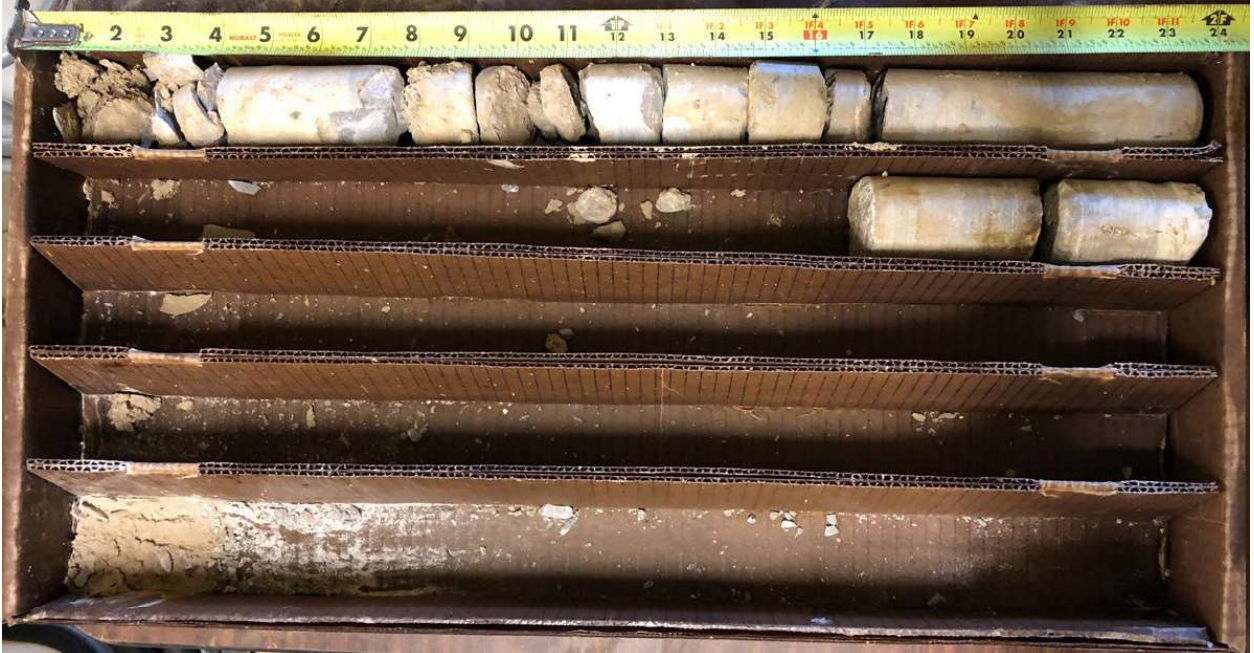
Rock Core extracted on 12-6-2021

BH-1 Rock Core at depth of 10.5 to 12.5 feet

Rock Quality Designation: 68% "Fair"

The Rock Quality Designation at BH-1 was 68% which is designated as “Fair” and defined as “moderately weathered rock.” A photo of the rock core sample extracted from BH-1 is at Appendix 3 and bedrock general classification and information is at Appendix 4.
