ADDENDUM NO. 2
TO
Hillsboro House Springs Road Bridge Replacement
STP-5403 (693)

**GEOTECHNICAL EXPLORATION
HILLSBORO HOUSE SPRINGS ROAD
BRIDGE
HILLSBORO, MISSOURI**

Prepared by:
**GEOTECHNOLOGY, INC.
ST. LOUIS, MISSOURI**

Date:
JULY 27, 2020

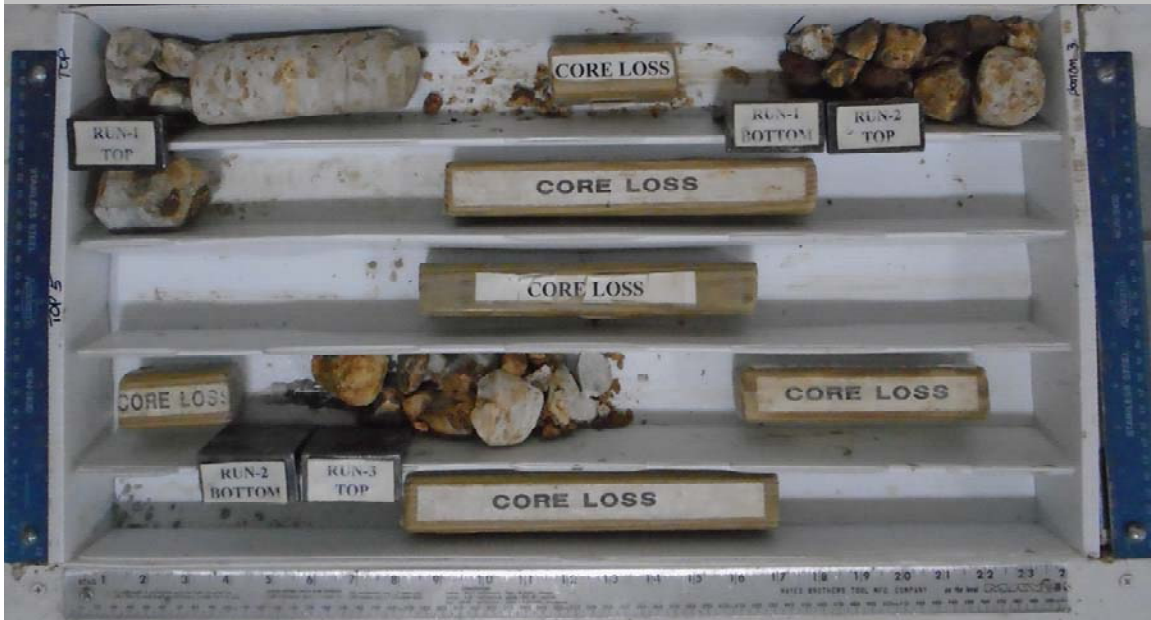
B-1
Box 1 of 2

<u>RUN</u>	<u>ELEVATION, FT</u>	<u>BORING B-1</u>	<u>RECOVERY, %</u>	<u>RQD, %</u>
1	631.5-630.0		44	27
2	630.0-625.0		13	0
3	625.0-cont.		10	0

Rock core photographs are included in Appendix D. A legend of the terms and symbols used on the boring logs and rock core descriptions are included in Appendix C.

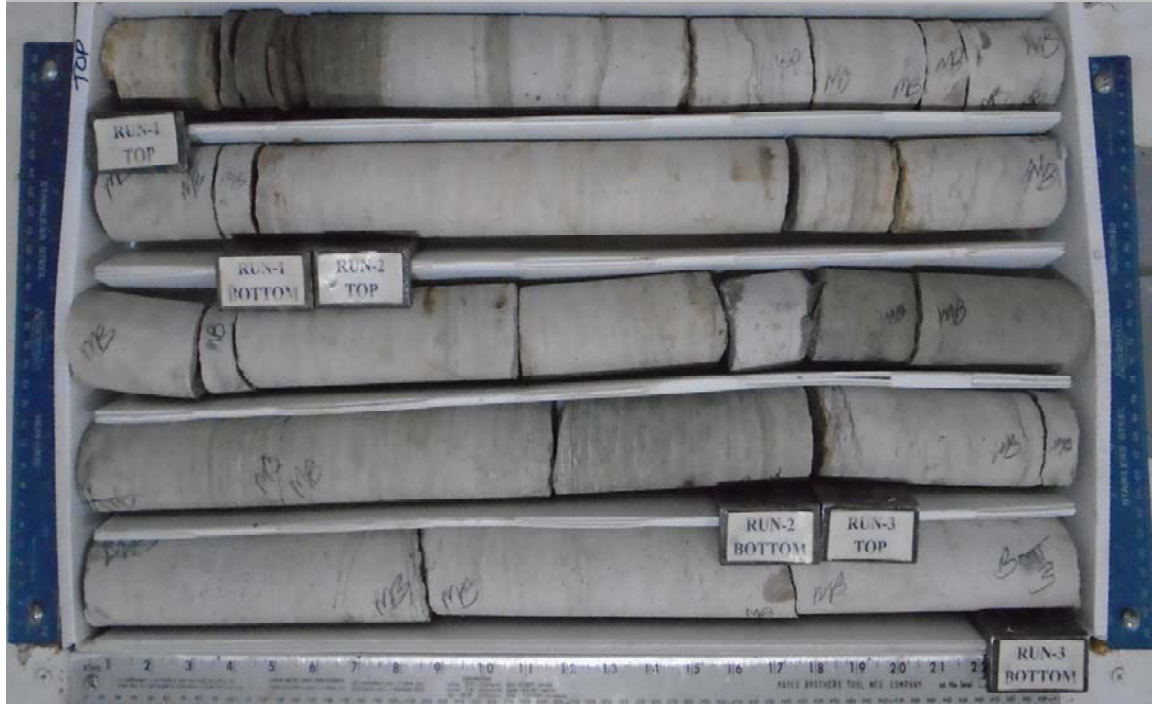
<u>RUN</u>	<u>ELEVATION, FT</u>	<u>BORING B-2</u>	<u>RECOVERY, %</u>	<u>RQD, %</u>
1	615.8-613.5		100	70
2	613.5-608.5		100	95
3	608.5-606.0		100	100
