# SPECIAL GEOTECHNICAL EXPLORATION

## ROUTE 19 BRIDGES KARST REVIEW SHANNON COUNTY, MO MODOT PROJECT NO. J9P3305

August 19, 2022

Olsson Project No. 020-1986

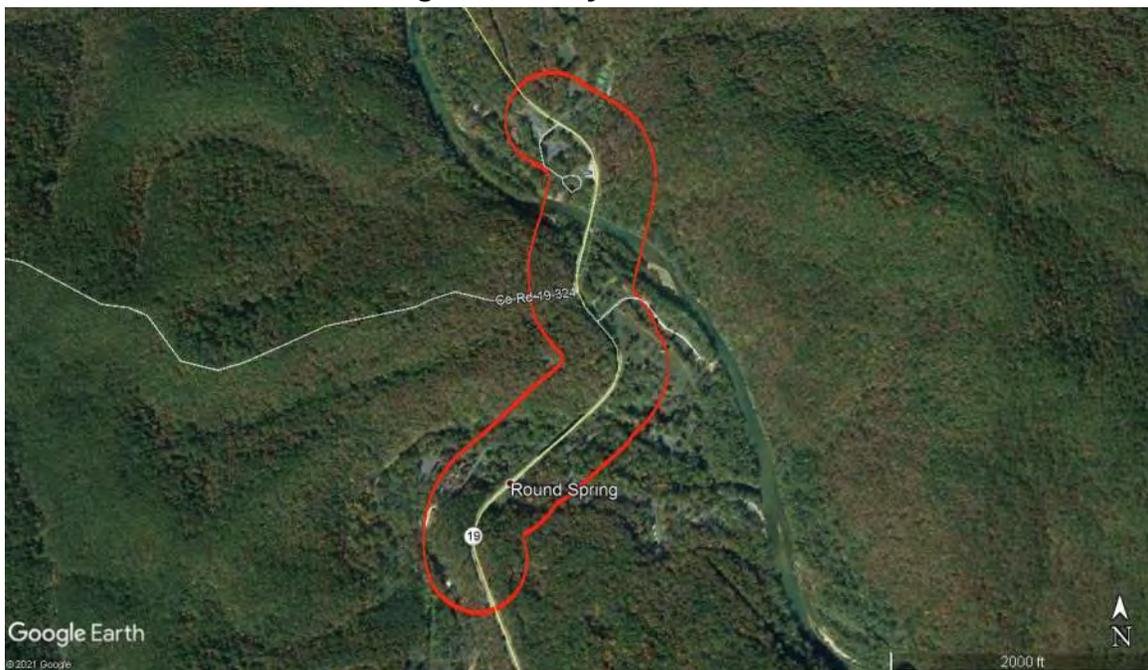
Figure 1: Study Area Limits

The study area extends from approximately 0.25 miles north of the existing Route 19 bridge over the Current River south on Route 19 to approximately 0.25 miles south of the existing Route 19 bridge over Spring Valley extending approximately 300 feet east and west on either side of existing Route 19, as depicted in Figure 1. The study area lies entirely within the National Parks Services (NPS) Ozark National Scenic Riverway (ONSR). Largely undeveloped, the land use descriptions of the study region include NPS ONSR Section 4f, large public use, and one private business. Route 19 is a rural, minor arterial paved road. NPS utilities and facilities within the study area include a treatment plant, water tower, pedestrian and utility bridge, ranger station, parking and river access points, service roads, trails, and spring/cave/camping/residence access points. The private business is located approximately 180 feet north of the Current river bridge and 50 feet west of Route 19.

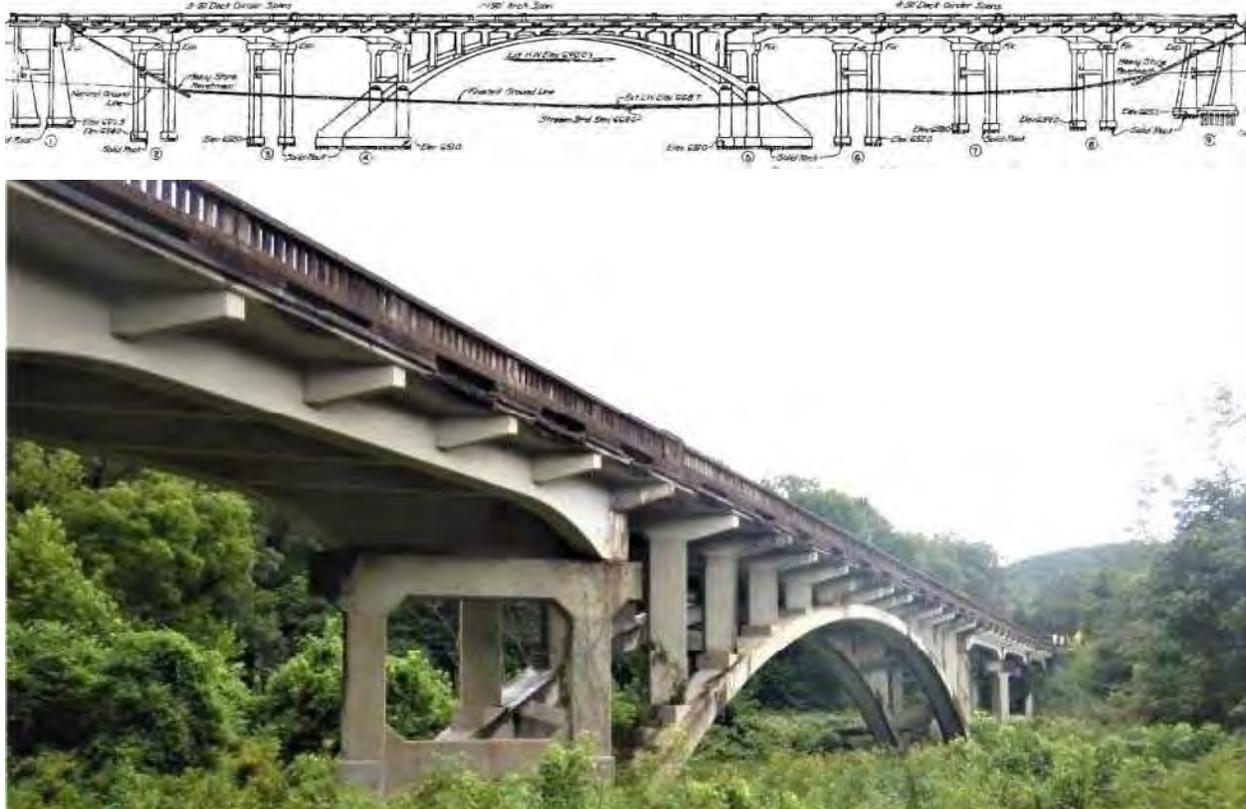
Figure 3: Spring Valley Creek Bridge Diagram and Photograph (J0420)

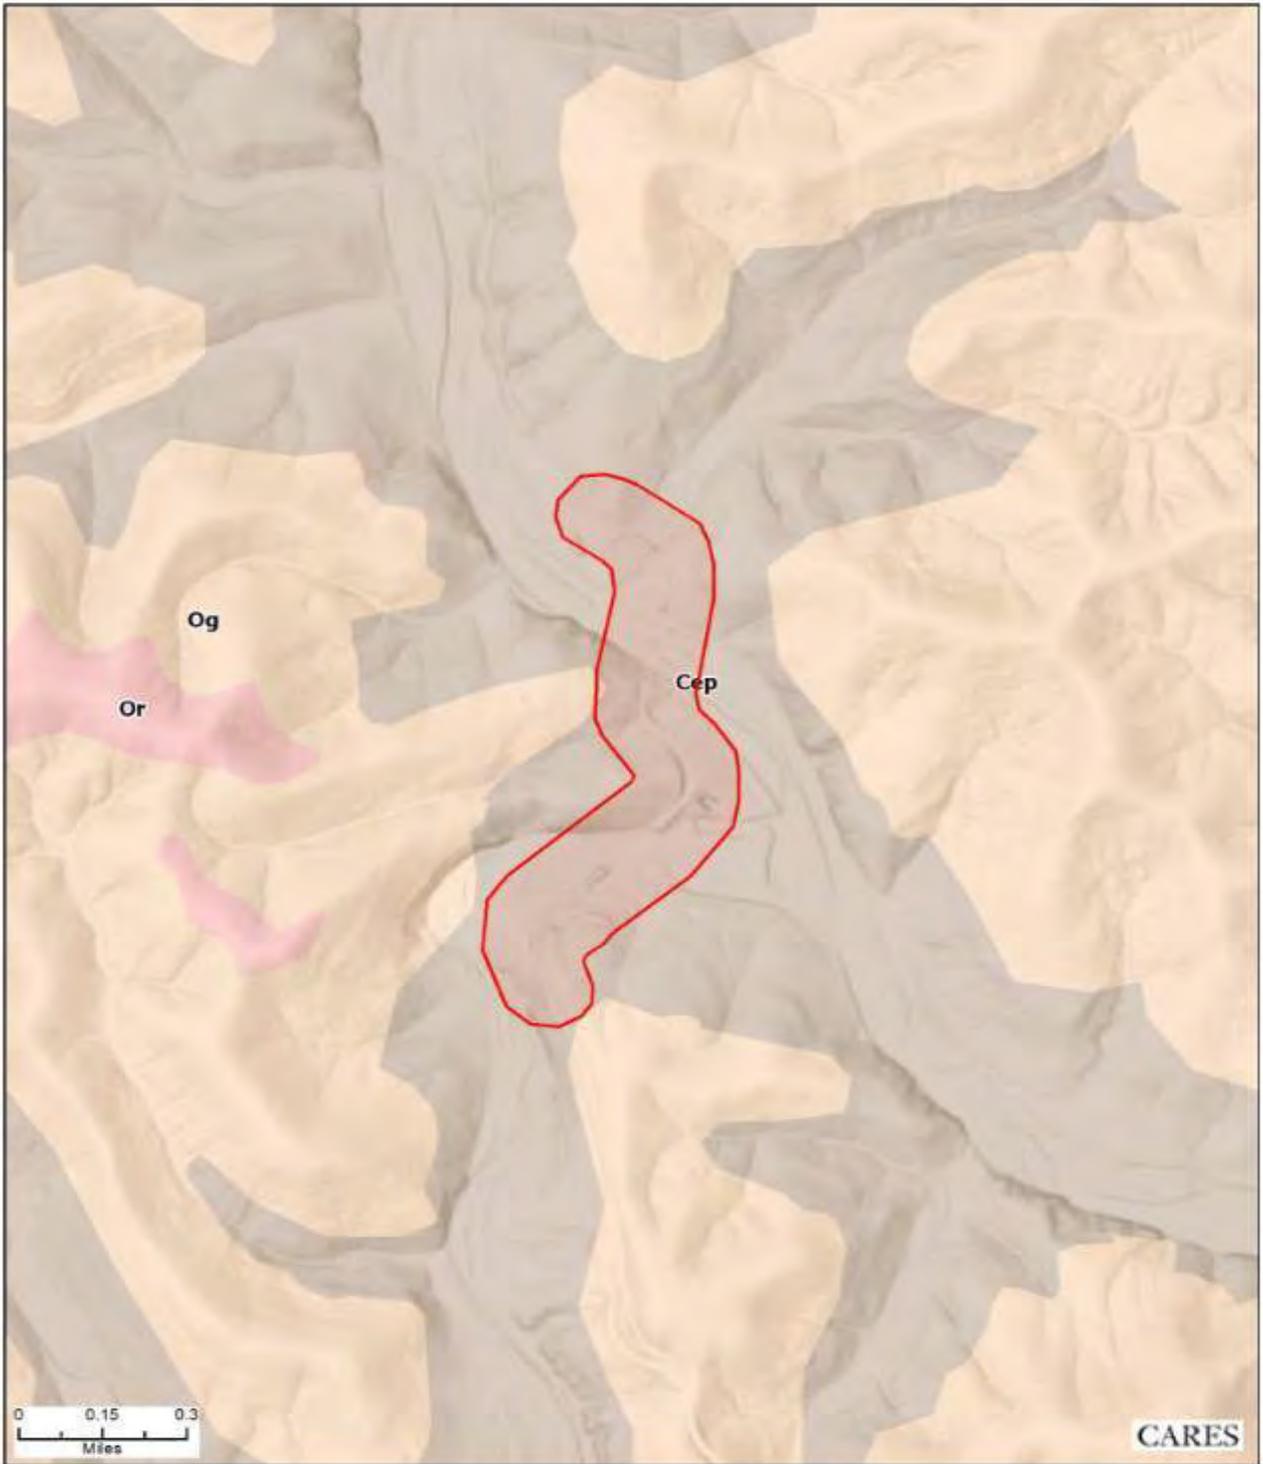
**Quaternary Geology by Region**

Bedrock, 1:500,000 Scale, MO DNR 2016

- Ordovician, Roubidoux
- Ordovician, Gasconade
- Ordovician System undifferentiated
- Cambrian, Eminence & Potosi

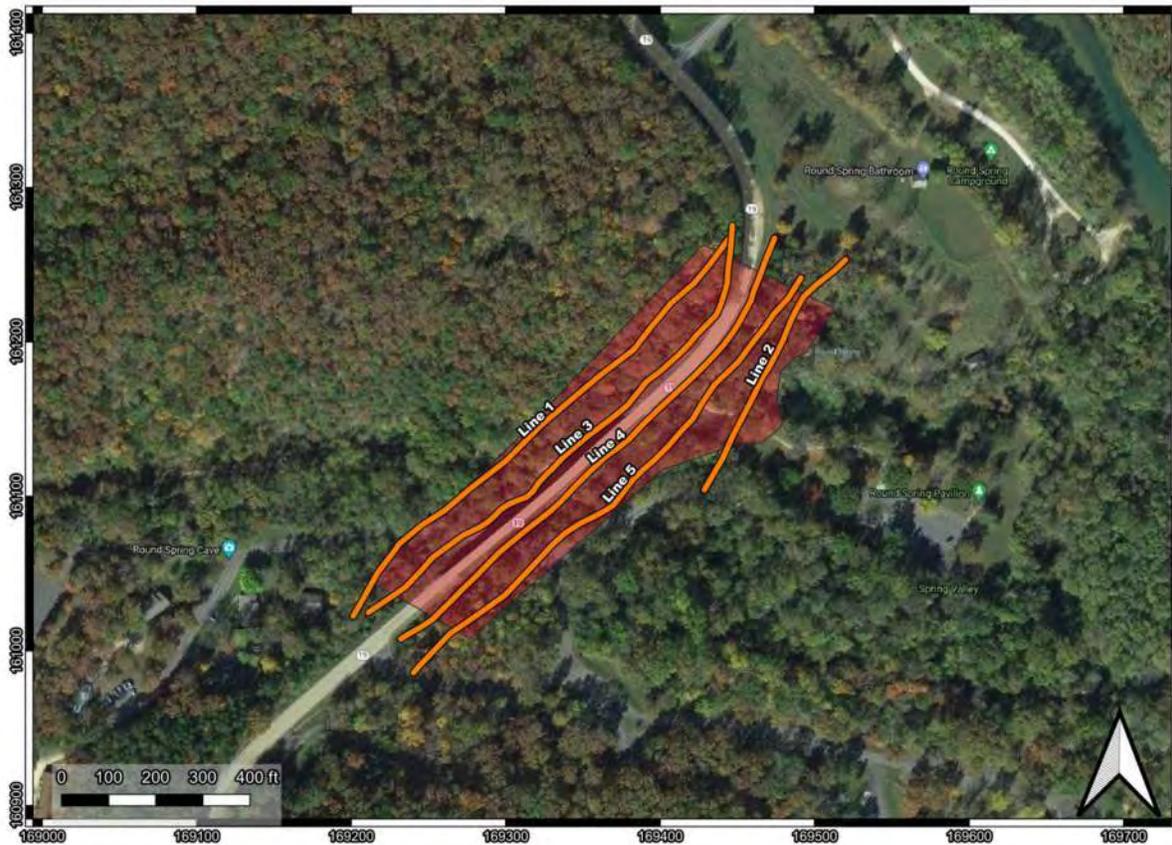
**Figure 3: Overview of project area with geophysical (ERT) lines (orange) and approximate area of interest for the investigation (shaded red). The SRT line was collected along the Line 4 profile.**

Five (5) ERT and one (1) SRT lines were collected parallel to and beneath the Spring Creek bridge within the area of interest (**Figure 3**). The geophysical lines locations were determined by HG in collaboration with Collier and the Missouri Department of Transportation (MODOT). The orientation and position of some lines were adjusted in the field to fit within the physical limitations of the site. The geophysical lines were numbered sequentially in the order they were acquired. The one SRT line was acquired coincident with ERT Line 4.

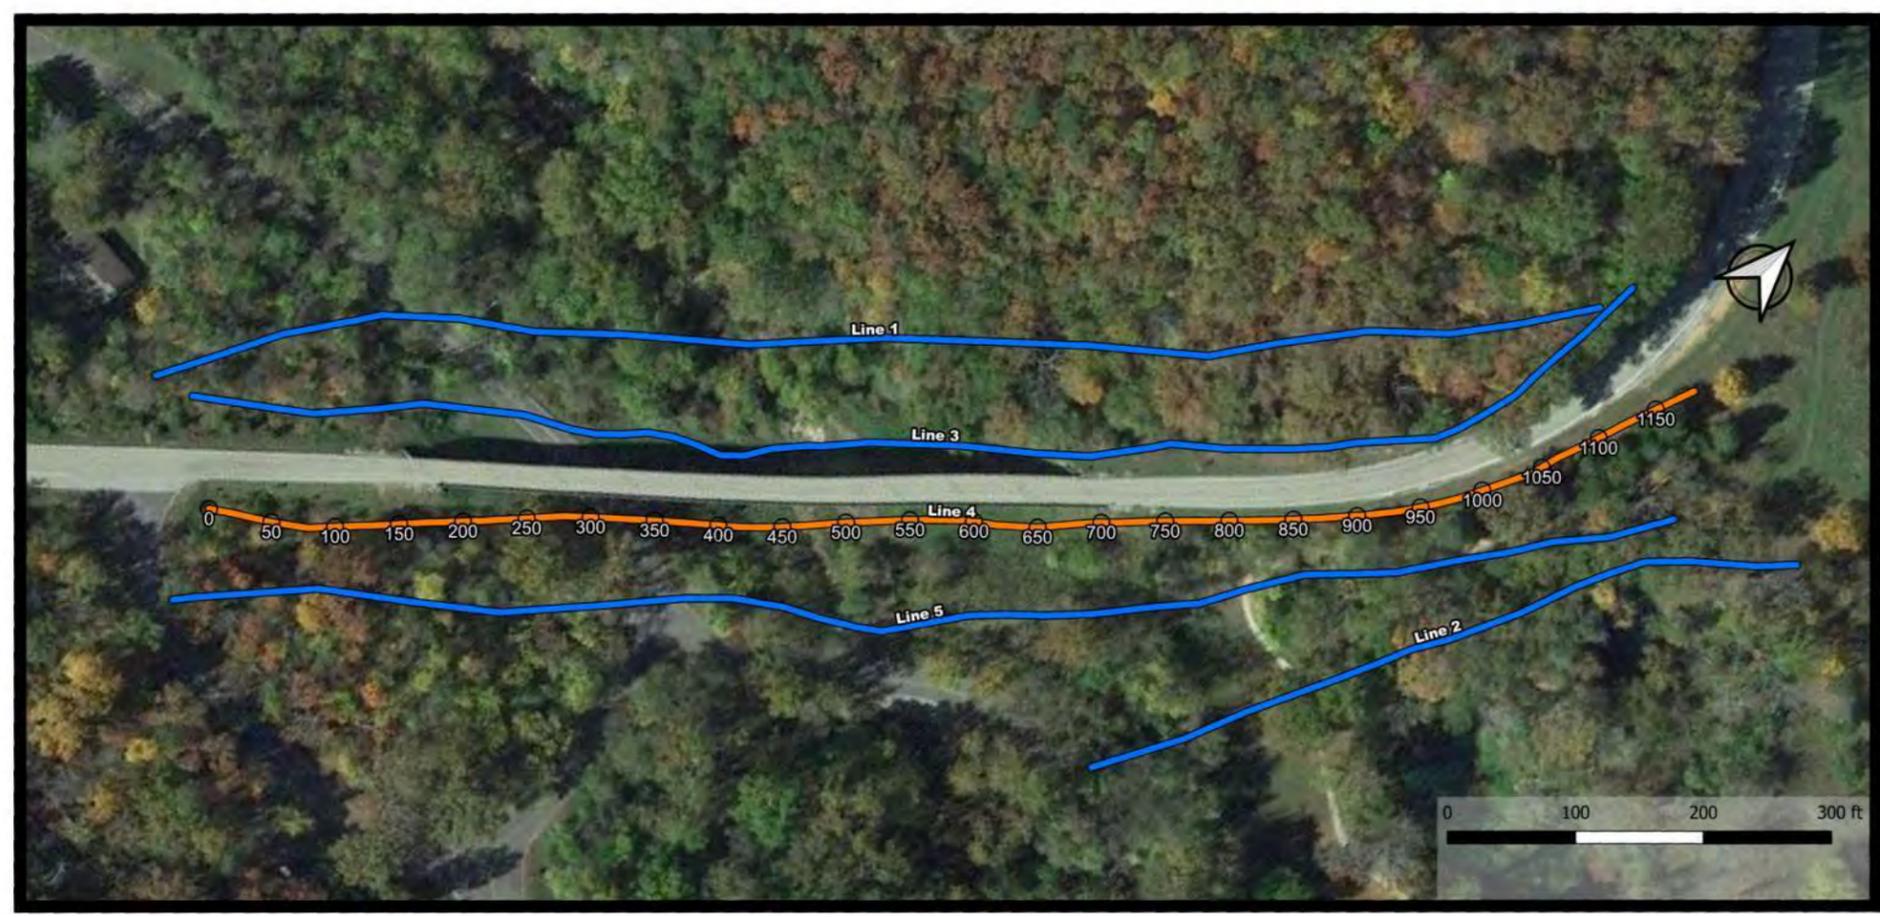
Seismic SRT - Line 4  
Round Spring Nat'l Park  
Eminence, MO
