BRIDGE REHABILITATION / REPLACEMENT ALTERNATIVES STUDY REPORT

Route 19 over Current River and Spring Valley
(Project No. J9P3305)

Bridges No. G0804 and J0420

October 2019

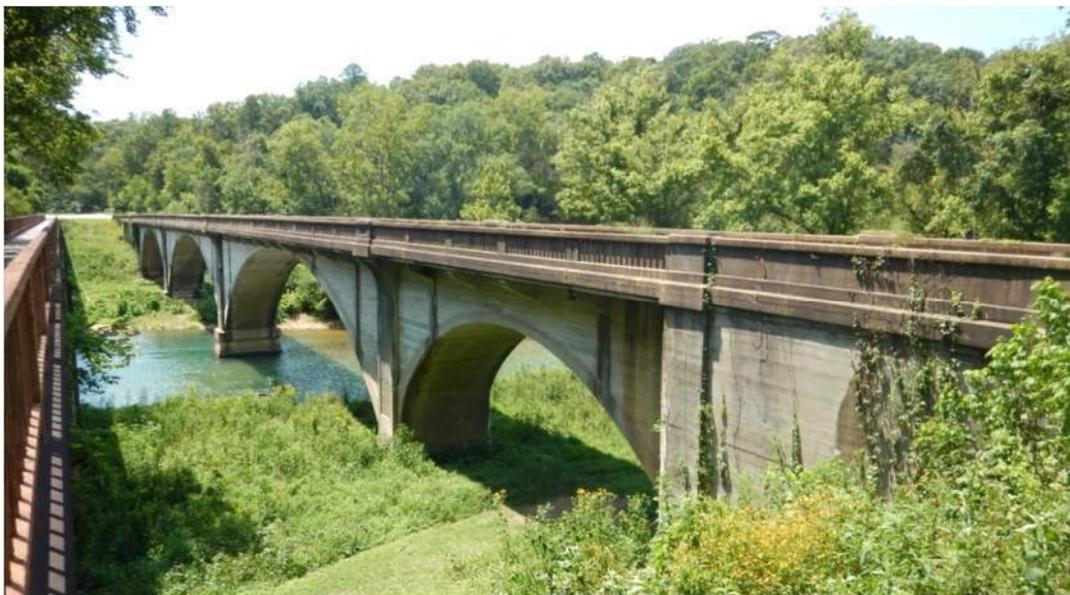
Elevation of Bridge

The bridge over the Current River (G0804) was built in 1924, has (60'-130'-130'-130'-60') filled arch spans with 34' filled deep abutments. The bridge has ratings of deck -5, superstructure-5 substructure-6, and has an 18' roadway. The bridge is posted for centerline only. Several of the overhang supports have significant deterioration. The deck between the arch walls is supported by the fill between the arch walls. The bridge is over the Current River within the National Park. There are trails, canoe rental businesses and canoe access to the river close by. There is a pedestrian / utility bridge located just downstream and parallel to G0804. The overall bridge elevation is shown looking southwest in the following photograph.

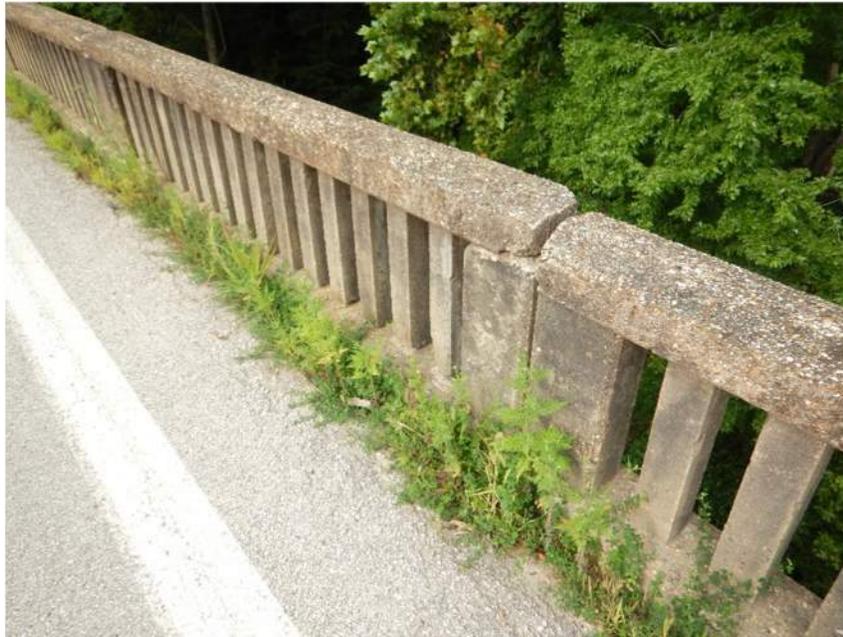
Collision Damage to the Railing

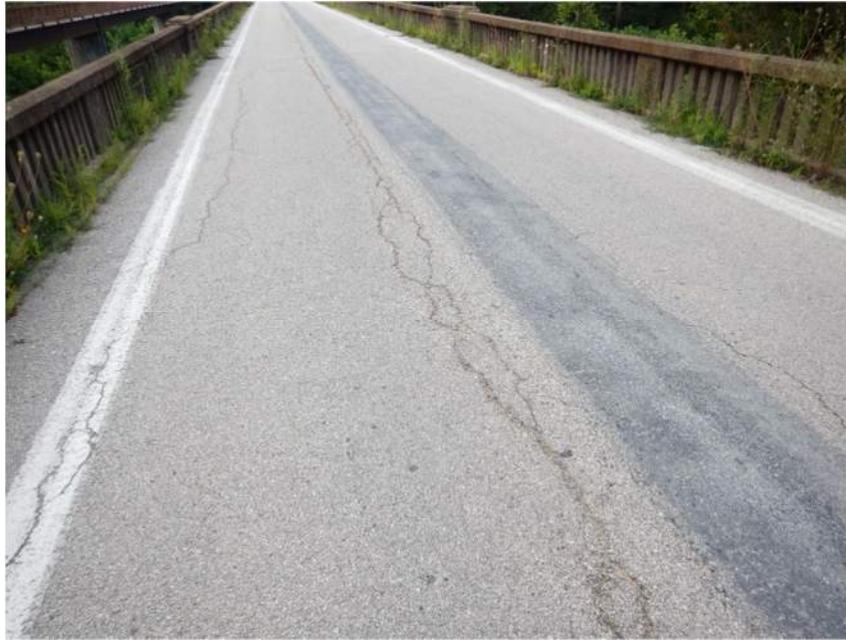
Condition of Wearing Surface

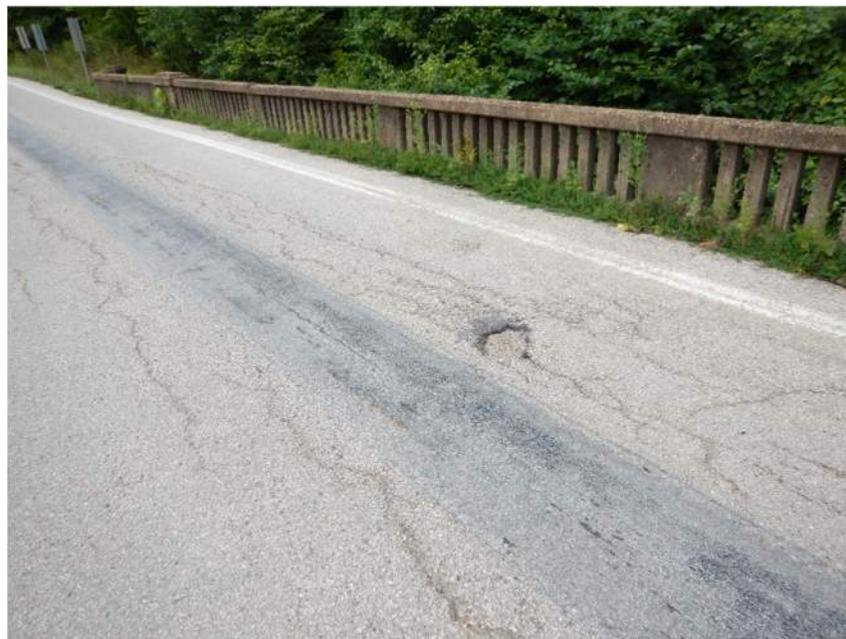
Deck Spall

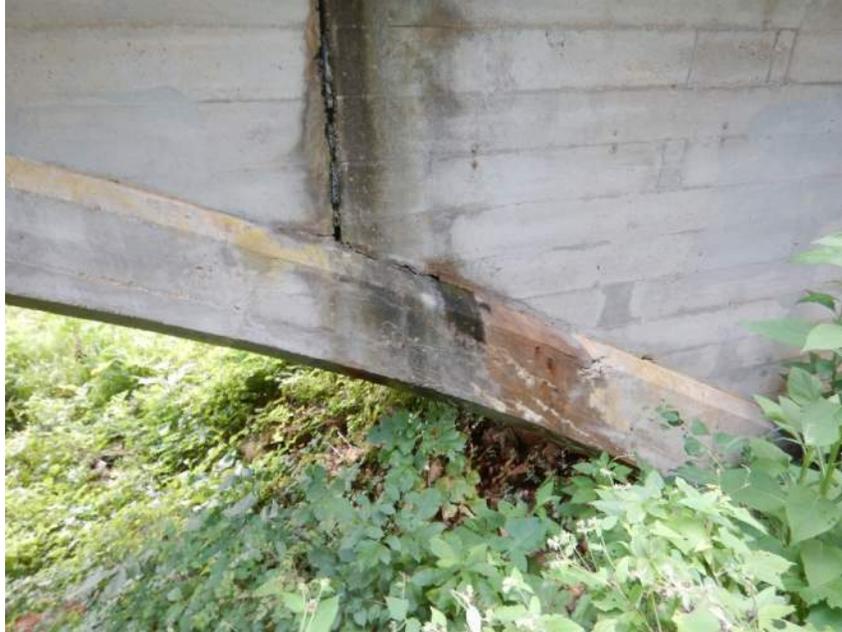
Spalling and Staining on Arch Ring

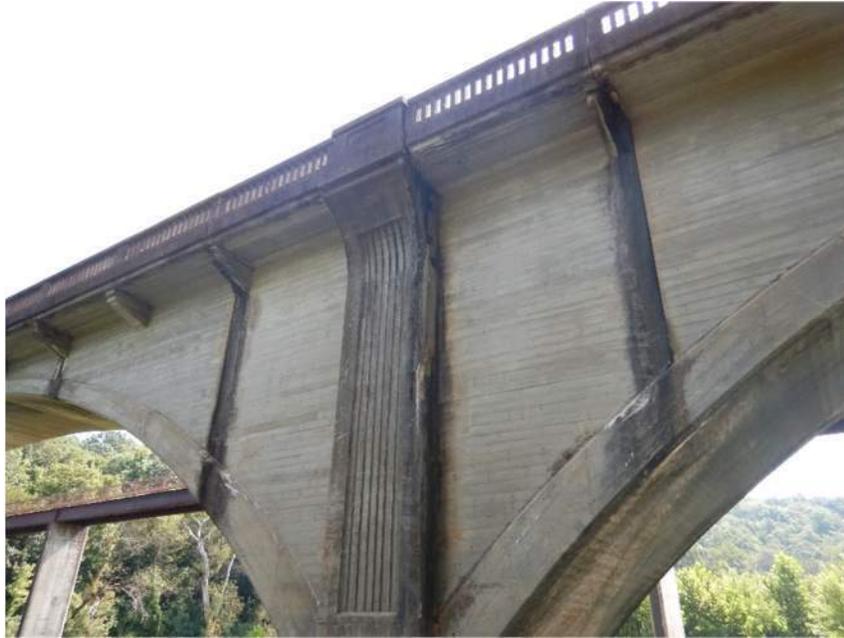
Leakage from Sidewall Joints

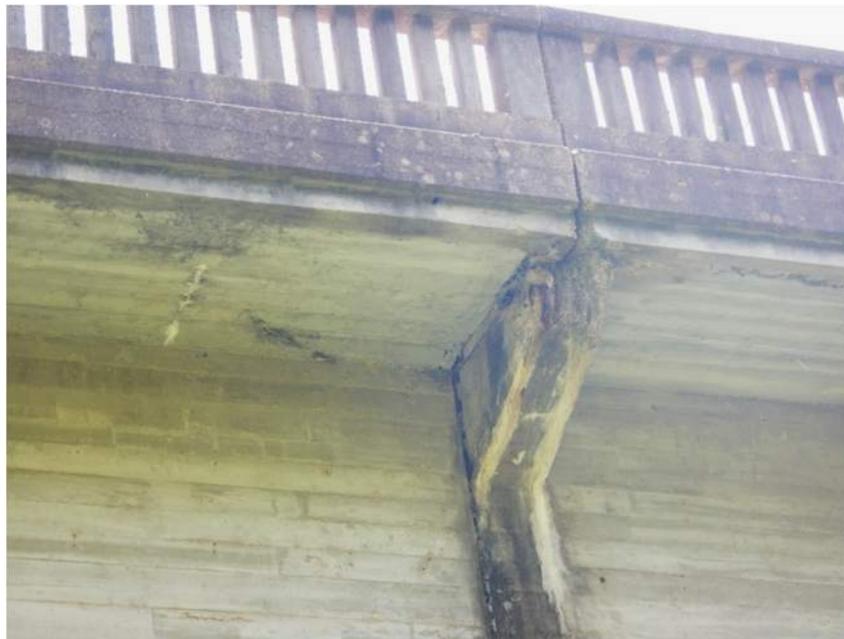
Heavy Deterioration with Loss of Bracket Support Area

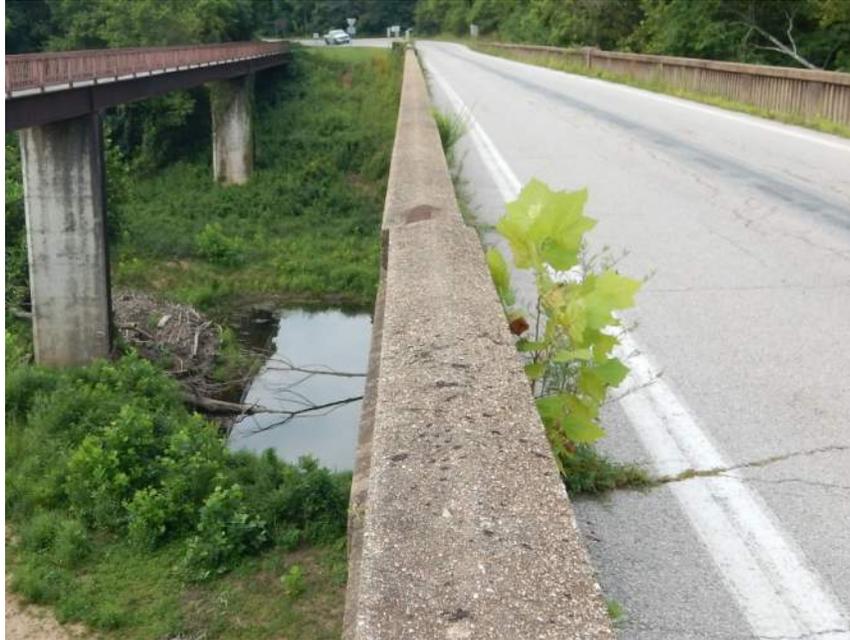
One additional observation on the superstructure was the differential lateral movement between the sidewall sections. The section of sidewall over the pier that extends to each joint is either connected from side to side with a floor beam or there are counterforts on the pier side of the joint. The wall that is on the opposite side of the joint is not likewise supported and appears to have deflected outward on the order of $\frac{3}{4}$ " per side. This results in a face of barrier dimension approximate $1\frac{1}{2}$ " wider than over the pier.

Differential Alignment of Barrier at Joints Adjacent to Pier

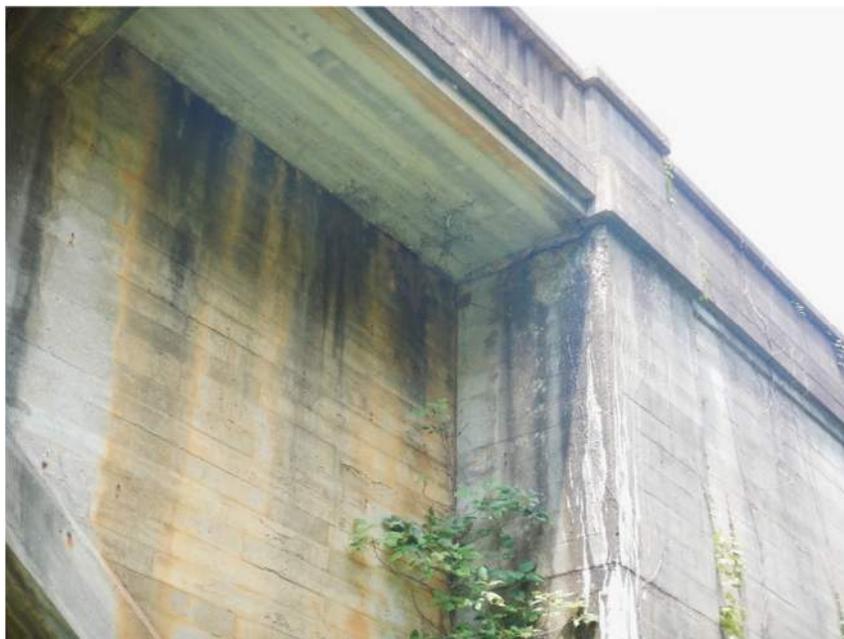
Typical Spalling at Abutment Corners

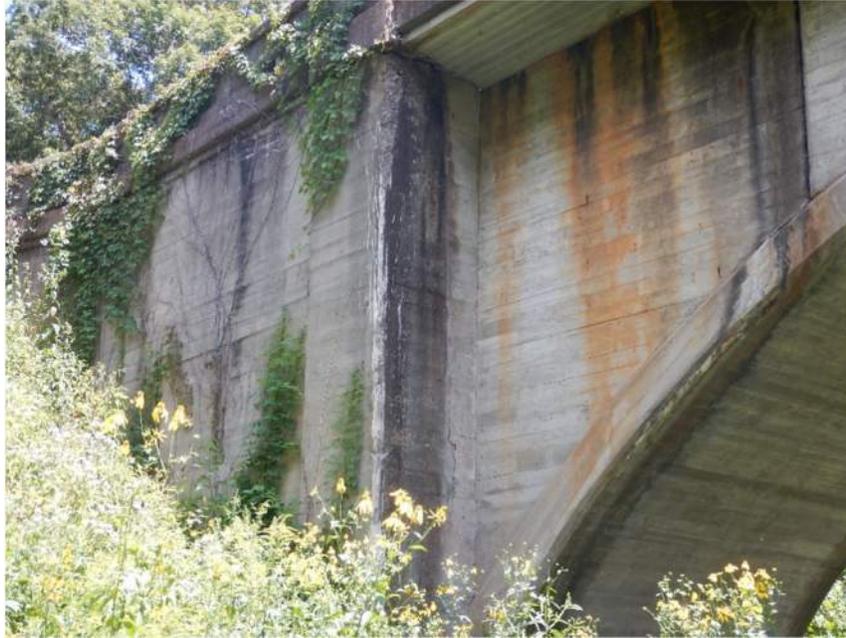
Cracking and Delamination at Abutments

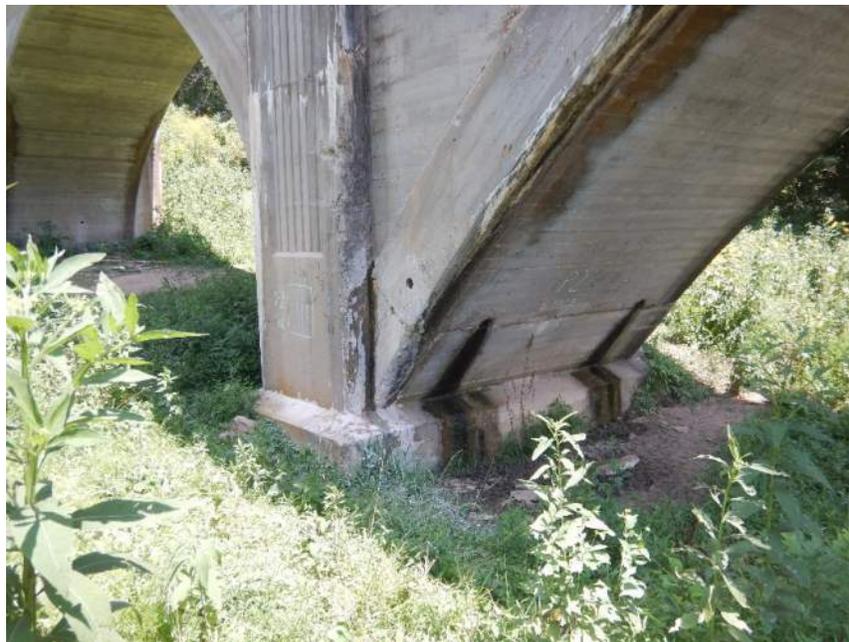
Scaling Along Pier Foundations

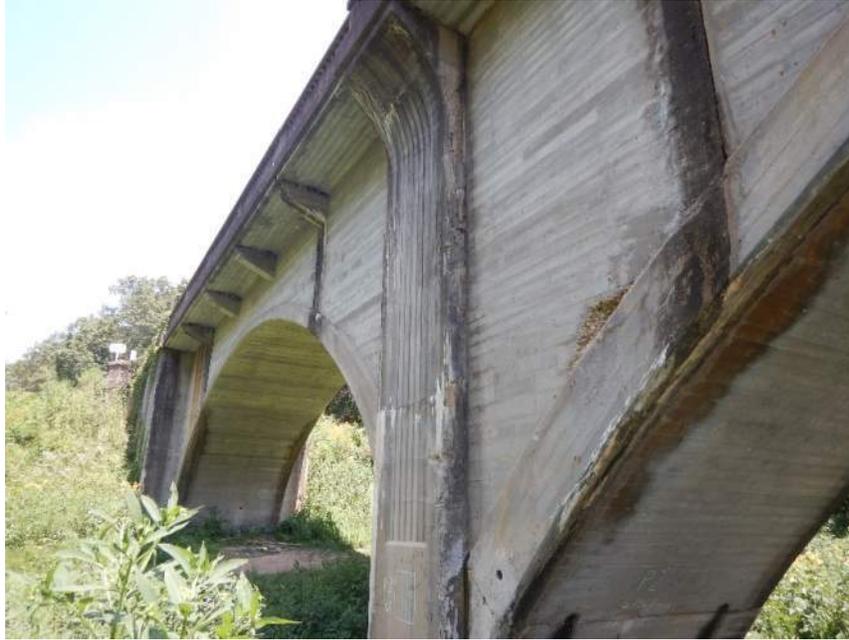
Spalling on Pier Surfaces

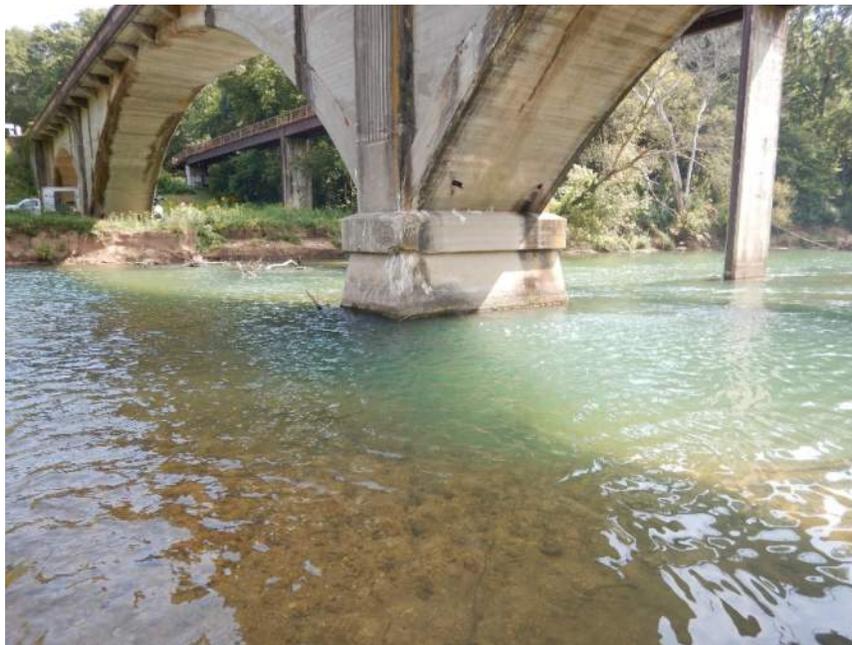
Scour Hole at Pier 3

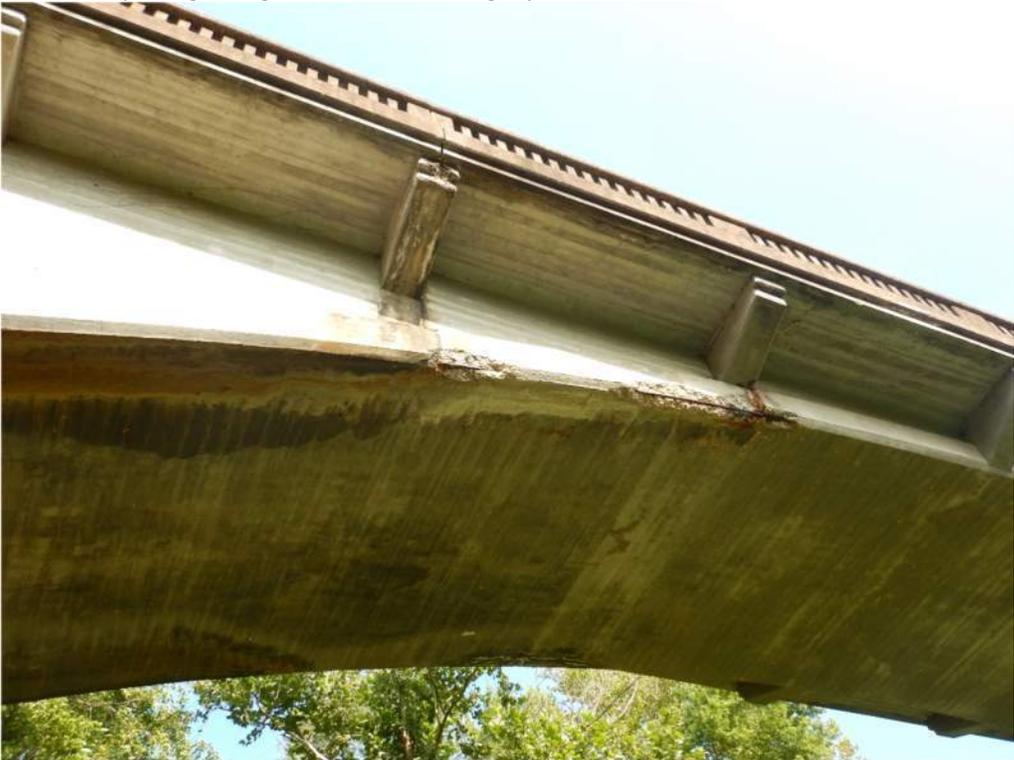
Pic. 006: Spalling along corner of arch ring, Span (4-5) east face

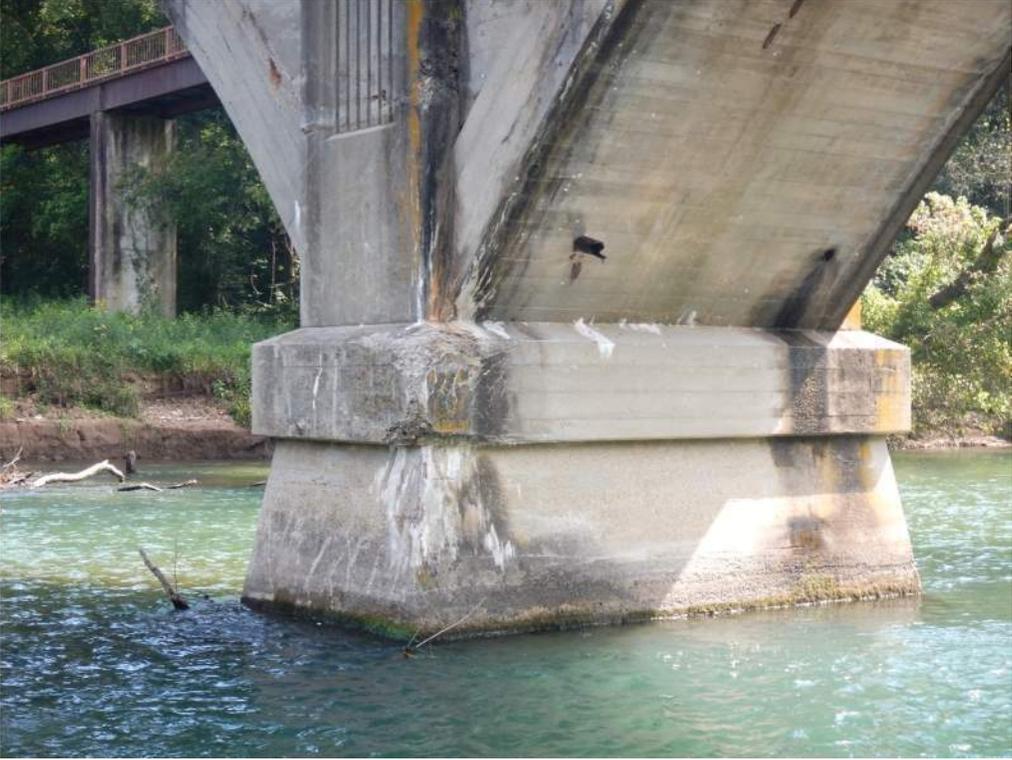
Pic. 009: Spalling and delamination on pilaster, Pier 2 east side

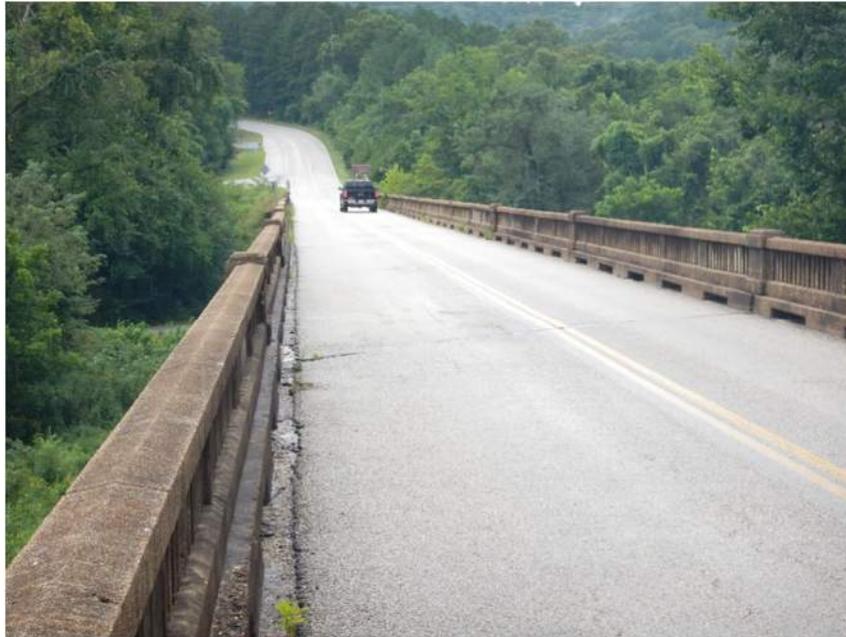
Collision Damage to the Railing

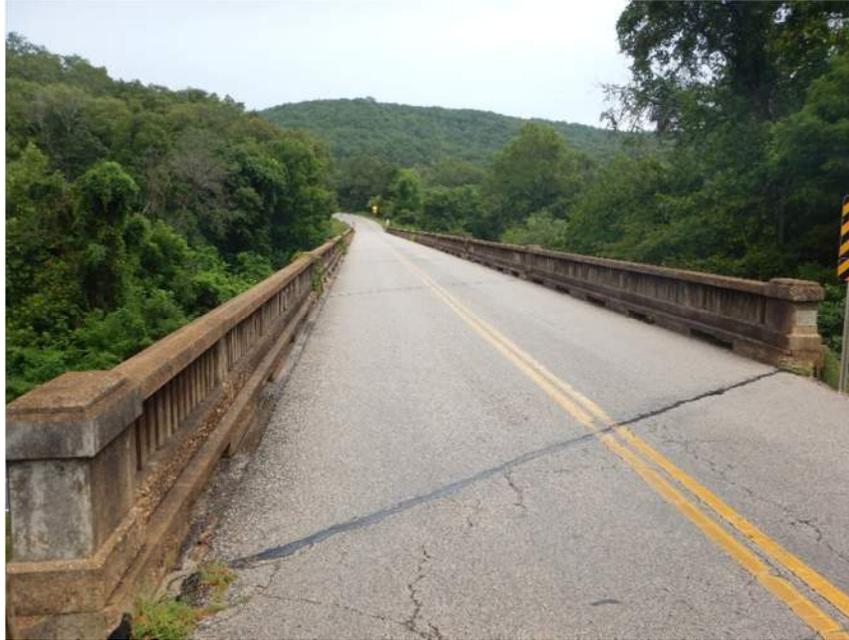
Condition of Wearing Surface

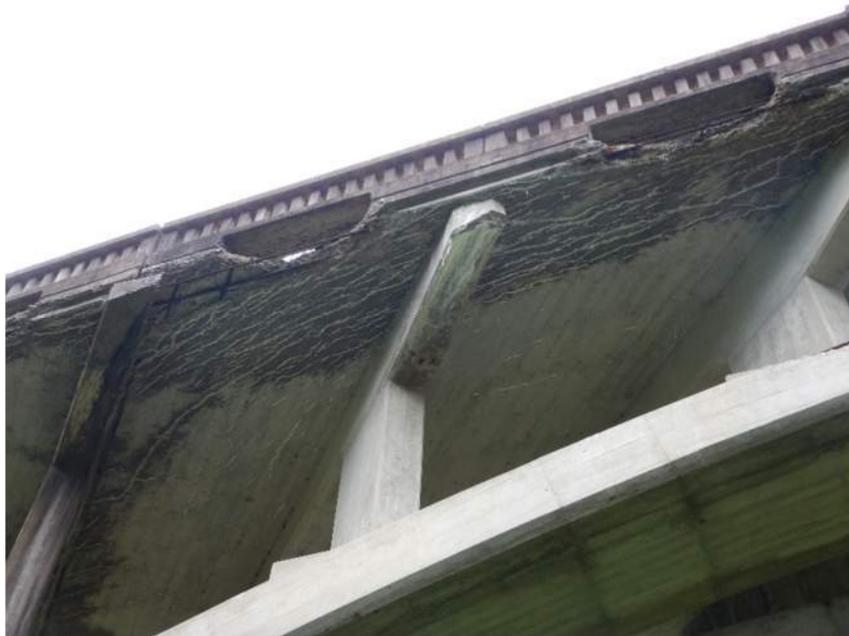
Heavy Deterioration of the Deck at Existing Drains

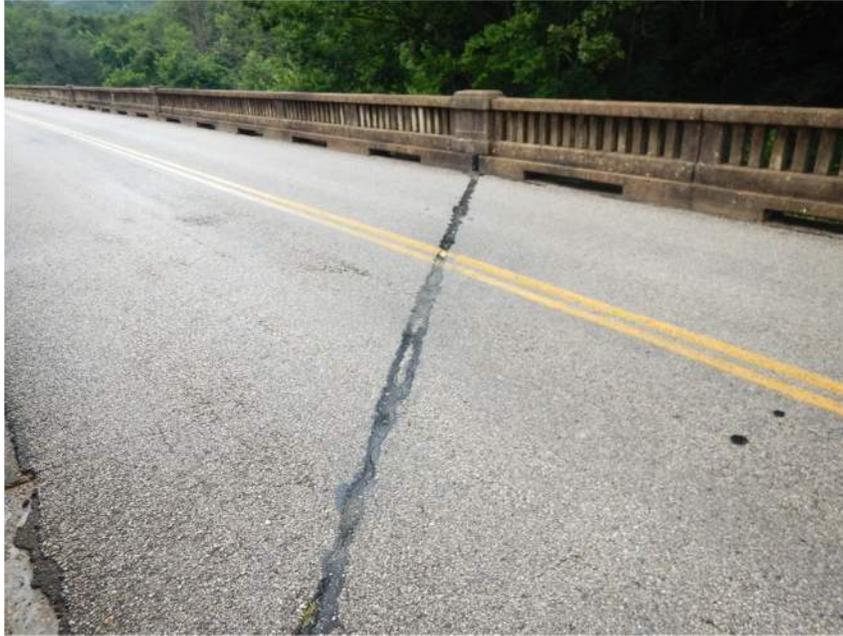
Typical Slab Expansion Joint

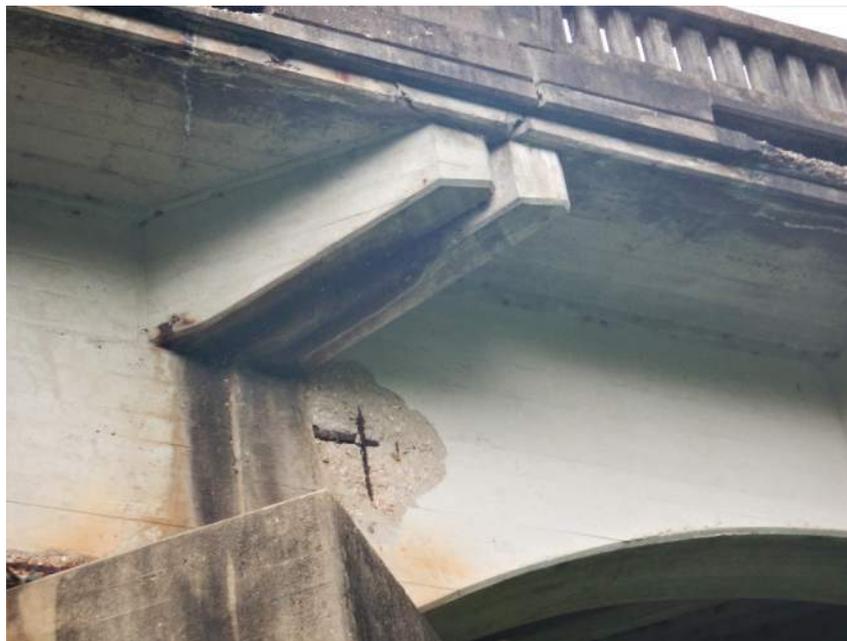
Typical Delamination on Girders

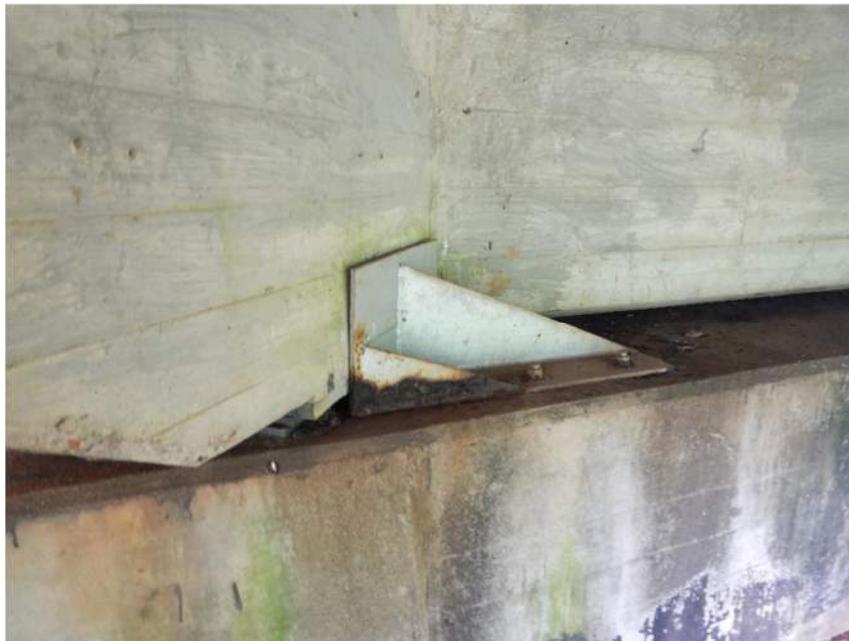
The bridge is on a 45 degree skew and is exhibiting lateral movement of the girders relative to the substructure due to the sharp skew. Previous retrofit projects have included the installation of brackets to keep the girders in line with the bearings. The girders are tight against these brackets. At Bent 9 there appears to have been an attempt to raise the east girder and realign the upper bearing plate with the girder. A jacking block had been added to the girder to facilitate this modification.

Typical Girder Restraint Bracket

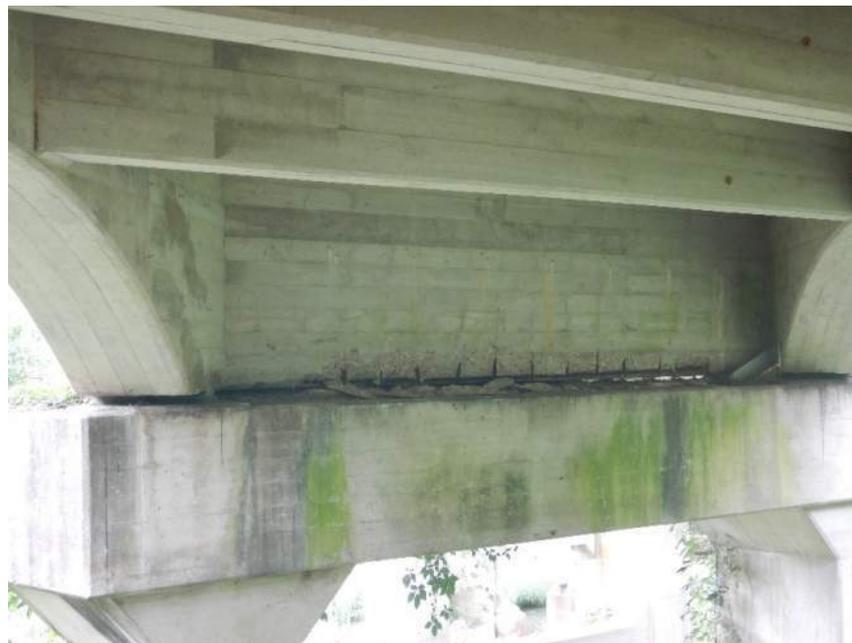
Deterioration of Floorbeams at Intermediate Bents

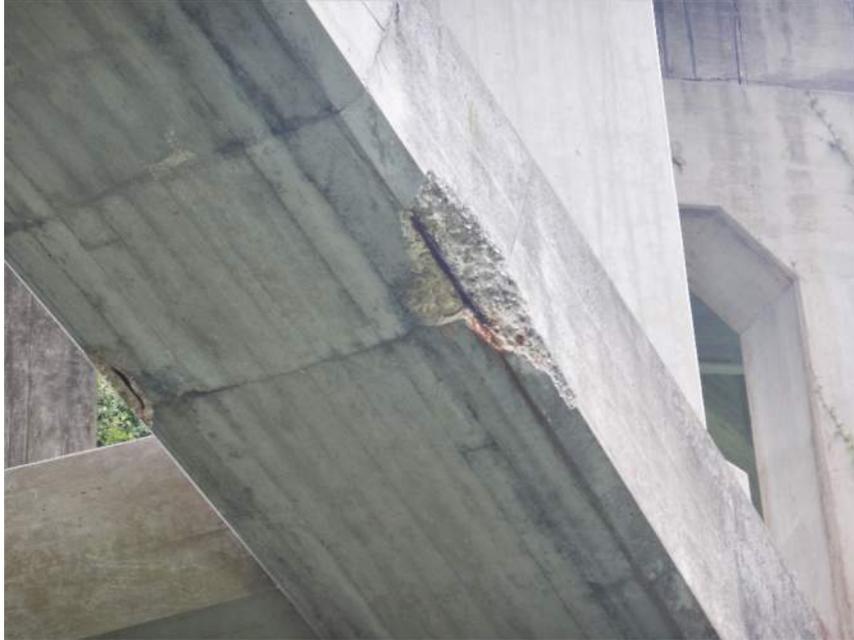
Spalling and Delamination of Arch Ribs

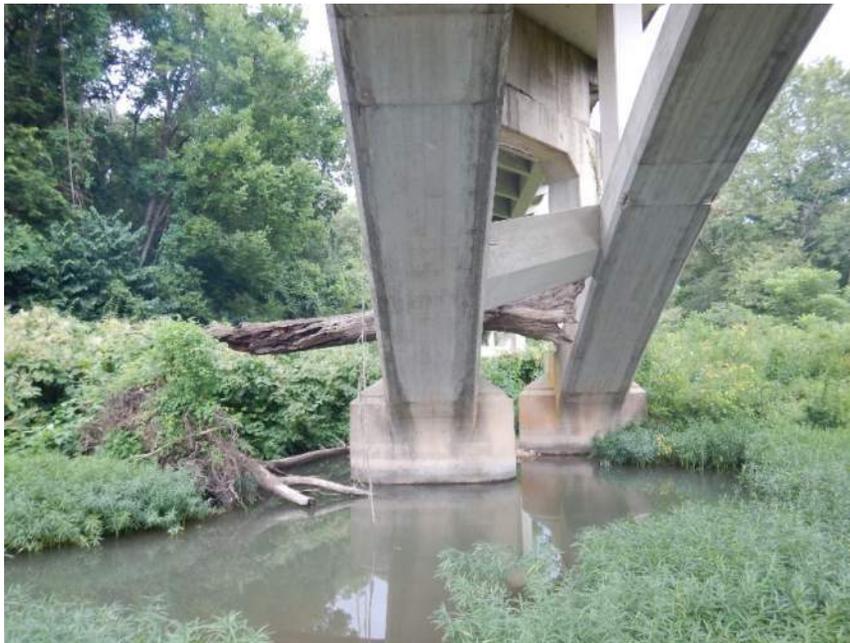
Drift in Structure

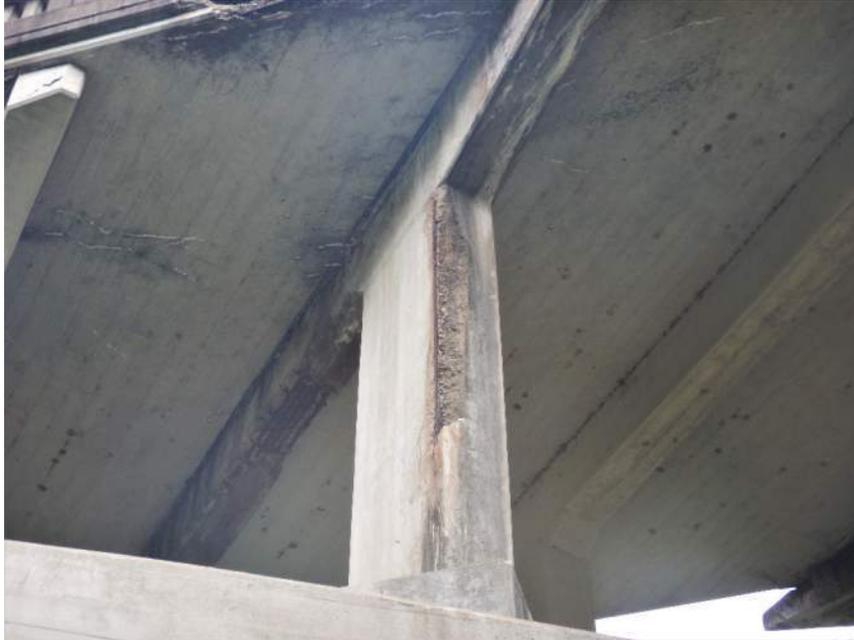
Typical Deterioration on Spandrel Columns

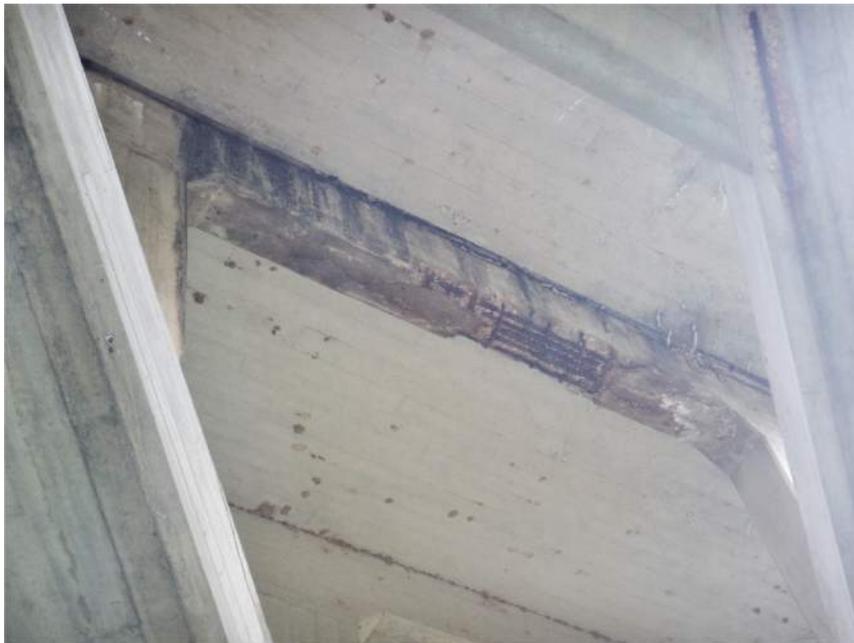
Typical Deterioration on Spandrel Capbeams

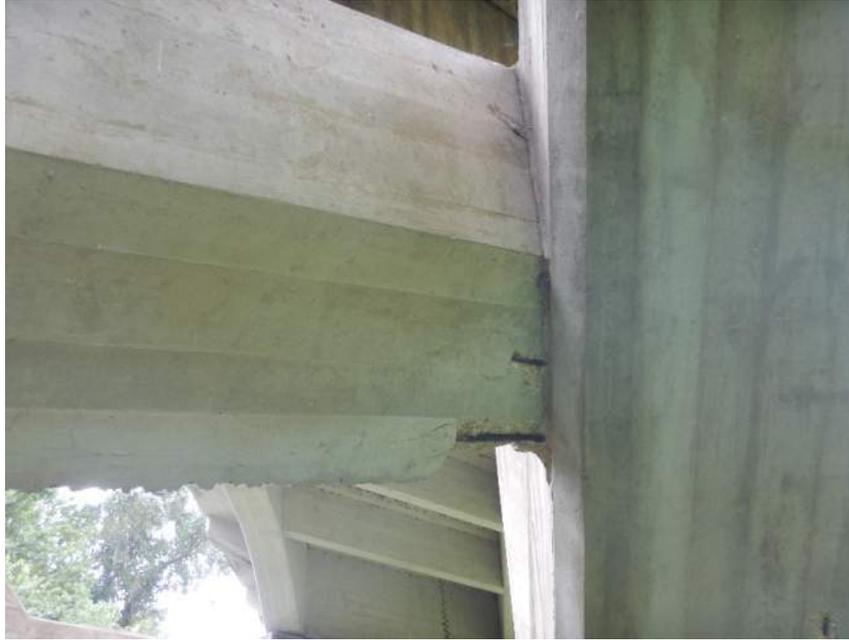
Lateral Bracing Between the Arch Ribs

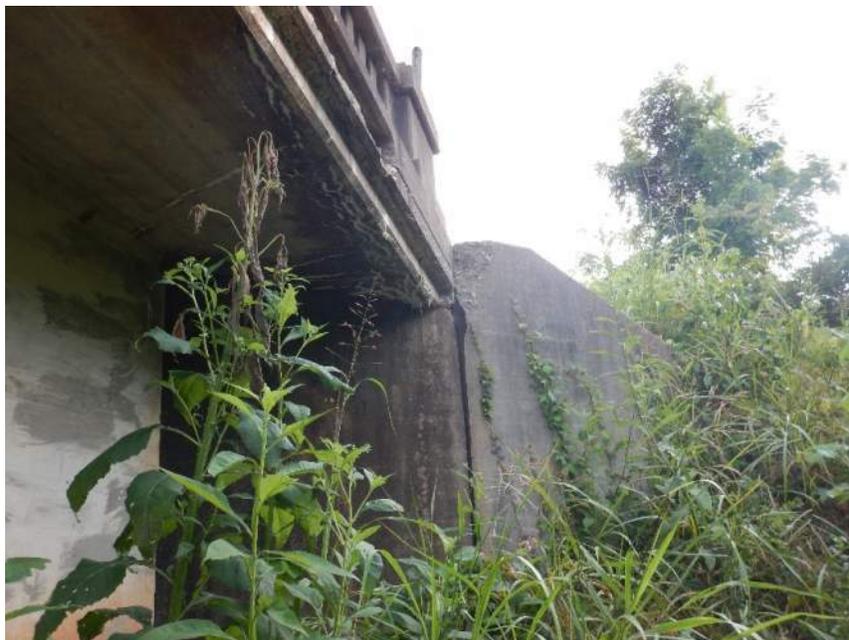
Typical Spalling at Abutment

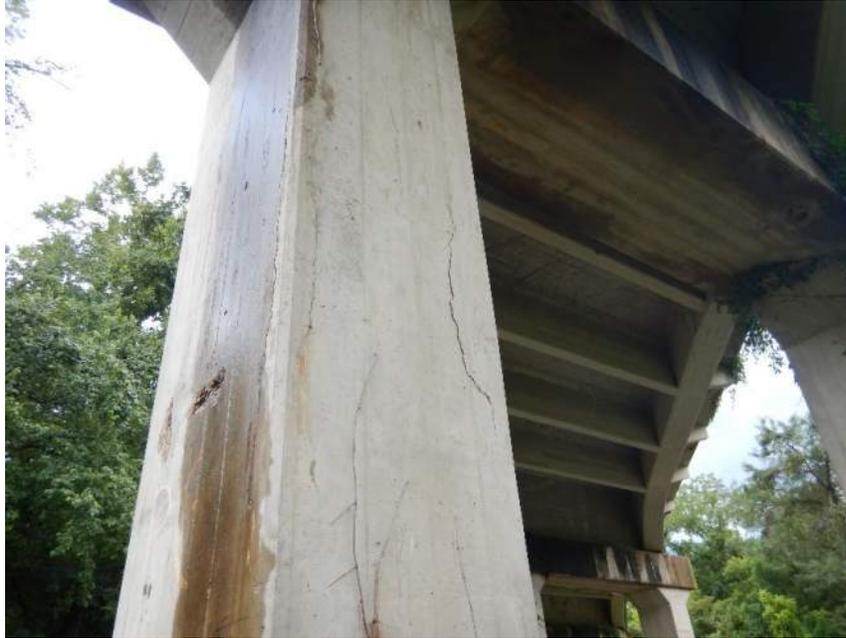
Deterioration of Intermediate Bent Columns

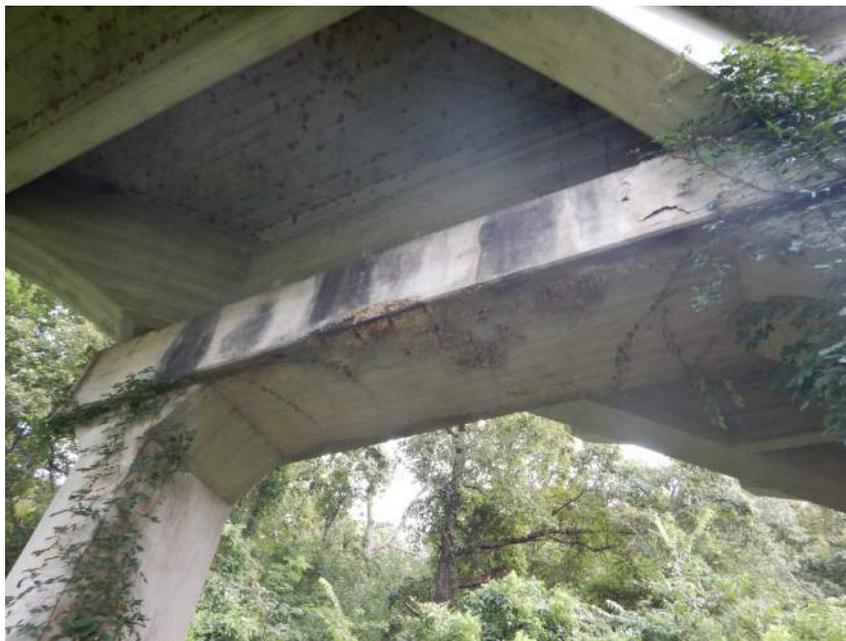
Deterioration of Intermediate Bent Cap Beams

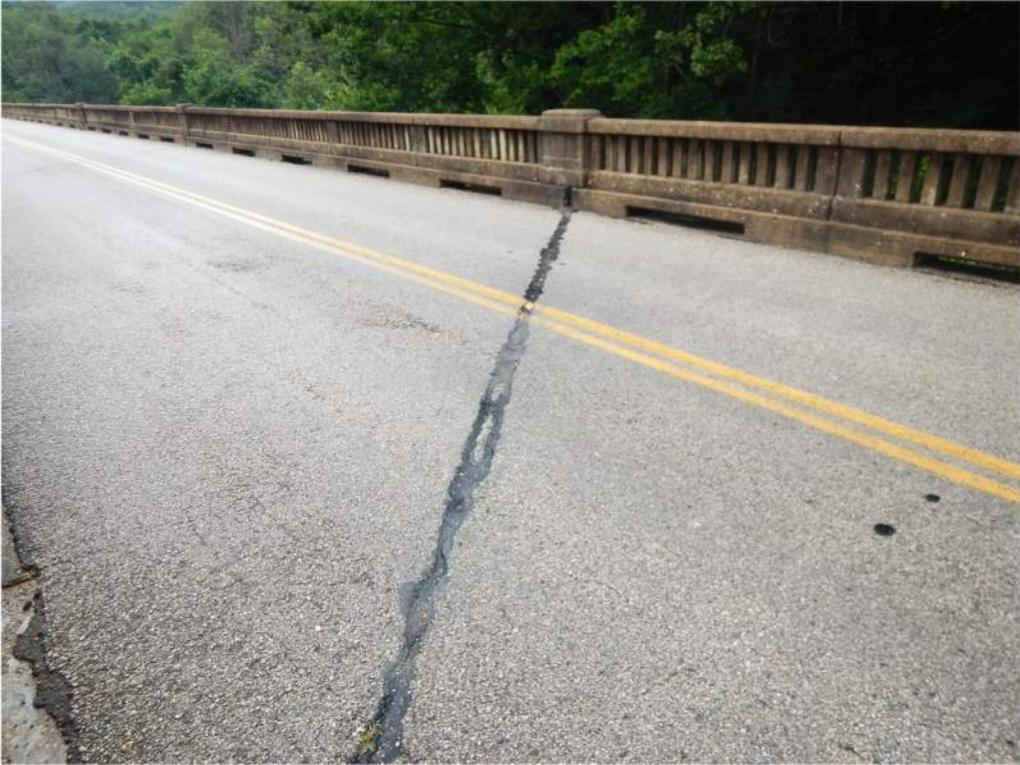
Pic. 002: Typical deck condition below curb openings

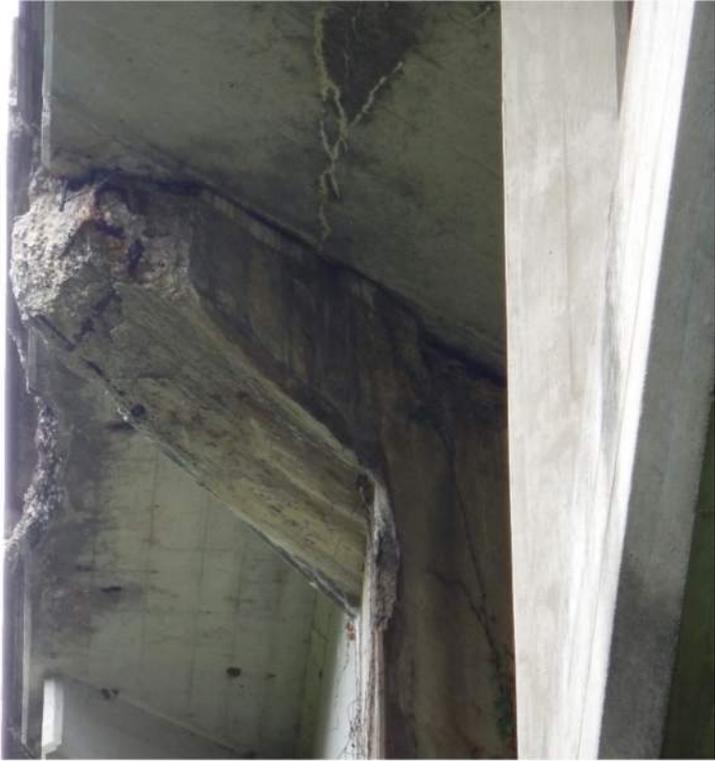
Pic. 006: Typical deterioration of spandrel capbeams

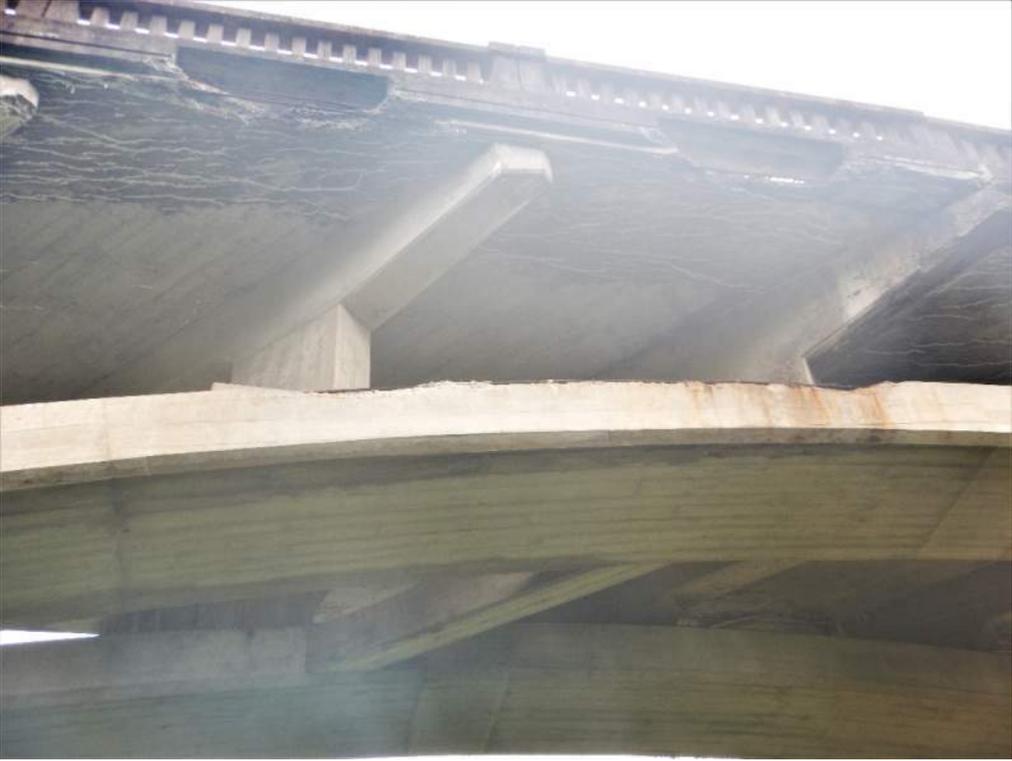
Pic. 008: Spalling of arch rib, west rib near south thrust block

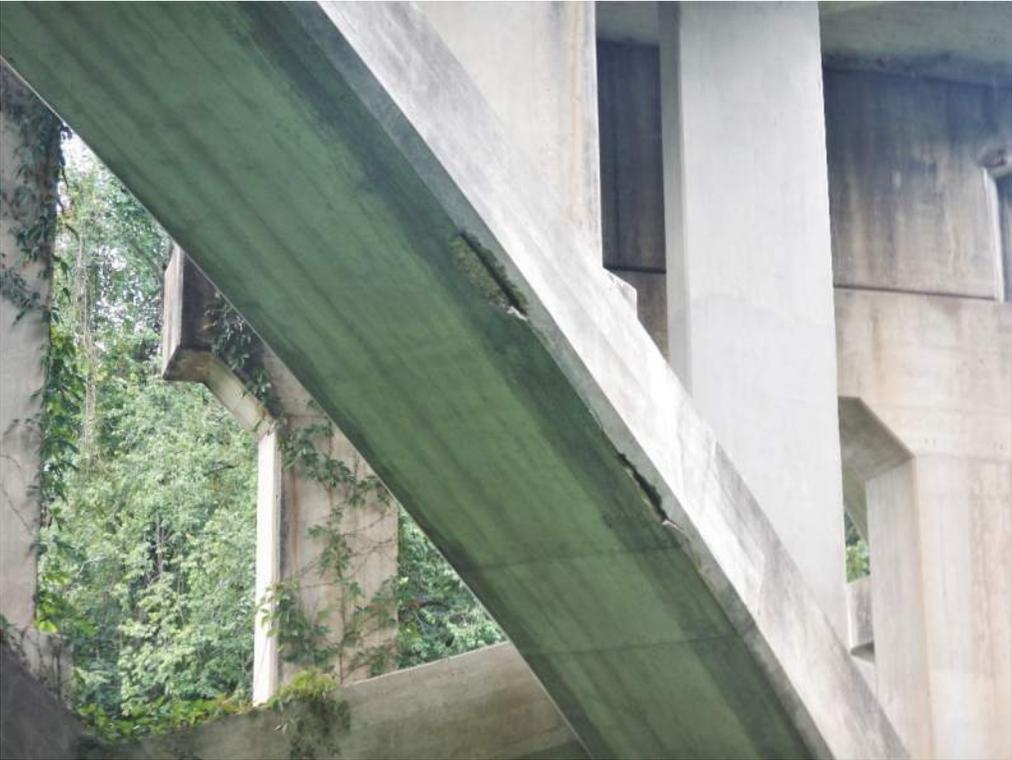
Pic. 009: Typical deterioration of spandrel column

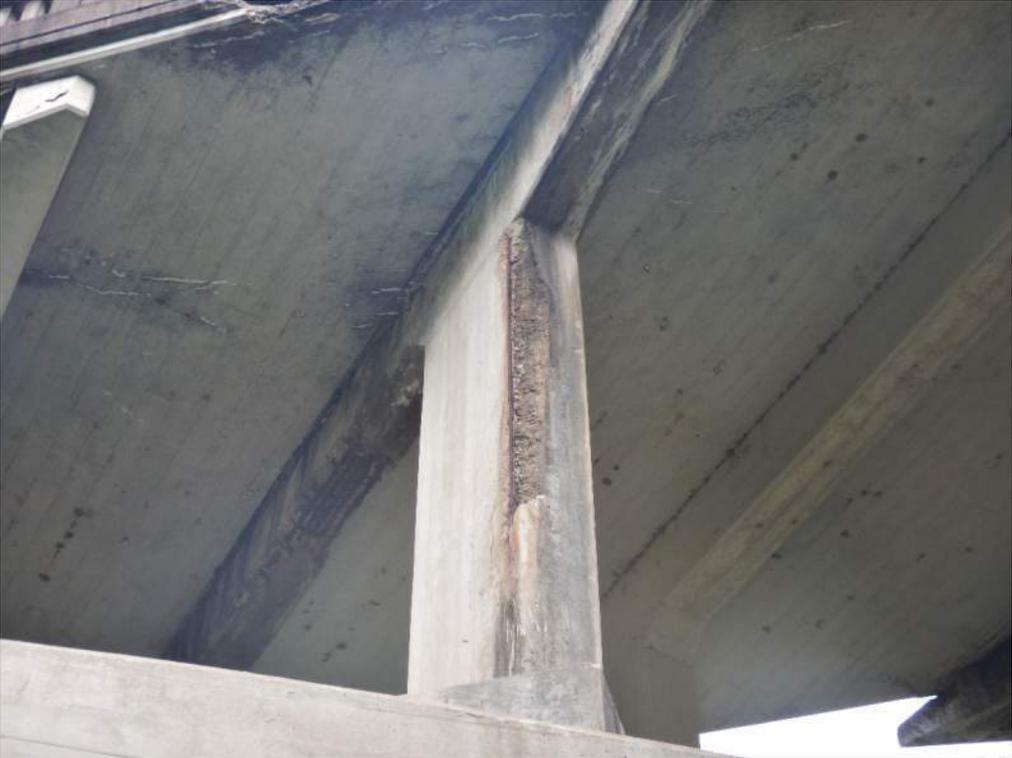
Pic. 010: Vertical cracking in column, Bent 3 shown

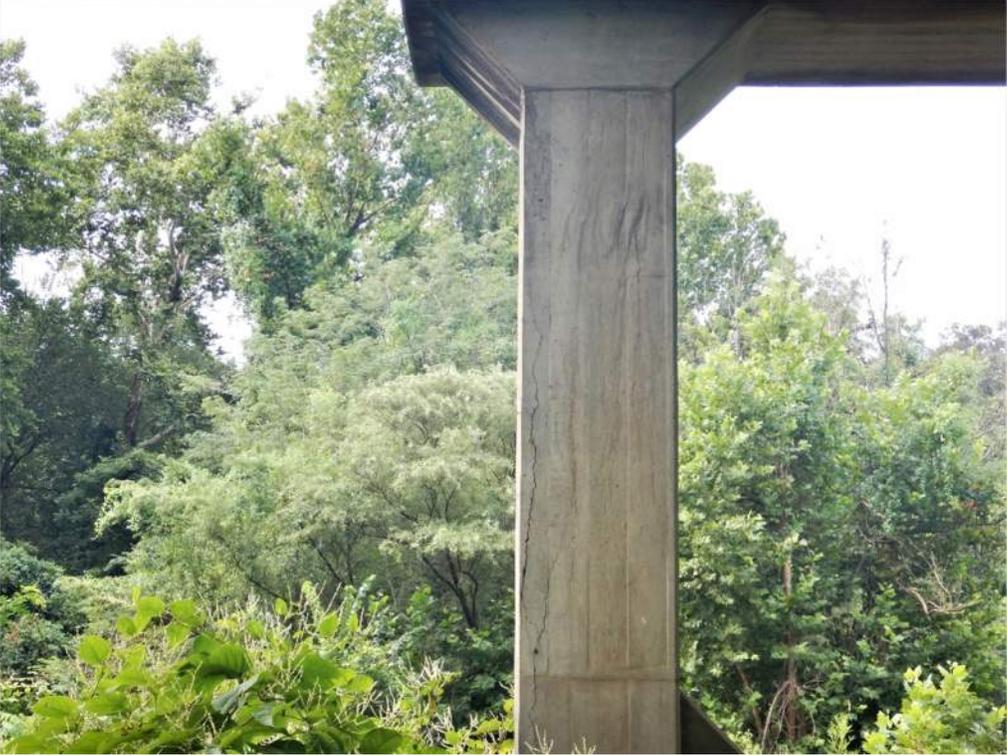
Pic. 011: Spalling and cracking on column, Bent 6 shown

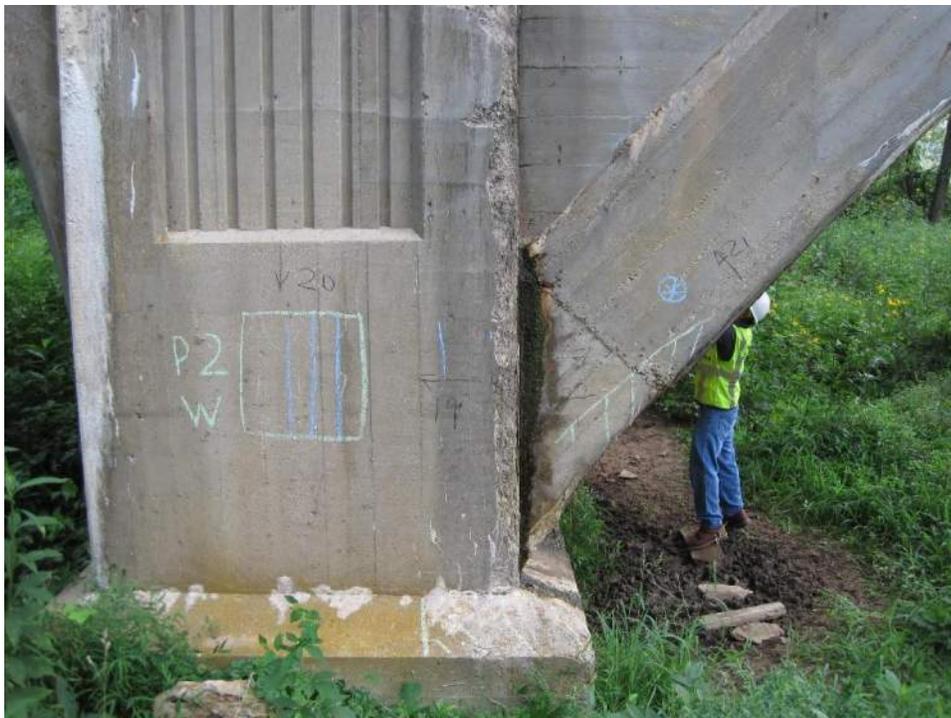
Photo 2: CRB, Typical spalling and deterioration along vertical corners of pier and edge of arch, West Face, pier 2 shown.
