BRIDGE REHABILITATION / REPLACEMENT ALTERNATIVES STUDY REPORT

Route 19 over Current River and Spring Valley
(Project No. J9P3305)

Bridges No. G0804 and J0420

October 2019

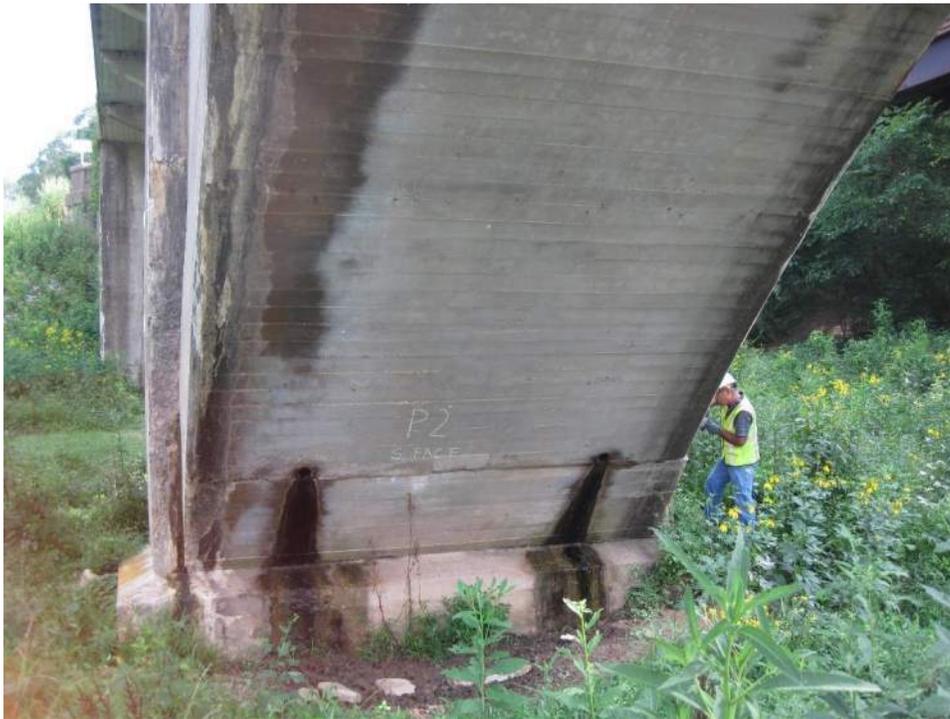
Photo 4: CRB, Typical leakage from drains at base of arch

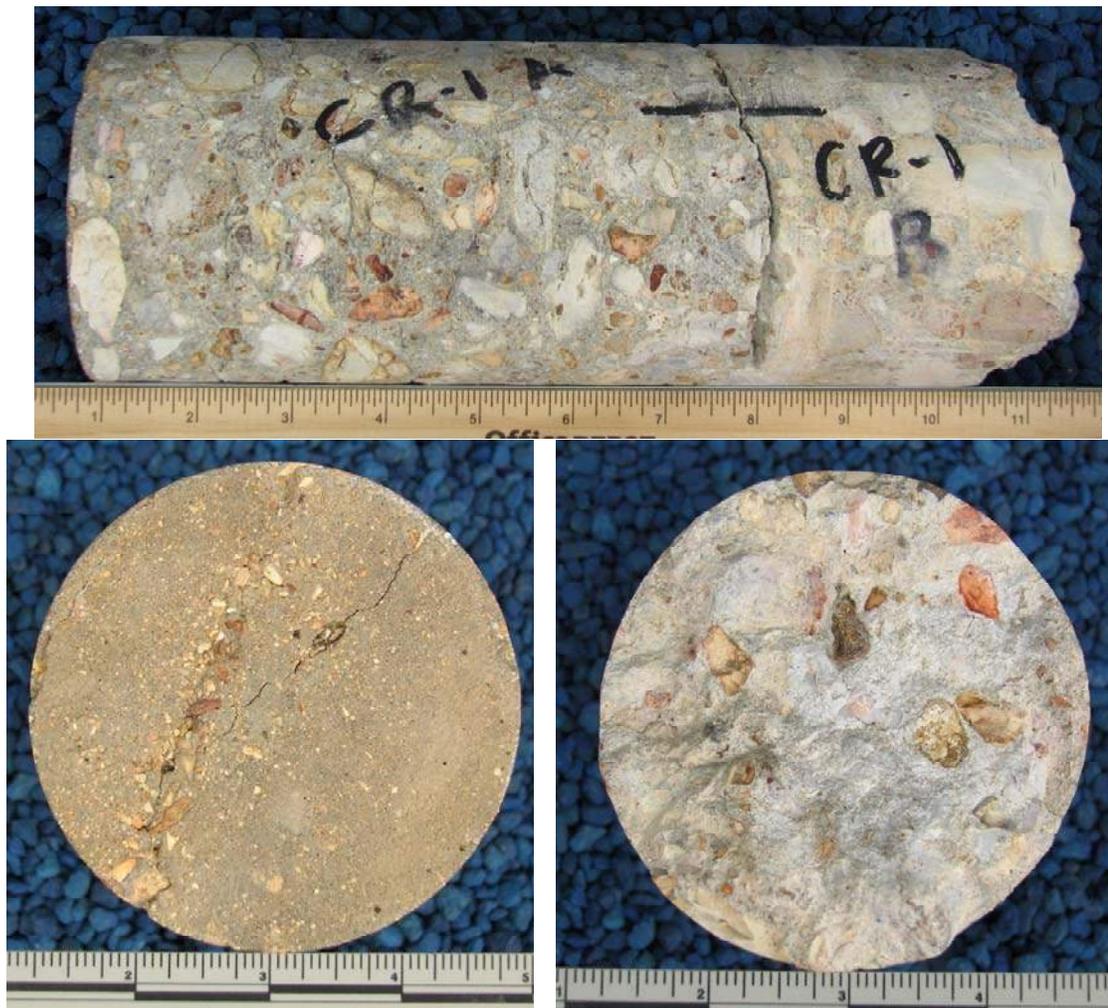
The core is 3.75-in. (95-mm) in diameter, 9.25-in. (235-mm) long and represents a partial member thickness (Figure 1). The outer surface has a smooth imprint of a formed surface (Figure 1). The inner surface is an irregular fracture surface (Figure 1). The concrete is well consolidated and shows no signs of segregation.

Figure 1: *Top*: Core CR-1 (outer surface oriented to the left). *Bottom*: Outer (left) and inner (right) surfaces of the Core CR-1.

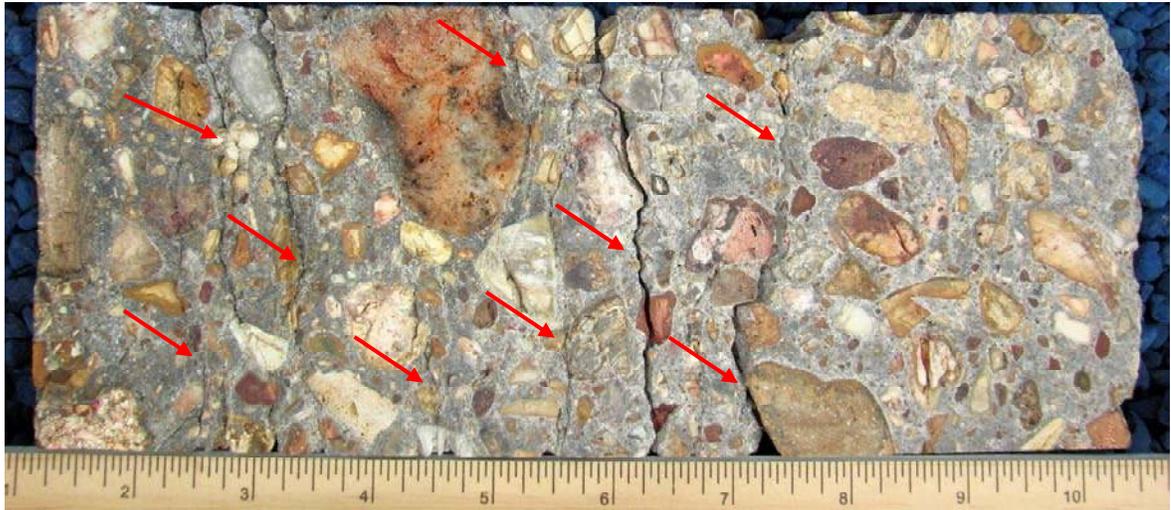
Multiple, interlaced cracks, oriented subparallel to the outer surface of the core, are present through the length of the core and have a range of widths from 0.1 to 6.0 mm. The cracks pass around and through aggregate particles. Cracks are depicted in Figure 2 below (red arrows).

Figure 2: Photograph showing the cracks in Core CR-1. The outer surface is to the left. Scale in inches.

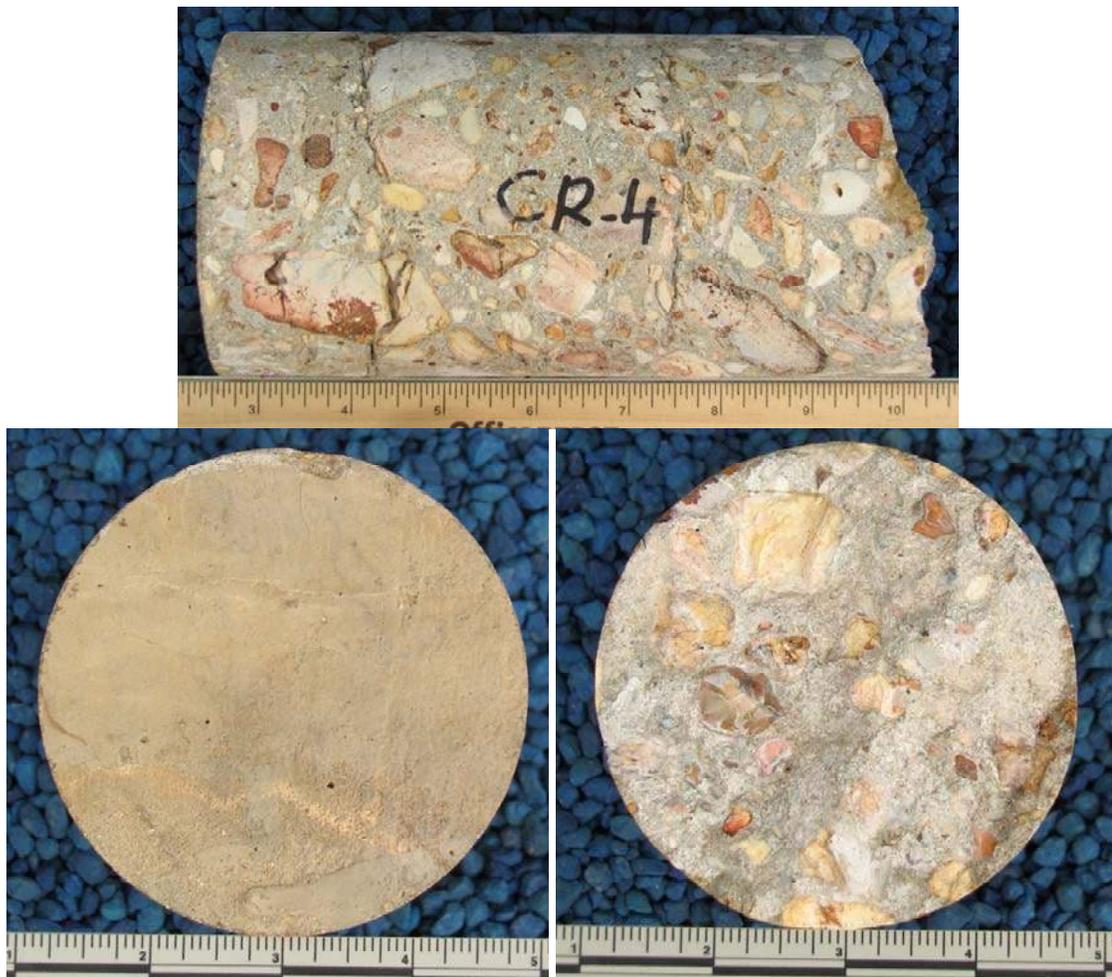
The core is 3.75-in. (95-mm) in diameter, 7.5-in. (191-mm) long and represents a partial member thickness (Figure 3). The outer surface has a smooth imprint of a formed surface (Figure 3). The inner surface is an irregular fracture surface (Figure 3). The concrete is well consolidated and shows no signs of segregation.

Figure 3: *Top*: Core CR-4 (outer surface oriented to the left). *Bottom*: Outer (left) and inner (right) surfaces of Core CR-4.

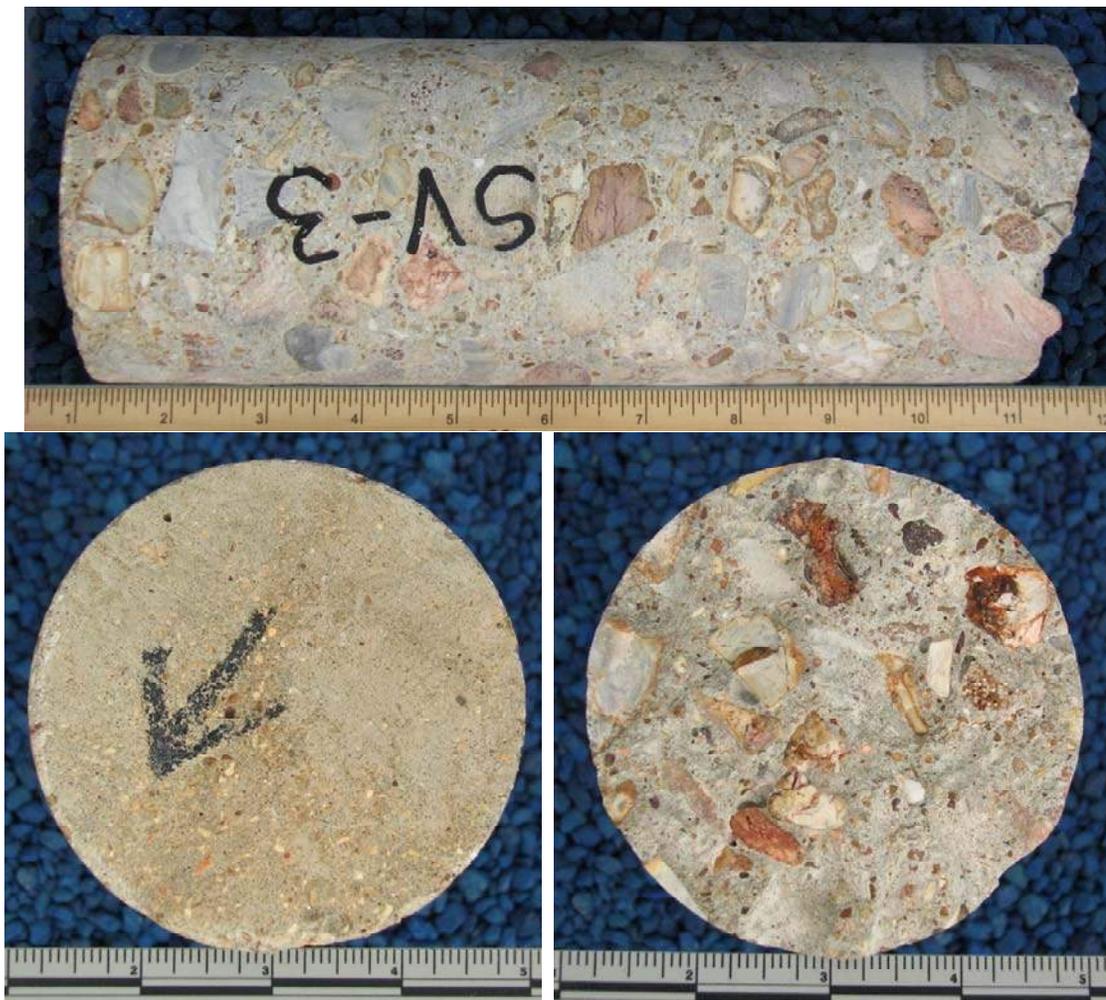
The core is 3.7-in. (95-mm) in diameter, 10.0-in. (254-mm) long and represents a partial member thickness (Figure 6). The outer surface has a smooth imprint of a formed surface (Figure 6). The inner surface is an irregular fracture surface (Figure 6). The concrete is well consolidated and shows no signs of segregation (Figure 7).

Figure 6: *Top:* Core SV-3 (outer surface oriented to the left). *Bottom:* Outer (left) and inner (right) surfaces of Core SV-3.

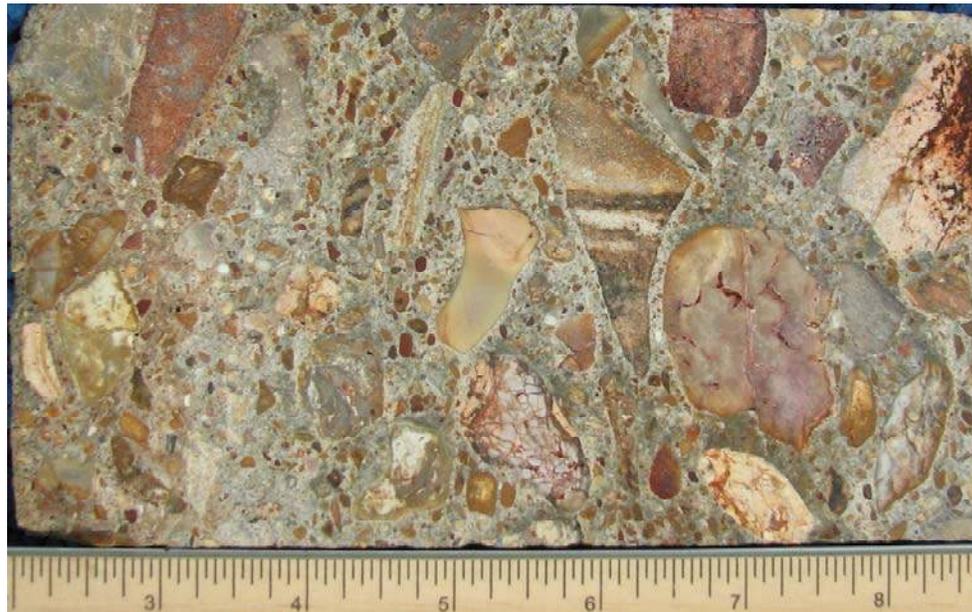
No cracks or microcracks are present in the core, as shown in Figure 7 below.

Figure 7: Photograph showing the good condition of Core SV-3. The outer surface is to the left. Scale in inches.
