Alternative / Option 1 Screening Technical Memorandum

DATE:	October 25, 2022
FROM:	WSP
SUBJECT:	Screening Analysis for Preferred Alternative and Option 1 Westphalia Segments
TO:	Missouri Department of Transportation, Central District

MoDOT Route 63 EIS Re-evaluation Study Area

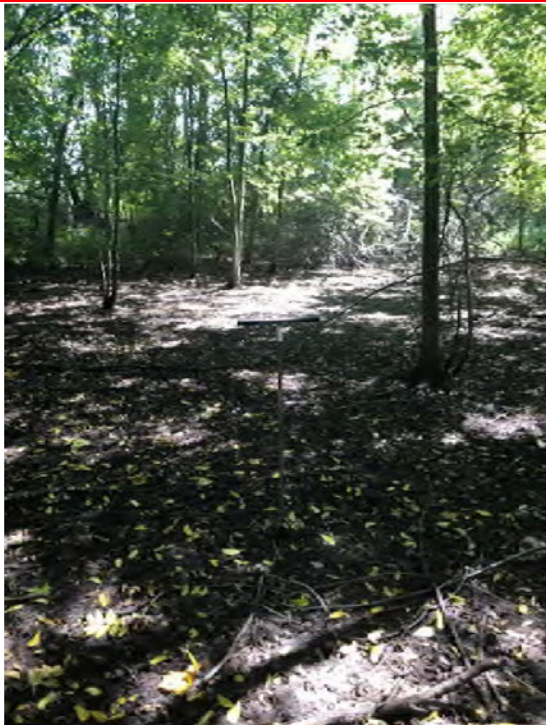
Perennial stream, looking downstream.

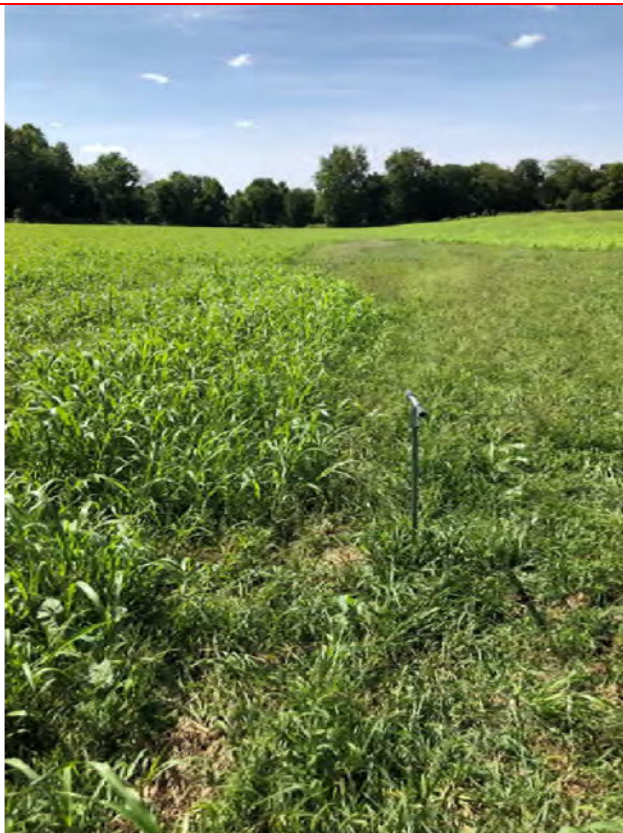
Photo 9. OC-WSP-0035b

OC-WET-0035 exists as a wet area within a managed sorghum field.

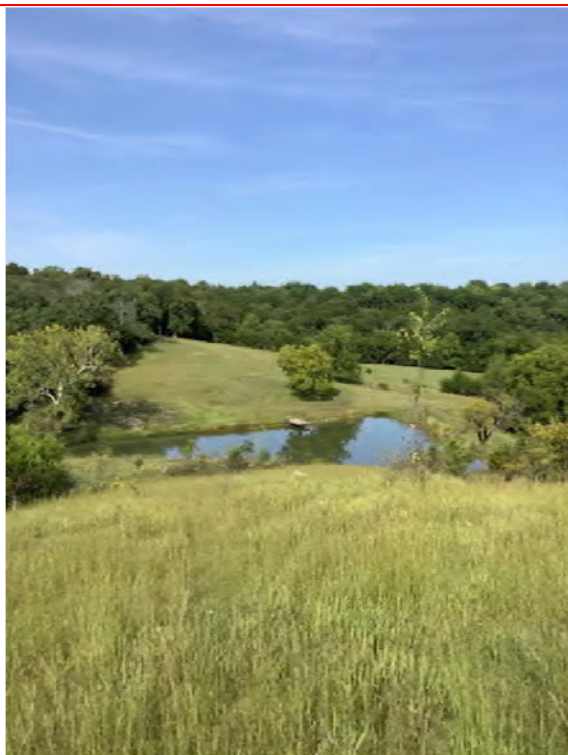
Photo 15. OC-OW-0080

Impounded open water body.

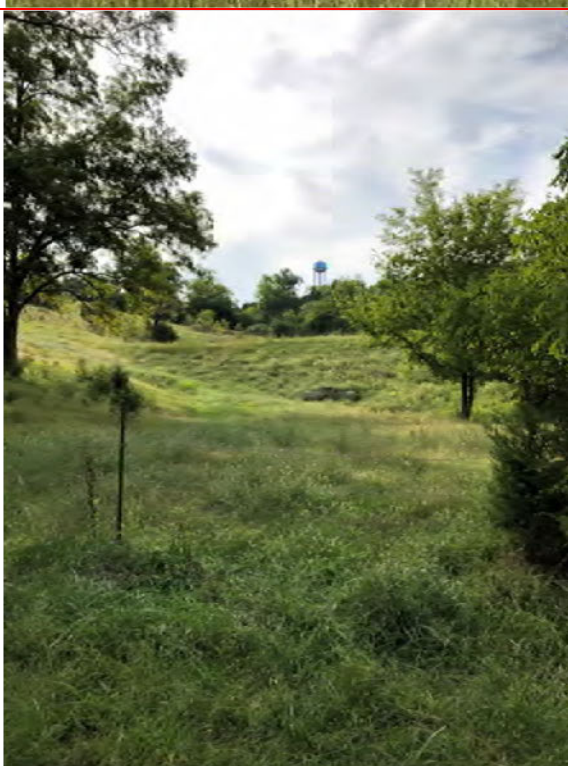
Back side of open water impoundment. Beginning of ephemeral stream OC-STR-0110.

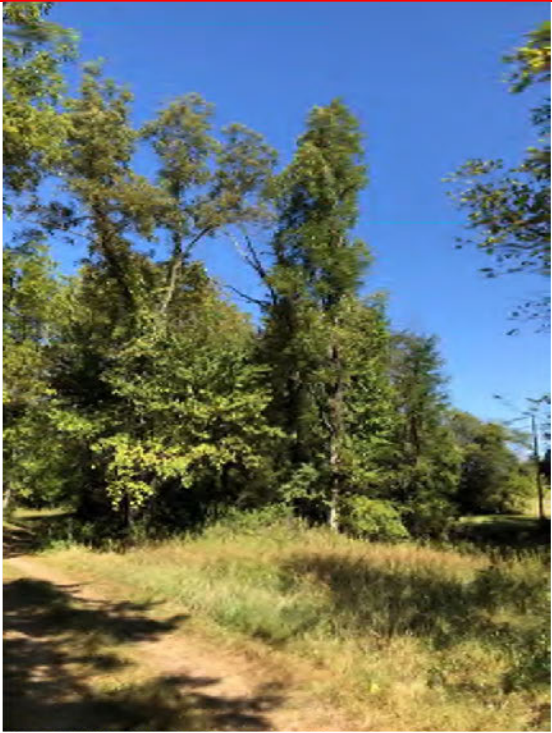
<p>09/15/2022</p> <p>Photo 3. OC-FS-0040</p> <p>Suitable bat roost habitat and transmission line corridor cutting through</p>

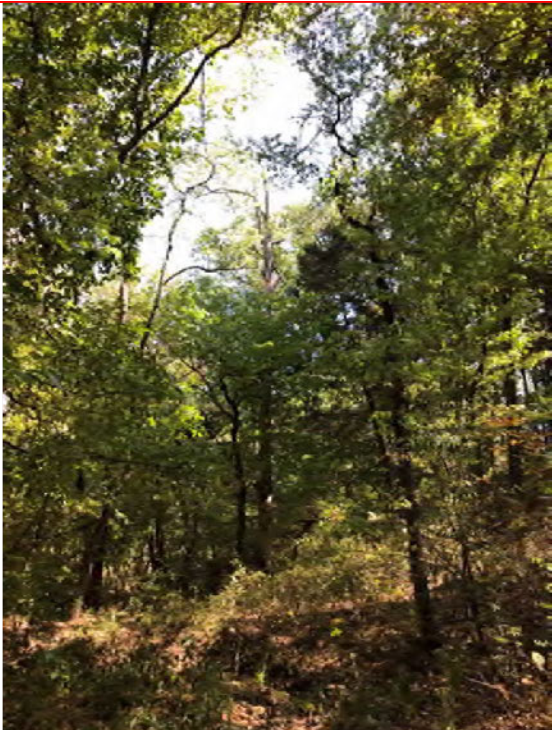
<p>09/15/2022</p> <p>Photo 4. OC-FS-0050</p> <p>Large deciduous forest stand with numerous potential bat roost trees</p>

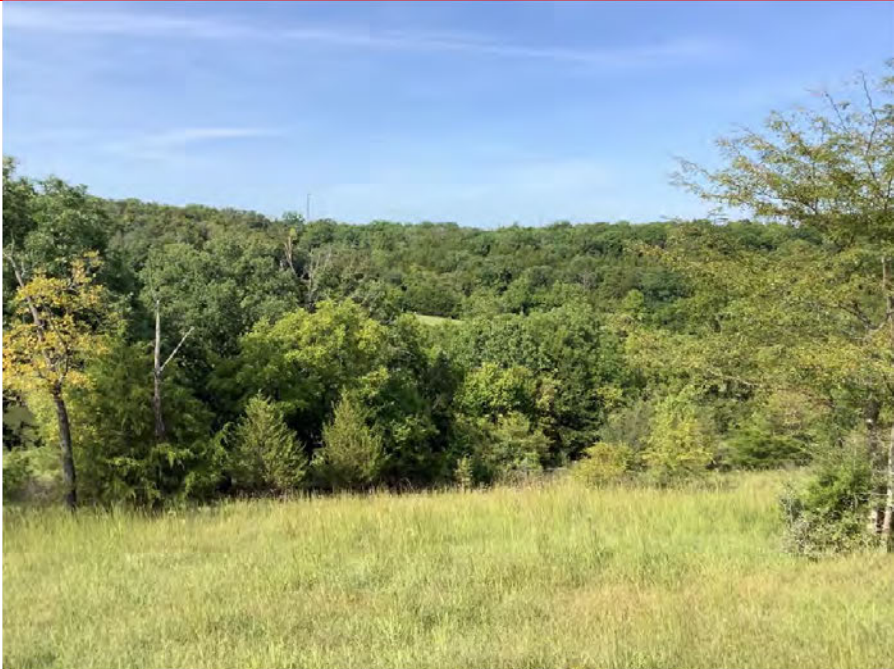
<p>09/14/2022</p> <p>Photo 9. OC-FS-0160</p> <p>Forested areas between cattle grazing fields with snags</p>

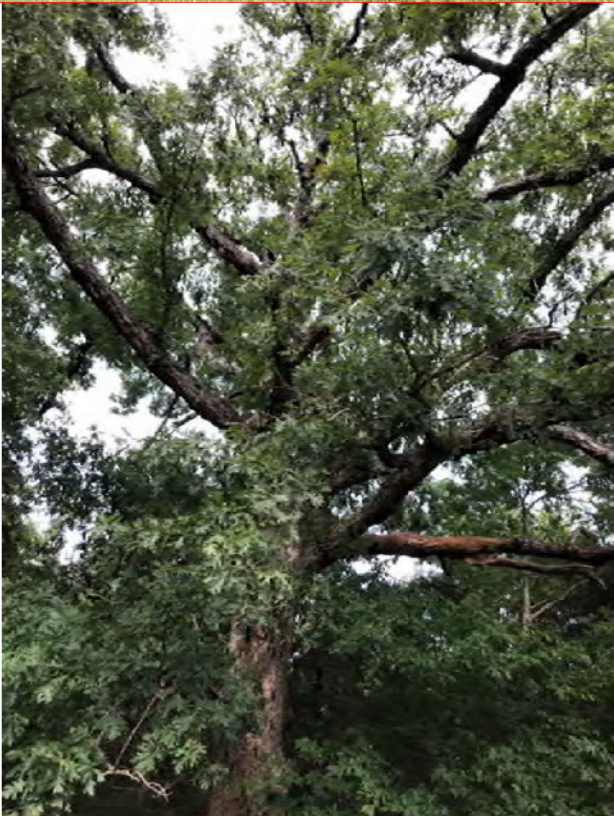
<p>09/15/2022</p> <p>Photo 10. OC-FS-0170</p> <p>Large white oak with peeling bark, crevices, and hollows within forested riparian stream corridor</p>
