**Appendix A: Bridge Rehabilitation and Reconstruction
Alternatives**

Re : Bridge Rehabilitation - H&C Response to Comments
Job No. : J9P0436, J9P0437 and J9P0438
Route : 19
County : Shannon
HCI No. : 10180-00

Re : Bridge Rehabilitation or Reconstruction Alternatives
Environmental Impact Study, Bridges G-804A, J-420, H-79
Rte 19, Shannon County

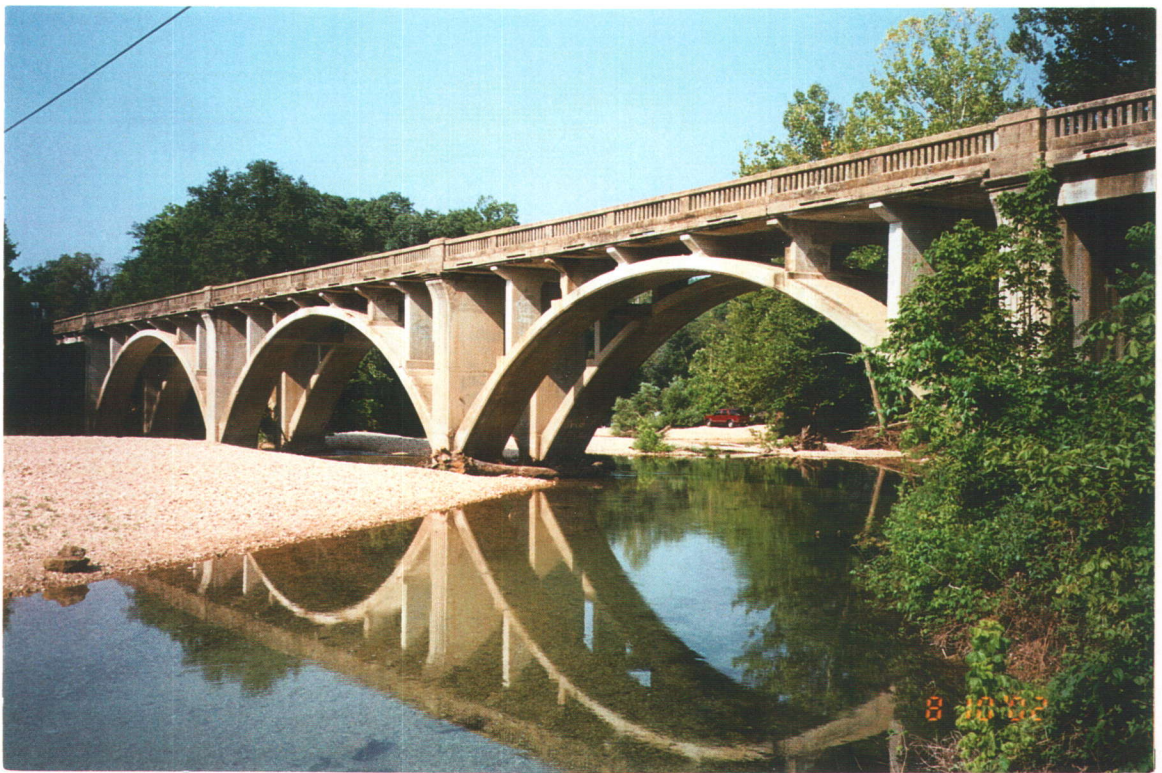
Elevation View - Looking East

Bridge H-79
Rte 19 over Sinking Creek

Several deficiencies were observed during the field inspection. The underside of the roadway slab is in poor condition. Large delaminations and areas of exposed reinforcing steel are present. Several delaminations are 4 ft. by 5 ft. in size. Moderate tapping with a hammer caused pieces of concrete to fall to the ground below. Significant cracking and spalling occurs on the second and fifth floorbeam in each arch span, at locations where transverse construction joints occurred in the original deck construction. Re-use of the deck and these floorbeams is not recommended based on visual observation.

Delaminated concrete was observed at the crown of all three east arches and the one west arch sounded. Areas up to 2.5 ft. wide and 7 ft. long were detected. Exposed reinforcing occurs at spalled corners of the arches. Chloride content at the east crown of the south arch span was measured at a high level of 5.1-5.8 lbs./cu.yd. Loose and crumbling concrete was also observed at decorative cornices near the pier tops.

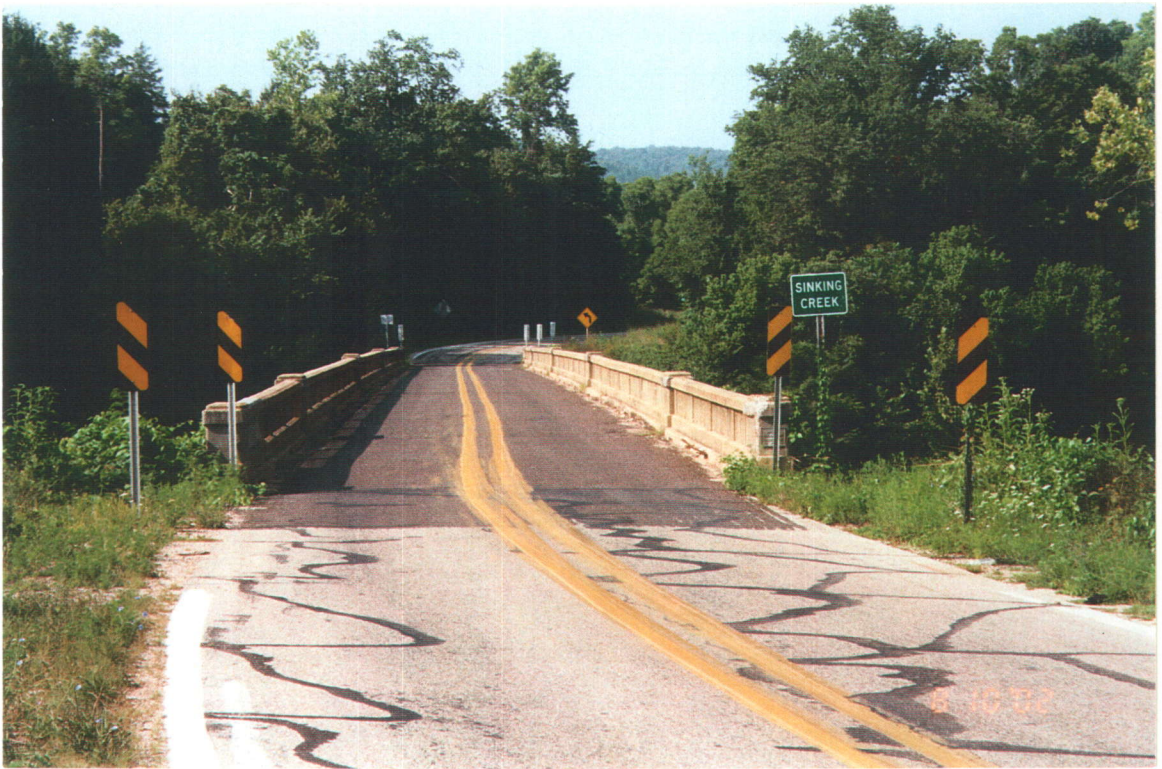
Roadway - Looking South

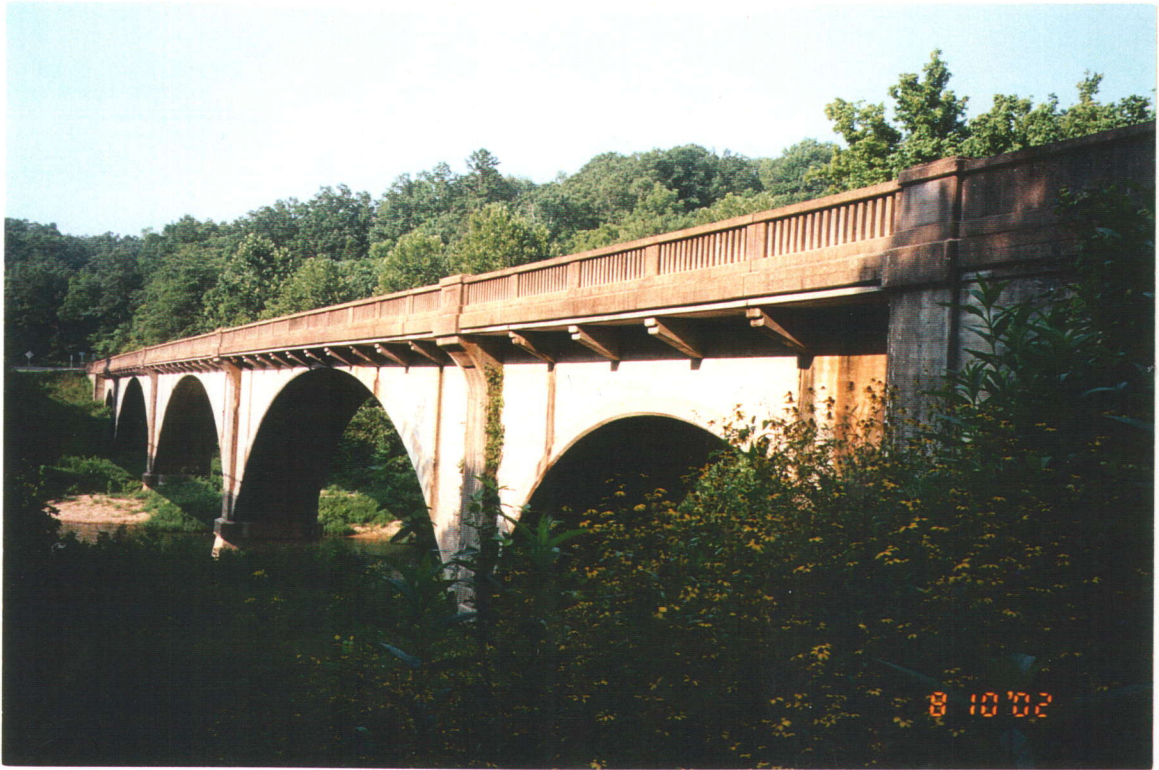
Elevation View - Looking Southeast

Bridge G-804
Rte 19 over the Current River

Staining on the spandrel walls occurs below the first, third, eighth and tenth cantilever brackets in each 130 ft. arch span. Vertical expansion joints in the walls occur at these locations. Similar staining occurs at expansion joint locations in the 60 ft. arch spans. Cantilever brackets at these locations exhibit significant concrete spalling and staining. Most of these support brackets would not be suitable for re-use in a rehabilitated structure based on visual observation. Water staining also occurs over many large areas on the underside of the arches. Chloride content in the arch samples was very low.

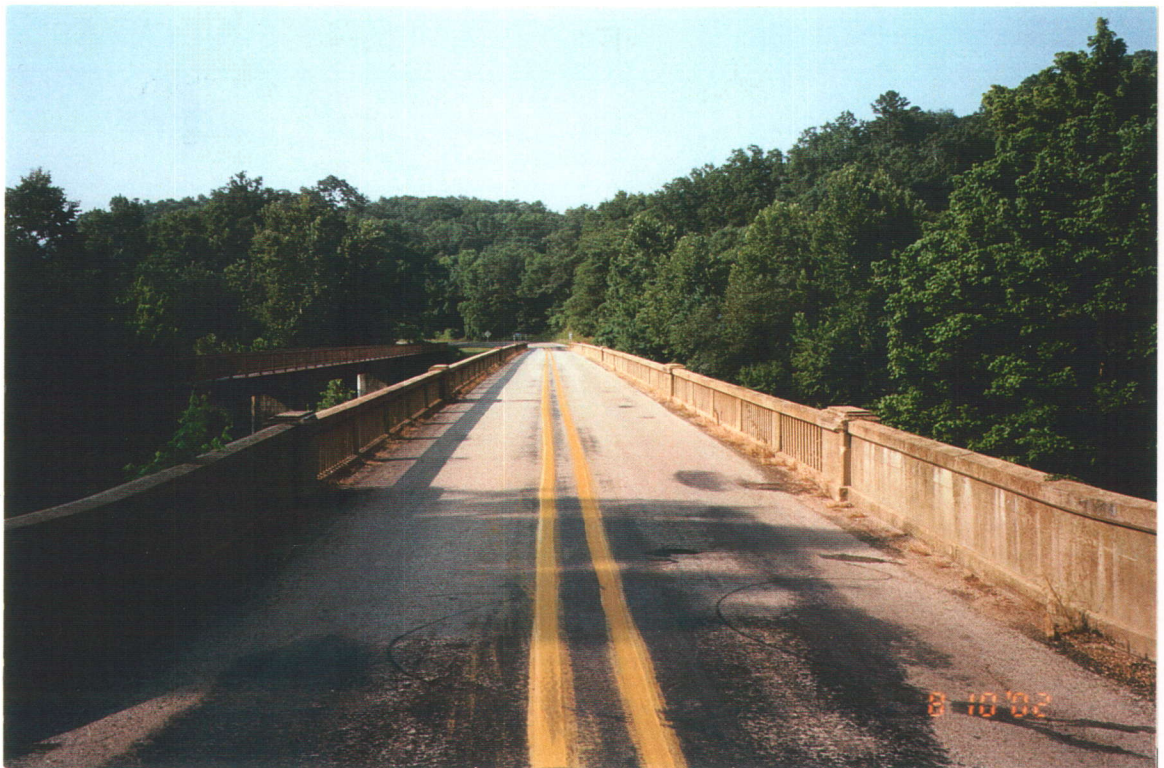
Roadway - Looking South
(Note utility/pedestrian bridge at left)

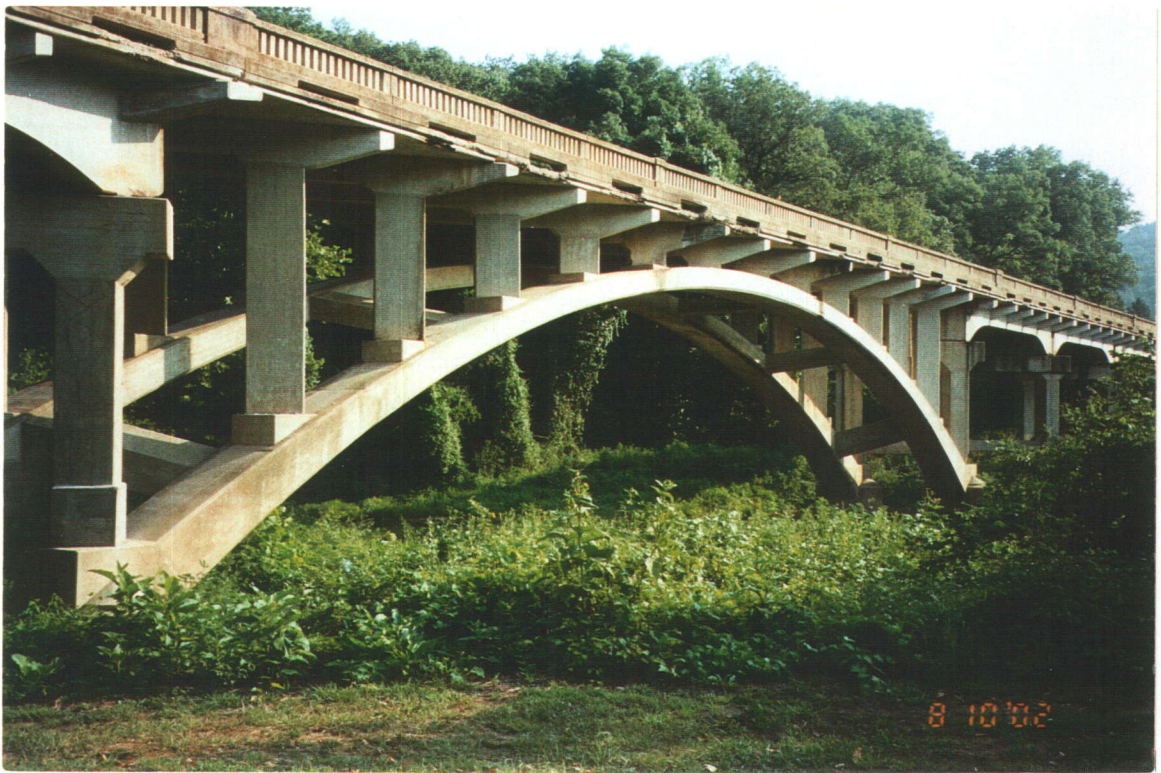
Elevation View - Looking Northeast

Bridge J-420
Rte 19 over Spring Valley

A few minor concrete spalls were observed on the arch spans. One 7 ft. length of exposed reinforcing occurs at the top outside corner near the crown of the east arch. Water staining, approximately 4 ft. along the length of the arches, occurs on the sides of the arches at the fifth and eighth floorbeams. The location near the exposed reinforcing and staining was chosen for the chloride sampling. Chloride content was found to be well within acceptable levels. Floorbeams supporting the deck slab at these locations are not acceptable for re-use based on visual observation. Water staining was also observed on one quarter of the width of the underside of the arches.

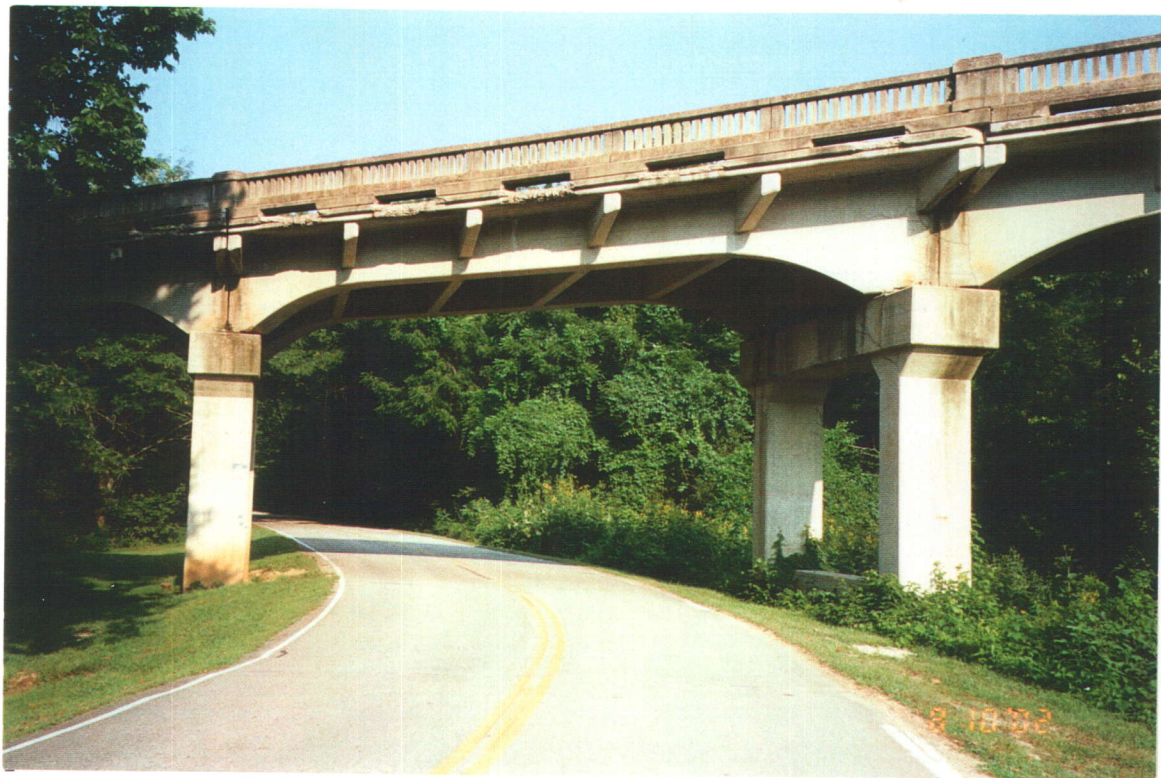
Span Over Park Road - Looking East

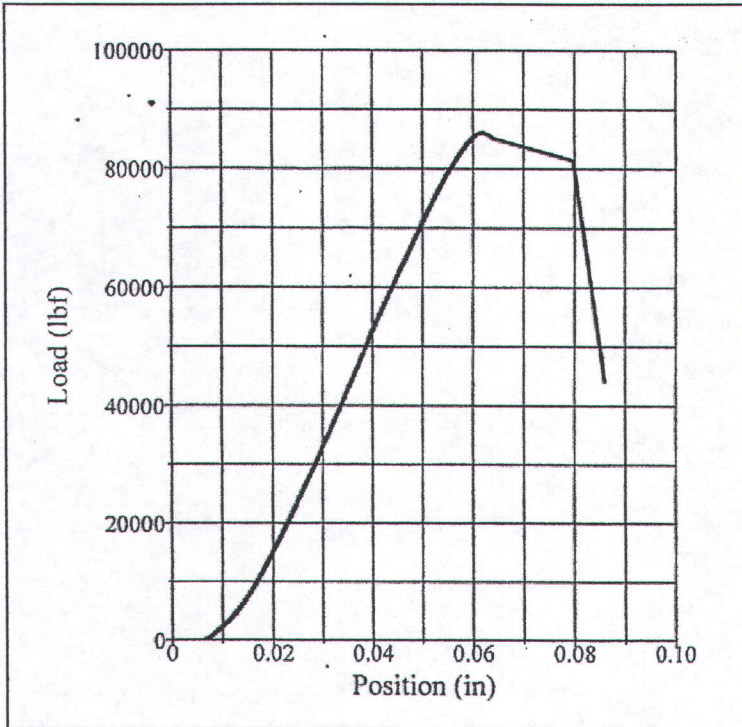
Bridge #: J-420
 Route: 19
 County: Shannon
 Sample Date: 12/17/02
 Location: Round Spring

Test Results
 Diameter: 3.7850 in
 Area: 11.2518 in²
 Compressive Strength: 7640 psi
 Peak Load: 85991 lbf

Test Summary
 Counter: 18641
 Elapsed Time: 00:02:52
 Specimen Identification: 2RJ5B336
 Operator: TECH
 Specimen #: 1
 Type of Fracture: CONE
 Procedure Name: Concrete Cores
 Start Date: 12/26/2002
 Start Time: 7:31:28 AM
 End Date: 12/26/2002
 End Time: 7:34:20 AM
 Workstation: MoDOT
 Tested By: TECH

The existing arch span over Spring Valley Creek is in surprisingly good condition for a 73 year old bridge. The arch span, skewed at 45 degrees, is generally suitable for re-use. Portions of the structure, including the railings, deck slab and two floorbeams are not suitable for re-use based on visual observation. Chloride content in the concrete arches is relatively low. Core samples indicate a high compressive strength of 7640 psi in the arch concrete.

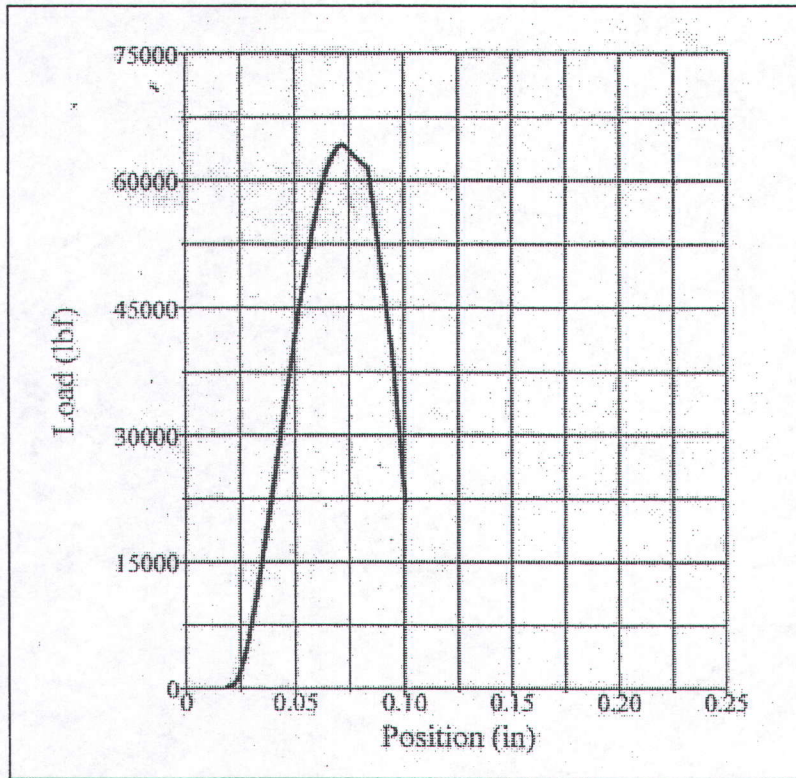
Bridge #: G-804A
 Route: 19
 County: Shannon
 Location: Current River

Diameter: 3.7900 in
 Area: 11.2815 in²
 Compressive Strength: 5690 psi
 Peak Load: 64193 lbf

Counter: 18642
 Elapsed Time: 00:02:13
 Specimen Identification: 2RJ5B337
 Operator: TECH
 Specimen #: 2
 Type of Fracture: CONE & SHEAR
 Procedure Name: Concrete Cores
 Start Date: 12/26/2002
 Start Time: 7:39:19 AM
 End Date: 12/26/2002
 End Time: 7:41:32 AM
 Workstation: MoDOT
 Tested By: TECH

The existing Current River bridge is in fair condition and generally suitable for re-use. Portions of the structure, including the railings, deck slab and some cantilever overhang brackets are not usable and would require replacement. Chloride content in the concrete arches is relatively low. Test results also indicate a compressive strength of 5690 psi in the arch concrete.

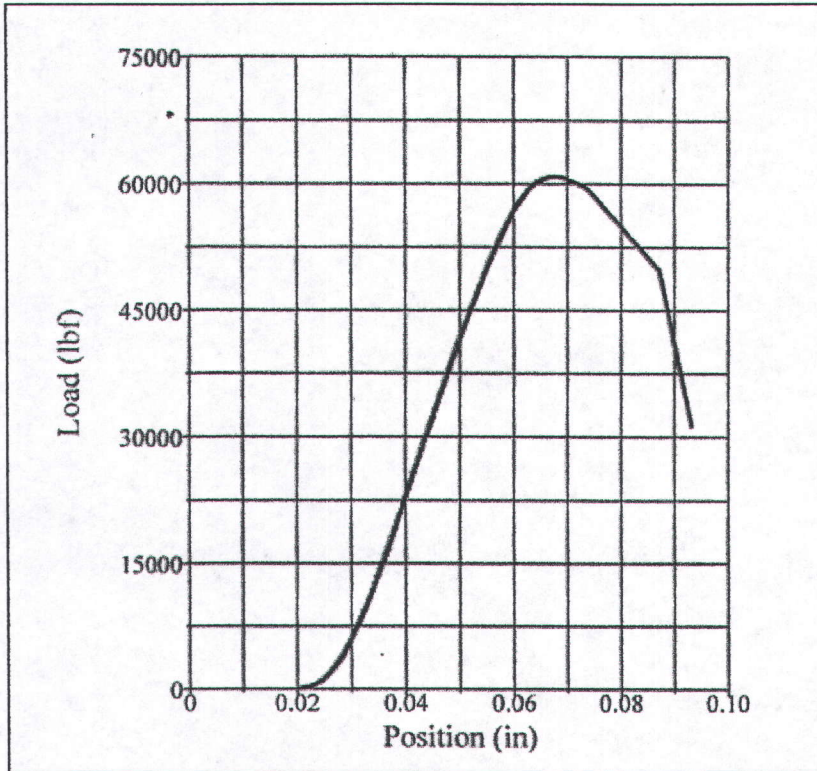
Bridge #: H-79
 Route: 19
 County: Shannon
 Location: Sinking Creek

Test Results
 Diameter: 3.7850 in
 Area: 11.2518 in²
 Compressive Strength: 5410 psi
 Peak Load: 60854 lbf

Test Summary
 Counter: 18643
 Elapsed Time: 00:02:06
 Specimen Identification: 2RJ5B338
 Operator: TECH
 Specimen #: 3
 Type of Fracture: CONE & SPLIT
 Procedure Name: Concrete Cores
 Start Date: 12/26/2002
 Start Time: 7:46:02 AM
 End Date: 12/26/2002
 End Time: 7:48:08 AM
 Workstation: MoDOT
 Tested By: TECH

The concrete is in amazingly good shape with the exception of chloride content on the top of the arch on the south span of the Sinking Creek bridge. The high chlorides, 5.1 – 5.8 Lbs./Cu.Yd., at the level of the rebar will continue to cause spalling of this concrete in the future. It would be very costly and impossible to replace all of the salt contaminated concrete in this area. Only the East arch was tested, so the West arch may be as badly contaminated in this span. Some kind of corrosion control treatment is needed if this arch is left in place, even if only for aesthetic reasons. Some of the options would be coating with a moisture proof sealer, chloride removal or a passive (galvanic) cathodic protection system. The cost of a sprayed on anode would be \$11-\$12/sf. Depending on the type, research funds could be secured at either the 100% or 80% federal level for this work. I would be happy to discuss these options with you, if in the design process you come to this same conclusion.

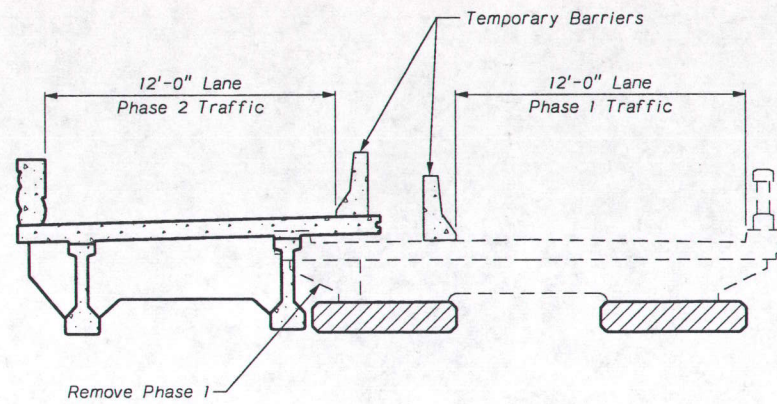
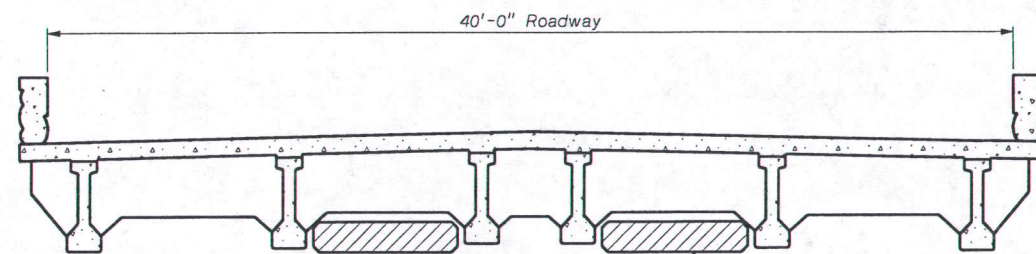
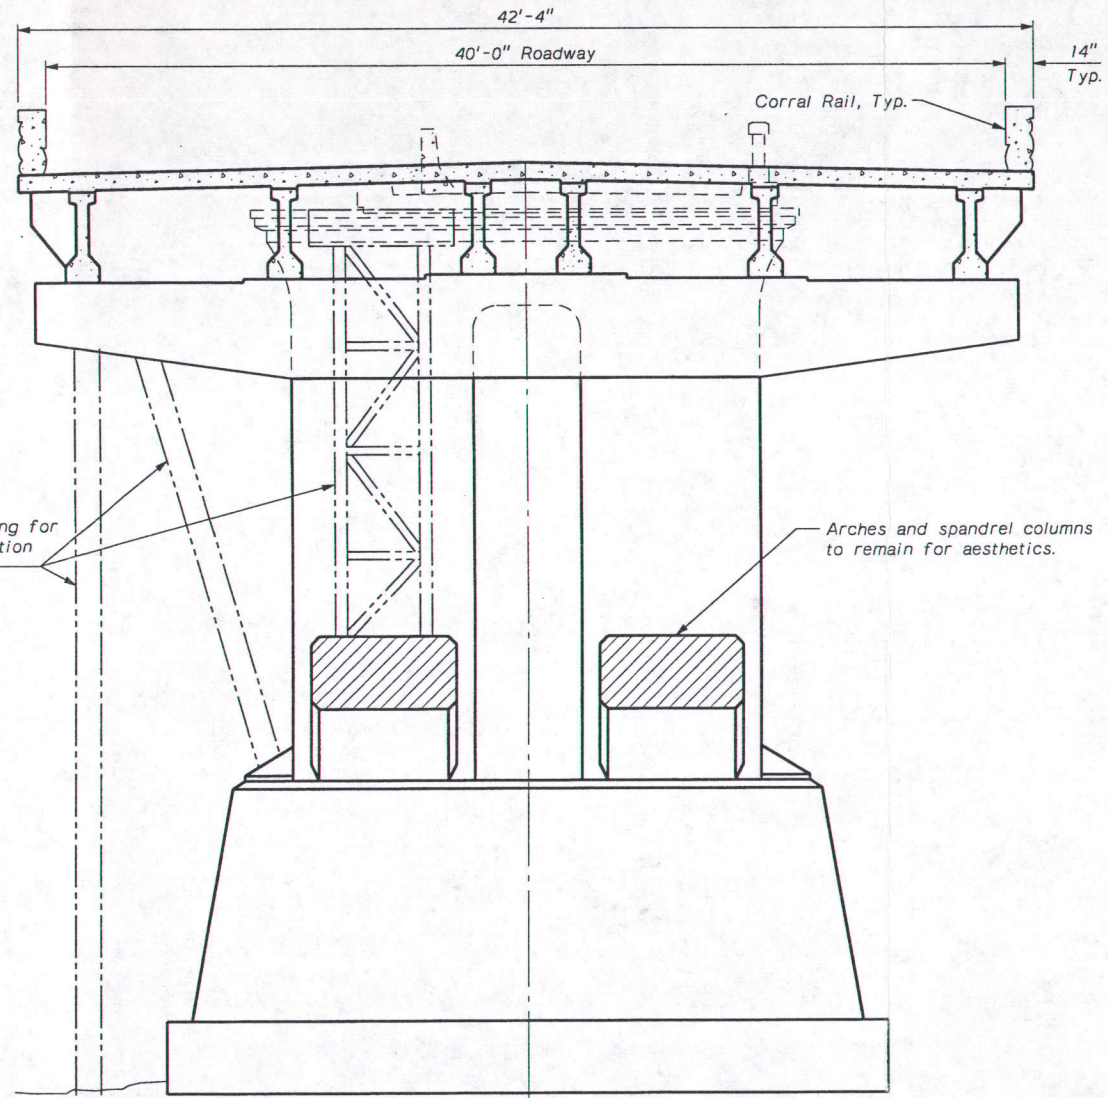
REHAB. WITH P/S GIRDER - SECTIONS
ROUTE 19 SINKING CREEK BRIDGE
Shannon County

Construction Staging

Section at Crown

Arches and spandrel columns
to remain for aesthetics.

Temporary Bracing for
Staged Construction
(Conceptual)

Section Near Pier

A new pier cap will be stage constructed on the existing pier shaft. Two MoDOT Type IV (3'-9") girders are placed outside of one existing arch while one lane of traffic is maintained on a portion of the existing bridge. These girders, with a new deck slab, can then carry one lane of traffic while the existing deck slab and floorbeams are removed. Arch preservation may occur after the new structure is complete. Options for preserving the arches include removing deteriorated concrete, chloride removal, moisture proof sealer or a passive (galvanic) cathode protection system.

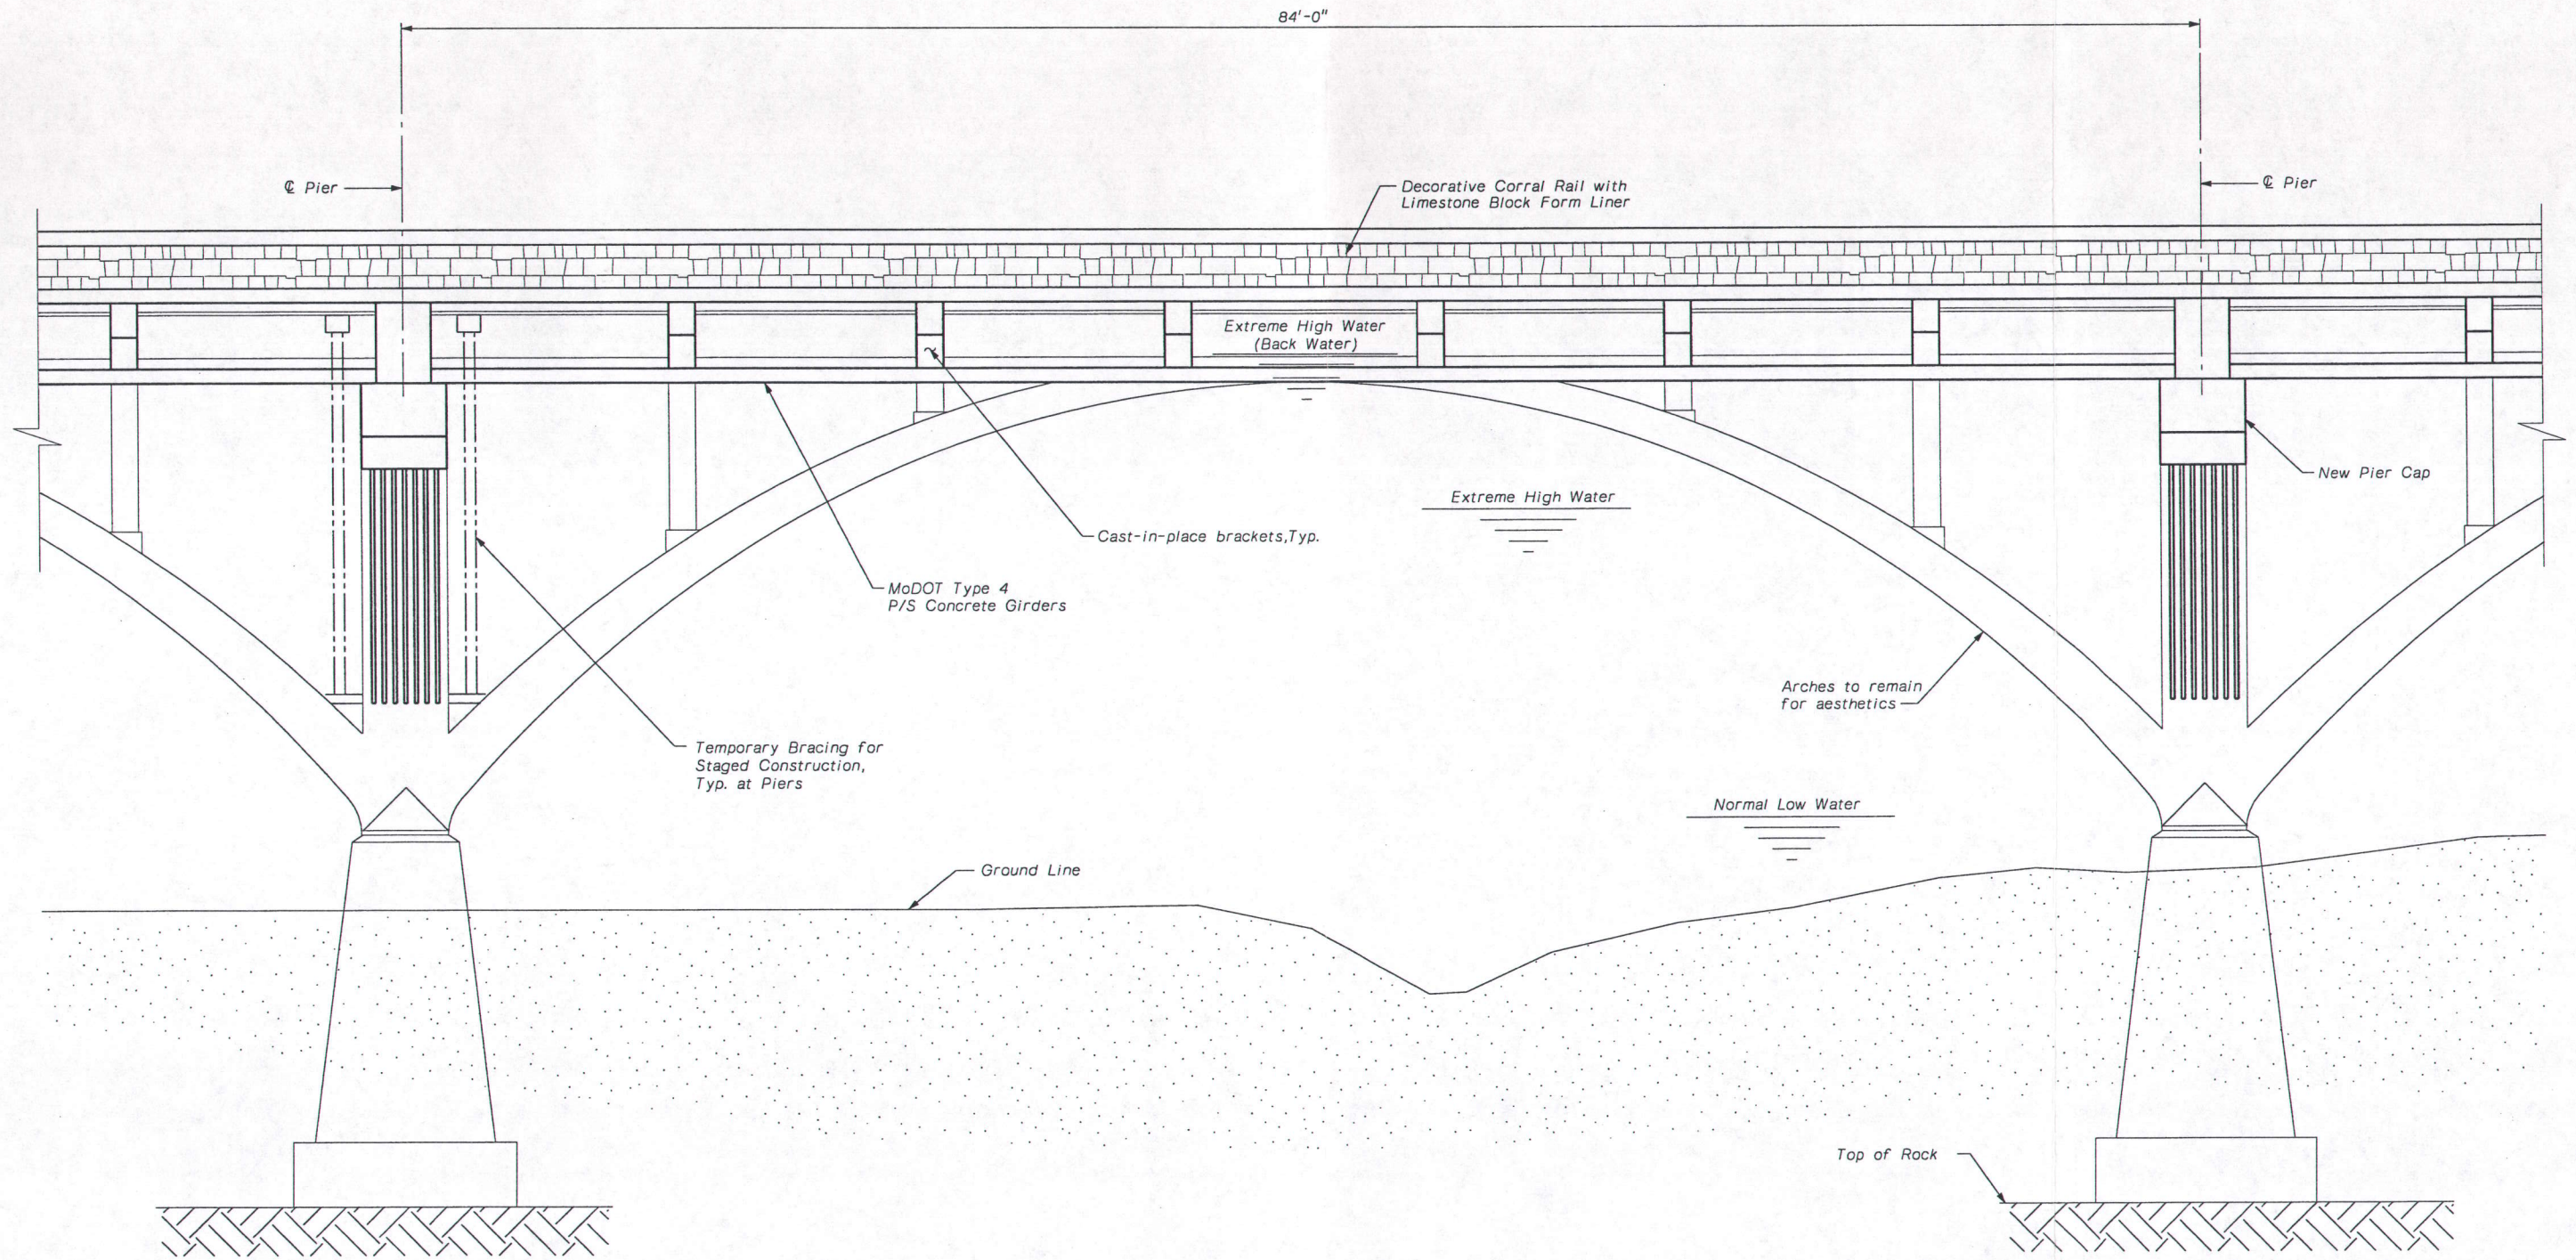
REHAB. WITH P/S GIRDER - ELEVATION
ROUTE 19 SINKING CREEK BRIDGE
Shannon County

ELEVATION

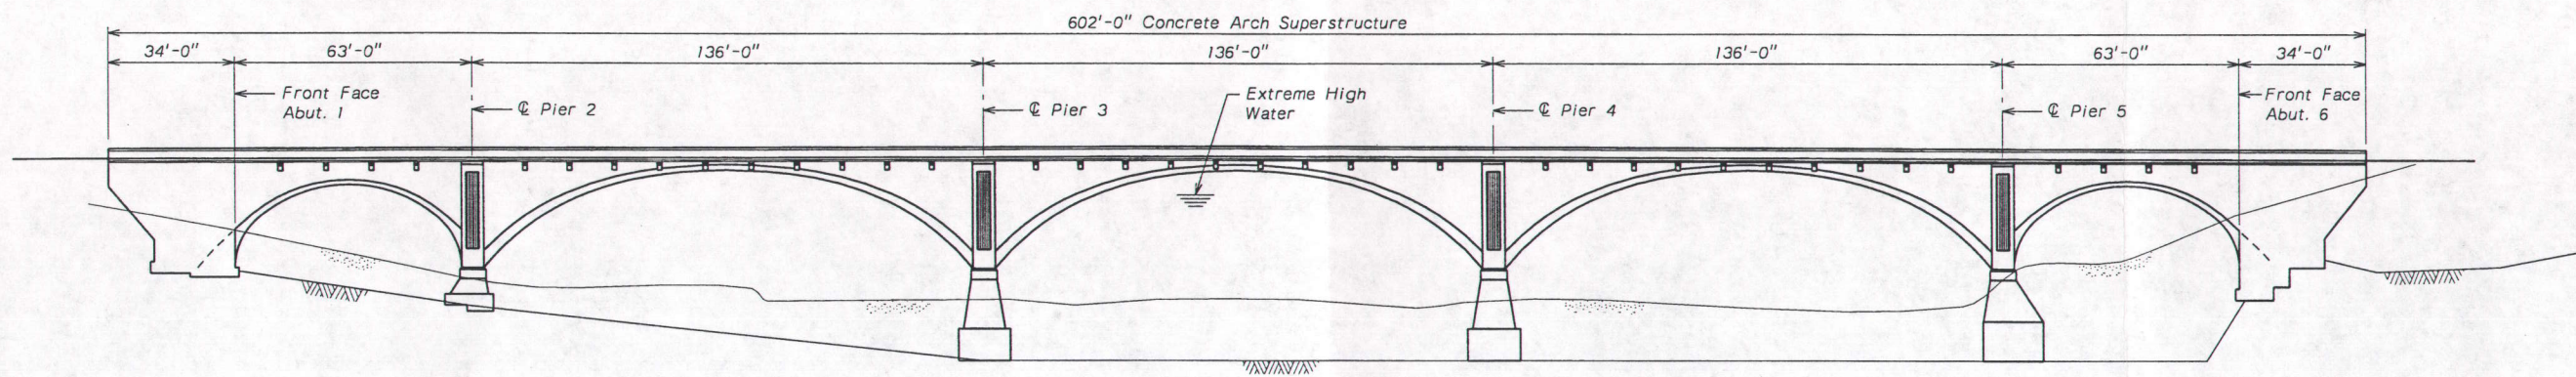
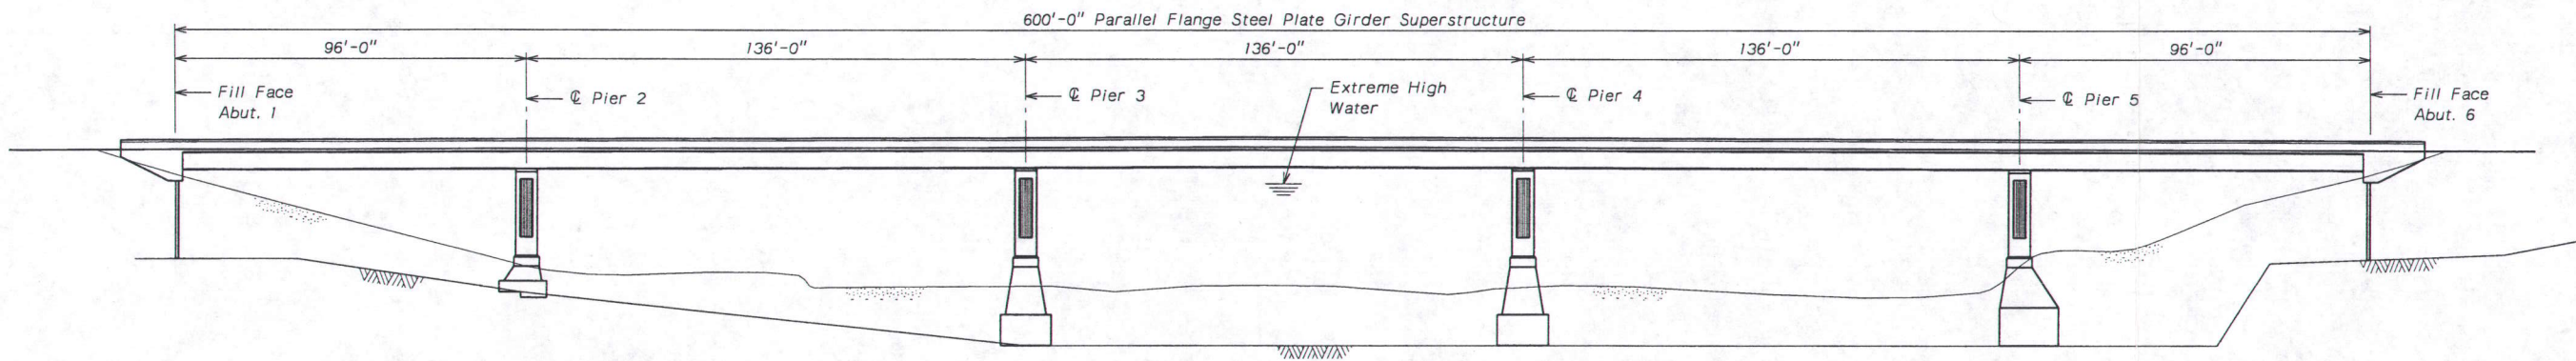
REHABILITATION SPAN LAYOUTS
 ROUTE 19 CURRENT RIVER BRIDGE
 Shannon County

Concrete Arch Alternate

Note: Rehabilitate, Reconstruct and Preserve Existing Arch.

Steel Plate Girder Superstructure Alternate

Note: Utilizes Existing Piers 2 - 5

Another possibility, shown in the exhibit drawings, utilizes parallel flange girders and re-use of the existing piers. This widening concept involves constructing a steel bridge immediately adjacent to the existing bridge, removing the arch bridge, constructing new pier caps on the existing piers, and using new steel girders to replace the arch

spans. Steel girder segments can be offloaded from the adjacent roadways. This option was considered to reduce foundation costs, however, the appearance of the existing bridge is not maintained.

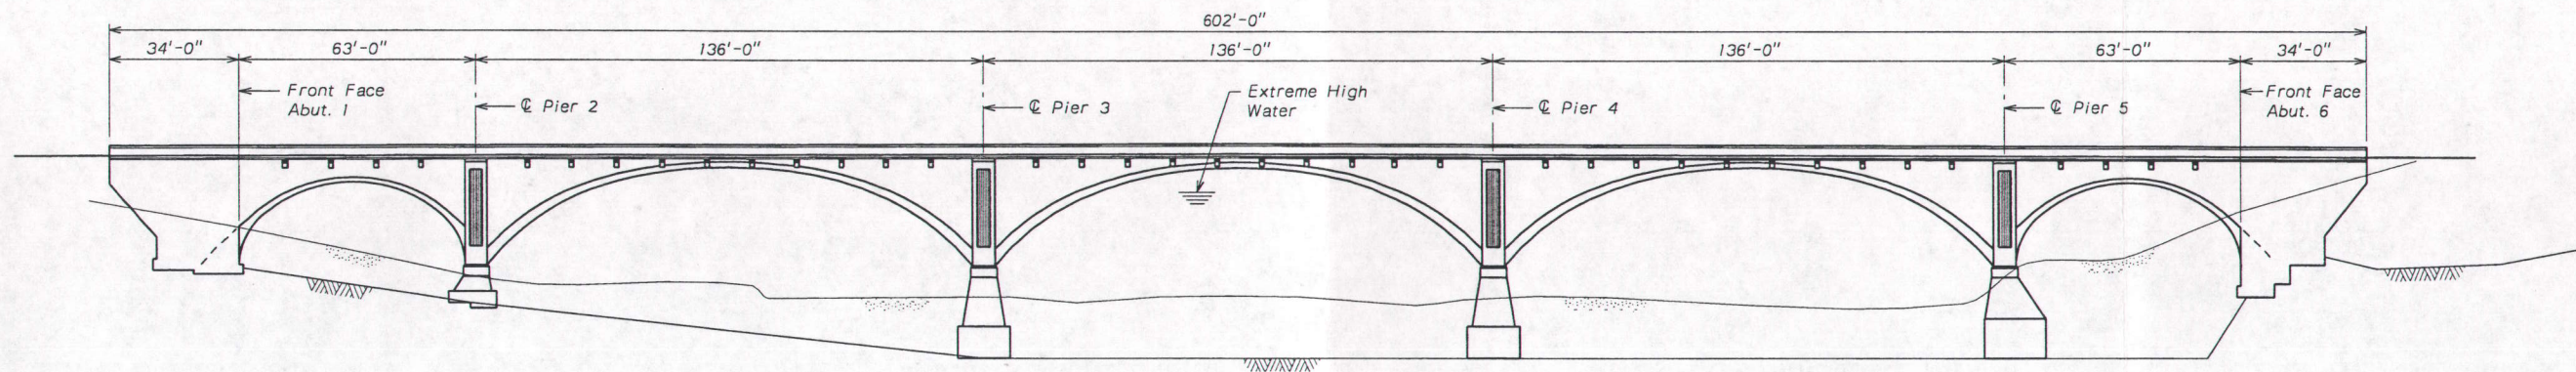
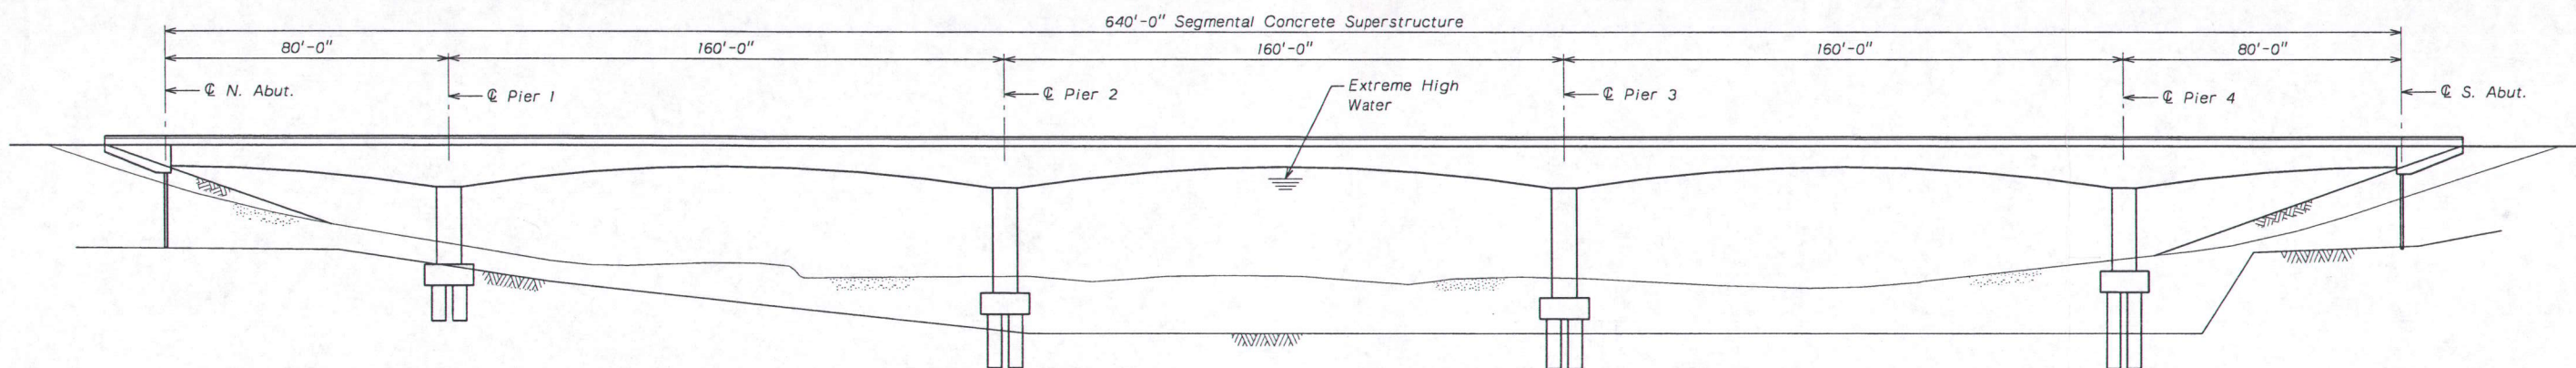
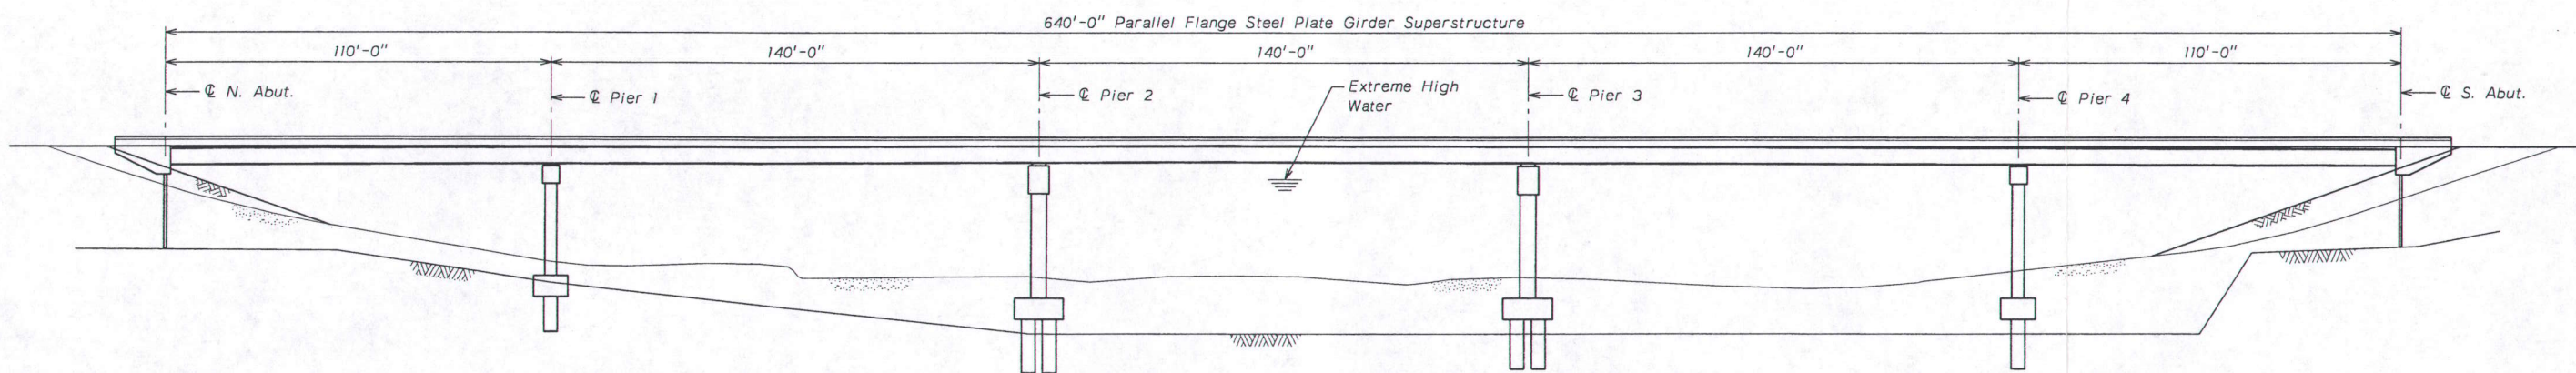
REALIGNMENT SPAN LAYOUTS
ROUTE 19 CURRENT RIVER BRIDGE
Shannon County

Existing Concrete Arch

Segmental Concrete Superstructure Alternate

Steel Plate Girder Superstructure Alternate
(Haunched Steel Plate Girder Similar)

Replacement of the arch bridge with a haunched segmental concrete box girder structure presents an attractive replacement possibility. The graceful shape of the segmental box approximates the shape and appearance of the existing filled arch. Balanced cantilever construction allows the entire superstructure to be constructed from above with minimal impact to the river valley. Slender piers can be constructed on drilled shaft foundations to minimize excavation within the river. Depth of haunches at the piers can be exaggerated to emphasize the arch shape of the new bridge.

Replacement of the existing arches with a steel girder bridge was also investigated. A new steel structure, utilizing haunched welded plate girders, can be built with the span arrangement and alignment described above for the segmental concrete alternate. The segmental concrete alternative provides a more attractive match to the existing bridge and is further developed in the exhibit drawings.

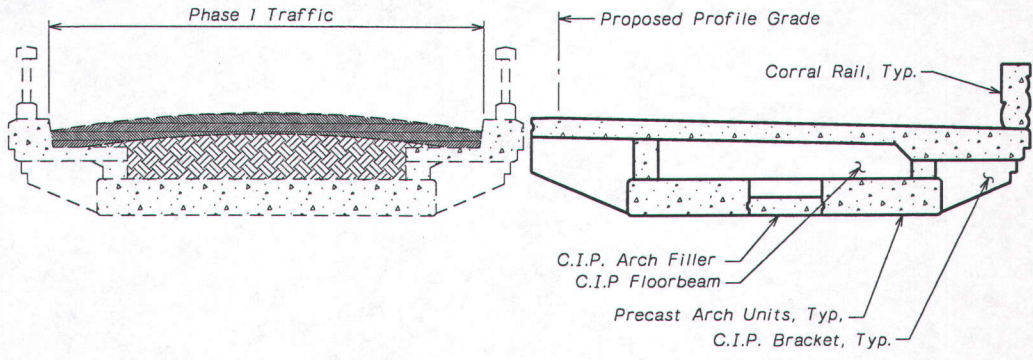
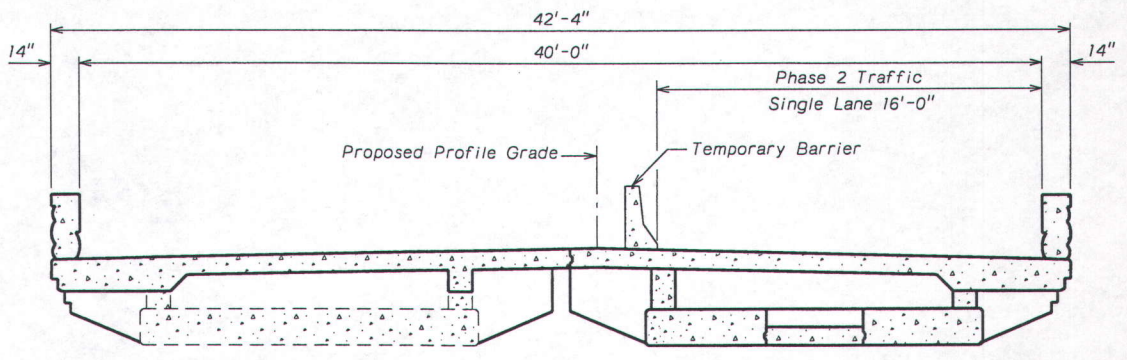
SECTIONS NEAR CENTER OF ARCH
 ROUTE 19 CURRENT RIVER BRIDGE
 Shannon County

Phase 1

Phase 2

--- Existing
 ——— New Construction

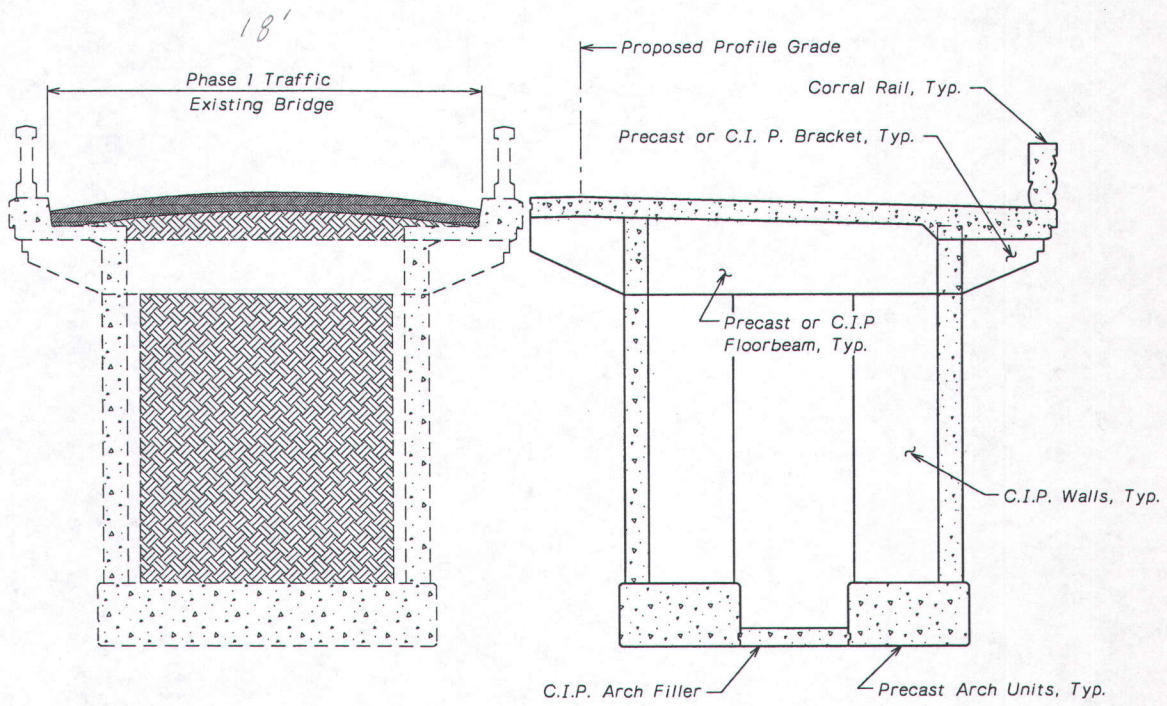
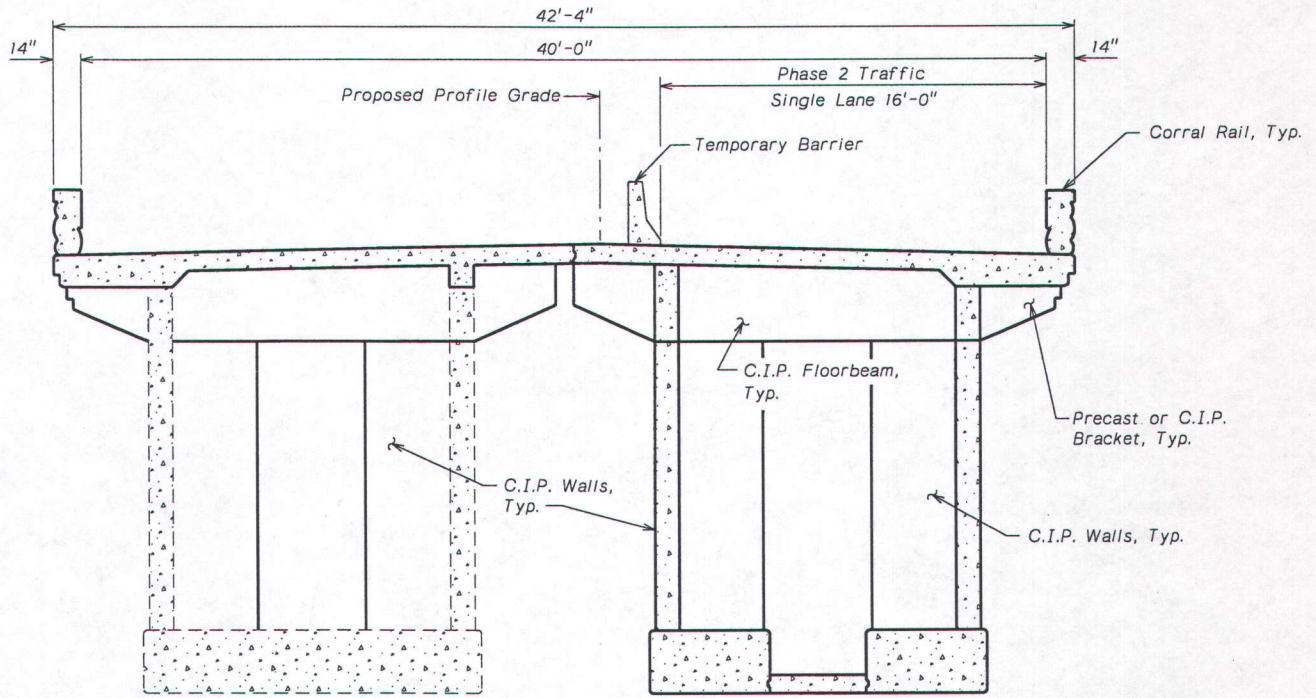
SECTION NEAR SPRINGING LINE
ROUTE 19 CURRENT RIVER BRIDGE
 Shannon County

Phase 1

Phase 2

--- Existing
 ——— New Construction
