**Appendix A: Bridge Rehabilitation and Reconstruction
Alternatives**

Re : Bridge Rehabilitation - H&C Response to Comments
Job No. : J9P0436, J9P0437 and J9P0438
Route : 19
County : Shannon
HCI No. : 10180-00

Re : Bridge Rehabilitation or Reconstruction Alternatives
Environmental Impact Study, Bridges G-804A, J-420, H-79
Rte 19, Shannon County

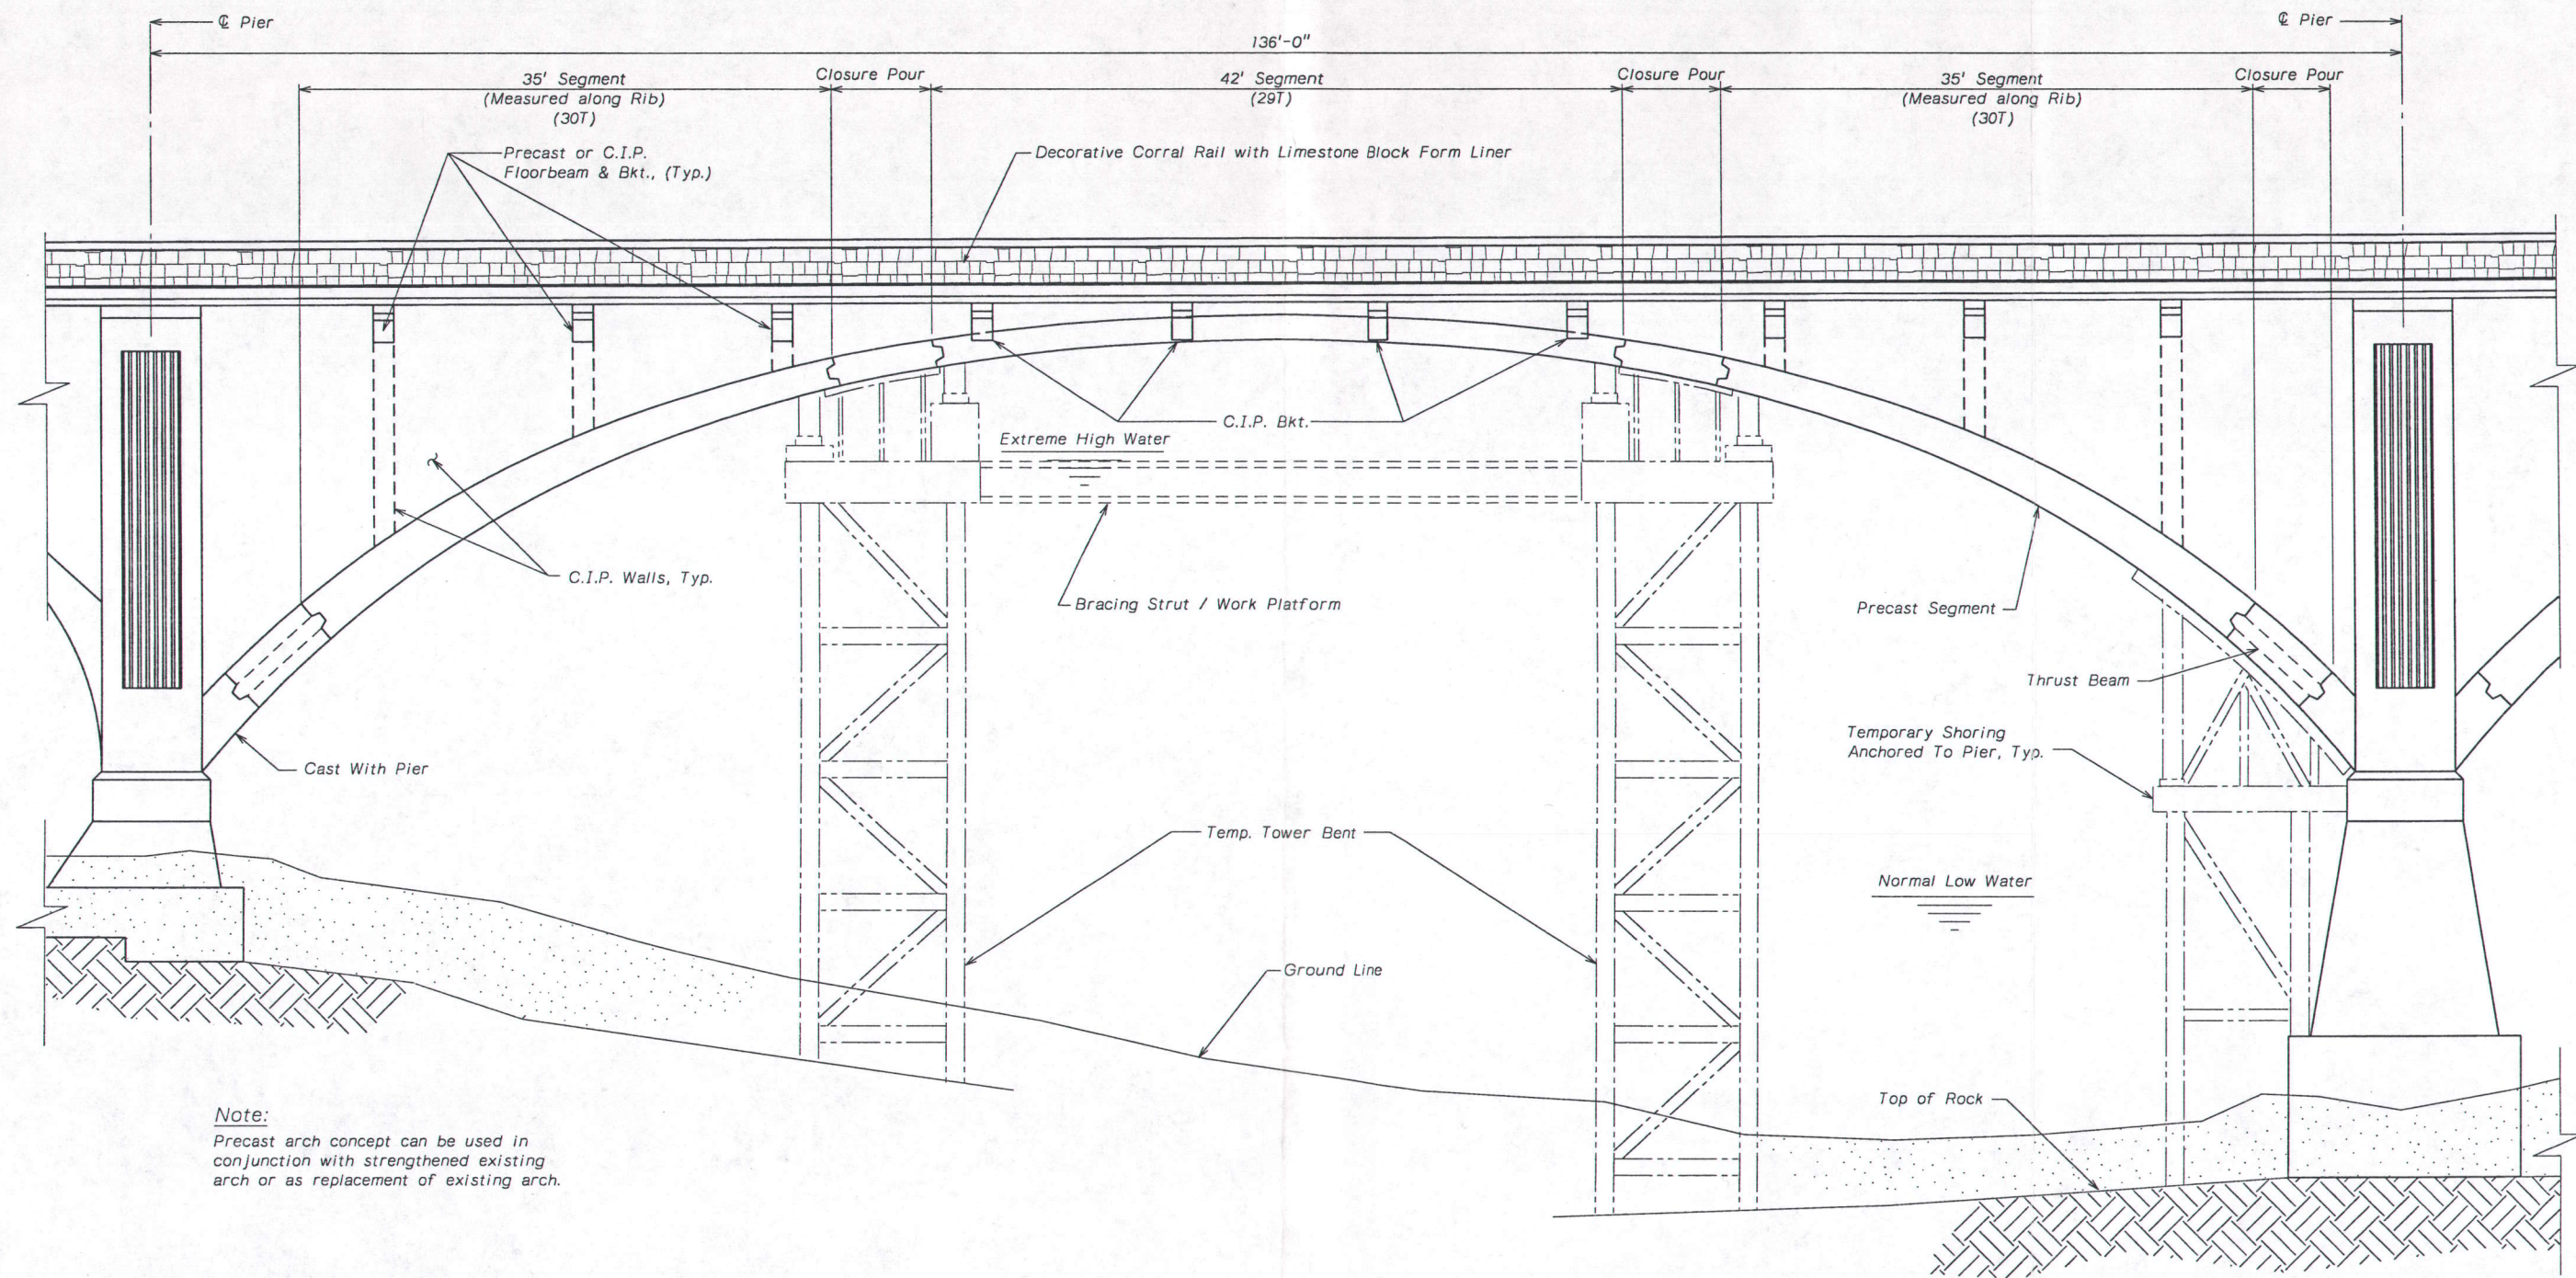
TYPICAL ELEVATION
 ROUTE 19 CURRENT RIVER BRIDGE
 Shannon County

Note:
 Precast arch concept can be used in
 conjunction with strengthened existing
 arch or as replacement of existing arch.

Reconstruction of the arch spans can be accomplished utilizing precast concrete arch segments and the existing foundations. A new arch rib can be constructed to replace the existing arch, similar to the precast concept described in the rehabilitation section above. Replacement of the arch and superstructure would occur after construction of the new widening. Traffic handling would be similar to the rehabilitation scheme. Additional reinforcement, doweled into the existing piers, would be required prior to closure pours.

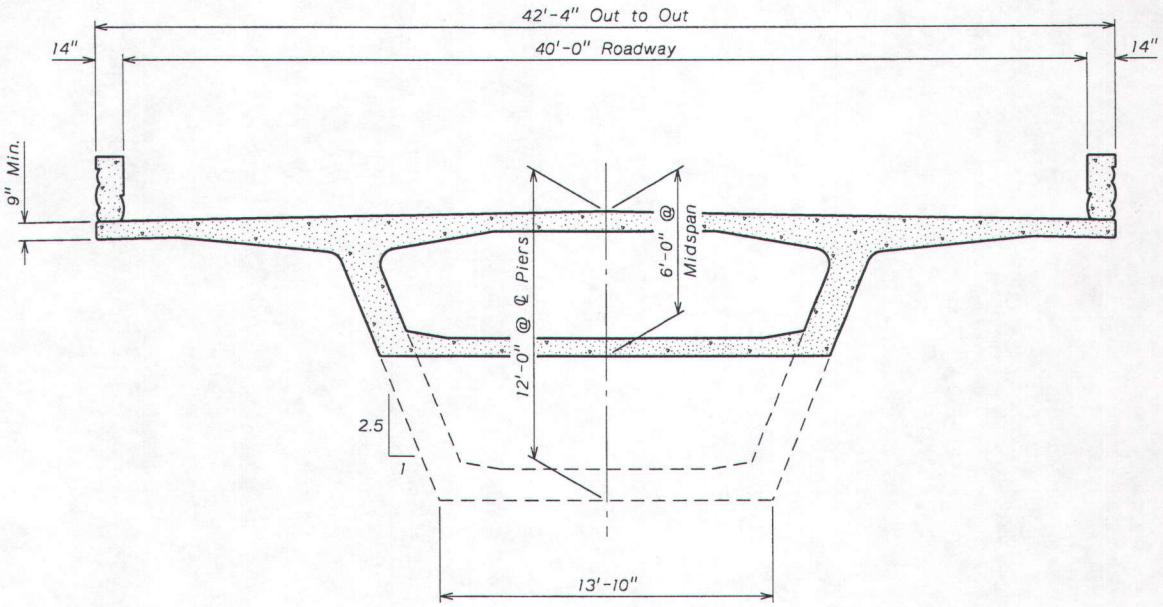
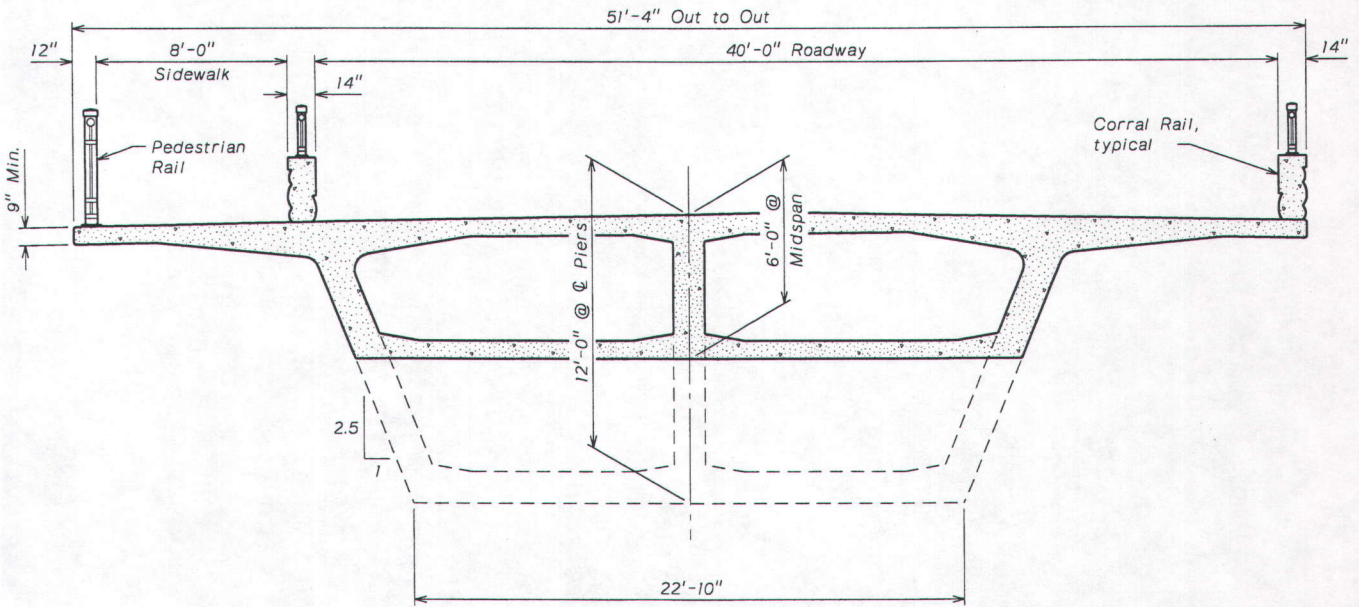
SEGMENTAL CONCRETE SECTIONS
ROUTE 19 CURRENT RIVER BRIDGE
Shannon County

TYPICAL SECTION
(without sidewalk)

TYPICAL SECTION
(with sidewalk)

Note:
Design box for additional effects of eccentricity, or consider two 6' sidewalks.

Replacement of the arch bridge with a haunched segmental concrete box girder structure presents an attractive replacement possibility. The graceful shape of the segmental box approximates the shape and appearance of the existing filled arch. Balanced cantilever construction allows the entire superstructure to be constructed from above with minimal impact to the river valley. Slender piers can be constructed on drilled shaft foundations to minimize excavation within the river. Depth of haunches at the piers can be exaggerated to emphasize the arch shape of the new bridge.

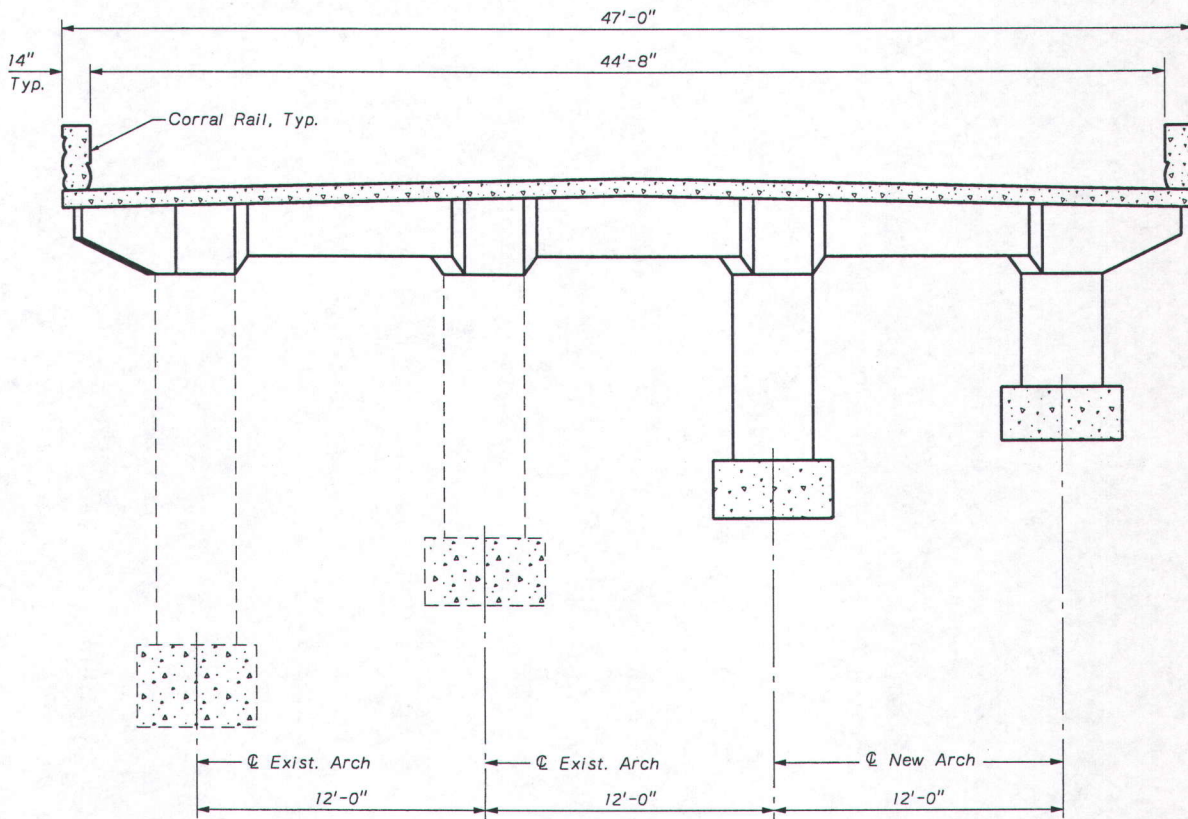
SECTION THRU ARCH SPAN
 ROUTE 19 SPRING VALLEY BRIDGE
 Shannon County

Final Roadway Section

--- Existing
 ——— New Construction

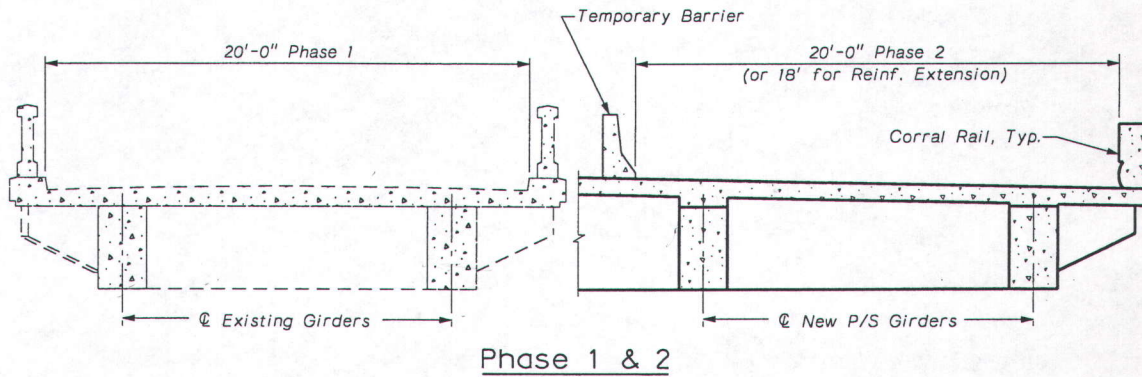
SECTIONS THRU APPROACH ROADWAY
ROUTE 19 SPRING VALLEY BRIDGE
 Shannon County

--- Existing
 ——— New Construction
