J6I3290
BRIDGE REHABILITATION
I-55 OVER MERAMEC RIVER
2026-2027

STAGE 3

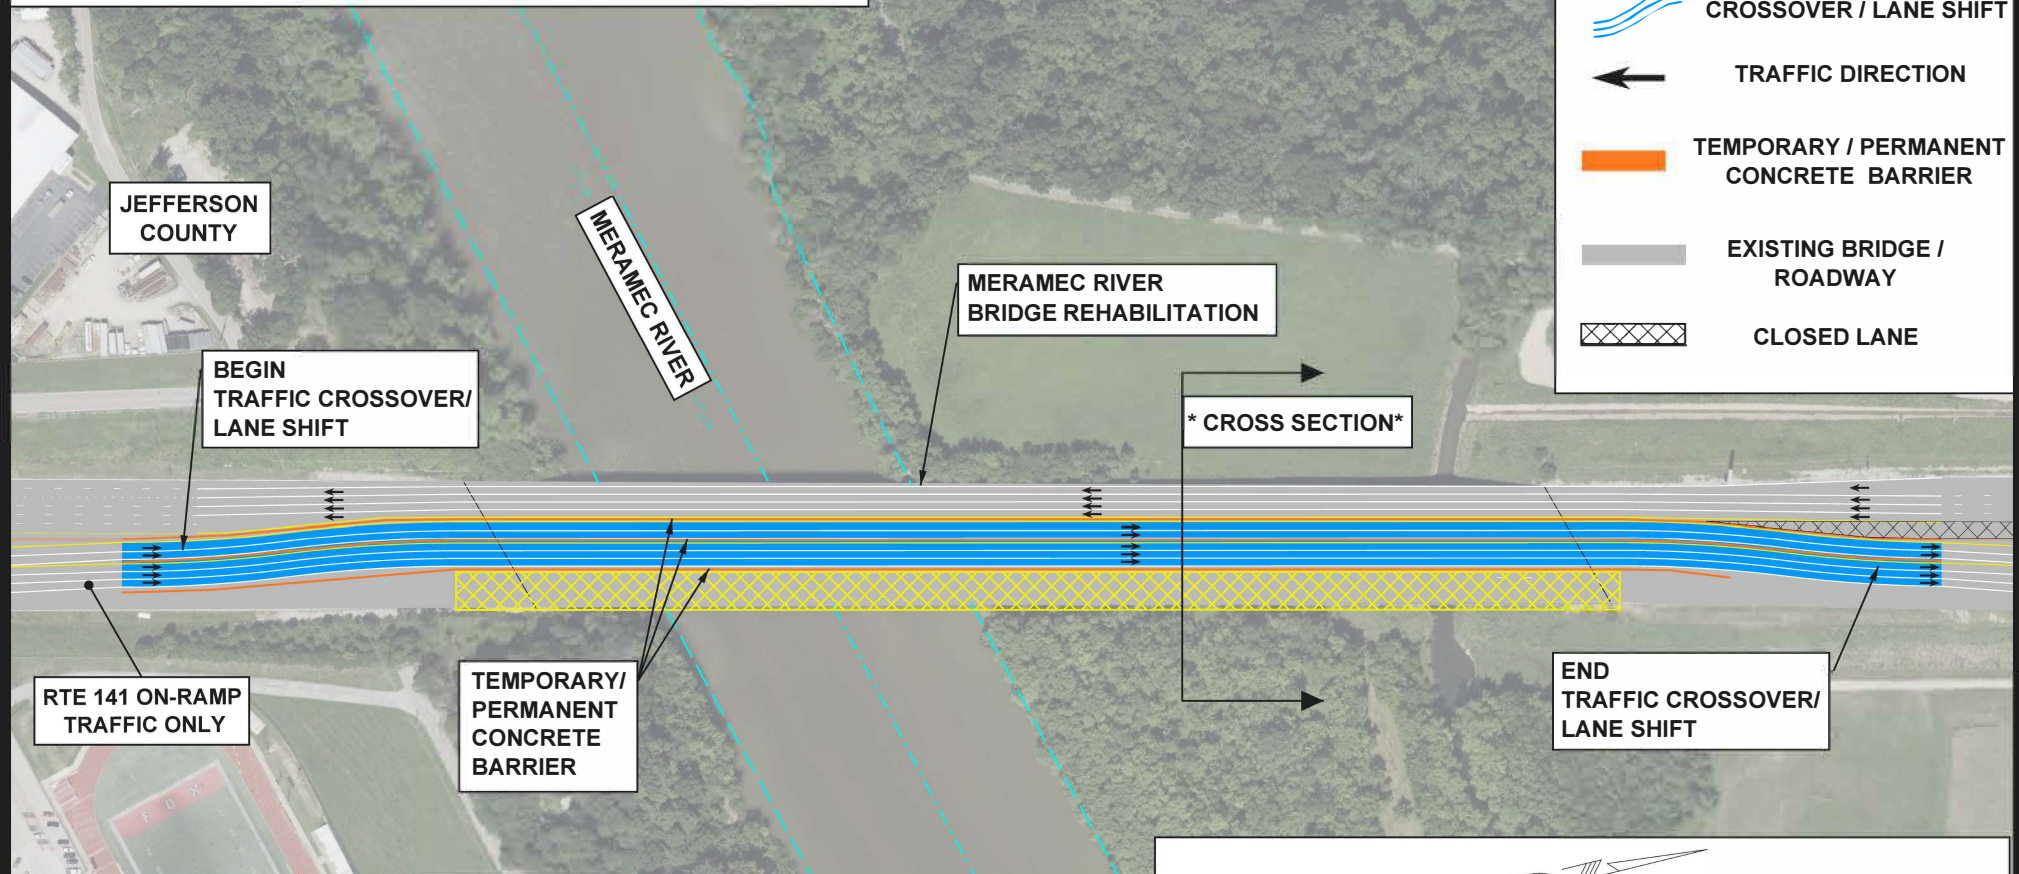
DURING THE EAST PORTION OF THE MERAMEC RIVER BRIDGE CLOSURE:

- THREE (3) NORTHBOUND LANES WILL REMAIN ON THE EASTERN SECTION OF THE BRIDGE
- AN ADDITIONAL TWO (2) NORTHBOUND LANES WILL CROSS OVER ONTO THE SOUTHBOUND MERAMEC RIVER BRIDGE
- FOUR (4) SOUTHBOUND LANES WILL REMAIN OPEN ON THE BRIDGE

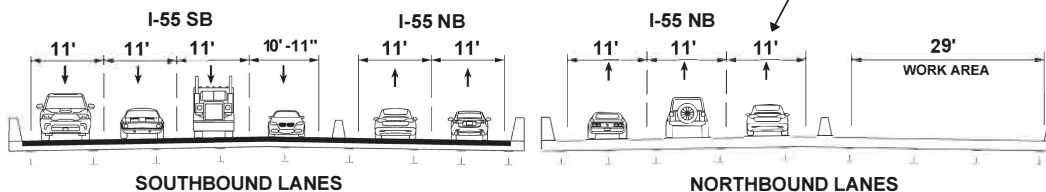
CROSS SECTION

STAGE 3

RTE 141 ON RAMP TRAFFIC ONLY
