# BRIDGE REHABILITATION / REPLACEMENT ALTERNATIVES STUDY REPORT

Route 19 over Current River and Spring Valley  
(Project No. J9P3305)

Bridges No. G0804 and J0420

October 2019

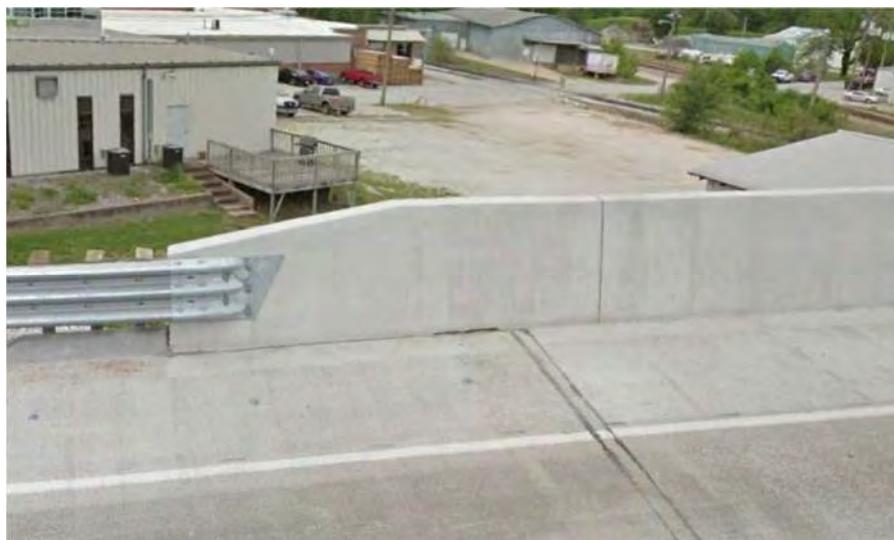
One option for the replacement of the bridge rail is the MoDOT Type D barrier curb. This is a 42 inch tall concrete barrier with a single sloping front face. It is the standard barrier curb used on most new construction in the state at this time. The height of this barrier combined with the solid face will limit the sight of the traveling public. The appearance of this barrier curb is a departure in form compared to the existing rail. A formliner pattern can be applied to the back side of this barrier only. This barrier curb is the least cost option considered for this project at approximately \$105 per linear foot if formliner is not used. A typical view of this type of barrier can be seen in Figure 8-4.

**Figure 8-4. MoDOT Type D Concrete Barrier Curb**

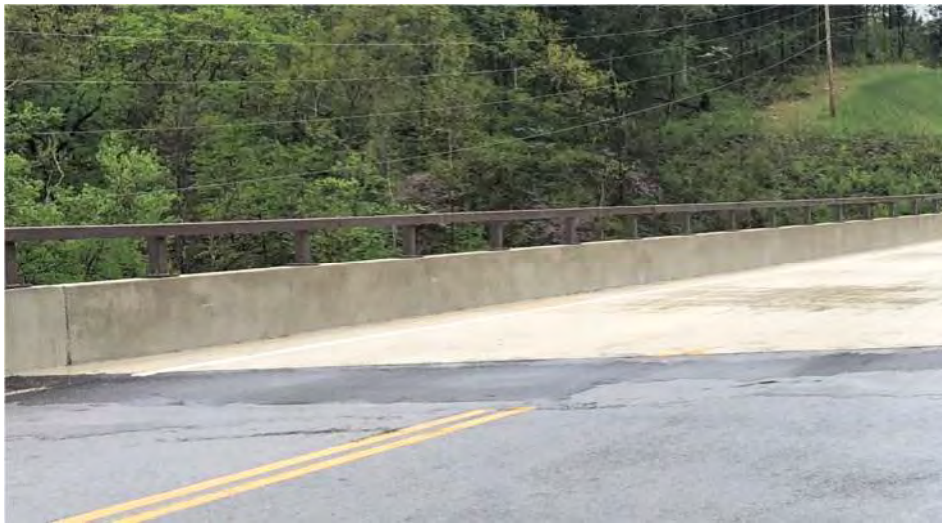
This bridge rail option consists of a 24 inch tall concrete barrier with an 18 inch tall single steel tube rail bolted to the top. This barrier is in place on the bridge carrying Route 19 over Sinking Creek. The overall height of the barrier / railing is 42 inches, but the open rail allows improved site lines from the bridge. The appearance of this barrier curb is a departure from the existing rail but matches the other bridge in the historic district on this route. A formliner pattern can be applied to the back side of this barrier only and a broken fin type pattern was used on the bridge over Sinking Creek. The average bid for this barrier and rail in January 2017 was \$190 per linear foot plus the cost of formliner. This rail was used in the cost estimates shown in Section 9 and a unit cost of \$200 per linear foot for the concrete barrier and rail combination was assumed. Views of this type of barrier in place on the bridge over Sinking Creek can be seen in Figure 8-5 and Figure 8-6.

**Figure 8-5. Vertical Concrete Barrier and Steel Tube Rail – Front Face**

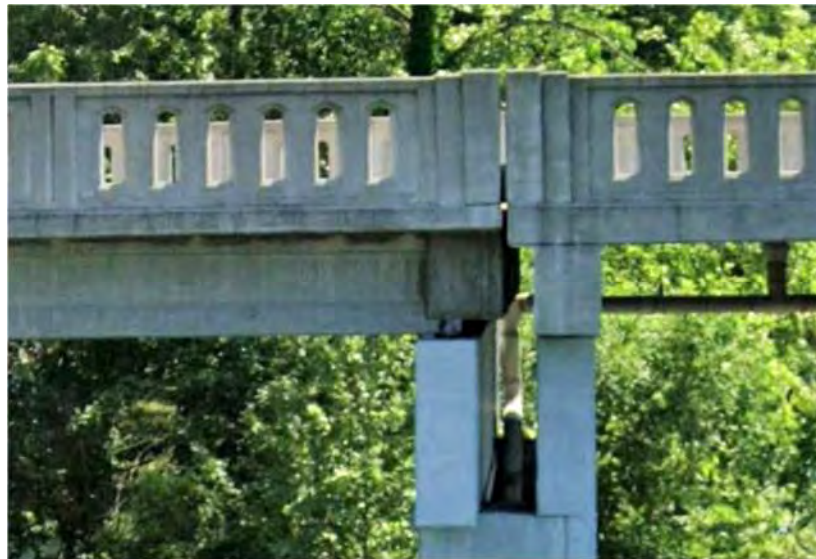
**Figure 8-9. Open Concrete Curb and Rail with Concrete Posts – Back Face**

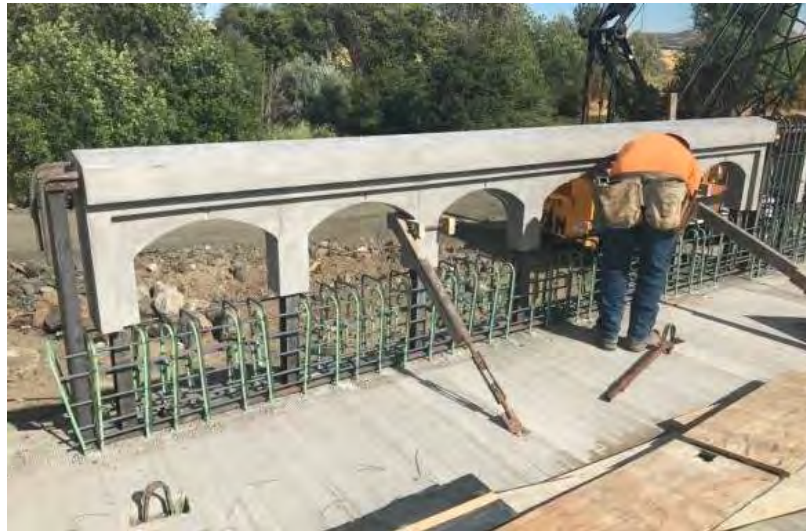
Recently, the Oregon DOT replaced some historic rail on a bridge in the Columbia River Highway District using a “stealth” rail. The rail consisted of a structural steel rail connected to the bridge deck surrounded by a precast concrete shell formed to mimic the shape of the existing bridge rail. The rail they utilized met design standards for safety and was designed for a TL-4 loading but was not crash tested. To remove snag hazards in the original bridge rail configuration, various shadow lines were included in the new rail and a continuous curb was included along the bottom to increase safety. ODOT is in the process of having their stealth rail design crash tested at a research facility in Texas. A “stealth” rail configuration similar to the existing bridge rail could be designed for this project. The thin spindles of the existing bridge rails may limit the effectiveness of this approach. The cost of this rail option was not available during preparation of this report but is expected to exceed the other options considered. Views of the stealth rail used by ODOT can be seen in Figure 8-10 and Figure 8-11.

**Figure 8-10. Oregon DOT Stealth Rail Installation**

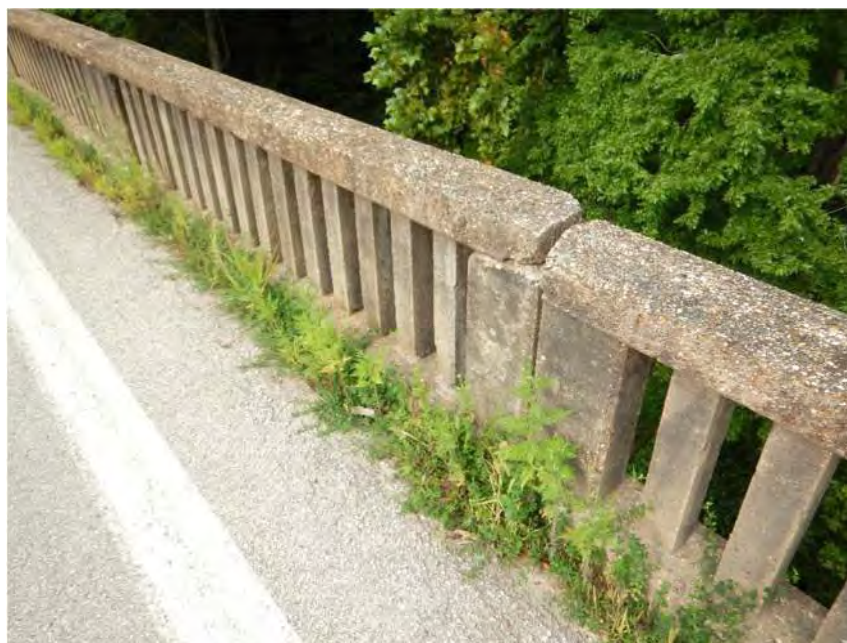
Collision Damage to the Railing

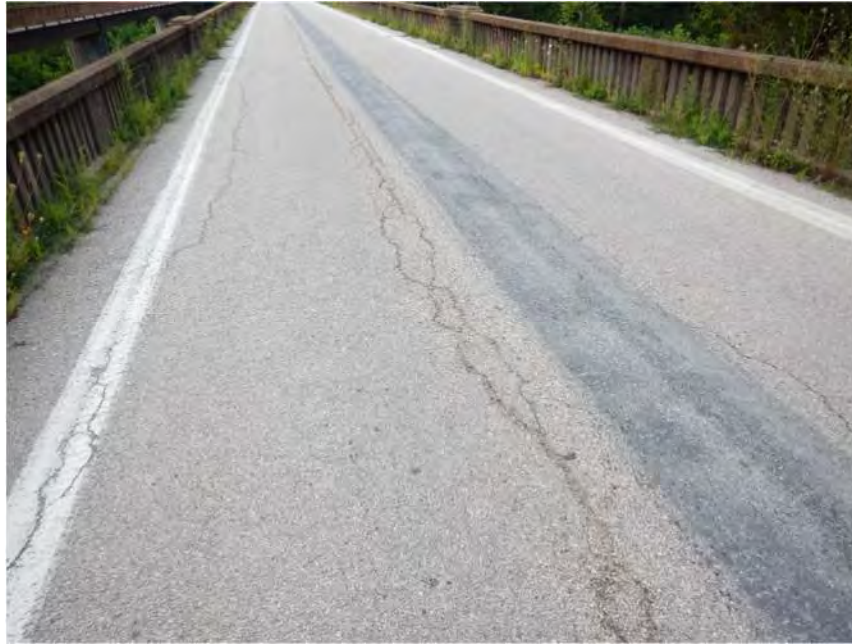
Condition of Wearing Surface

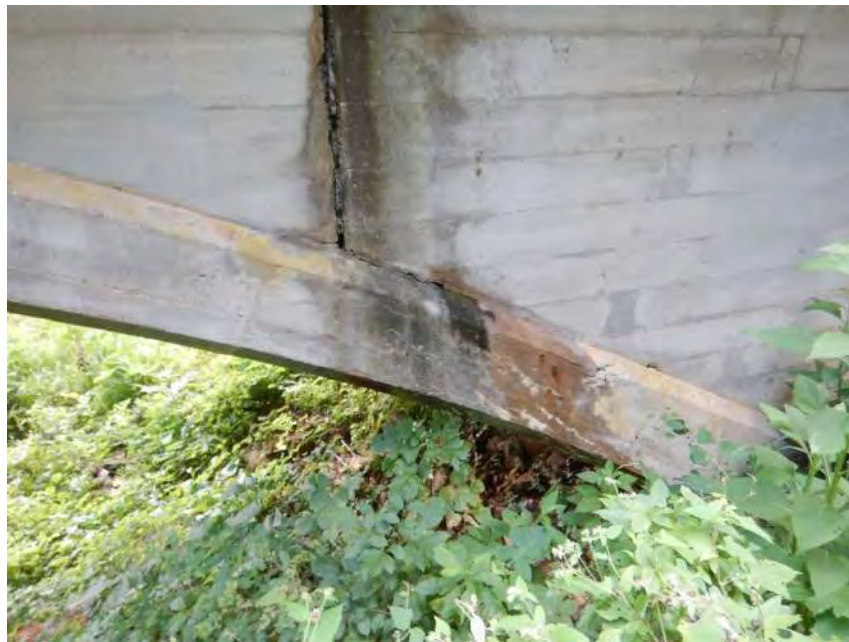
Spalling and Staining on Arch Ring

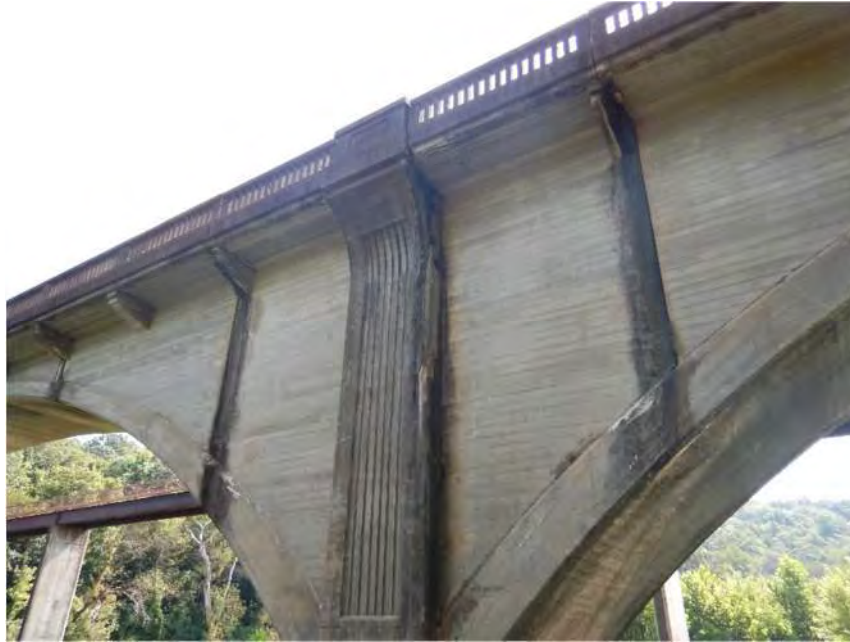
Leakage from Sidewall Joints

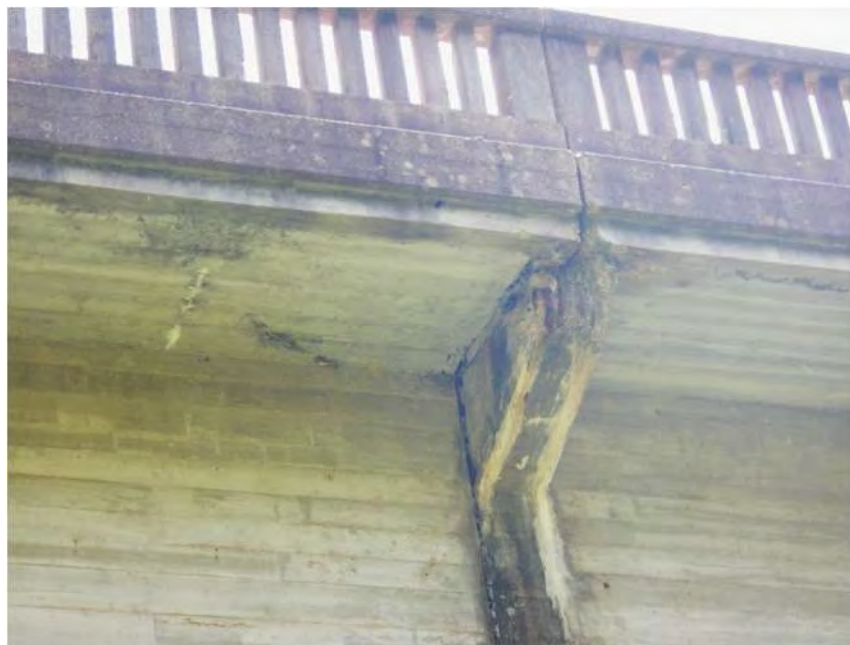
Heavy Deterioration with Loss of Bracket Support Area

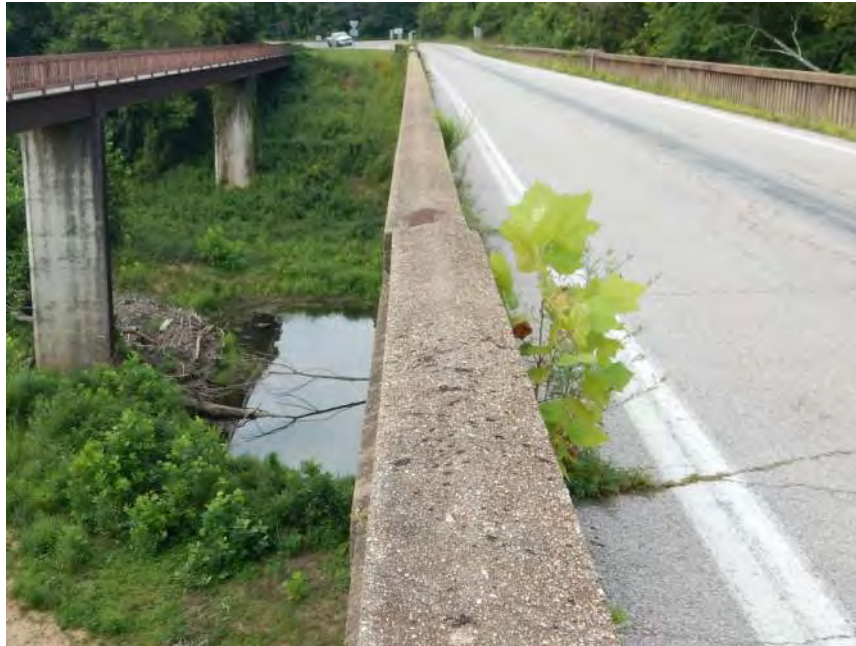
One additional observation on the superstructure was the differential lateral movement between the sidewall sections. The section of sidewall over the pier that extends to each joint is either connected from side to side with a floor beam or there are counterforts on the pier side of the joint. The wall that is on the opposite side of the joint is not likewise supported and appears to have deflected outward on the order of  $\frac{3}{4}$ " per side. This results in a face of barrier dimension approximate  $1 \frac{1}{2}$ " wider than over the pier.

Differential Alignment of Barrier at Joints Adjacent to Pier

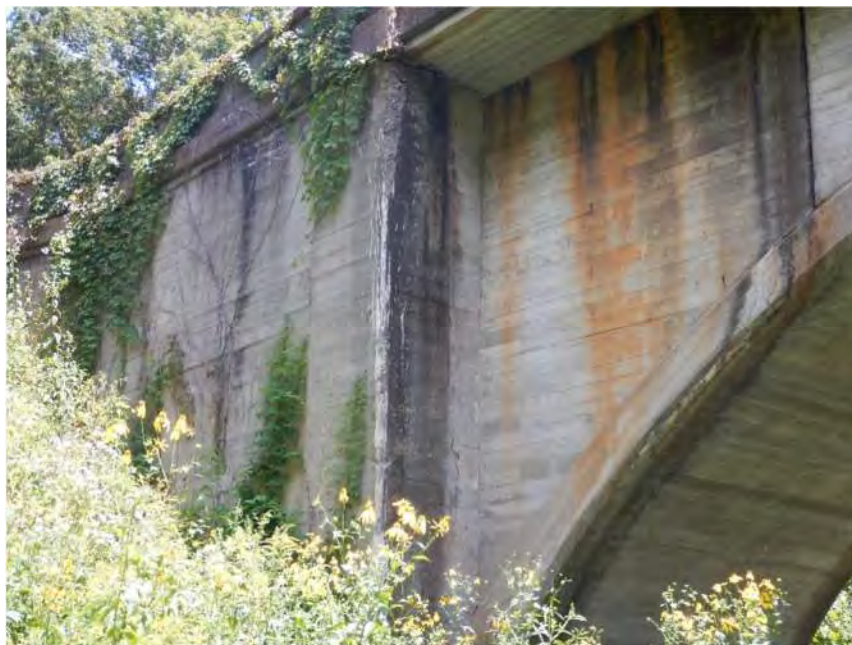
Cracking and Delamination at Abutments

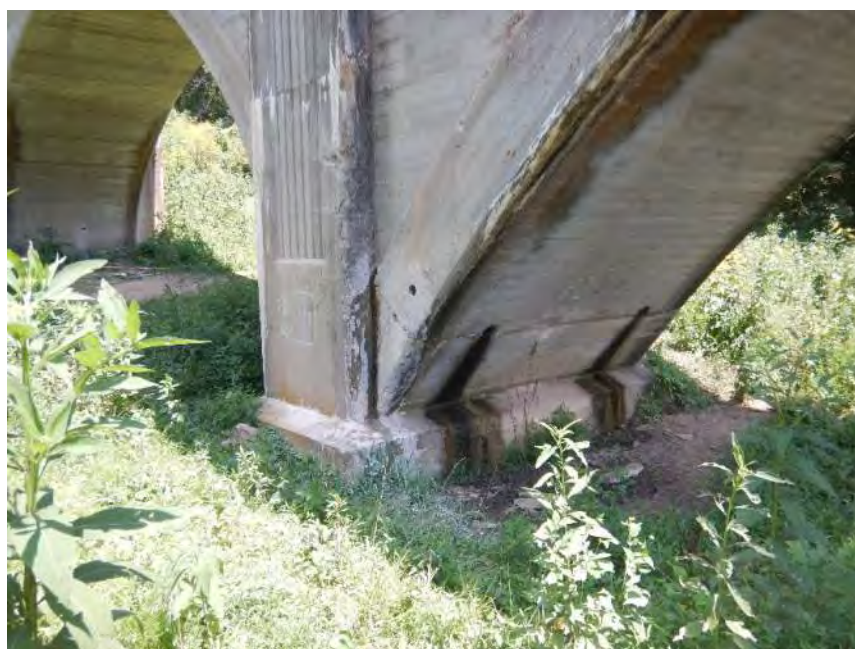
Scaling Along Pier Foundations

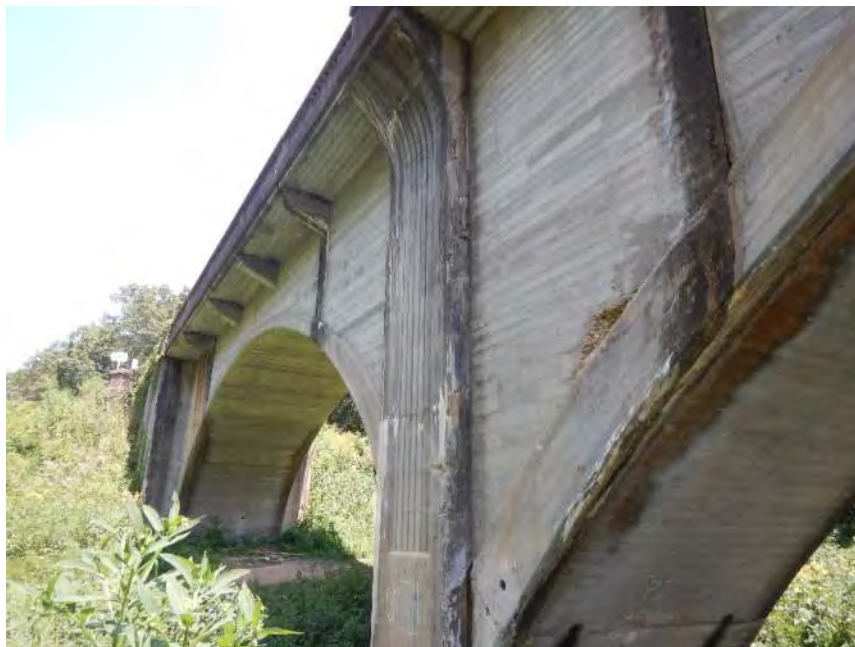
Spalling on Pier Surfaces

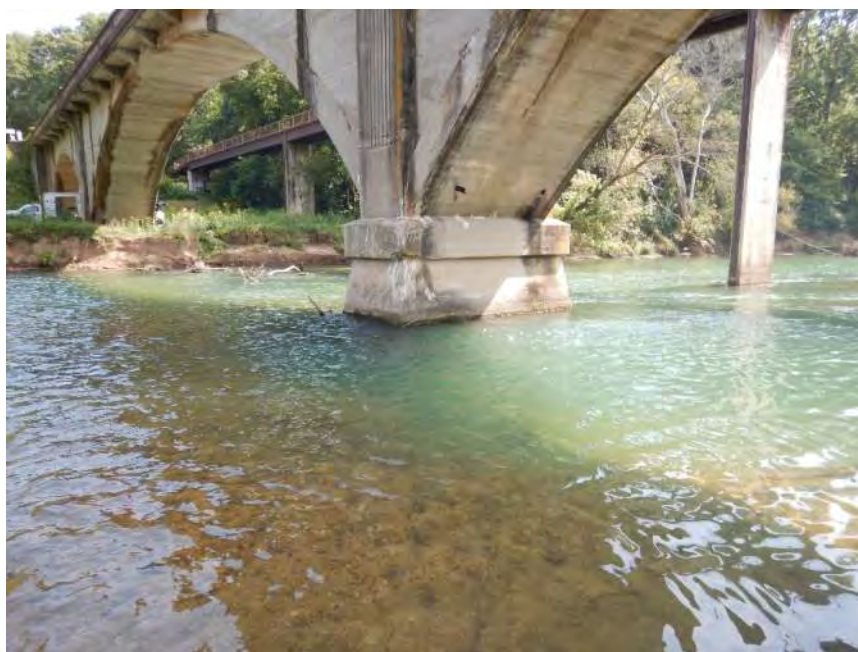
Scour Hole at Pier 3

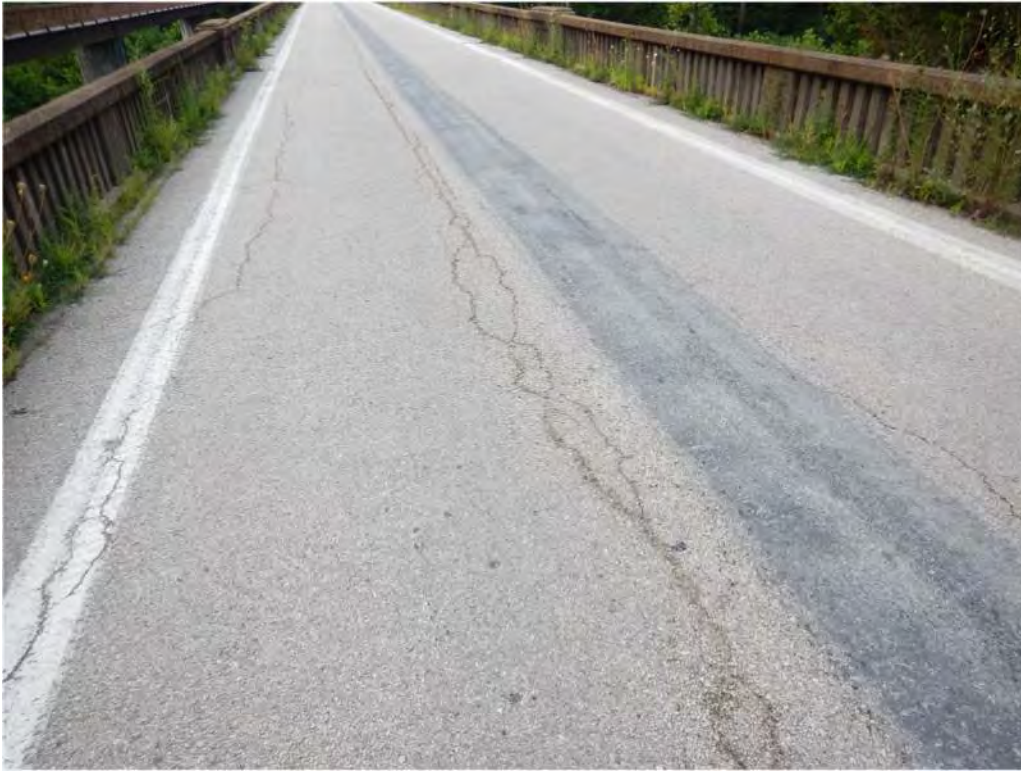
Pic. 002: Typical leakage from sidewall joints

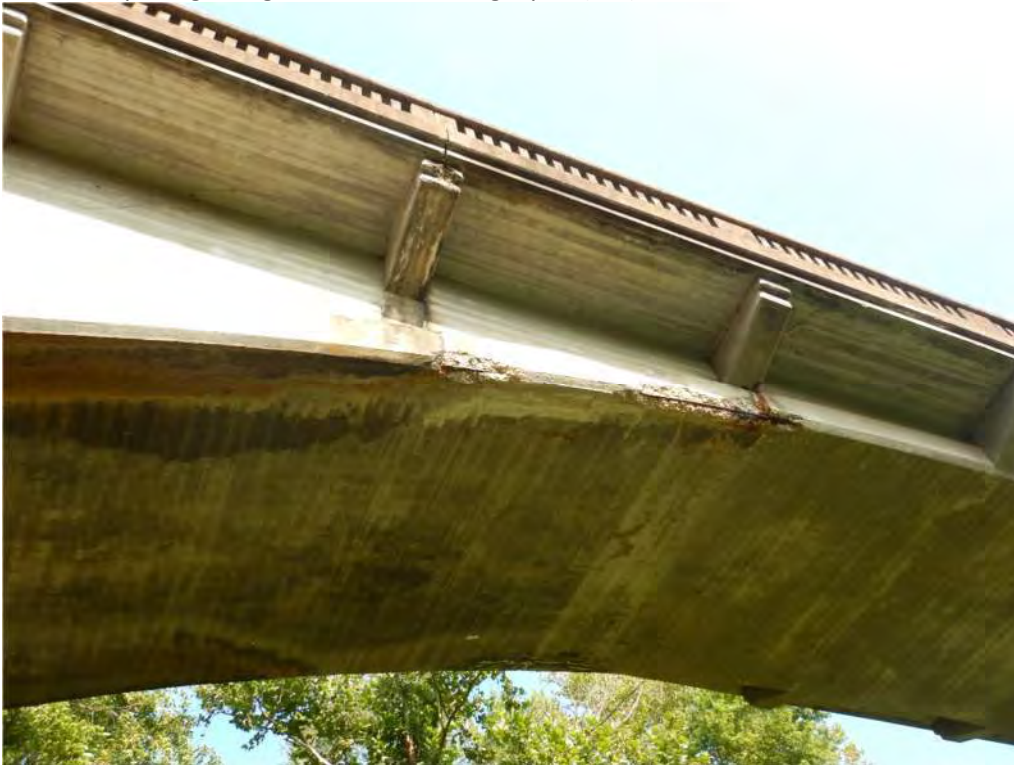
Pic. 006: Spalling along corner of arch ring, Span (4-5) east face

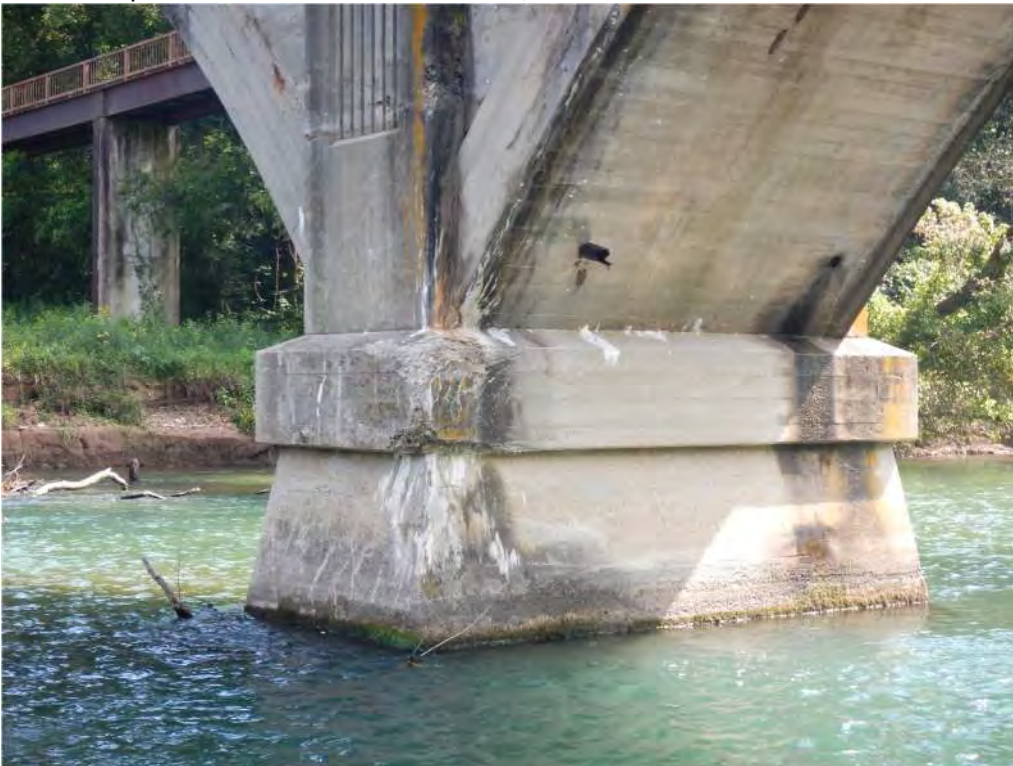
Pic. 009: Spalling and delamination on pilaster, Pier 2 east side

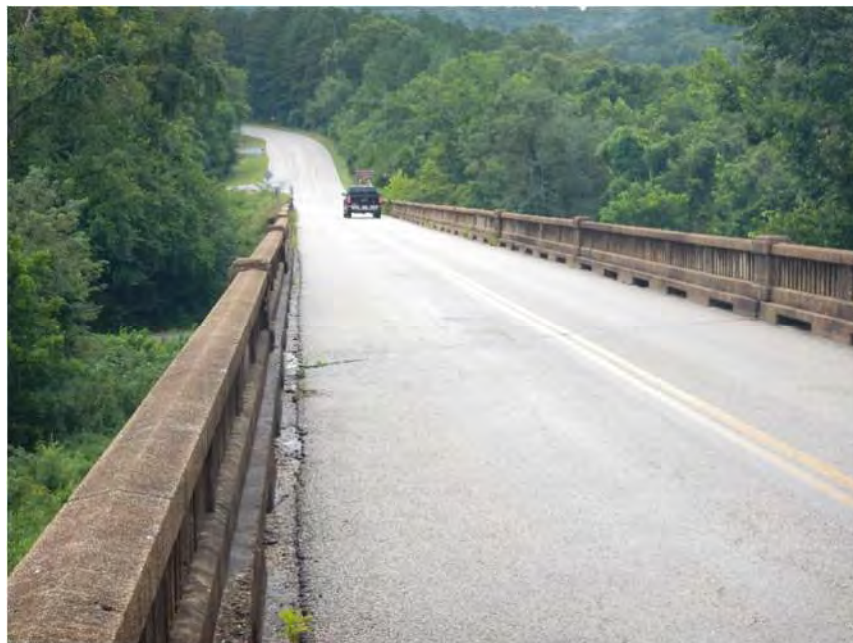
Collision Damage to the Railing

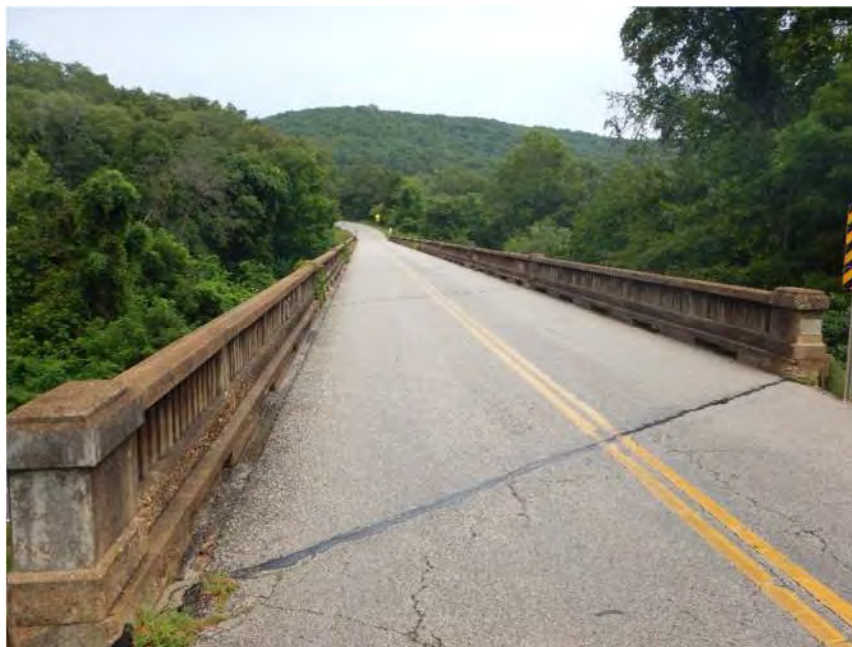
Condition of Wearing Surface

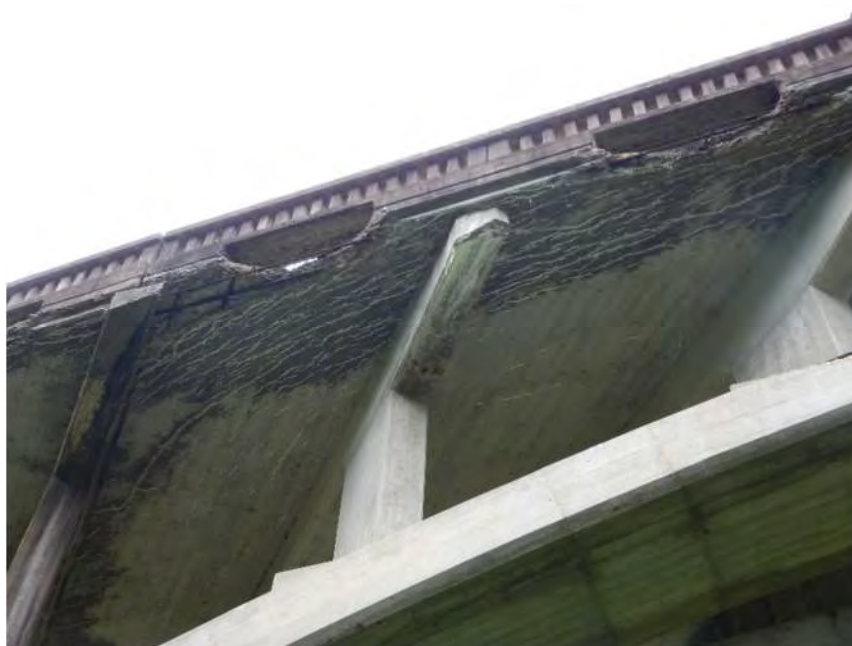
Heavy Deterioration of the Deck at Existing Drains

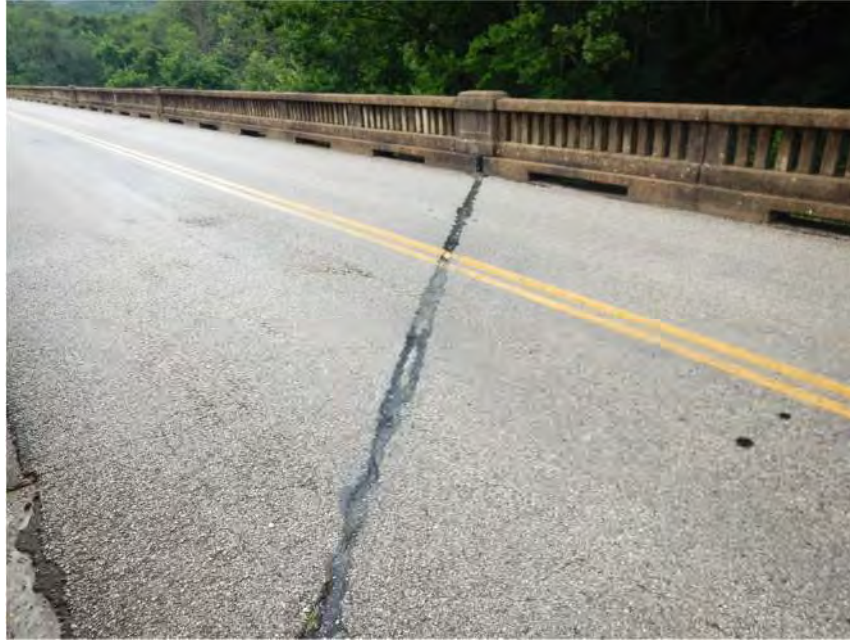
Typical Slab Expansion Joint

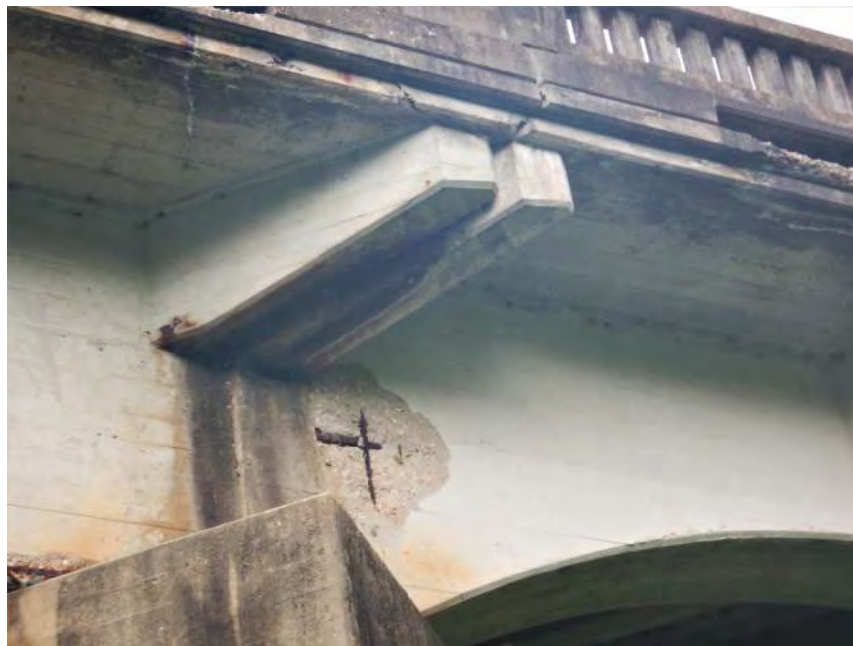
Typical Delamination on Girders

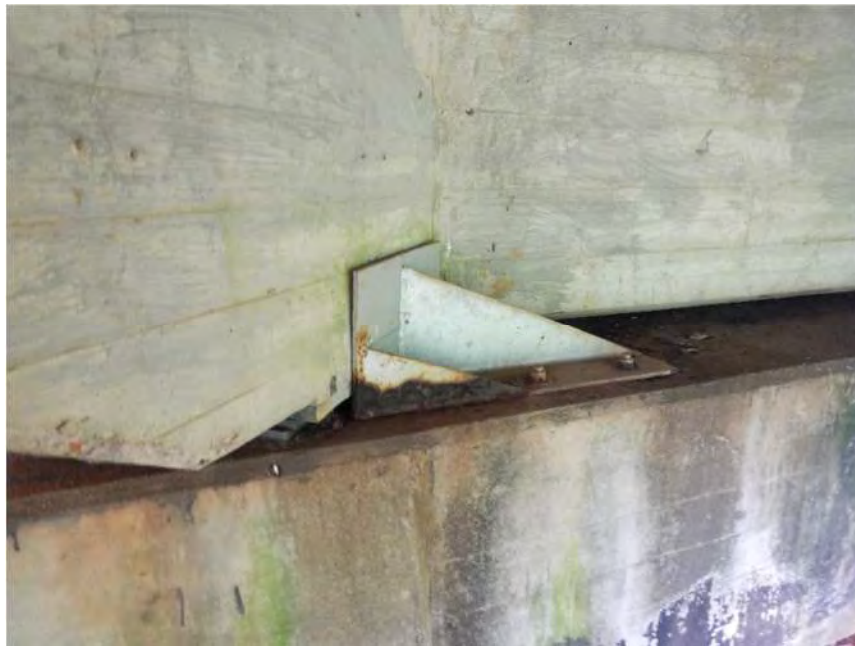
Typical Girder Restraint Bracket

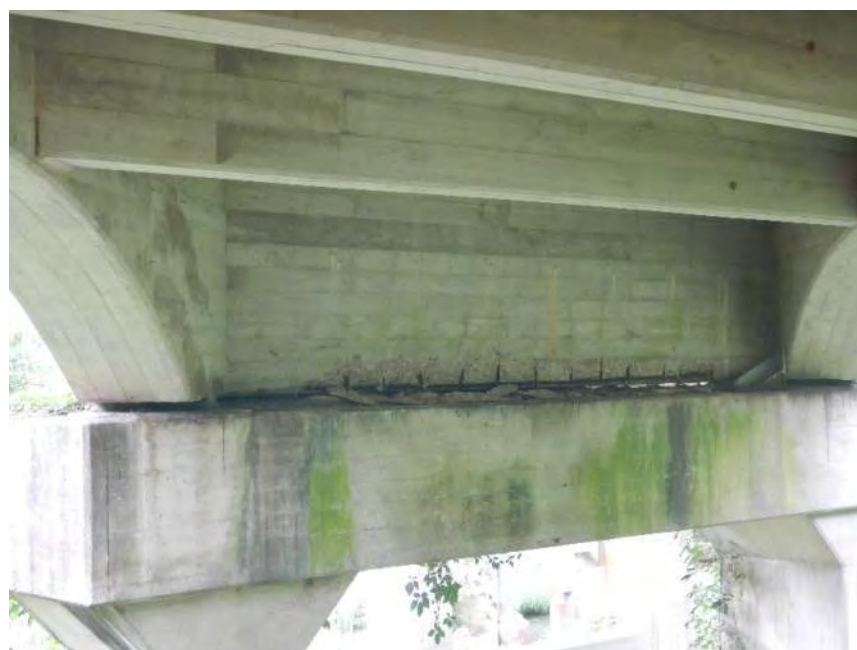
Deterioration of Floorbeams at Intermediate Bents

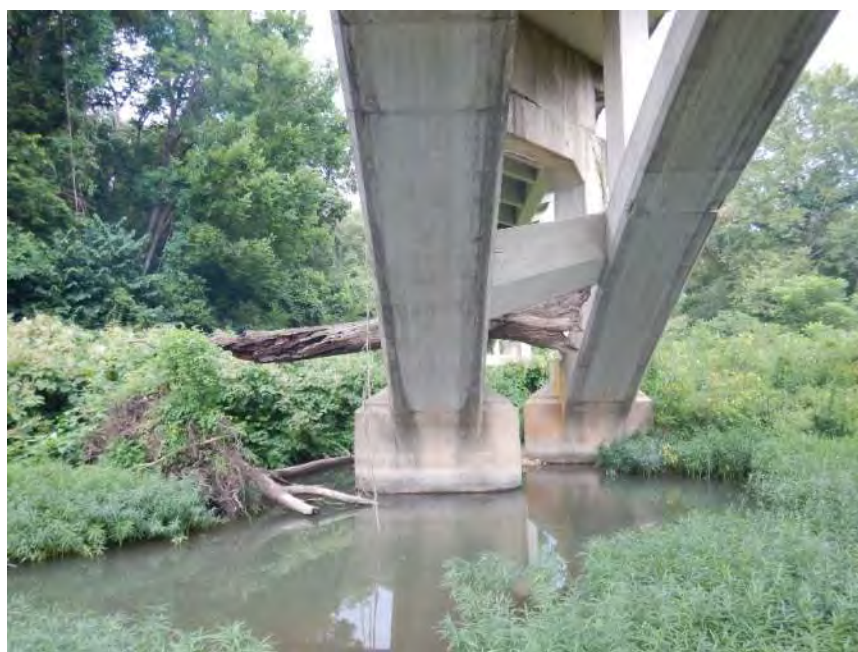
The bridge is on a 45 degree skew and is exhibiting lateral movement of the girders relative to the substructure due to the sharp skew. Previous retrofit projects have included the installation of brackets to keep the girders in line with the bearings. The girders are tight against these brackets. At Bent 9 there appears to have been an attempt to raise the east girder and realign the upper bearing plate with the girder. A jacking block had been added to the girder to facilitate this modification.

Drift in Structure

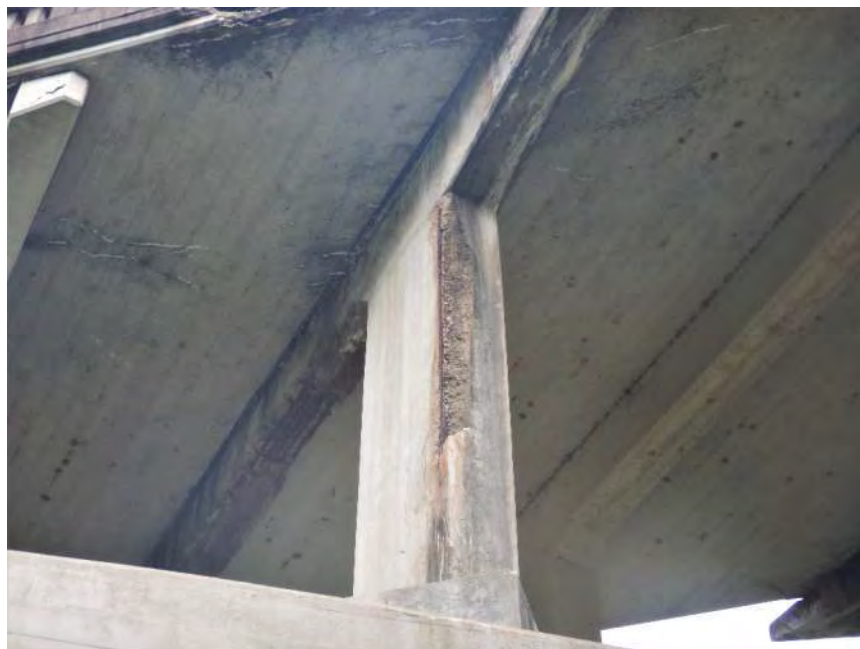
Typical Deterioration on Spandrel Columns

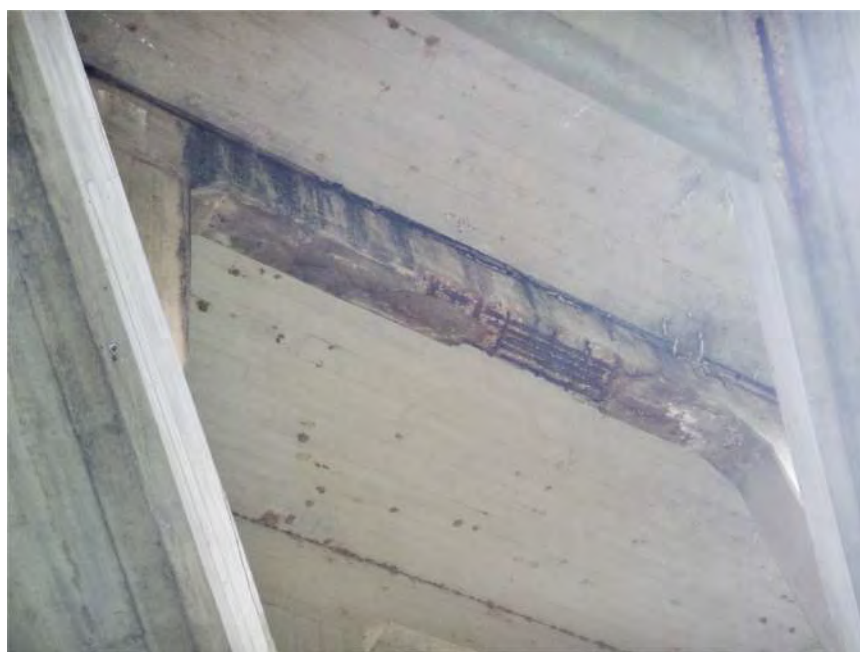
Typical Deterioration on Spandrel Capbeams

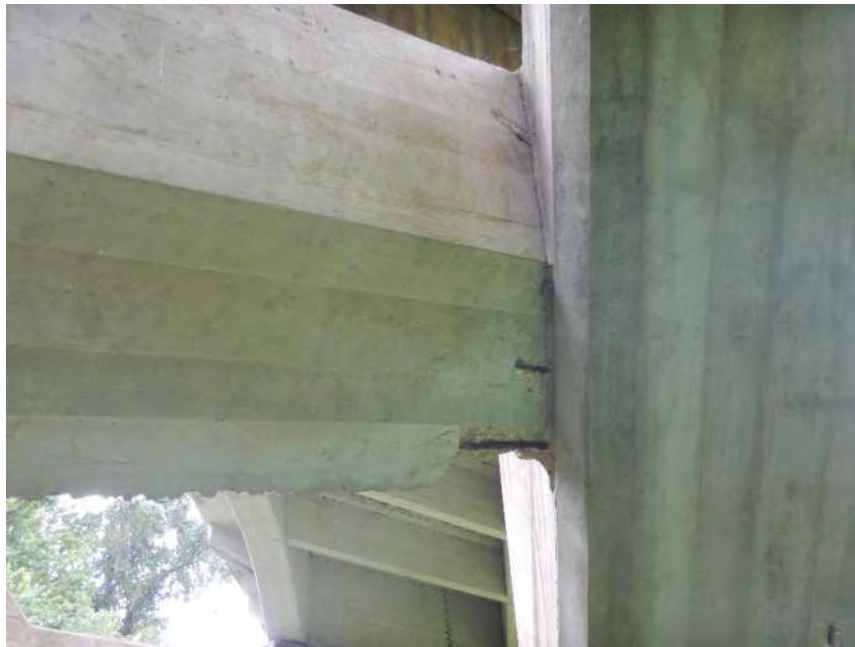
Lateral Bracing Between the Arch Ribs

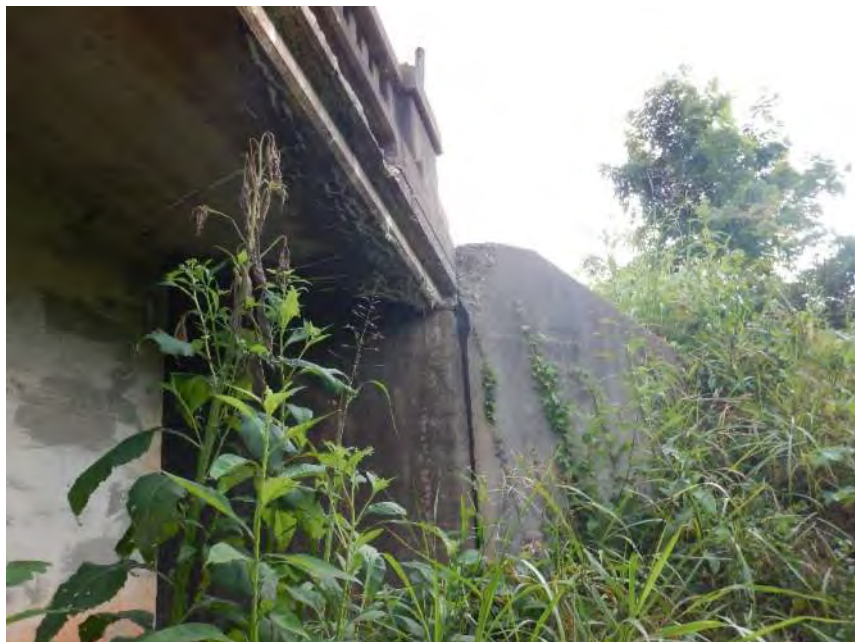
Typical Spalling at Abutment

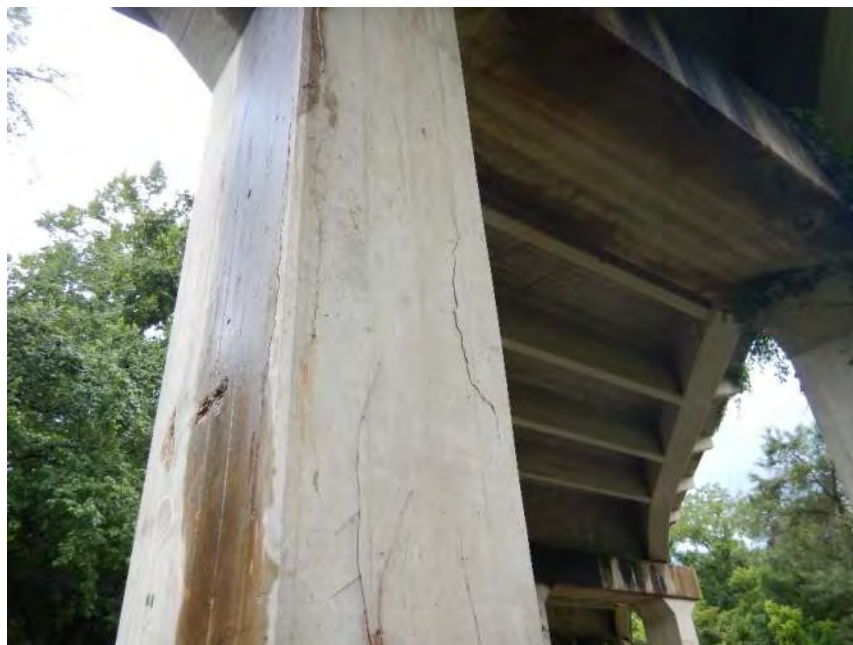
Deterioration of Intermediate Bent Columns

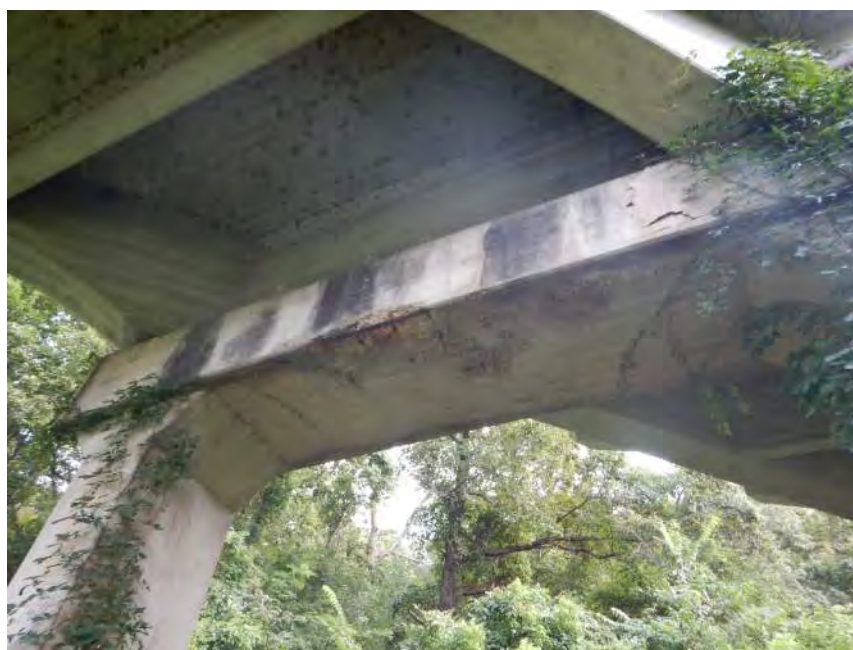
Deterioration of Intermediate Bent Cap Beams

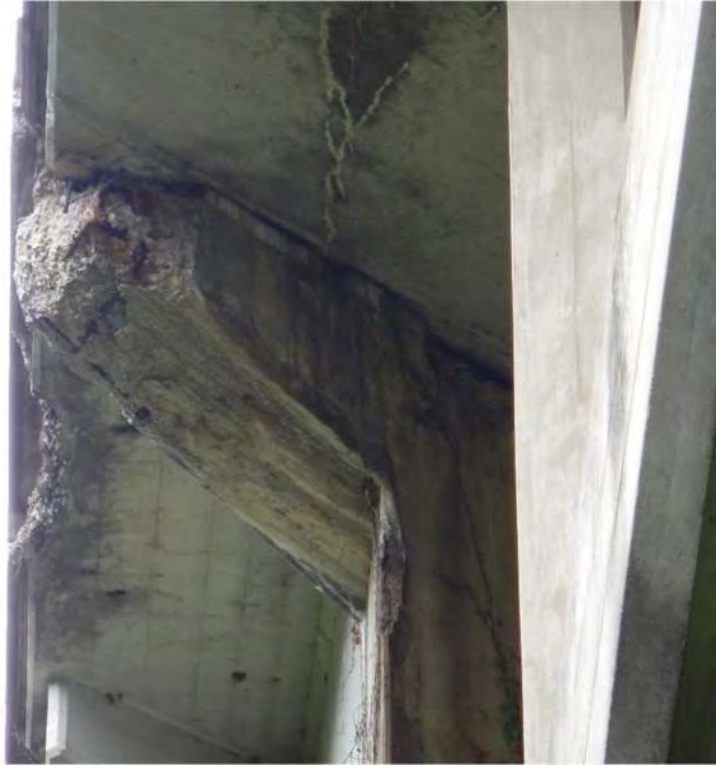
Pic. 006: Typical deterioration of spandrel capbeams

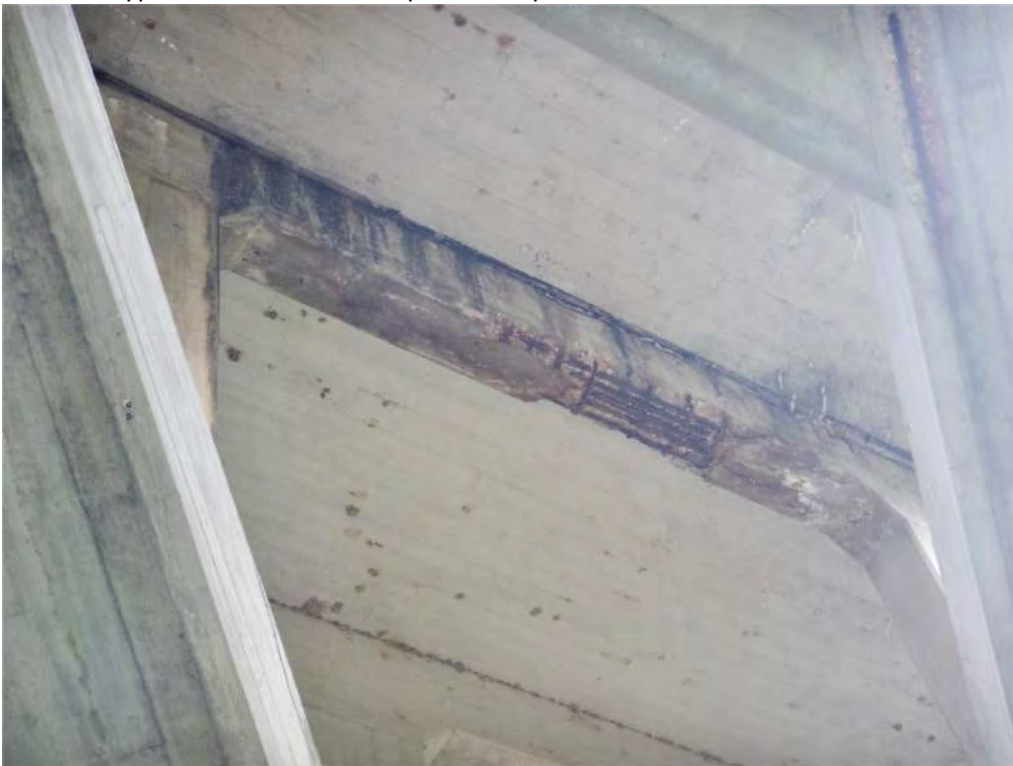
Pic. 007: Spalling near center of arch rib, east rib

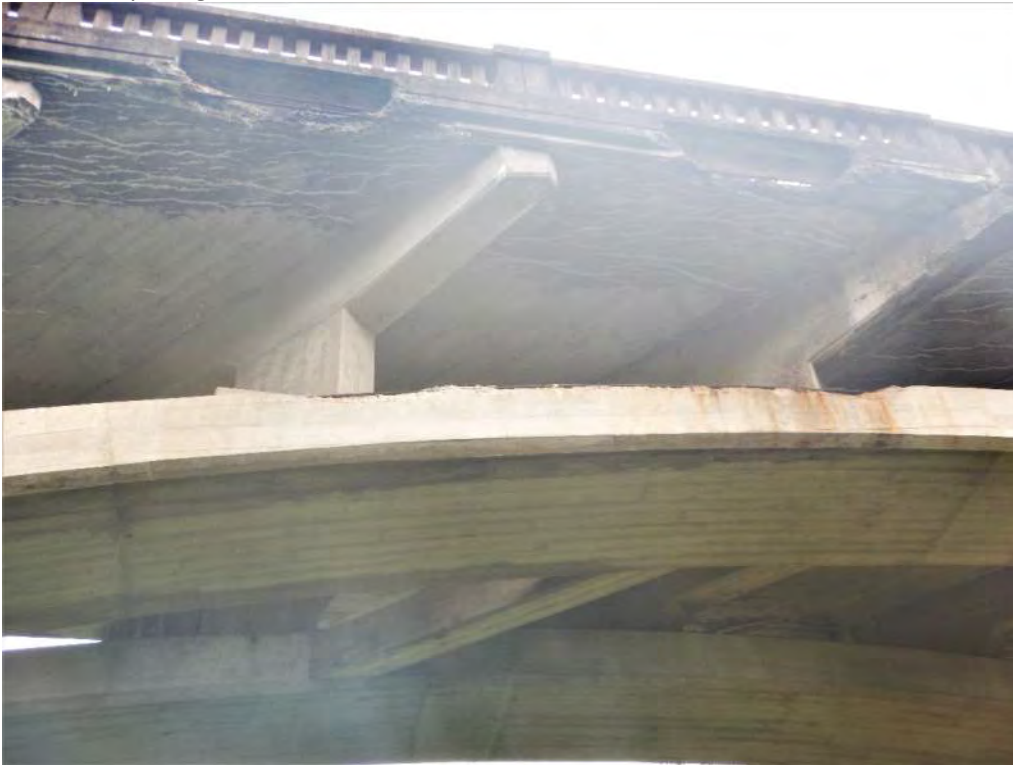
Pic. 008: Spalling of arch rib, west rib near south thrust block

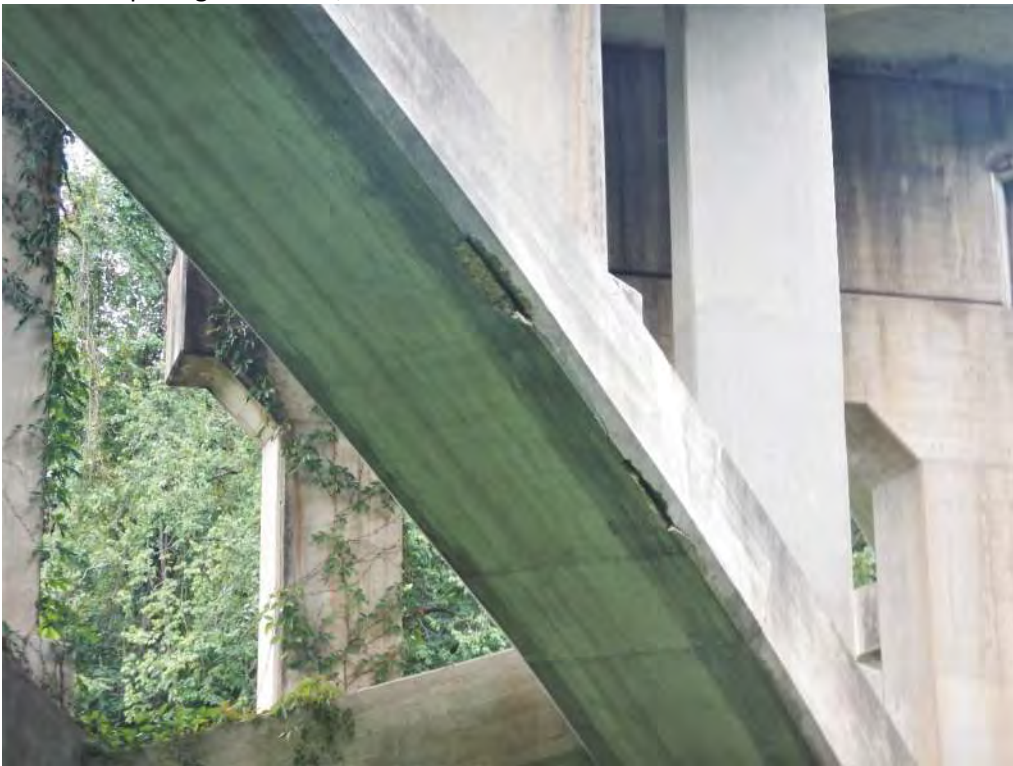
Pic. 009: Typical deterioration of spandrel column

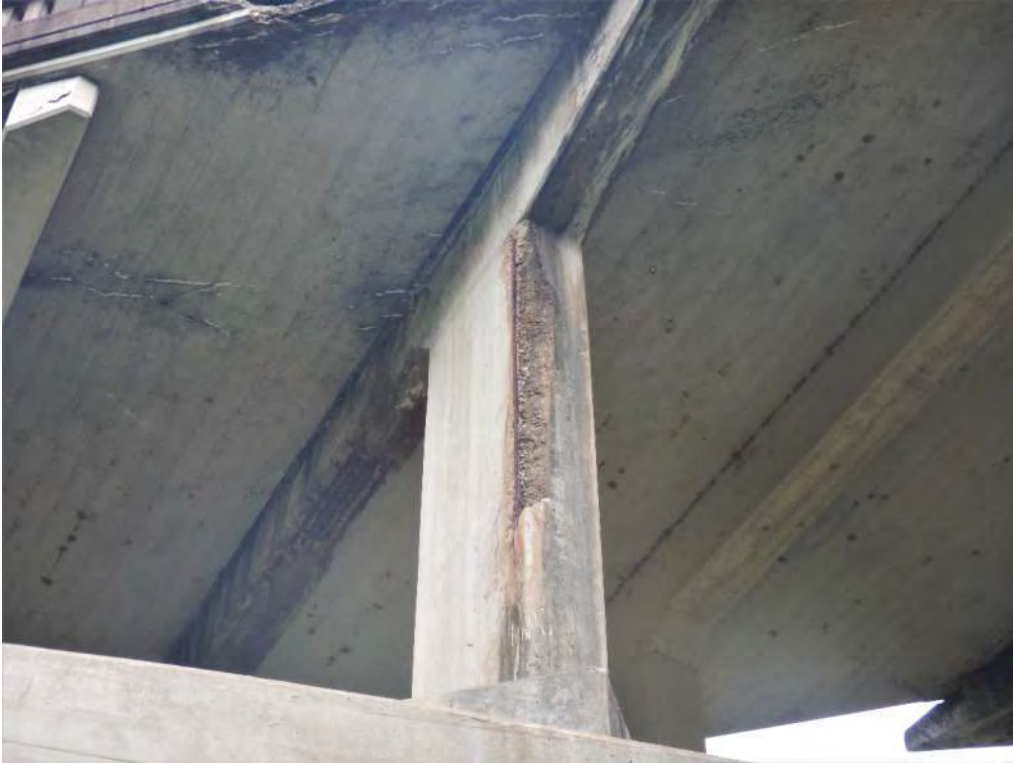
Pic. 010: Vertical cracking in column, Bent 3 shown
