# BRIDGE REHABILITATION / REPLACEMENT ALTERNATIVES STUDY REPORT

Route 19 over Current River and Spring Valley  
(Project No. J9P3305)

Bridges No. G0804 and J0420

October 2019

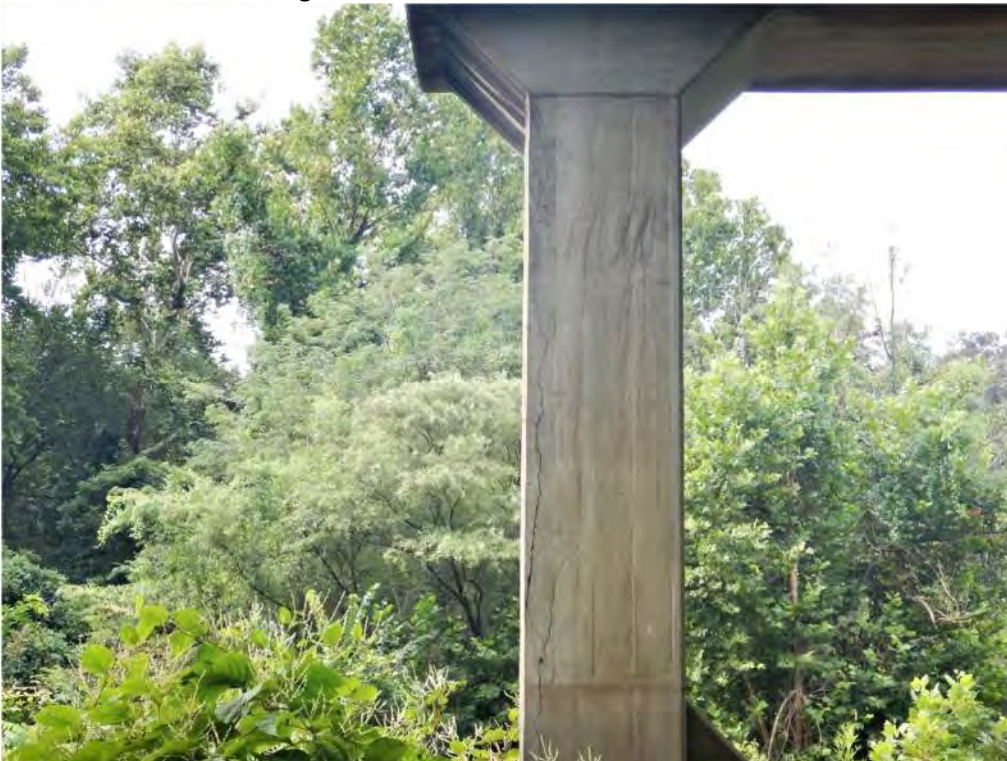
Pic. 011: Spalling and cracking on column, Bent 6 shown

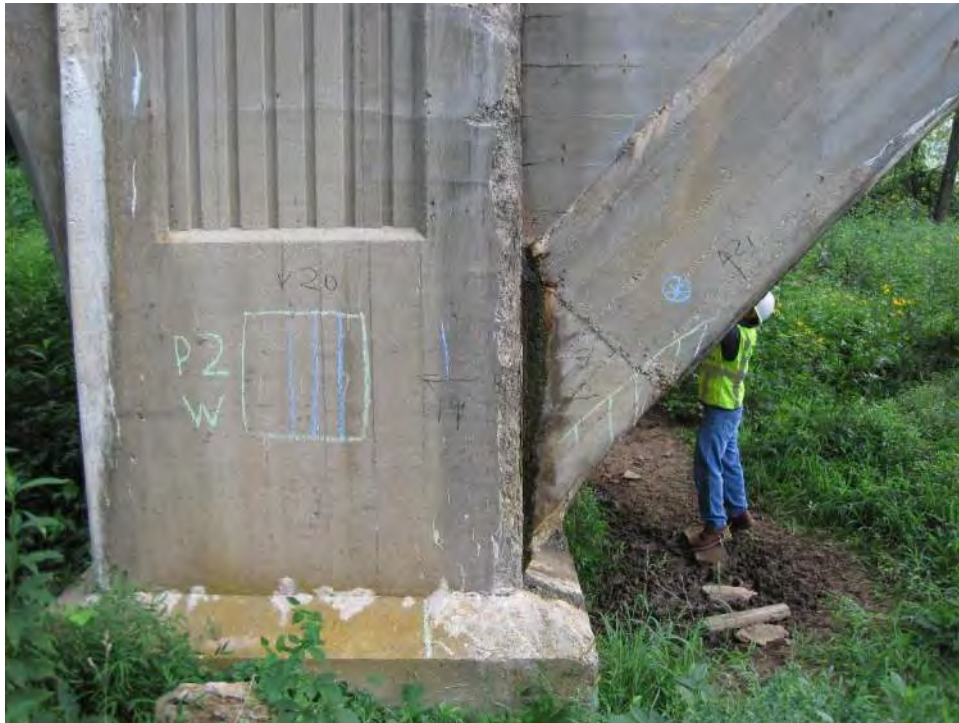
**Photo 2: CRB, Typical spalling and deterioration along vertical corners of pier and edge of arch, West Face, pier 2 shown.**

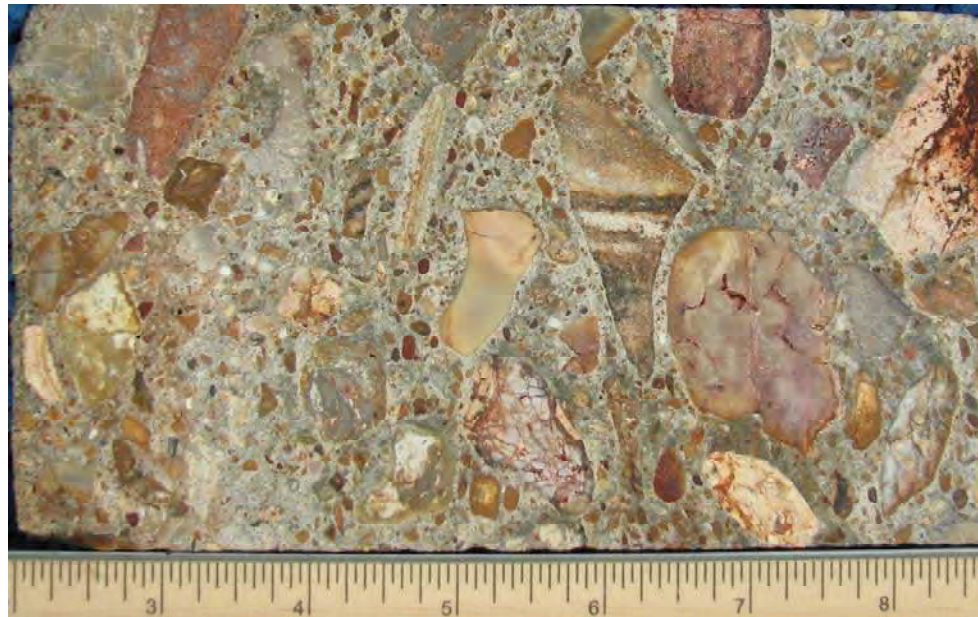
No cracks or microcracks are present in the core, as shown in Figure 7 below.

Figure 7: Photograph showing the good condition of Core SV-3. The outer surface is to the left. Scale in inches.
