MEMORANDUM

SUBJECT: Major Bridge Inspection Reports
D 6 -- St. Louis County
L0623 and A2643 - Fenton
I – 44 over the Meramec River

**MAJOR BRIDGE INSPECTION REPORT
BRIDGE NO. L0623 (FENTON)
IS 44 WESTBOUND, ST. LOUIS COUNTY
OVER THE MERAMEC RIVER**

**MAJOR BRIDGE INSPECTION REPORT
BRIDGE NO. A2643 (FENTON)
IS 44 EASTBOUND, ST. LOUIS COUNTY
OVER THE MERAMEC RIVER**

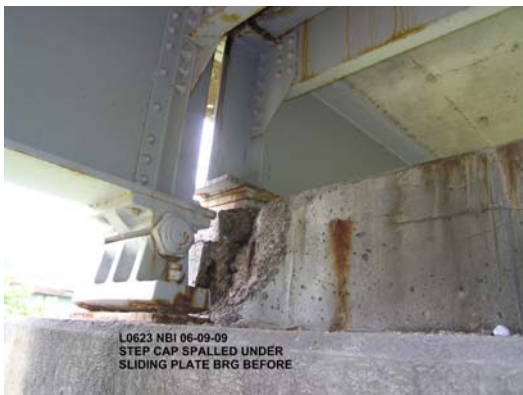
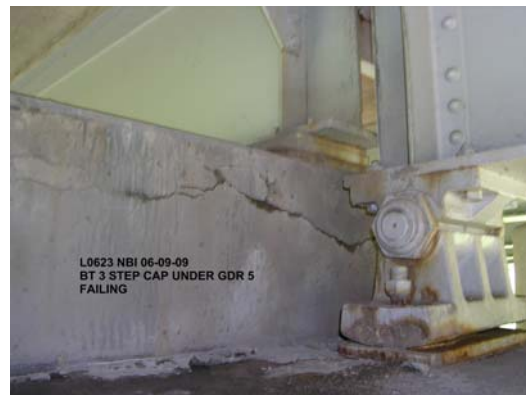
Bridge Log – L0623 (Fenton) - Inspection June 9, 2009

<u>Item</u>	<u>Deficiency</u>	<u>Location</u>	<u>Recommend</u>	<u>Photos</u>
1	Deterioration	Bt 3	Repair	6-9-09- IMG0029
2	Drift	Bt 12	Remove	6-9-09- P6090107
3	Rusting Plates	Bt 10	Clean/paint	6-9-09- P6090117
4	Rusting Plates	Bt 10	Clean/paint	6-9-09- P6090112
5	Delaminations	Bt 10	Repair	6-9-09- P6090120
6	Holes in overlay	Bt 15	Seal	6-9-09- IMG0002
7	Holes in nosing	Bt 14	Repair	6-9-09- IMG0004
8	Holes in overlay	Bt 13	Seal	6-9-09- IMG0006
9	Holes in overlay	Bt 10	Seal	6-9-09- IMG0008
10	Exp full of debris	Bt 9	Clean	6-9-09- IMG0010
11	Exp full of debris	Bt 6	Clean	6-9-09- IMG0012
12	Holes in overlay	Bt 3	Seal	6-9-09- IMG0014
13	Holes in overlay	Bt 2	Seal	6-9-09- IMG0016

- ❖ Install missing load post sign (65t) at east approach
- ❖ Replace or re-build step cap at bent 3
- ❖ Clean & seal pin connector plate areas with “anti rust” gel
- ❖ Repair expansion joints, bents 6, 9, 14
- ❖ Seal holes in asphalt overlay at expansion joints (pave mend), bents 2, 3, 10, 13, 15
- ❖ Cut trees / brush
- ❖ Clean, paint, reset rockers at bents 6, 9, 13, 14
- ❖ Remove drift at bent 12
