Secondary Bridges

June 8, 2021

Laurel McKean, Project Director

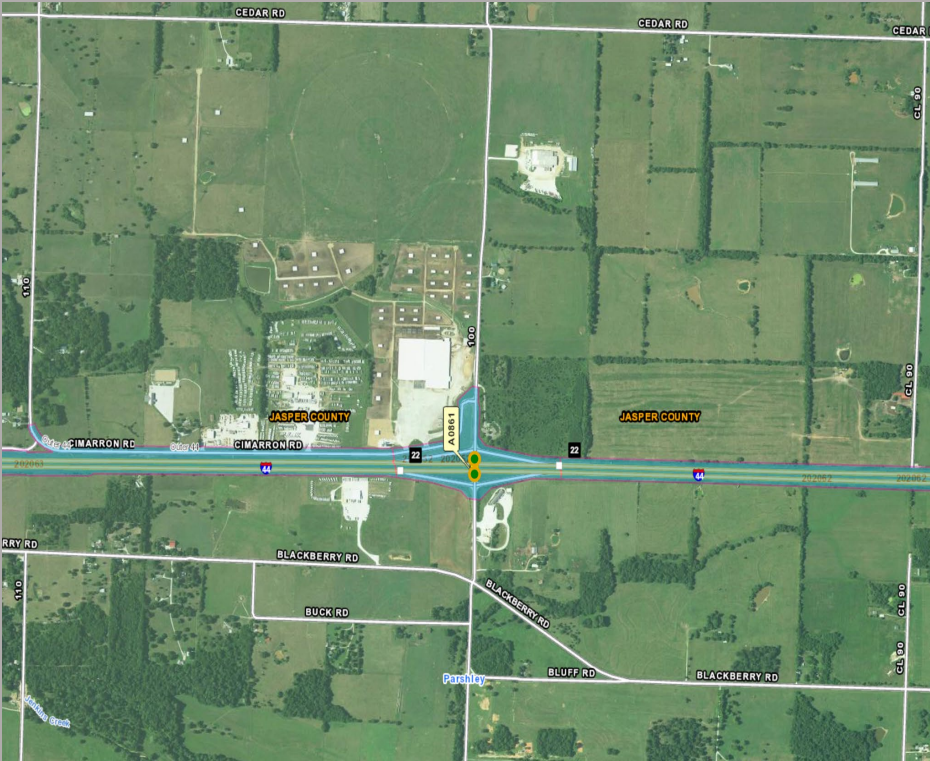
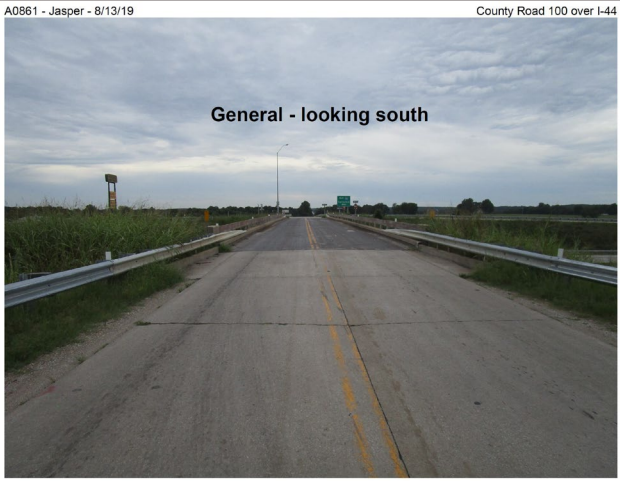
Bridge #A0861 CRD100 over I-44 EB&WB Jasper County

- Joplin Regional Stockyards in NW quadrant
- Heaviest day for Stockyard is Saturdays
- RV businesses on each side of 44
- Steel company has yards on both sides of 44
- WB67 design critical
- Guardrail damaged on every corner
- Better striping at end of the ramps
- Concern with how to tie OR and entrances
- Sight distance at end of ramps crucial
- Already a bit of a sight distance issue at WB ramps seeing NB vehicles

- 5 total crashes
- 3 at EB Ramp – 1 angle, 1 driving too fast and unable to stop, 1 RE
- 2 at WB Ramp – 1 out of control due to driver not stopping at ramp, 1 swung too wide turning right and hit SB vehicle

Mandatory:	N	AADT:	1198
Ratings:	4,4,7	Truck %:	10.9
Min Treatment:	Replacement	Existing Bridge Type:	Voided Concrete Slab
Potential Grade Change:	2'-3"+	I44 Incident Bypass Route:	
Crossing Type:	Interstate

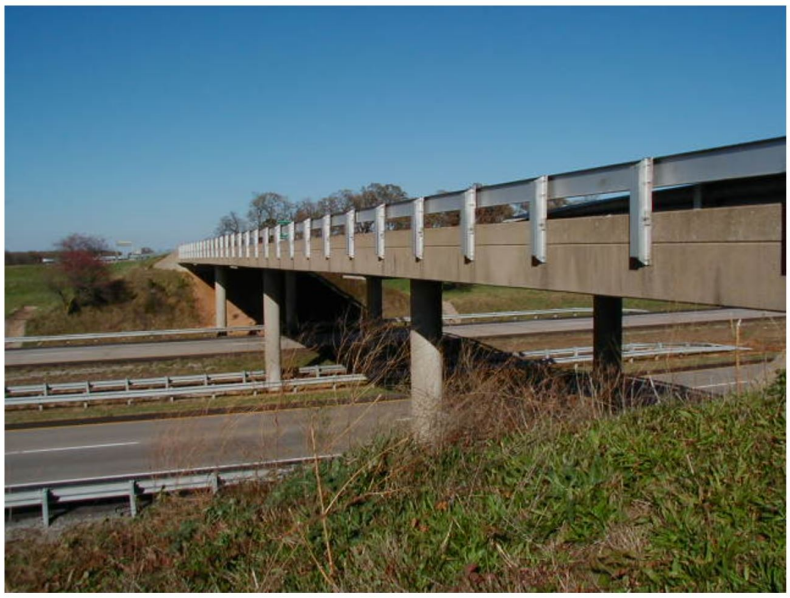
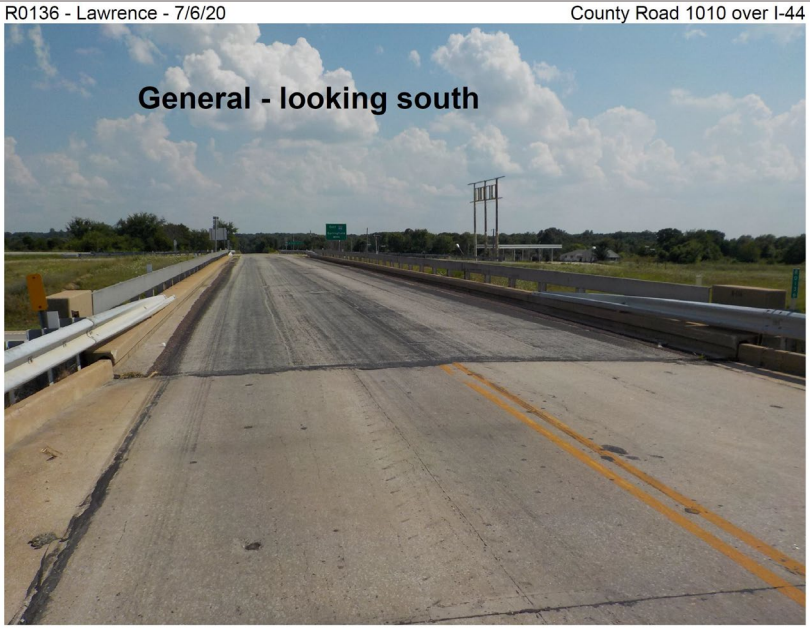
Bridge #R0136
CRD1010 over I-44 EB&WB
Lawrence County

Mandatory:	N	AADT:	581
Ratings:	5,5,7	Truck %:	10.9
Min Treatment:	Replacement	Existing Bridge Type:	Voided Concrete Slab
Potential Grade Change:	2'-2"	I44 Incident Bypass Route:	No
Crossing Type:	Interstate

- Mainly farming around the area
- WB 67 design critical
- Potential truck stop being built in SW corner
- Down the OR is a truck was and a trailer sales business
- Sight distance concern when raise bridge
- Ditches are wet
- Guardrail damage all around

- 1 crash at S OR when tractor-trailer tried to turn and clipped front of car

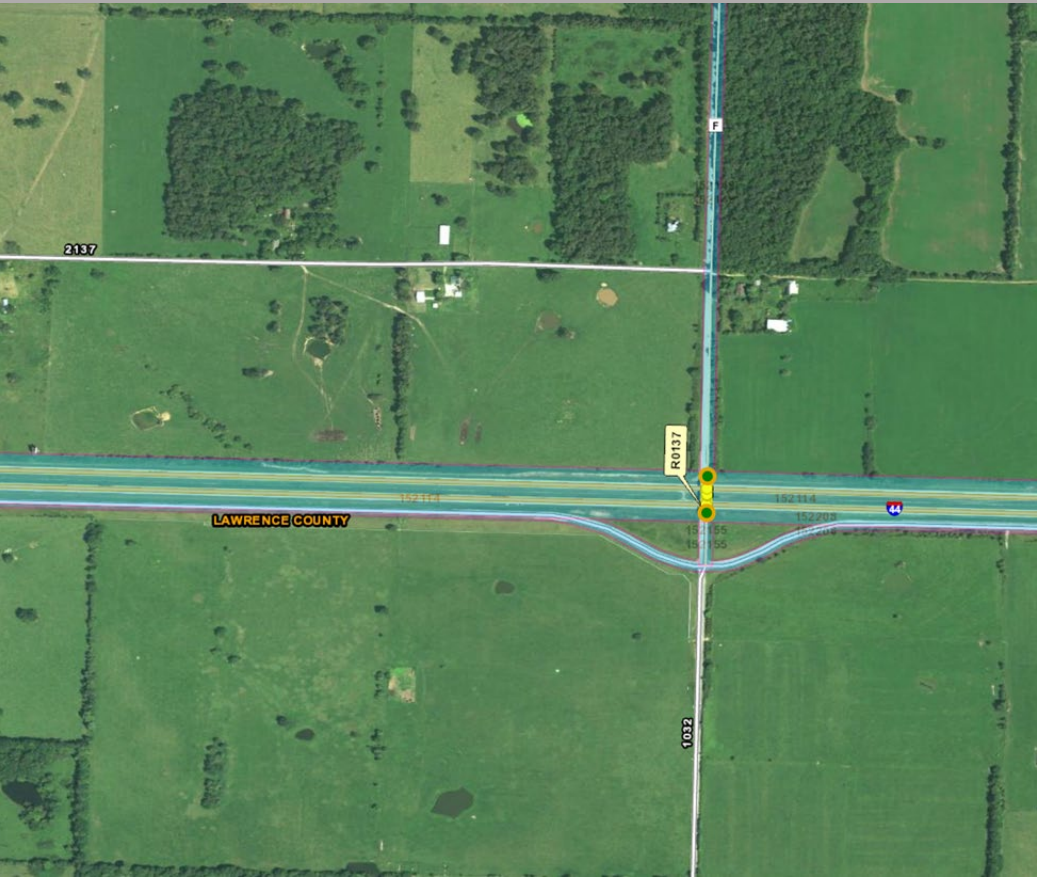
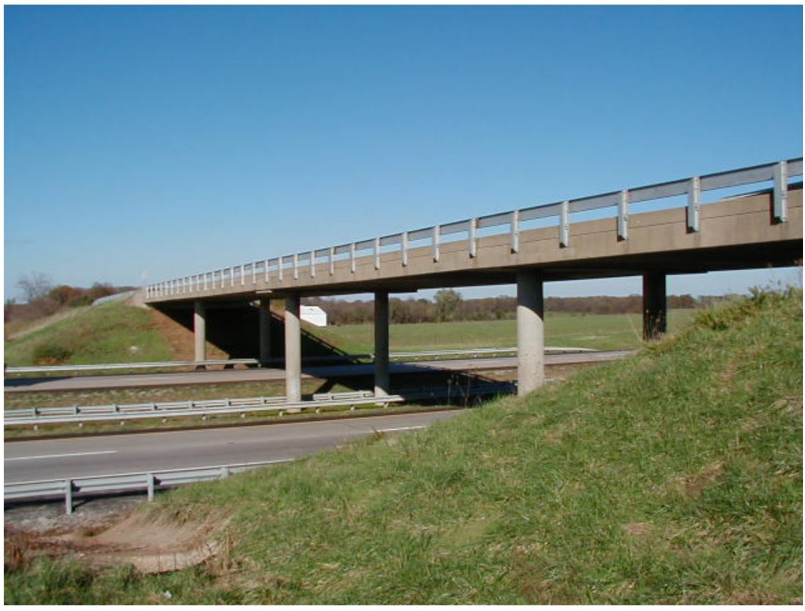
Bridge #R0137
Route F over I-44 EB&WB
Lawrence County

- Mainly farming in the area
- Profile of road before and after bridge is not consistent
- Ditches along I44 full of water
- No crashes
- Visibility of Stop sign with raised bridge profile

Mandatory:	N	AADT:	213
Ratings:	5,5,7	Truck %:	10.5
Min Treatment:	Replacement	Existing Bridge Type:	Voided Concrete Slab
Potential Grade Change:	2'-4"	I44 Incident Bypass Route:	No
Crossing Type:	Interstate

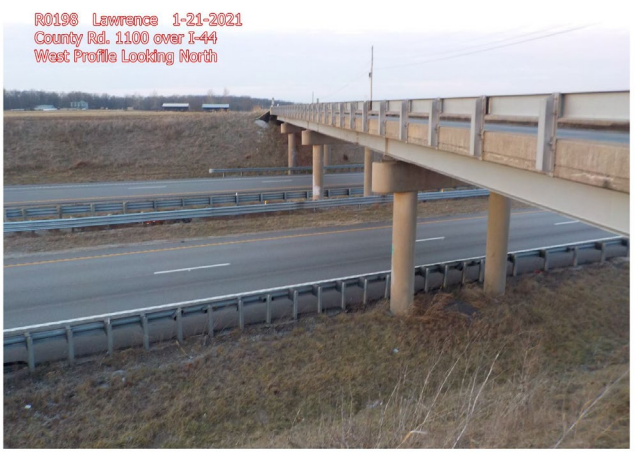
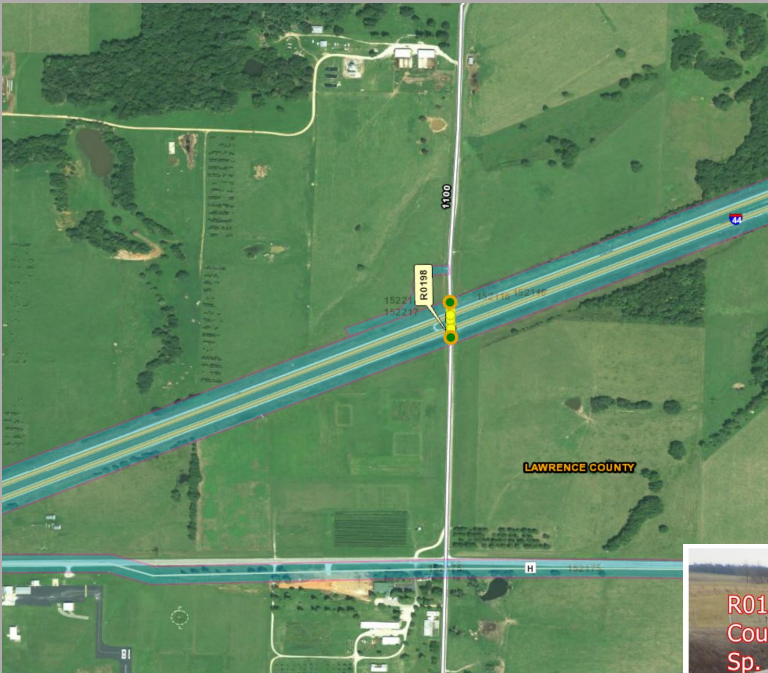
Bridge #R0198 CRD1100 over I-44 EB&WB Lawrence County

- Detour for local when other bridges are closed due to flooding
- Might need to extend guardrail
- Overhead powerline on East side
- Small airport South of bridge
- No crashes

Mandatory:	N	AADT:	210
Ratings:	4,6,7	Truck %:	4
Min Treatment:	Rehab	Existing Bridge Type:	Wide Flange Girder
Potential Grade Change:	2'-0"	I44 Incident Bypass Route:	No
Crossing Type:	Interstate

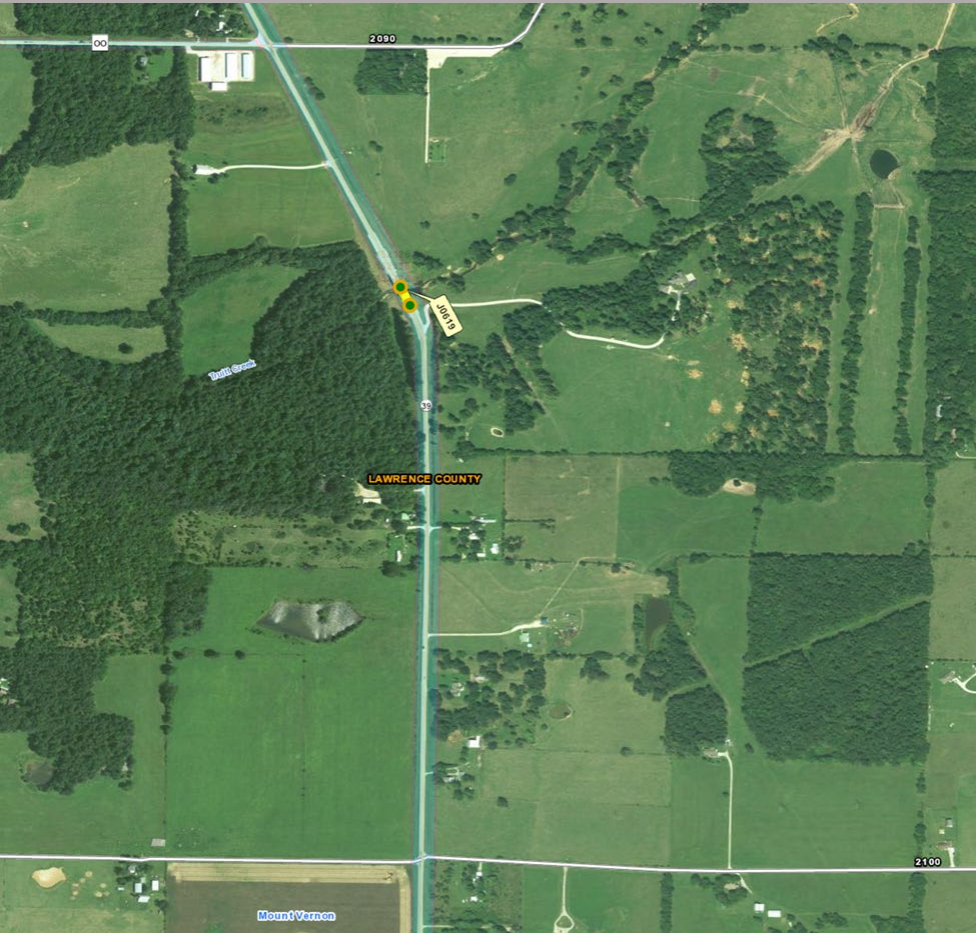
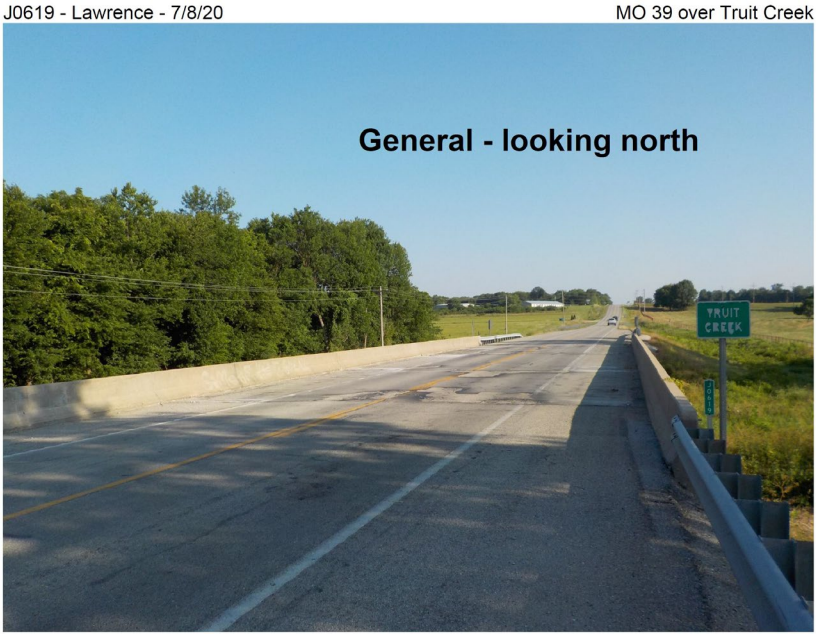
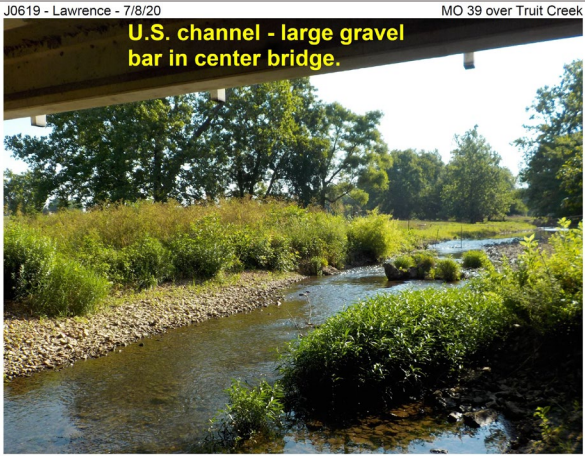
Bridge #J0619
MO39 over Truitt Creek
Lawrence County

- 1 alcohol involved lost control
- 1 came around curve, got in the gravel and lost control

- No known overtopping issues
- Clean drift once every 2 years
- Jackie Moore cattle trucks and feed trucks
- Fuel trucks and delivery trucks
- Might not be able to reduce width of road due to past history
- Curve on South side

Mandatory:	N	AADT:	3375
Ratings:	4,4,6	Truck %:	12.2
Min Treatment:	Replacement	Existing Bridge Type:	Concrete Deck Girder
Potential Grade Change:	0"	I44 Incident Bypass Route:	No
Crossing Type:	Water

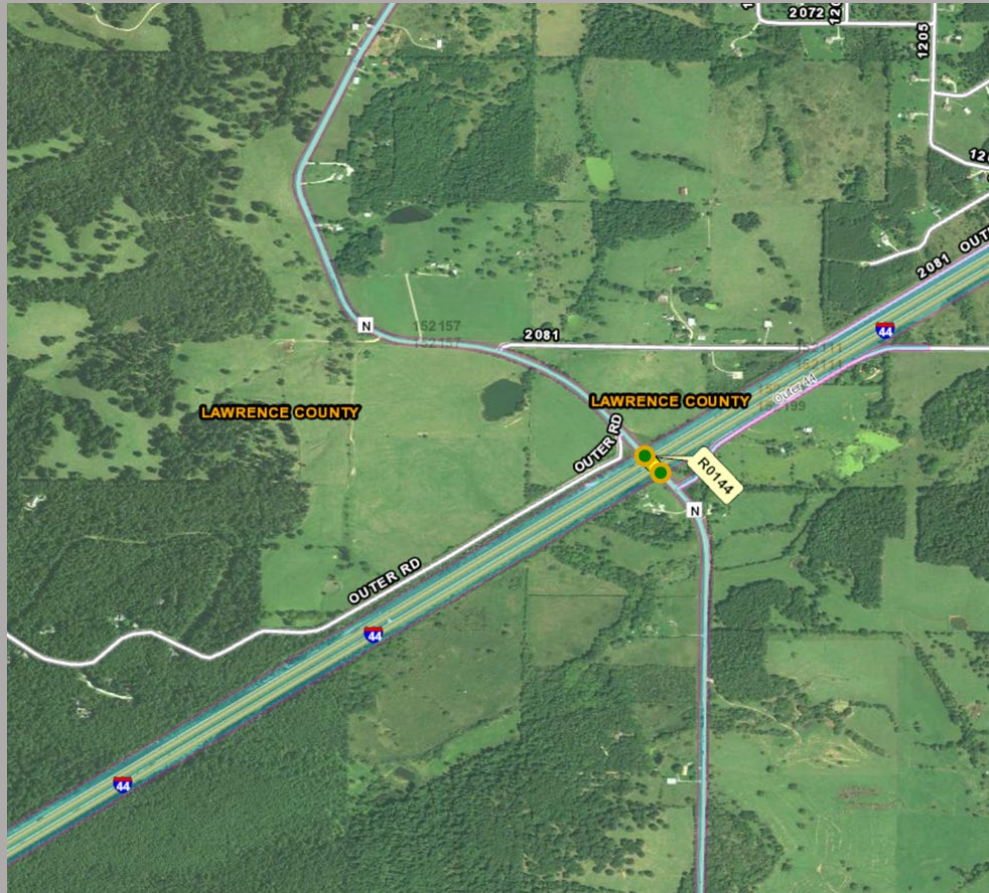
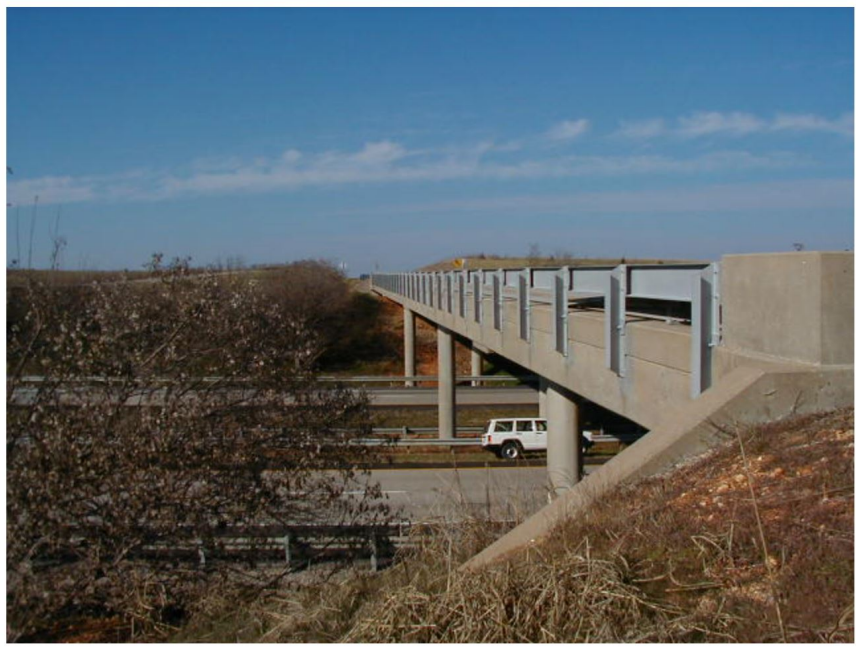
Bridge #R0144
Route N over I-44 EB&WB
Lawrence County

- Farming is the main use
- Subdivision in the NE side which has asked for full interchange multiple times
- Concern with OR tie-ins due to raise in profile of bridge

Mandatory:	N	AADT:	376
Ratings:	5,5,6	Truck %:	11.5
Min Treatment:	Replacement	Existing Bridge Type:	Voided Concrete Slab
Potential Grade Change:	2'-2"	I44 Incident Bypass Route:	No
Crossing Type:	Interstate

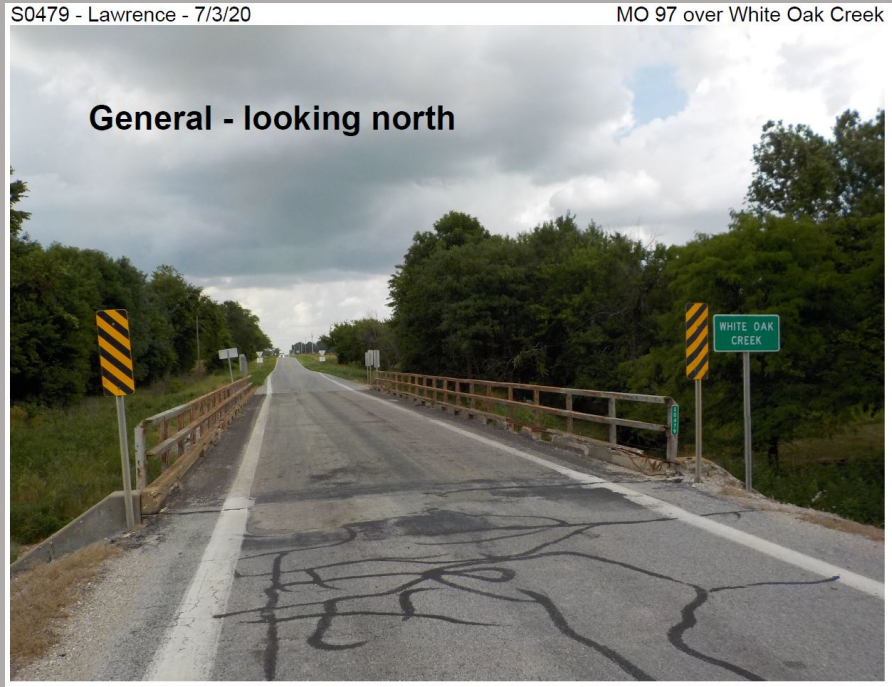
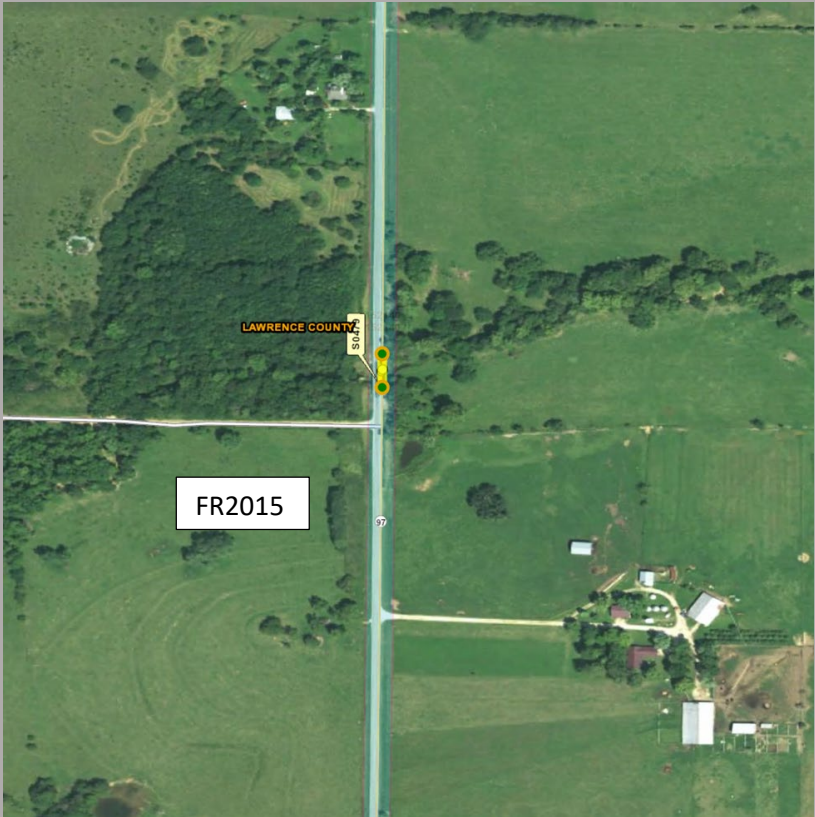
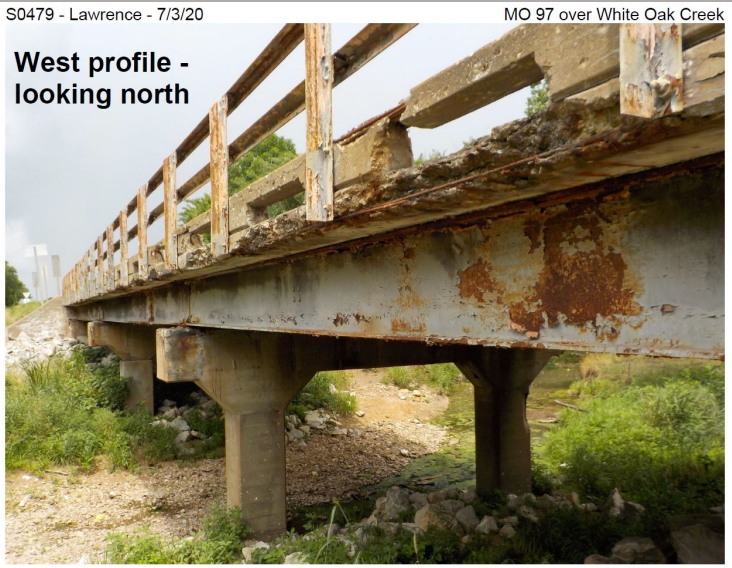
Bridge #S0479 MO97 over N White Oak Creek Lawrence County

Mandatory:	N	AADT:	1042
Ratings:	5,4,6	Truck %:	14.3
Min Treatment:	Replacement	Existing Bridge Type:	Wide Flange Girder
Potential Grade Change:	9"	I44 Incident Bypass Route:	No
Crossing Type:	Water

- No reported issues of water overtopping the road
- No reported issues of removing debris often
- Used by farming industry, grain trucks and trash trucks going to the landfill in Lamar, MO
- Channel trying to move toward N abutment
- FR2015 very close on S end
- Narrow R/W
- No crashes

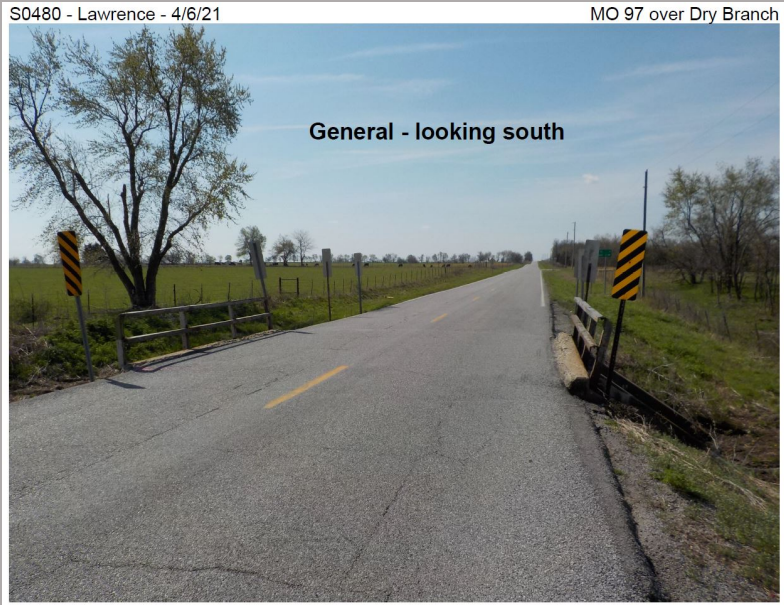
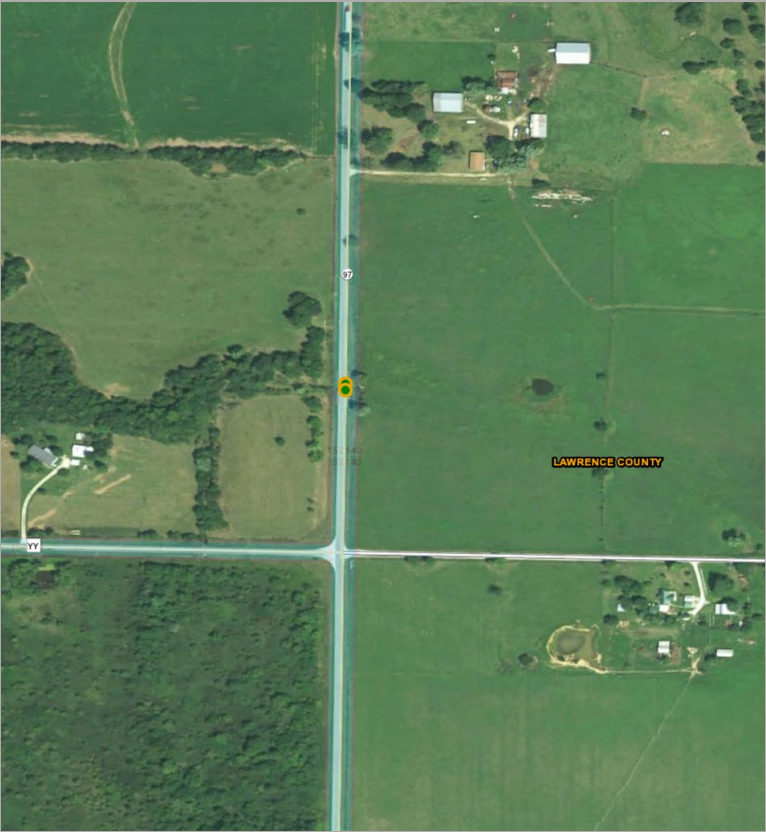
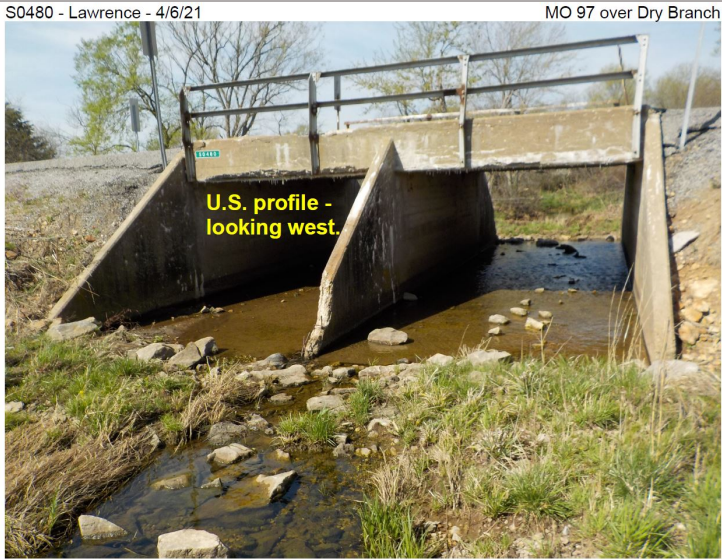
Bridge #S0480
MO97 over Dry Branch
Lawrence County

- No reported issues of water overtopping the road
- No reported issues of drift being removed often
- Trash trucks hauling to Lamar Landfill
- S&H Farm Supply
- Grain and Feed trucks
- Farming
- Narrow
- East side property owner might have concerns
- Buried cable
- Water Sitting on both sides in ditch
- No crashes

Mandatory:	N	AADT:	1042
Ratings:	5	Truck %:	14.3
Min Treatment:	Replacement	Existing Bridge Type:	Concrete DBL Box Culvert
Potential Grade Change:	0"	44 Incident Bypass Route:	No
Crossing Type:	Water

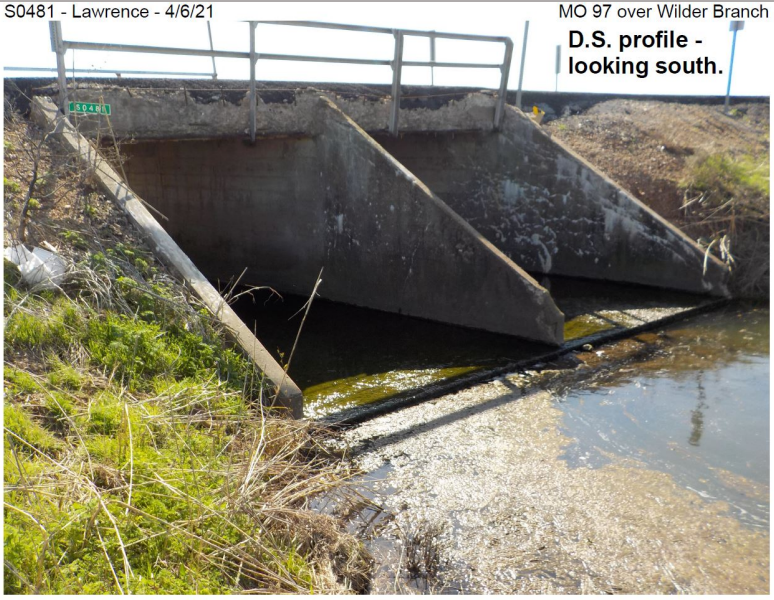
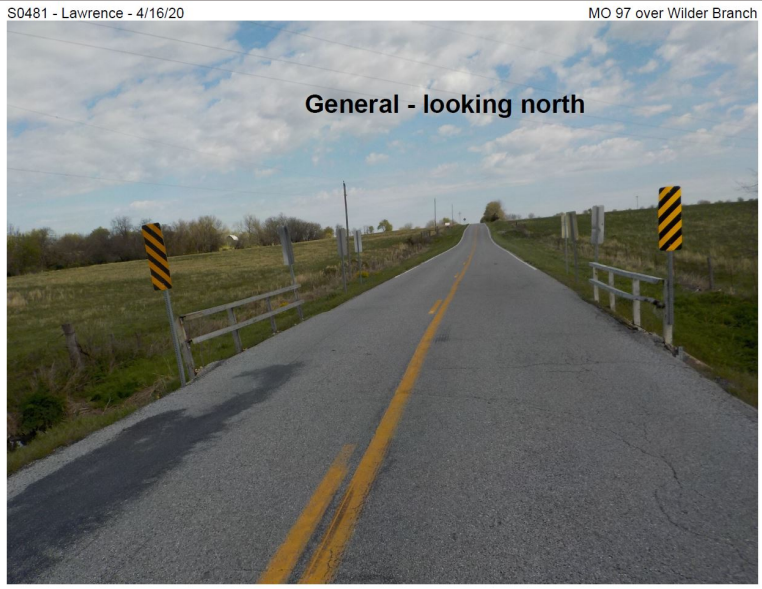
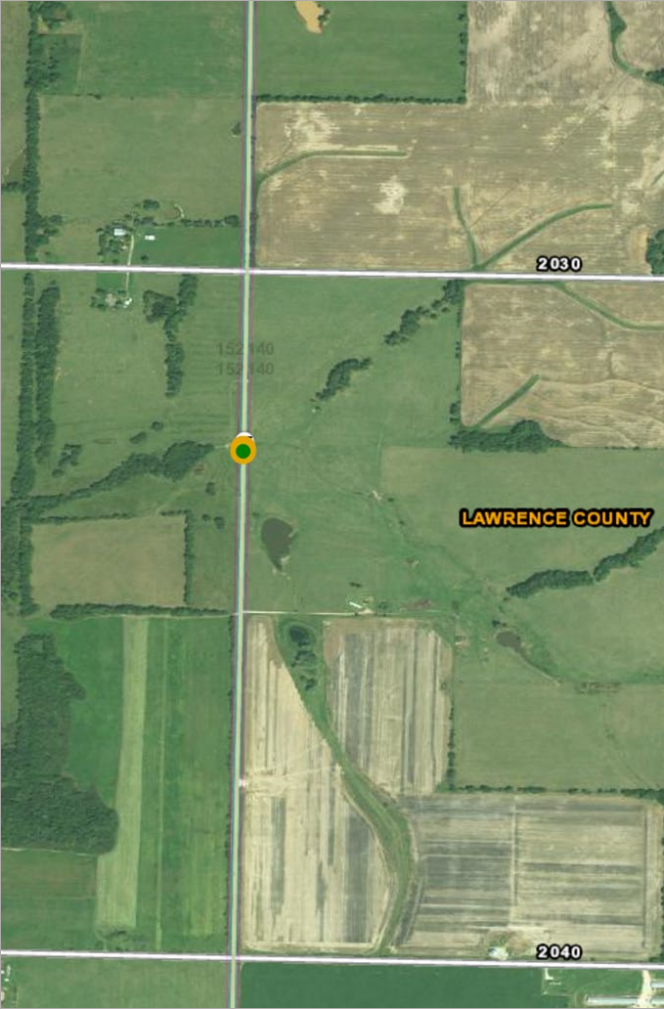
Bridge #S0481
MO97 over Wilder Branch
Lawrence County

- No reported issues of water overtopping
- No reported issues of removing debris often
- Used by farming industry, grain trucks and trash trucks going to the landfill in Lamar, MO
- Steep slopes
- Overhead transmission line 100’ N of structure
- Narrow
- 1 crash – distracted driver lost control and hit end of structure

Mandatory:	N	AADT:	1030
Ratings:	4	Truck %:	14.4
Min Treatment:	Replacement	Existing Bridge Type:	Concrete DBL Box Culvert
Potential Grade Change:	0"	I44 Incident Bypass Route:	No
Crossing Type:	Water

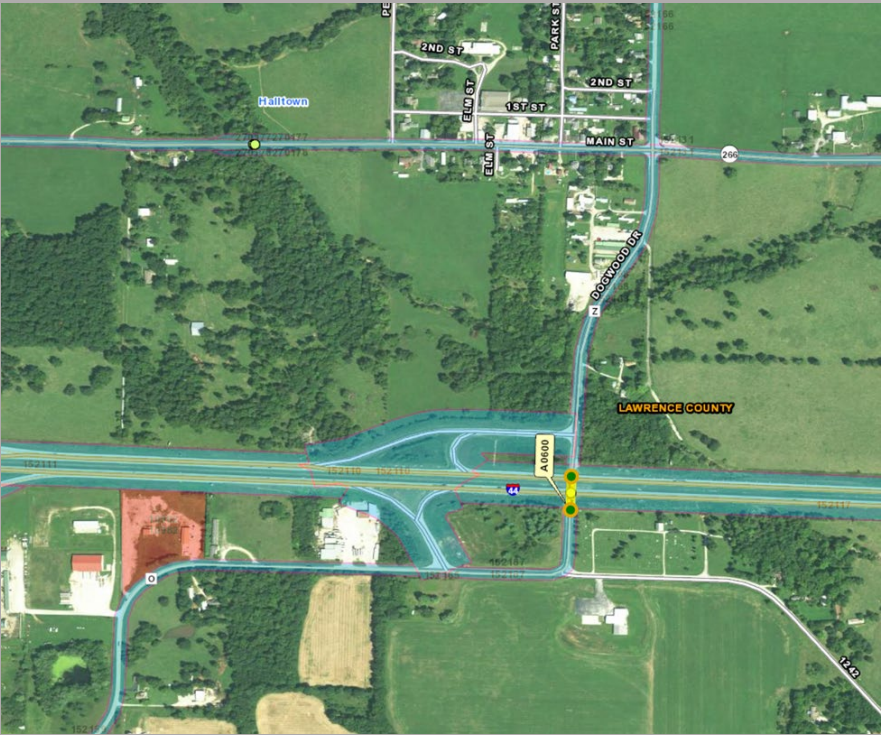
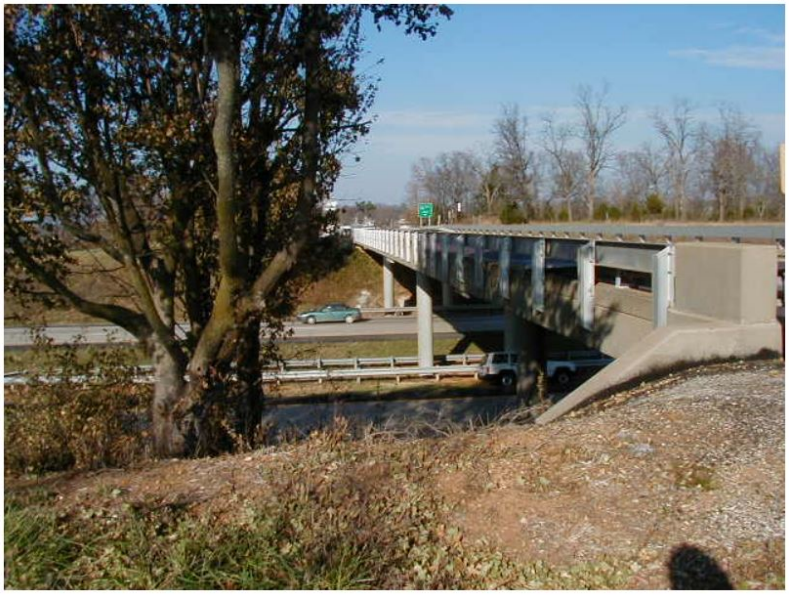
Bridge #A0600
 Route O/Route Z over I-44 EB&WB
 Lawrence County

Mandatory:	N	AADT:	305
Ratings:	5,5,7	Truck %:	11.3
Min Treatment:	Replacement	Existing Bridge Type:	Voided Concrete Slab
Potential Grade Change:	2'-2"	I44 Incident Bypass Route:	No
Crossing Type:	Interstate

- Weight restricted Pony Truss bridge on MO266 in Halltown is being replaced – potential detour impact
- Crash information provided on next slide
- WB67 consideration in design
- Cemetery in SE quadrant
- Gas station and large engine repair in SW quadrant
- Used by fuel trucks, semis and farming
- Will provide past AJR to shortlisted teams

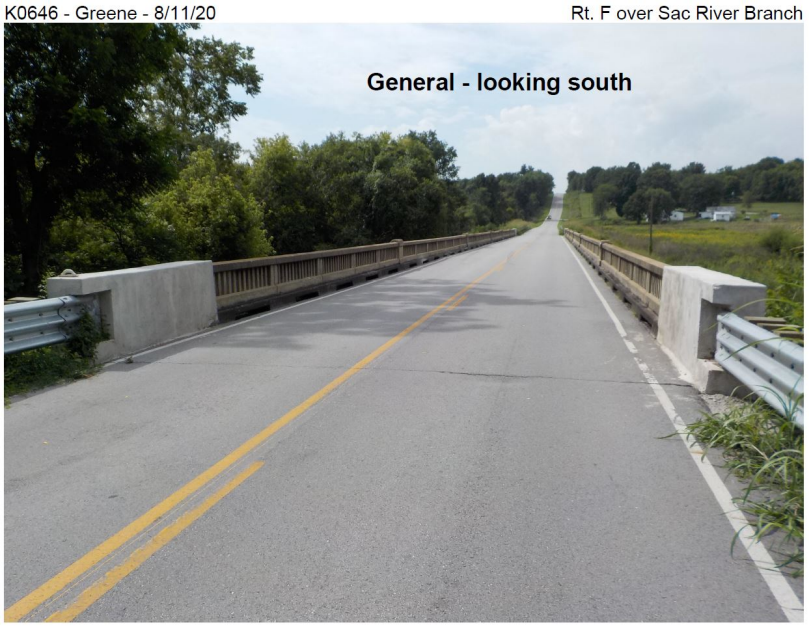
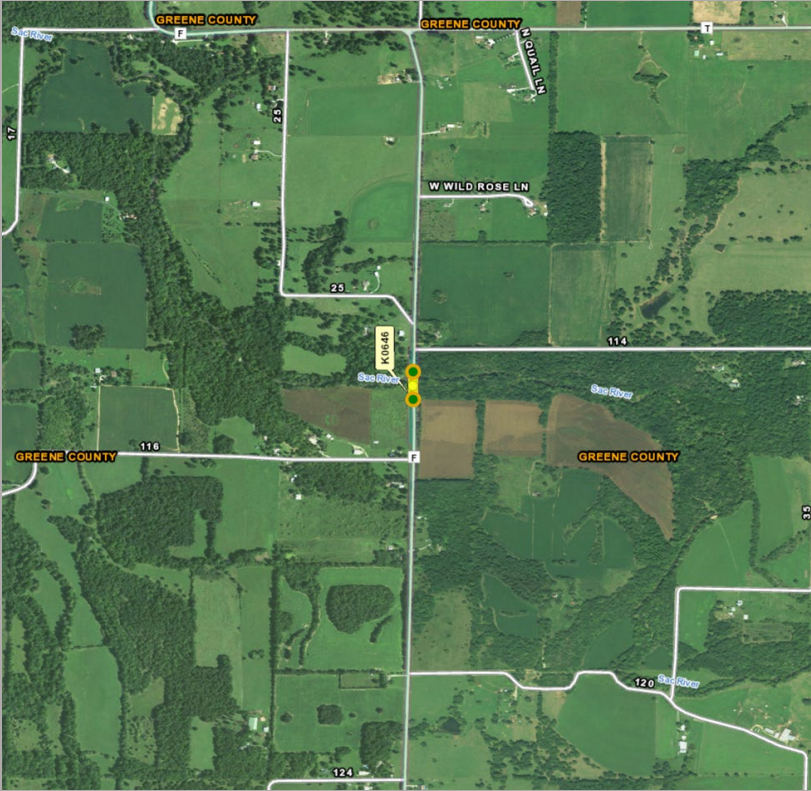
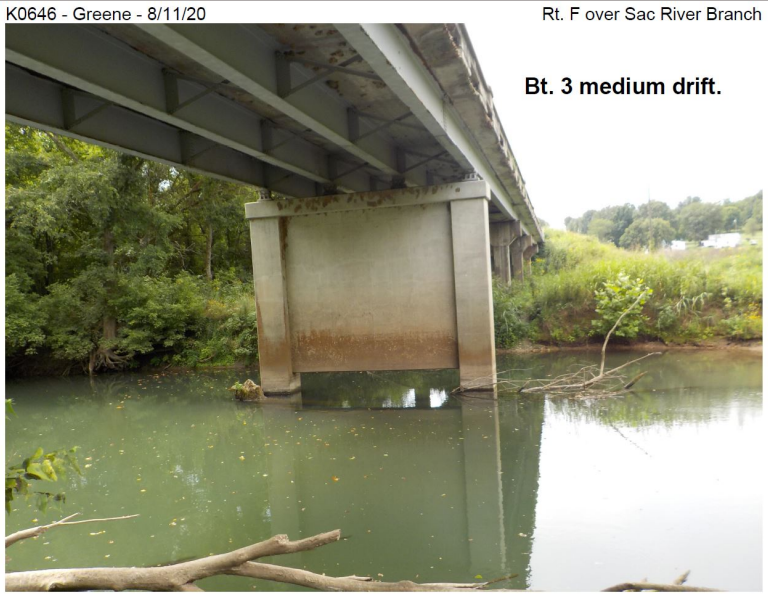
Bridge #K0646 Route F over Sac River Branch Greene County

Mandatory:	N	AADT:	736
Ratings:	4,6,4	Truck %:	5.8
Min Treatment:	Replacement	Existing Bridge Type:	Cont Non Comp&Simple Wide Flange
Potential Grade Change:	0"	I44 Incident Bypass Route:	No
Crossing Type:	Water

- No known knowledge of water overtopping
- Remove drift about every 10 years
- Farm equip. Grain and Milk trucks, fuel and delivery trucks; Seen several trash trucks cutting through this way; I-44 traffic to Ash Grove/Deliveries especially if issues on I44
- Narrow bridge
- County Rd 114 close to the N
- 2 crashes (2015-2021): 1 mirrors colliding when crossing, 1 out of control trying to avoid deer

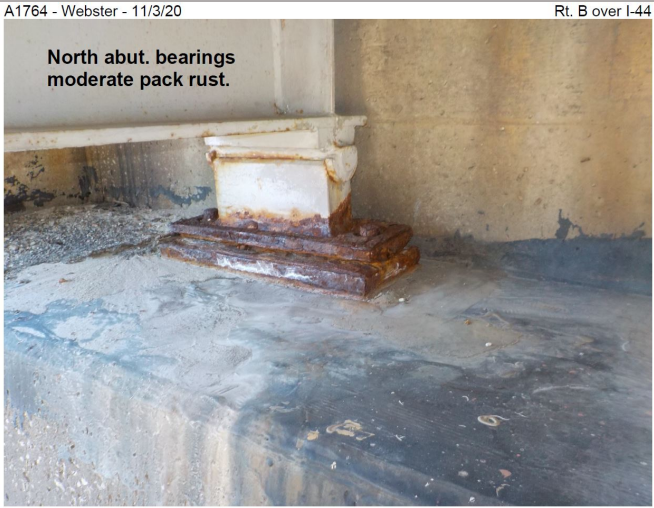
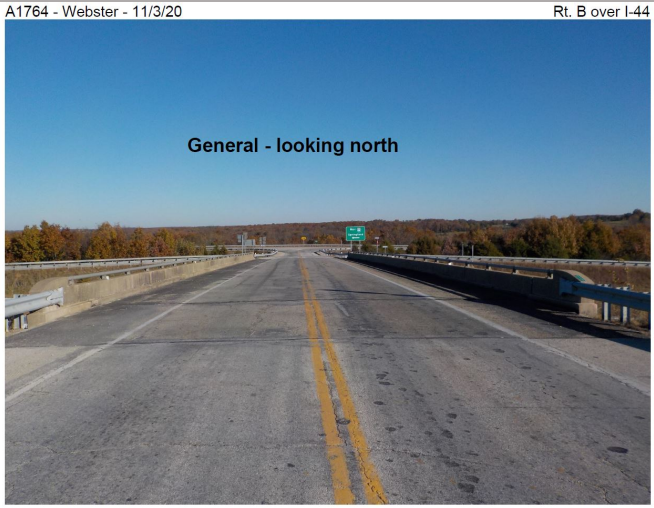
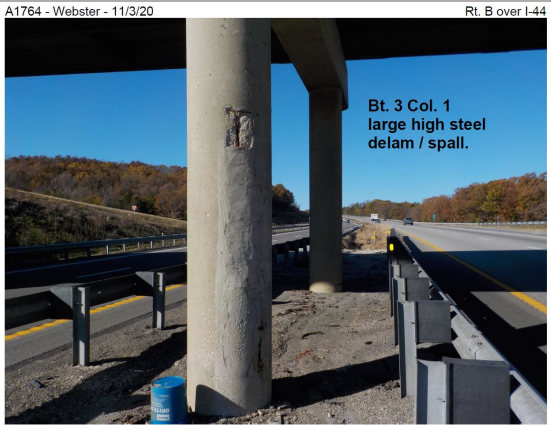
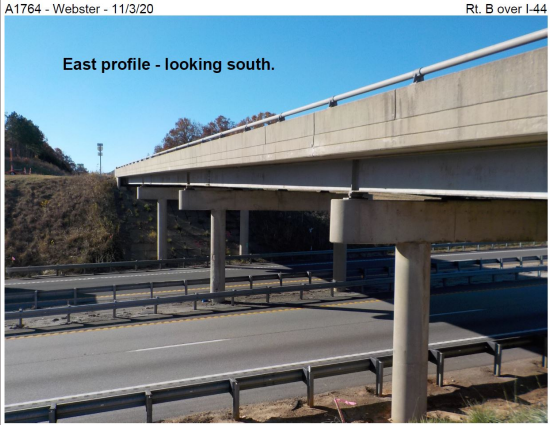
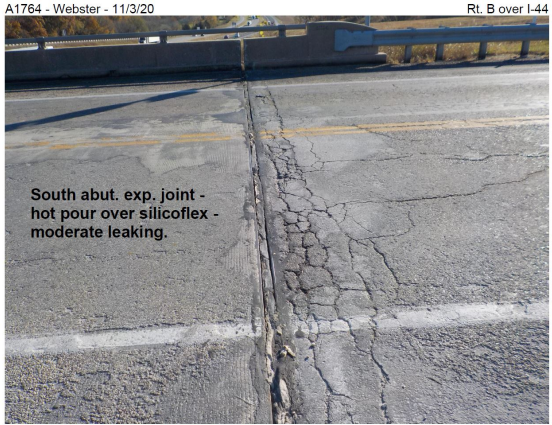
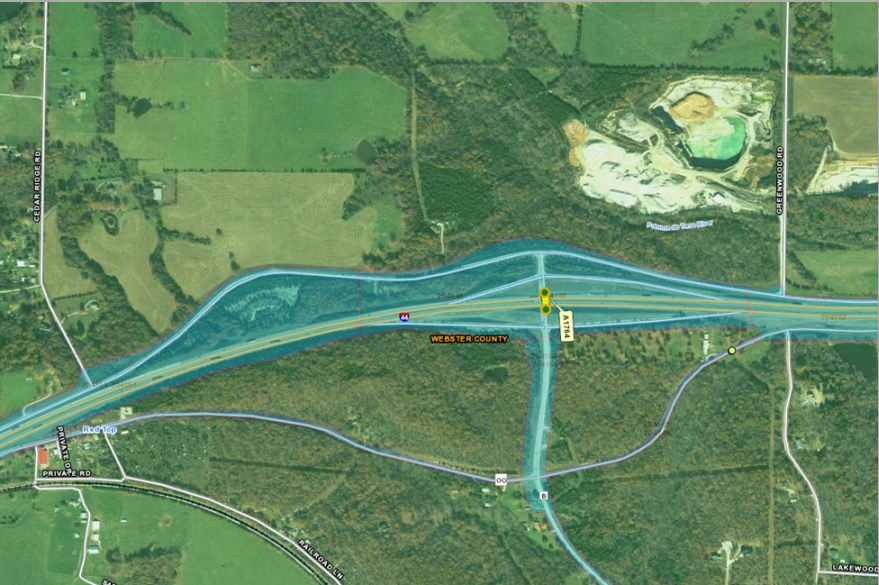
Bridge #A1764

Mandatory:	N	AADT:	1174
Ratings:	5,6,6	Truck %:	11.2
Min Treatment:	Redeck-Replace	Existing Bridge Type:	Wide Flange Girder
Potential Grade Change:	0'-10"	I44 Incident Bypass Route:	
Crossing Type:	Interstate

- Lile Quarry (with multiple contractors) and Rost ready mix cross this bridge multiple times daily.
- Guardrail damage consistent on the WB I-44 on Ramp due to tight radius for semi traffic.
- Also known as Northview bridge, we own gated lot on the NW side (on Evergreen pkwy) of this site if needed for site prep or storage area.
- Outer Roads go to MO125
- Be conscious of sight distance of ramp tie-ins if replaced
- 3 crashes typical of intersection angle and turning

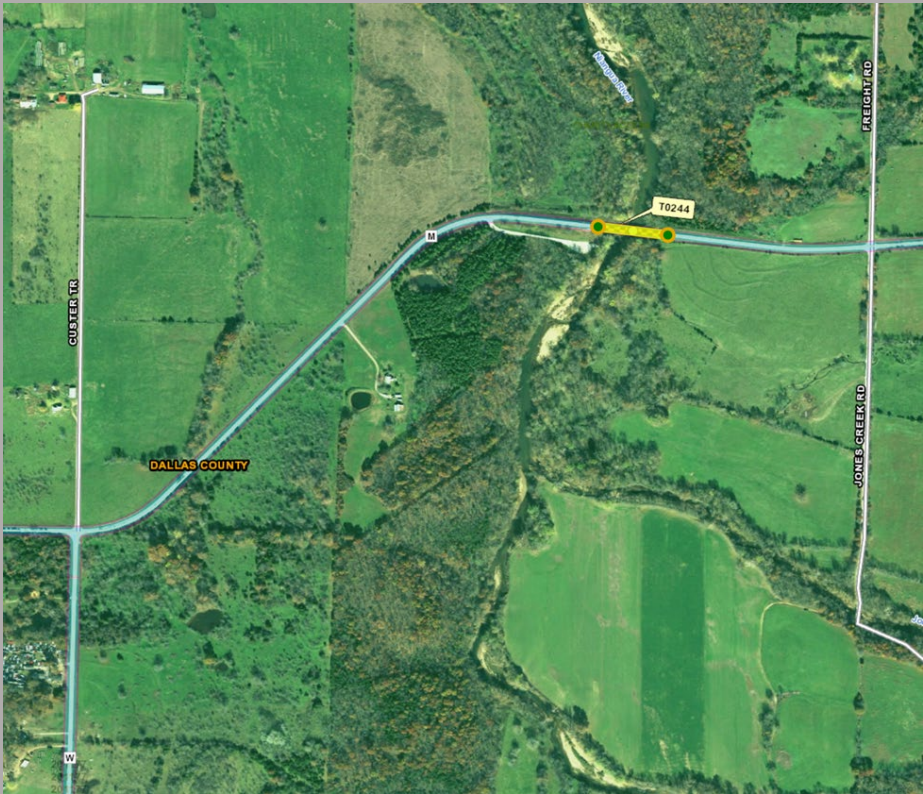
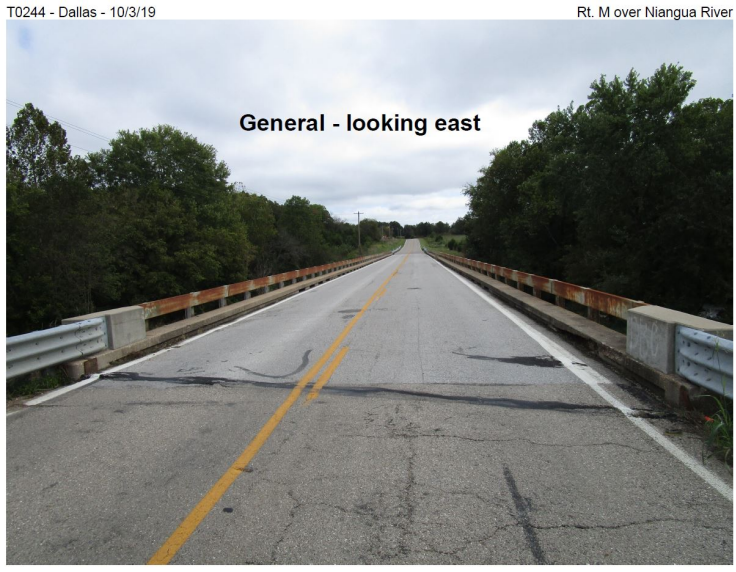
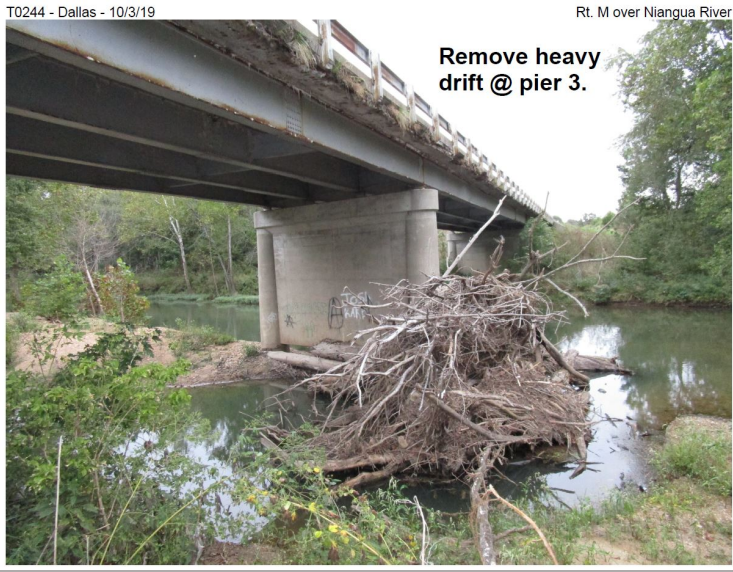
Mandatory:	N	AADT:	487
Ratings:	4,5,6	Truck %:	13.6
Min Treatment:	Replacement	Existing Bridge Type:	Wide Flange Girder
Potential Grade Change:	0.04'	I44 Incident Bypass Route:	No
Crossing Type:	Water

- No known issues of water overtopping
- Minor drift issues – hard to remove
- Farming/ dump trucks/trash trucks/grain trucks;Local/semi-local trucking transport & deliveries such as live poultry & livestock, milk, feed; regional trucking using Route M as a by-pass between I-44 and US 65, local farmers and equipment
- Undeveloped Conservation land underneath, public river access, boat ramp. No known established encampments.
- Powerline on N side
- Steep slopes
- No crashes

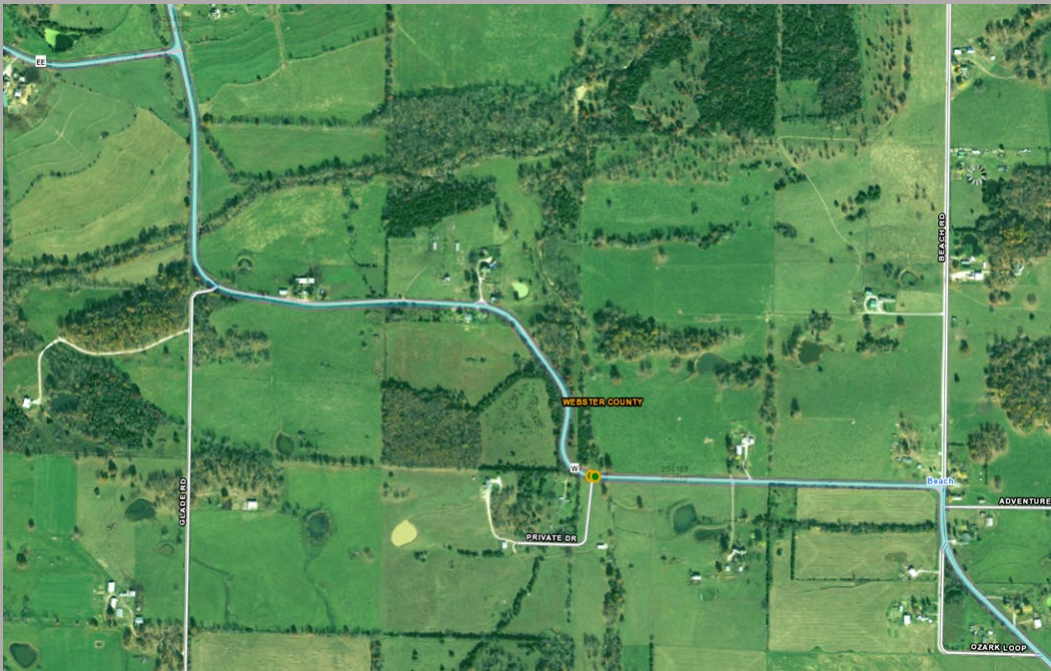
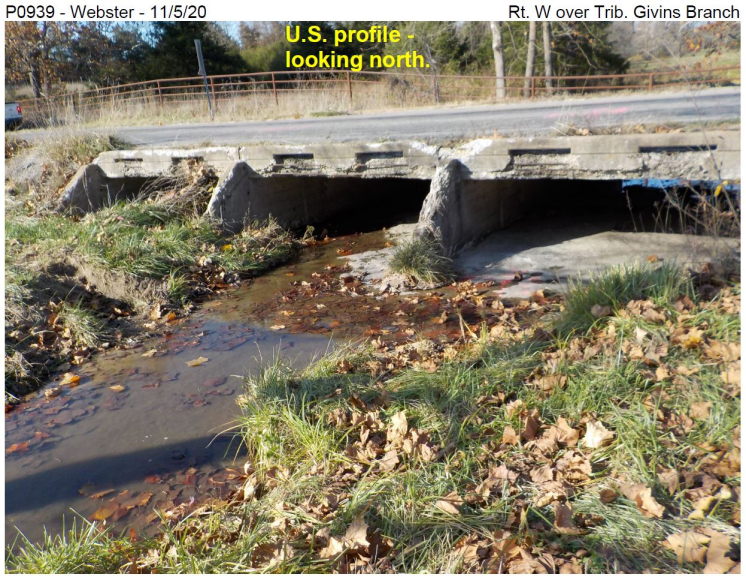
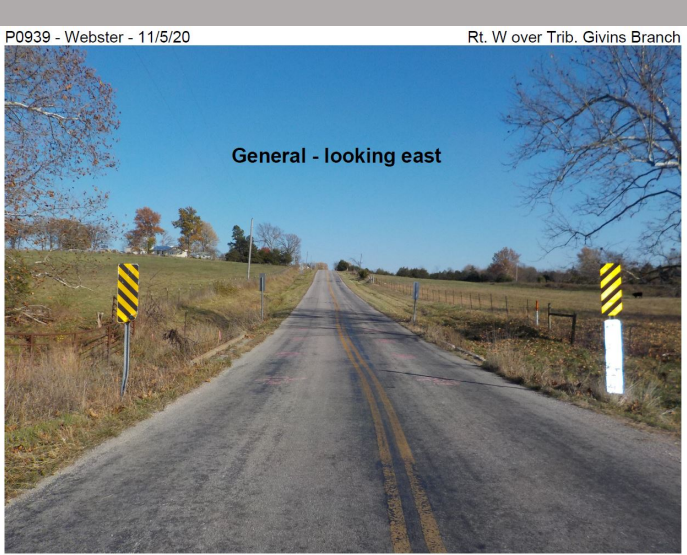
Bridge #P0939

Mandatory:	N	AADT:	439
Ratings:	4	Truck %:	11.4
Min Treatment:	Replacement	Existing Bridge Type:	Concrete Triple Box Culvert
Potential Grade Change:	4.17'	I44 Incident Bypass Route:	No
Crossing Type:	Low Water

- Low water crossing
- Maybe once per year at the most that we know of and only during extremely heavy localized flash flooding events
- About how deep does the water get when it goes over? **2'**
- How far up the road from the bridge ends does the water reach when water over tops? **50 - 150'**
- Convenience store food service and fuel trucks, feed trucks, milk trucks, some logging trucks. No established industry other than farming.
- West (north) end of culvert approach is just at the base of a sharp, elevated curve with minimal sight distance for traffic. Driveway entrances immediately adjacent to the culvert.
- R/W tight
- Buggy traffic
- Overhead lines on N side
