MEMORANDUM
Missouri Department of Transportation

SUBJECT: District St. Louis - Design
Route 231, St. Louis County
Route 231 Rehabilitation
Job No. 6S3275 (HR Green Project No. 171052)
Conceptual Study Report

SUBJECT: Condition Survey
Job No.: J6S3275
Route: 231, St. Louis County

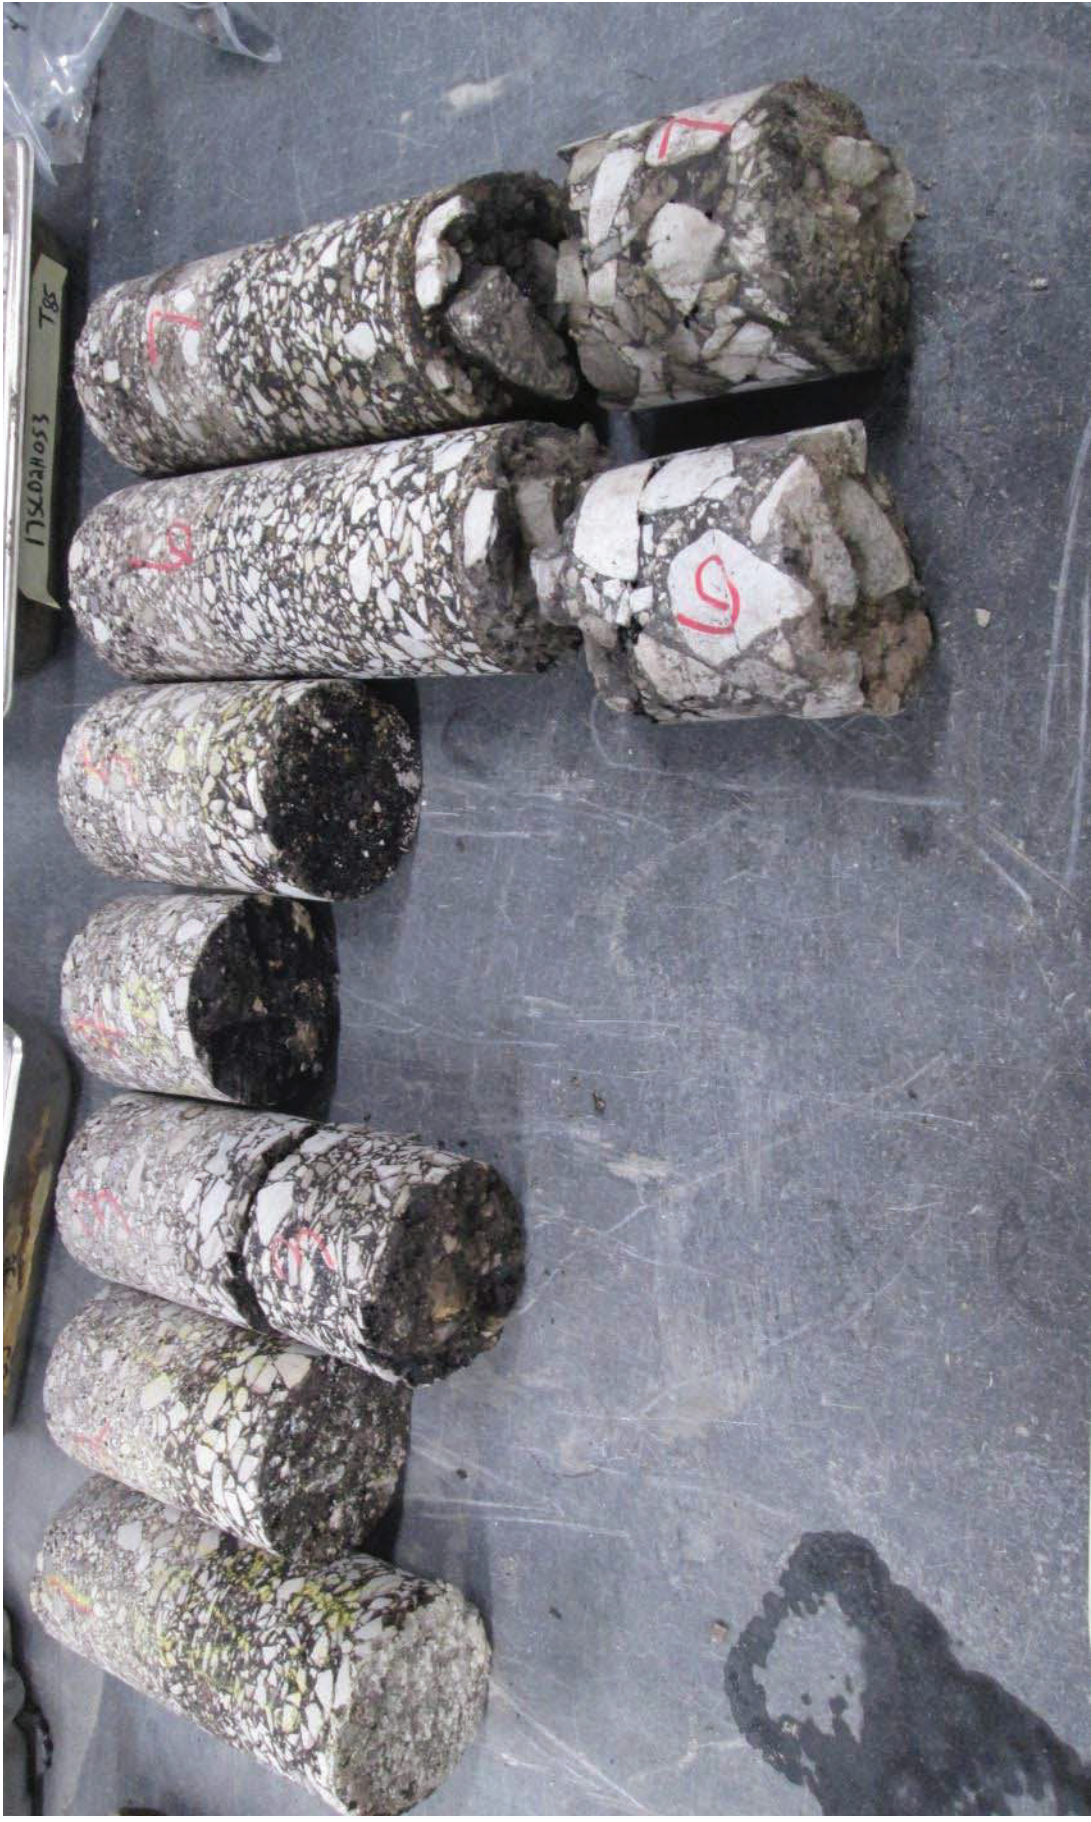
Cores 1 through 7 from left to right

Based upon the condition survey, the top 3 ¾-inches of the previous SuperPave material is in good condition with minimal stripping. The majority of the lifts appear to be bonded. Severe stripping and unstable material was noted at the bottom asphalt lifts from older pre-SuperPave asphalt mixtures. The core below illustrates the typical condition of the pavement section.

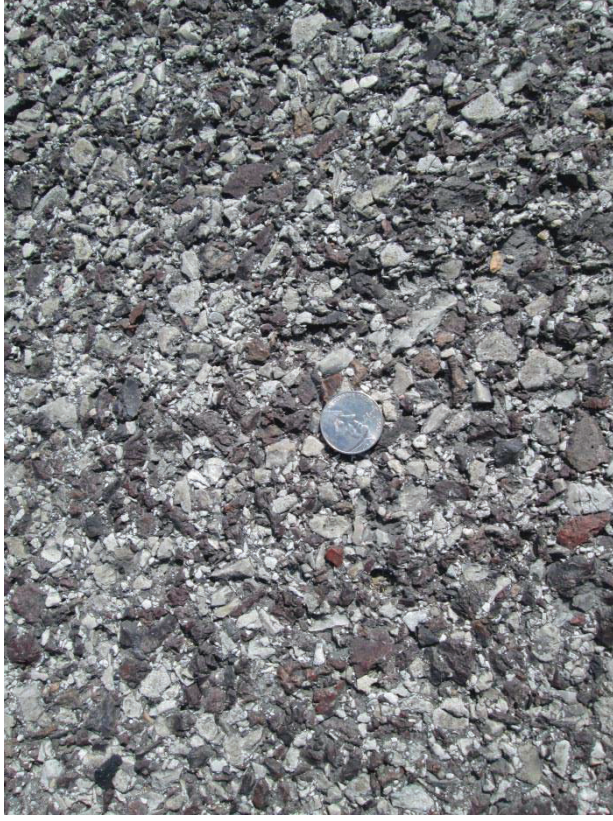
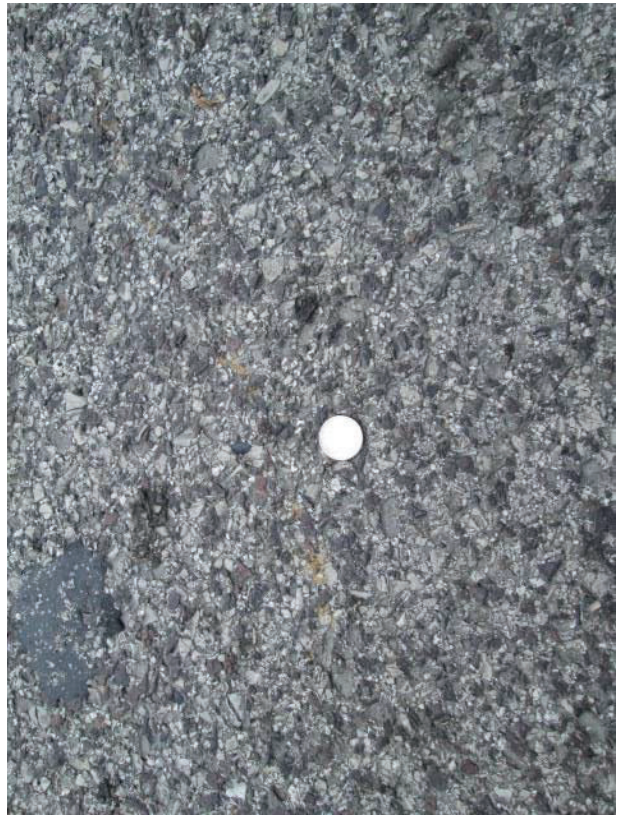
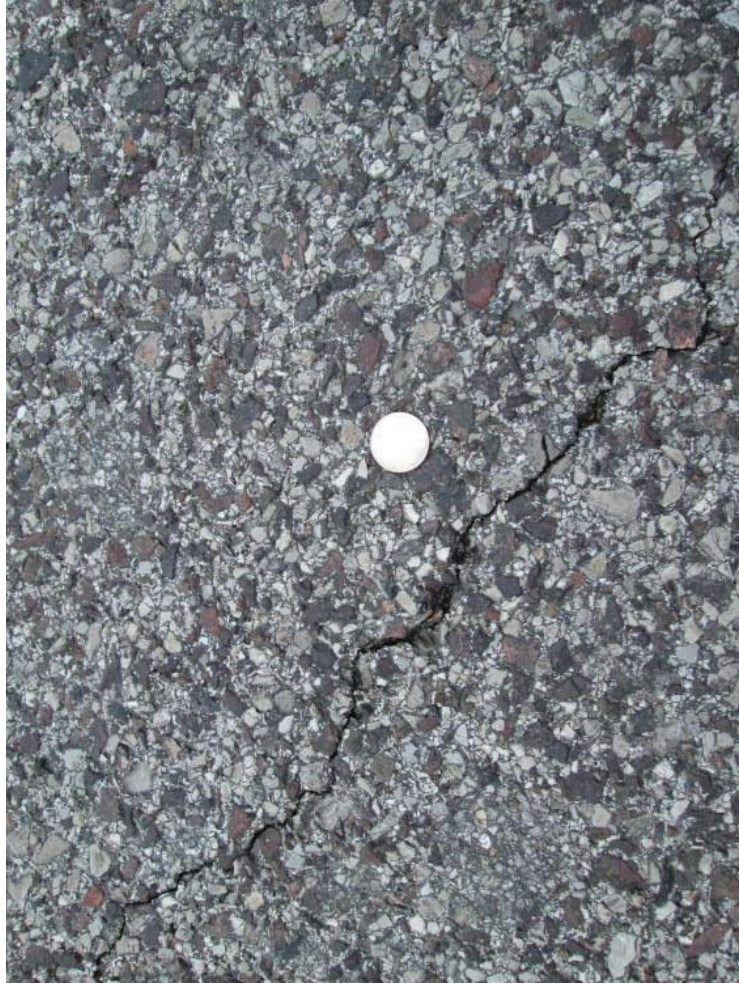
Macrotexture

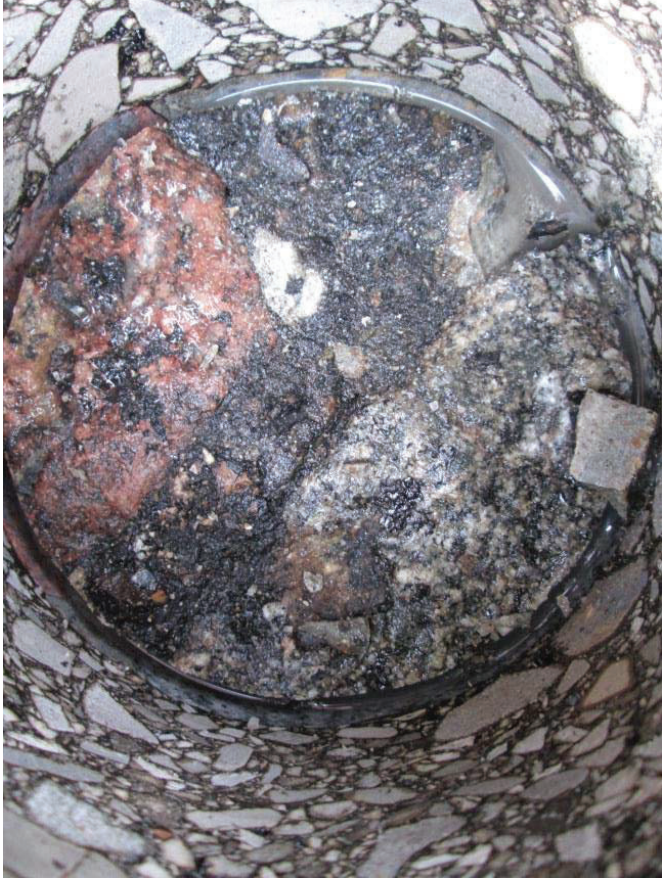
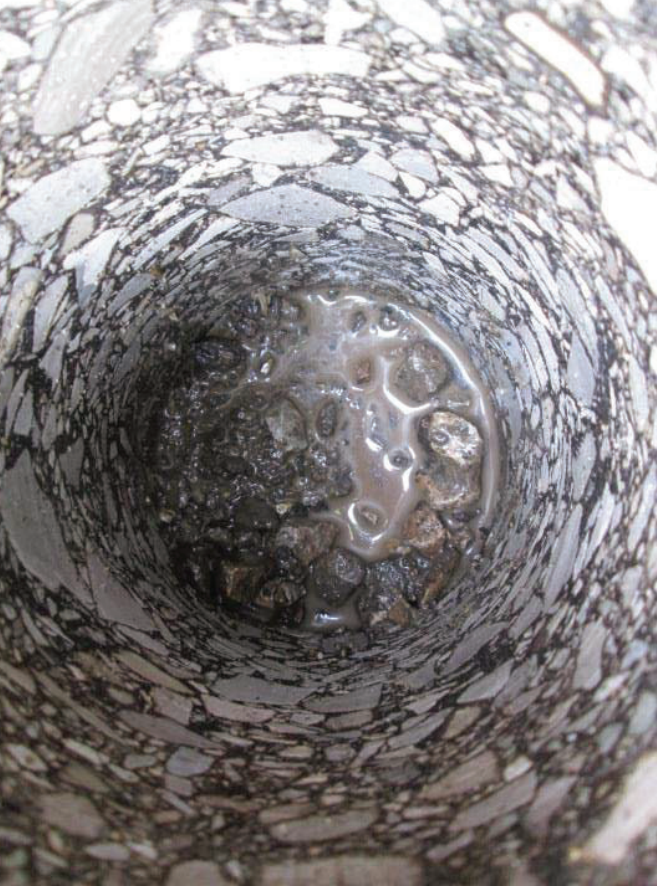
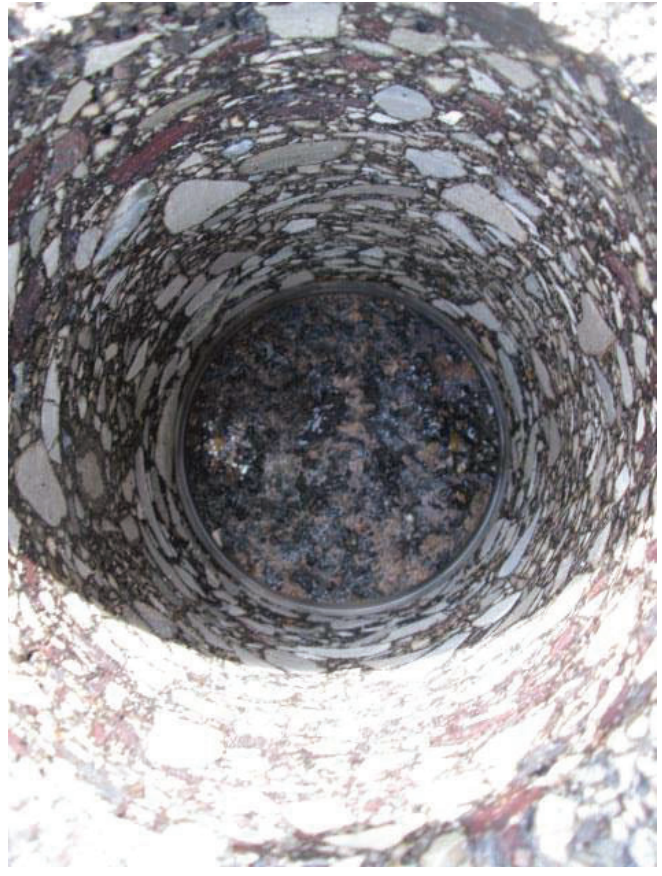
Underlying materials vary greatly

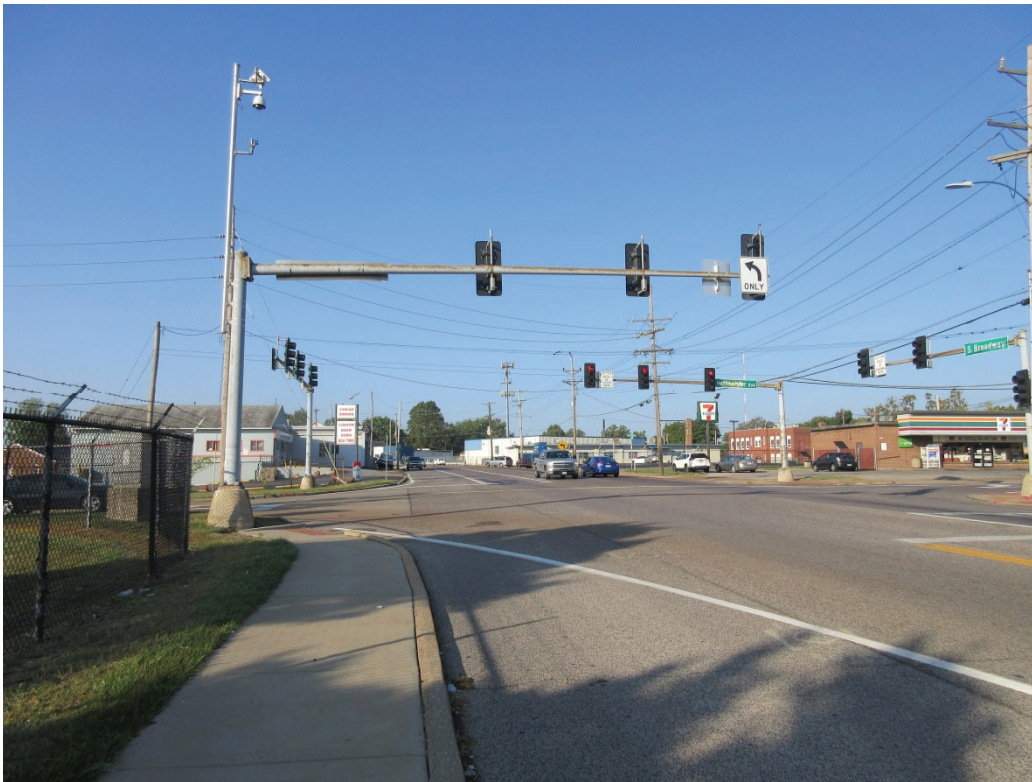
Figure 15: Route 231 at Hoffmeister Avenue (Southbound)

The traffic signal operates with a protected/permissive flashing yellow arrow for the northbound left turn phase, and a permissive only southbound left turn. The side streets operate with permissive only left turn phasing. The controller is located in the northeast quadrant and in-line with potential improvements at that corner. The traffic signal is controlled with a Siemens M60 controller. The cabinet is equipped with 12-position load switch bays, of which phases 1 – SB Left, 2 – NB Thru, 3 – WB OL , 4 - EB, 5 – NB Left, 6 – SB, 7 – EB OL, 8 – WB, and 9 – NB OL are currently being utilized. Existing vehicle detection appears to be accommodated with a Gridsmart video detection system. See **Figures 14 and 15** in the Existing Signal Conditions Appendix for photographs of this existing signalized intersection. Aerial photography and review of St. Louis County parcel information boundaries indicate that all signal equipment appears to be within the existing right-of-way or easements.
