RECEIVED**BRIDGE REPORT**

COUNTY St. Francois PROJ. NO. S-1291(2) STA. NO. 57+93.65 BRIDGE NO. _____ DESIGN NO. Y-935*ON ROAD FROM Pilot Knob TO Mineral City : 4.3 MILES N. E. OF Pilot KnobBRIDGE OVER Brewers Creek SEC. 15 TWP. 34 N. RG. 4 E.REPORTED BY O. A. Wetzel DATE 4-2-52

BRIDGE INSPECTION REPORT

COUNTY St Francis ROUTE NUMBER V BRIDGE NUMBER Y935
 DATE OF INSPECTION 4-15-54 INSPECTION MADE BY JAW
 TYPE OF SUPERSTR. 3-10' conc slabs TYPE OF SUBSTR. conc bents & abut

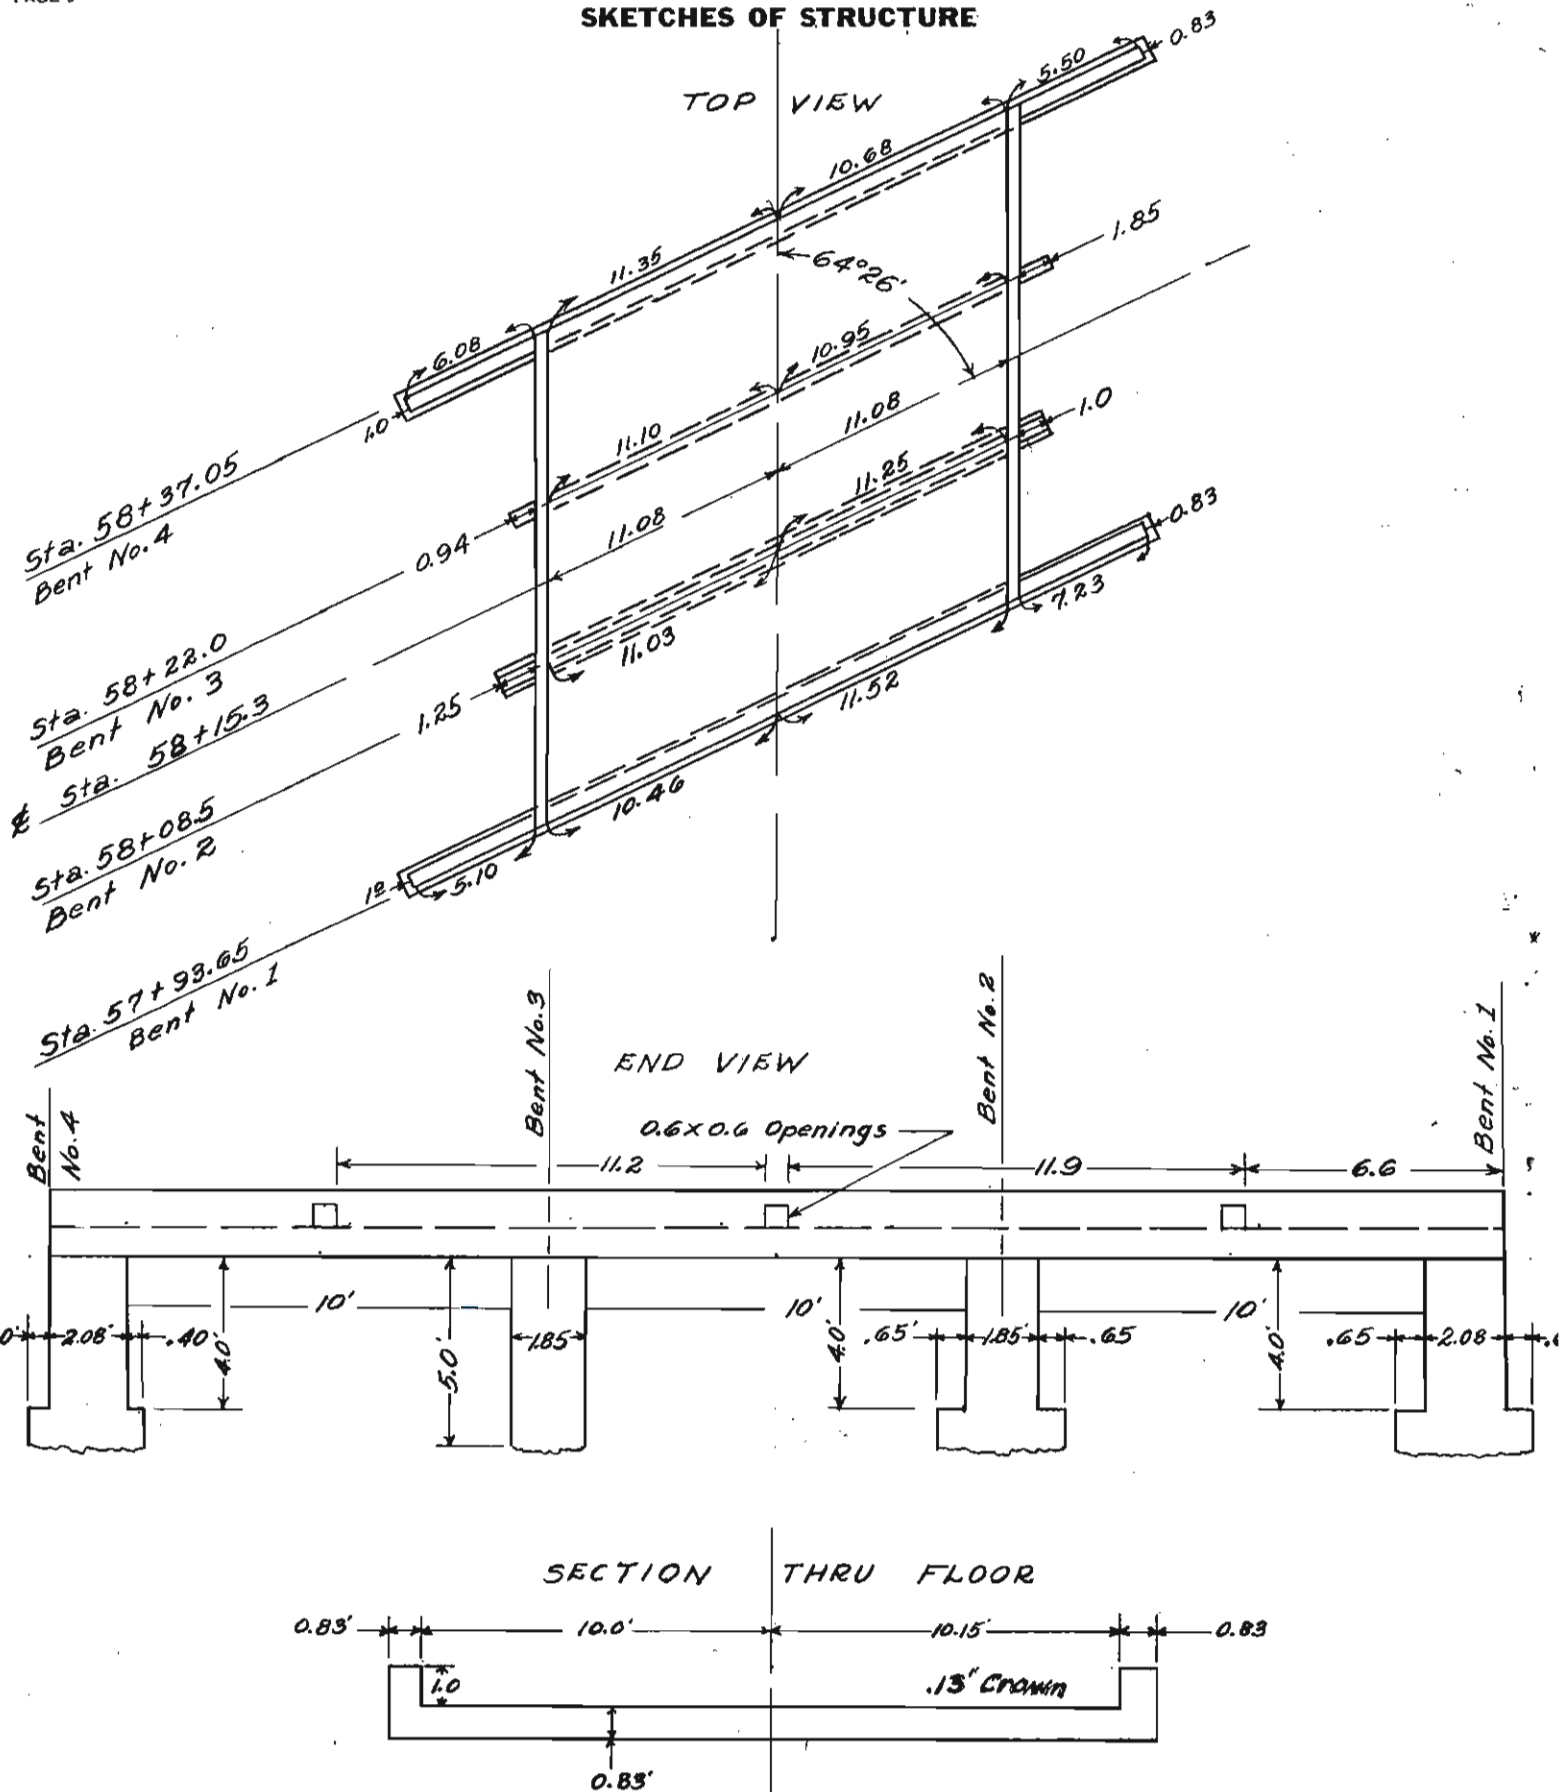
SKETCHES OF STRUCTURE

The #2 pier on the upstream end has been undermined by the water so that the pier is broken approximately 8' from the upstream side, and the pier has settled so that there is an opening of approximately $\frac{1}{4}$ " to $\frac{1}{2}$ " between the top of the pier and the bottom of the floor slab.

We believe that this structure may be satisfactorily repaired by building concrete aprons (tee walls) across the channel between the wings and paving the flow line with grouted rock. The holes at the upstream end of the intermediate walls may be completely filled with concrete while paving the flow lines. Attached is a sketch indicating the above described work.
