Missouri Department of Transportation

STRUCTURAL REHABILITATION CHECKLIST

Bridge No.: **A6500**

Route: **I-70**

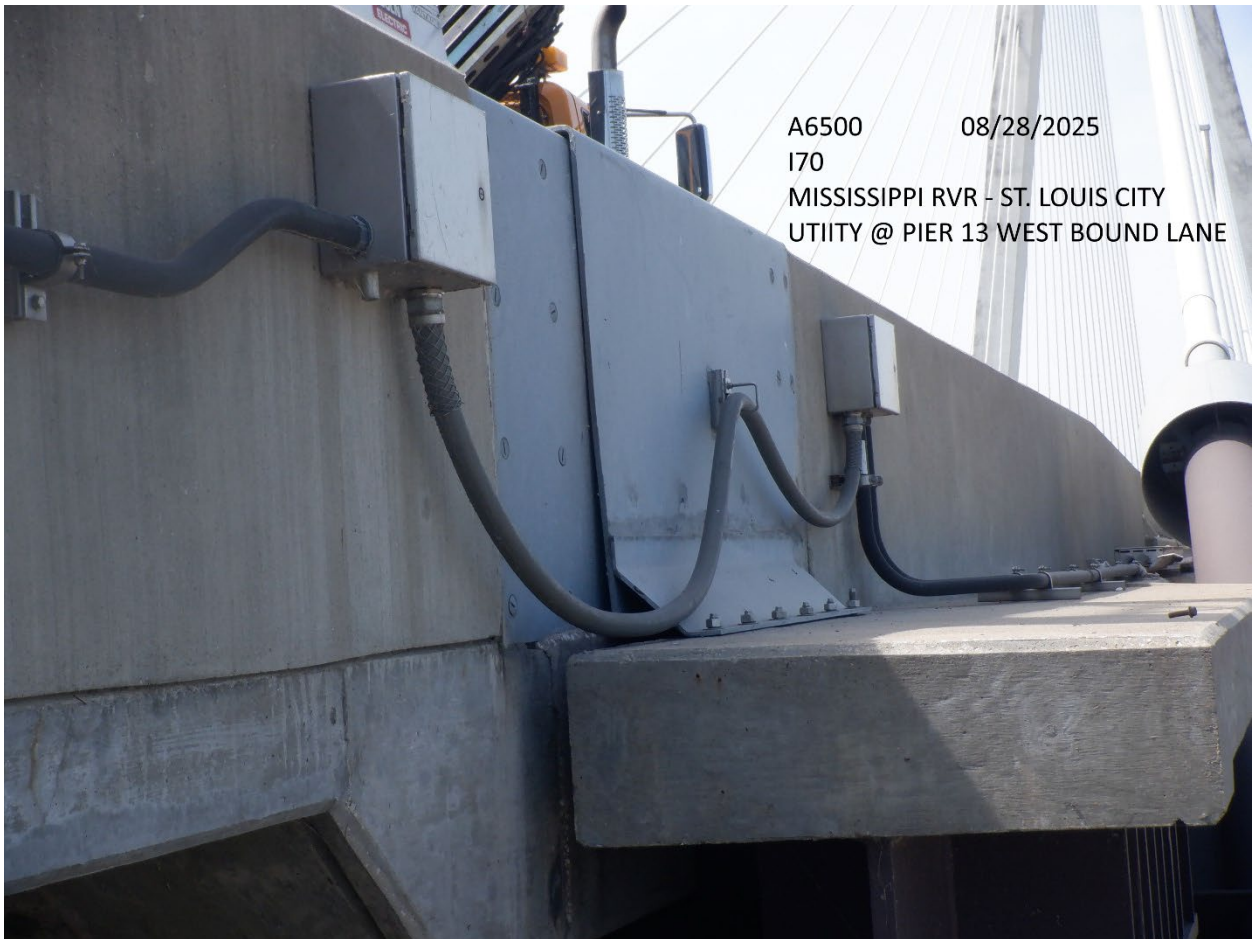
A6500 08/28/2025
I70
MISSISSIPPI RVR - ST. LOUIS CITY
UTILITY @ PIER 13 WEST BOUND LANE

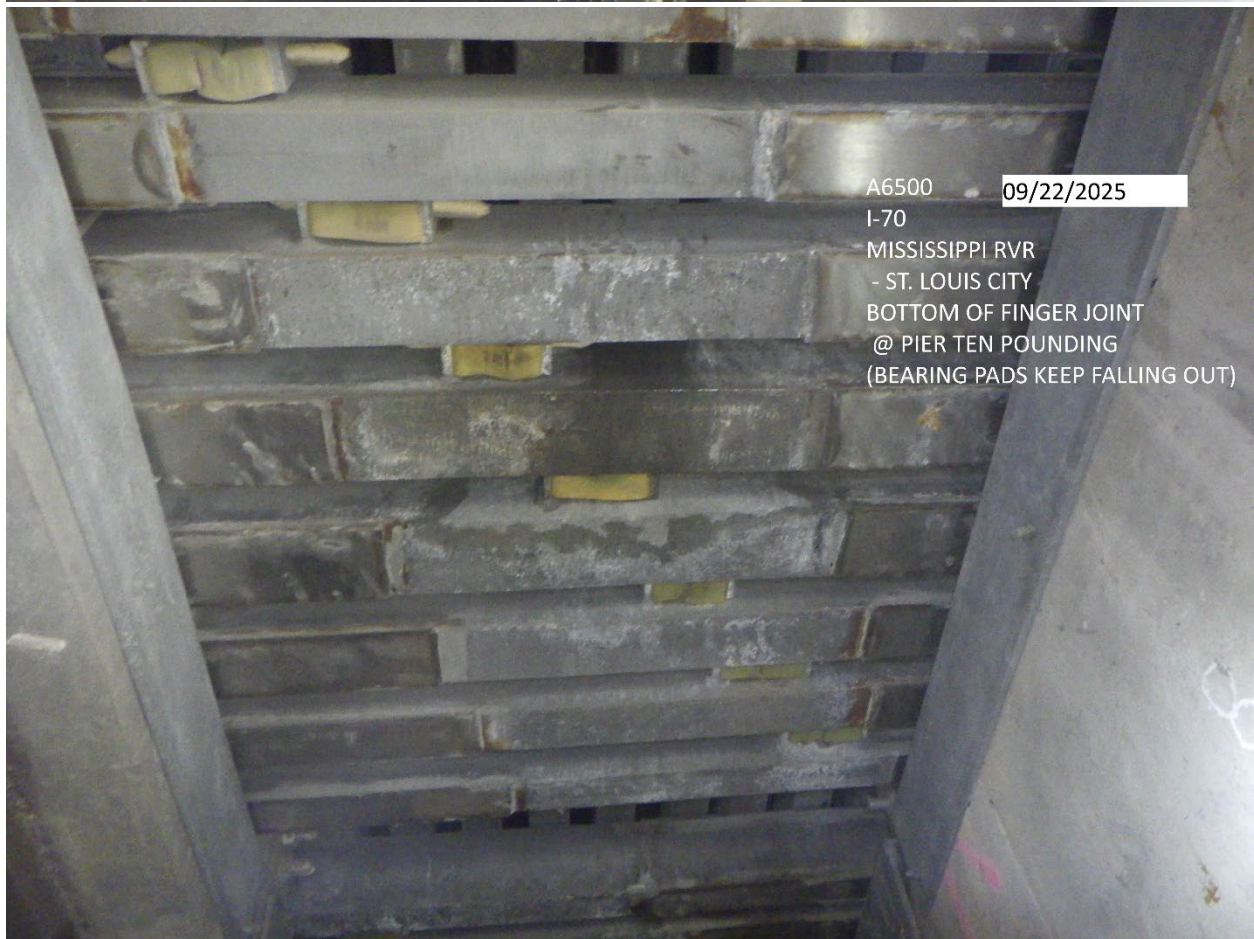
A6500 09/22/2025
I-70
MISSISSIPPI RVR
- ST. LOUIS CITY
BOTTOM OF FINGER JOINT
@ PIER TEN POUNDING
(BEARING PADS KEEP FALLING OUT)

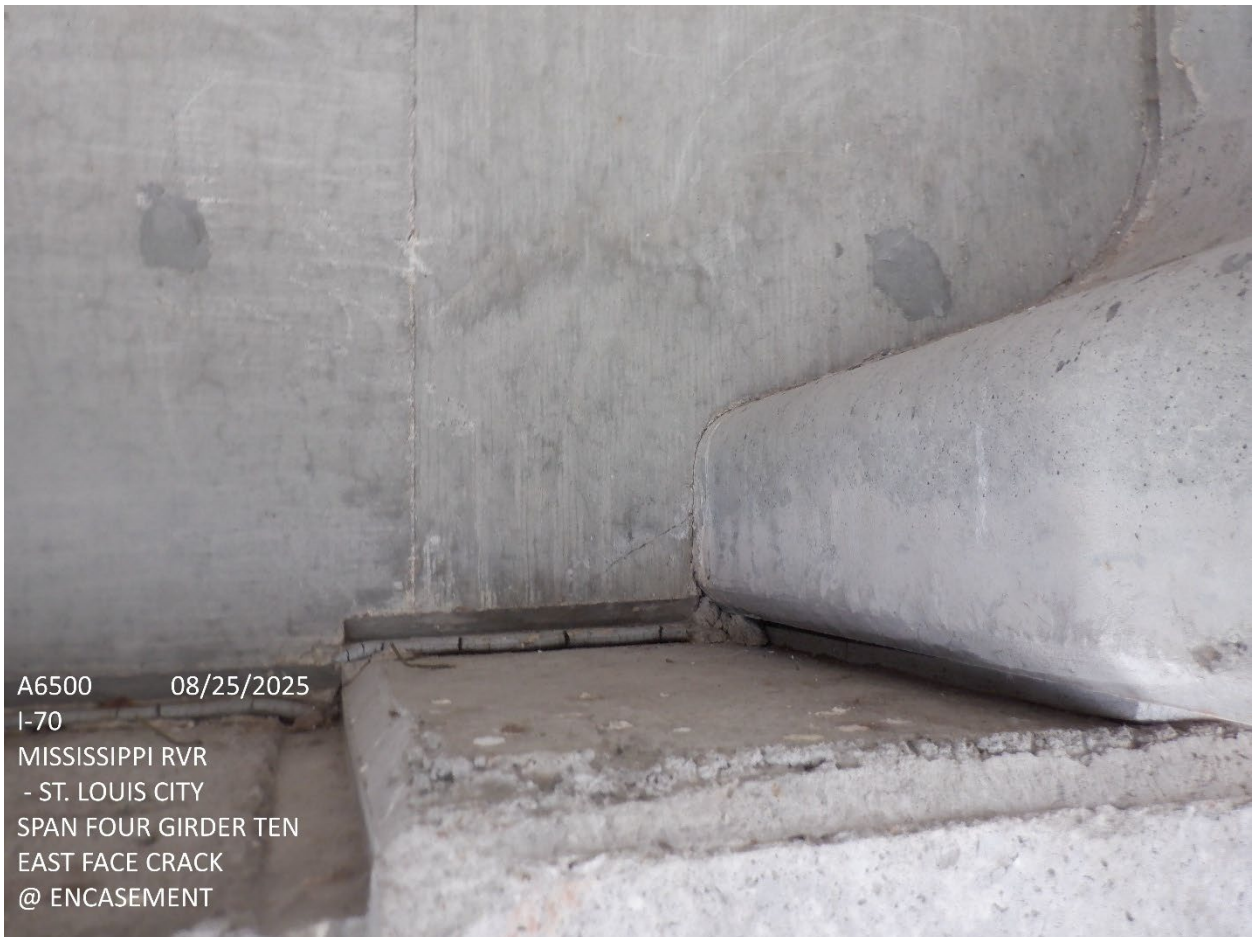
A6500 08/25/2025
I-70
MISSISSIPPI RVR
- ST. LOUIS CITY
SPAN FOUR GIRDER TEN
EAST FACE CRACK
@ ENCASEMENT

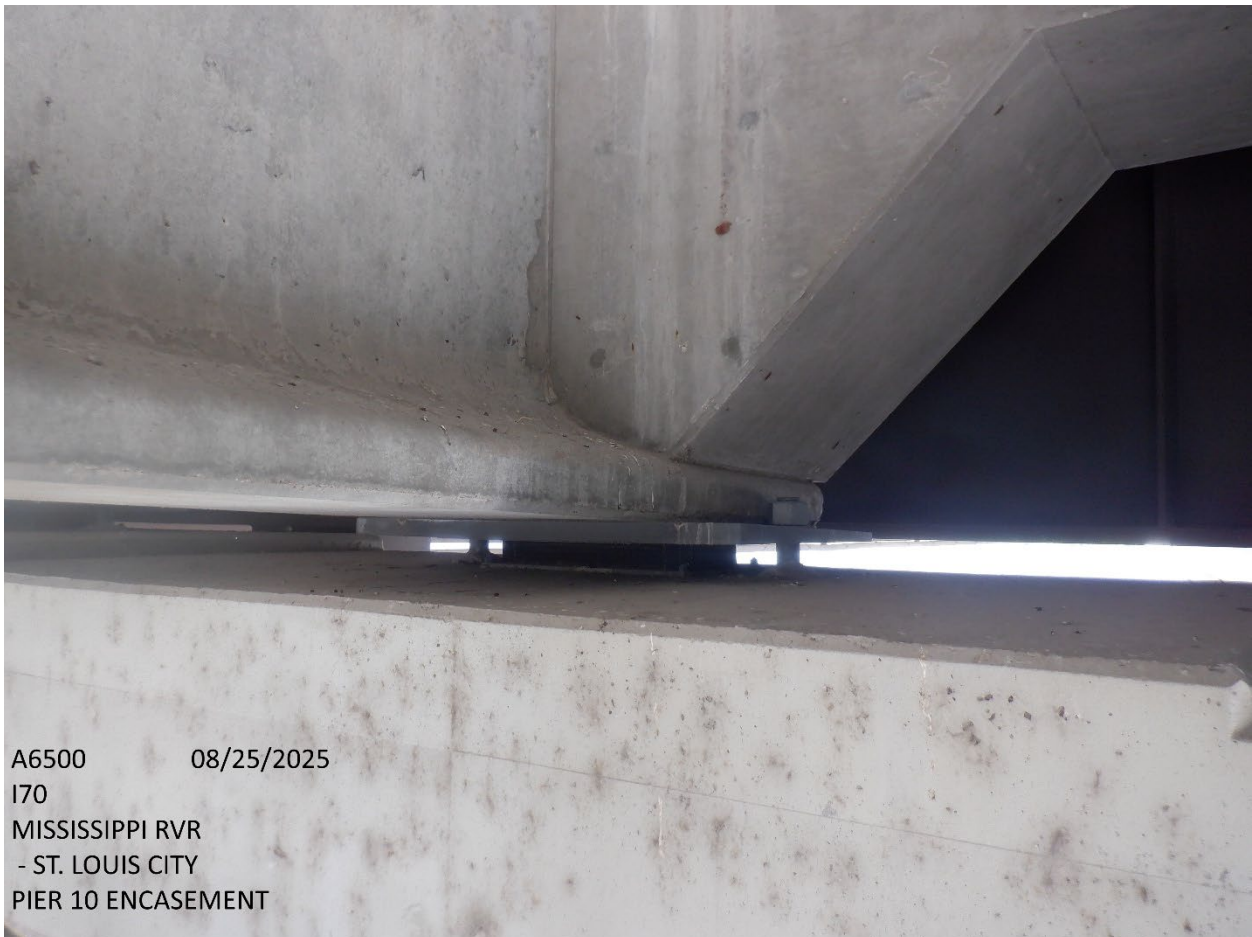
A6500 08/25/2025
I70
MISSISSIPPI RVR
- ST. LOUIS CITY
PIER 10 ENCASEMENT

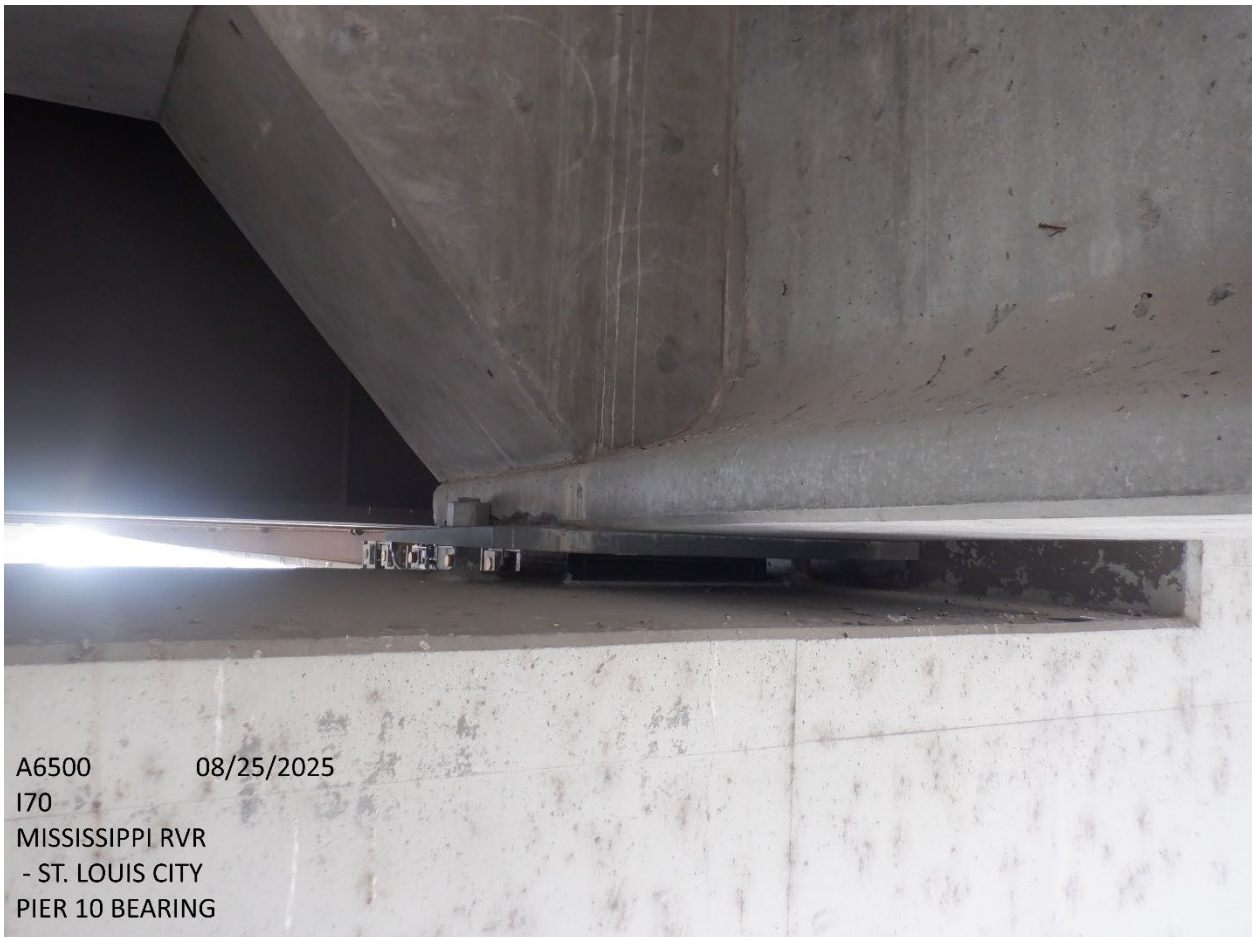
A6500 08/25/2025
I70
MISSISSIPPI RVR
- ST. LOUIS CITY
PIER 10 BEARING

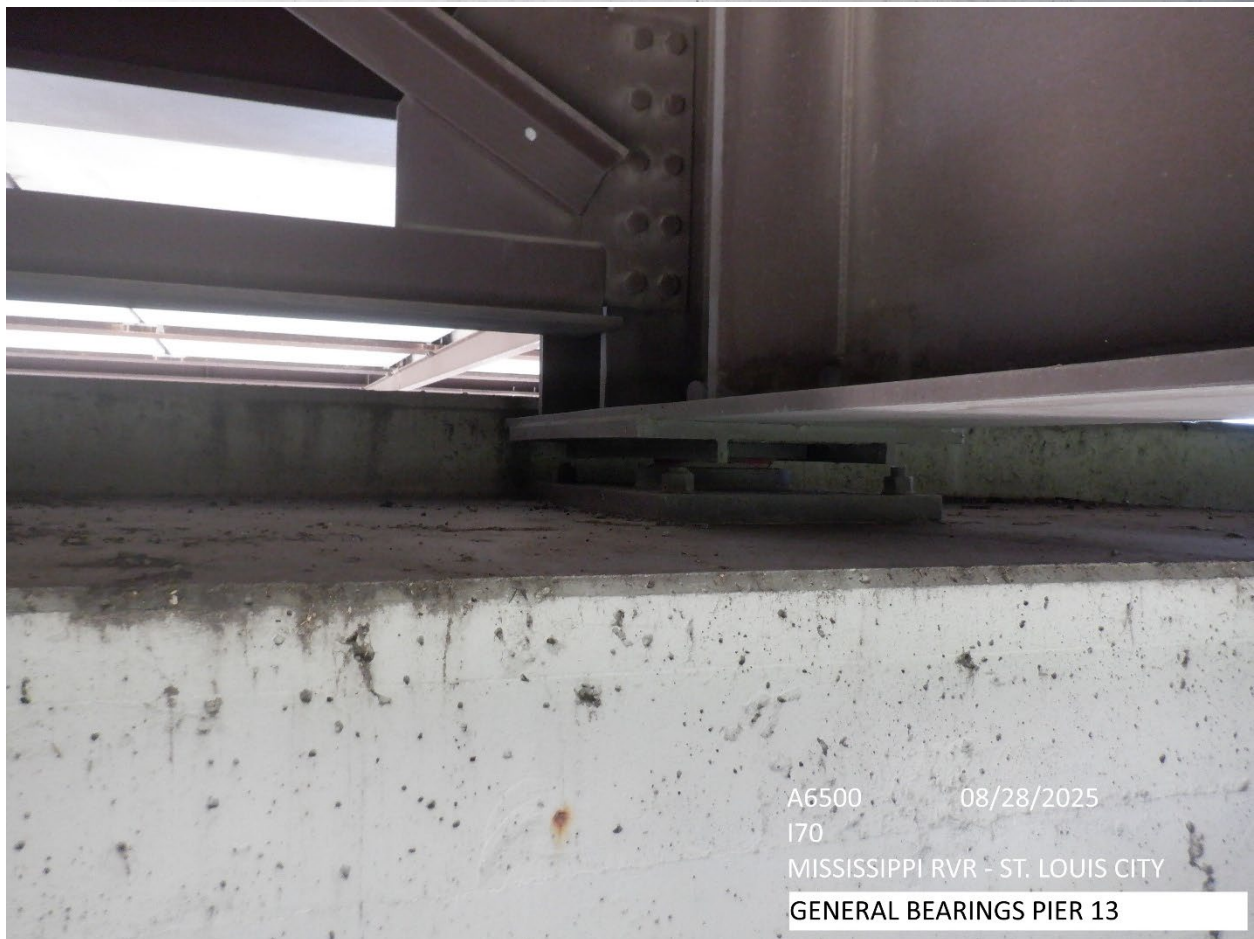
A6500 08/28/2025
I70
MISSISSIPPI RVR - ST. LOUIS CITY
GENERAL BEARINGS PIER 13

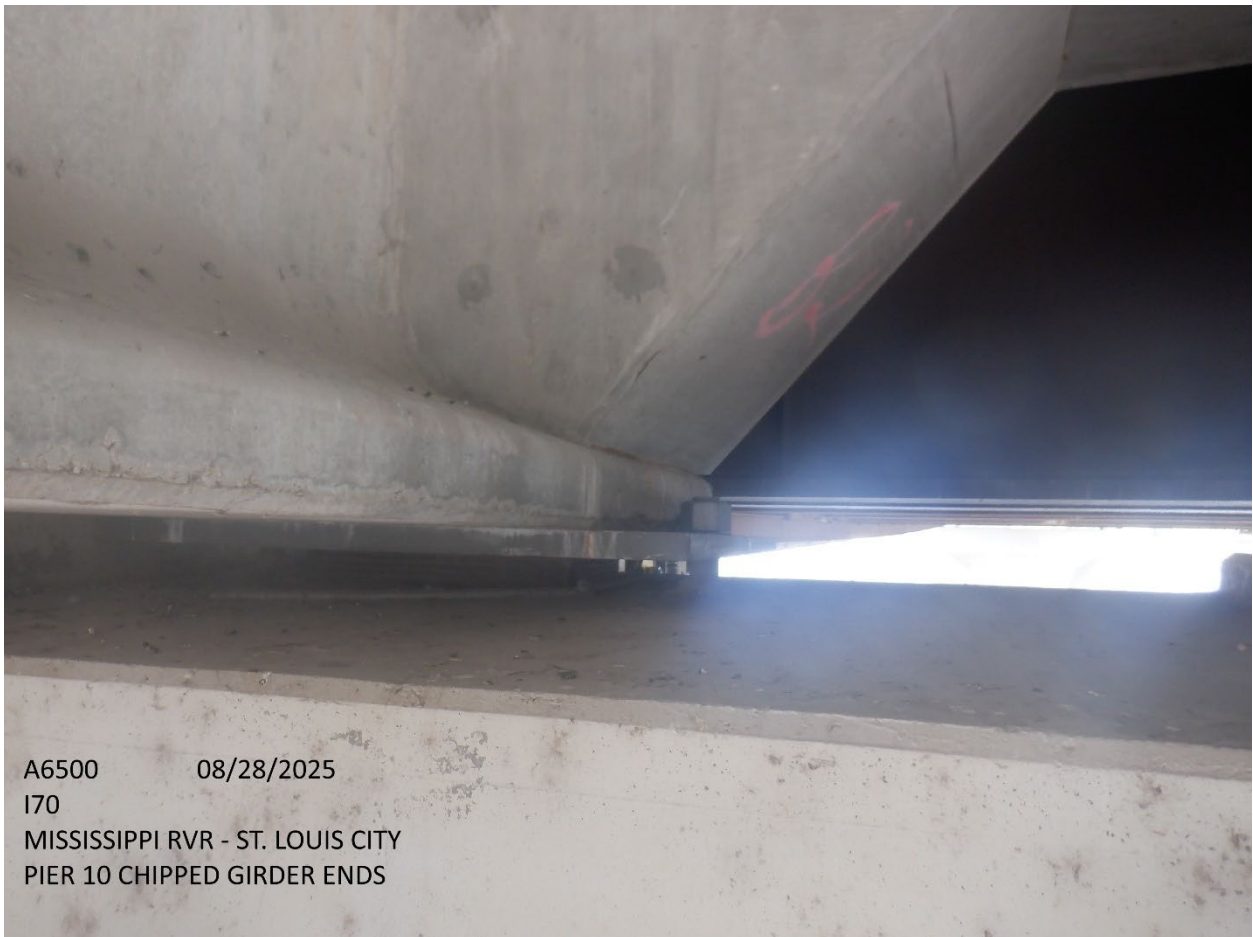
A6500 08/28/2025
I70
MISSISSIPPI RVR - ST. LOUIS CITY
PIER 10 CHIPPED GIRDER ENDS

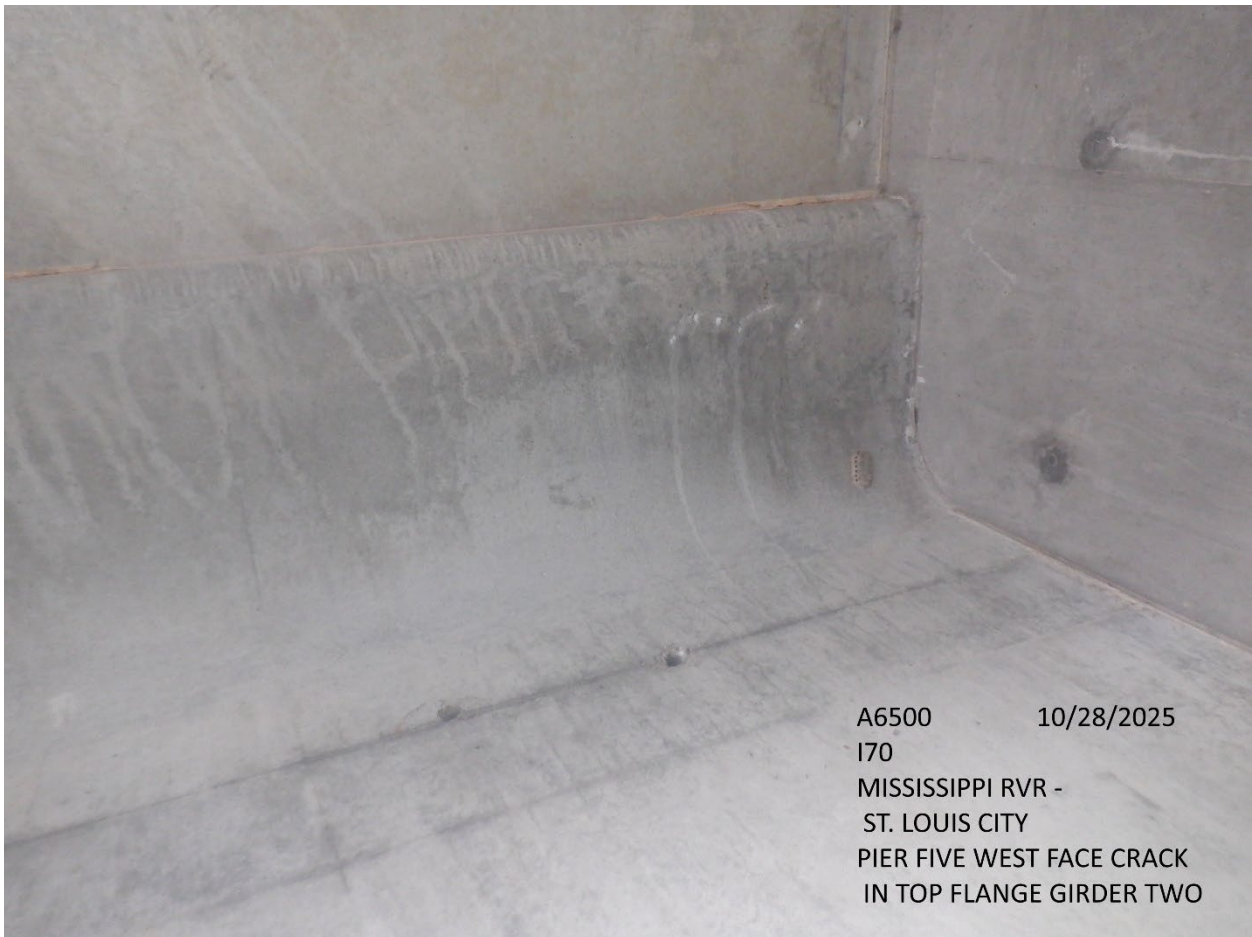
A6500 10/28/2025
I70
MISSISSIPPI RVR -
ST. LOUIS CITY
PIER FIVE WEST FACE CRACK
IN TOP FLANGE GIRDER TWO

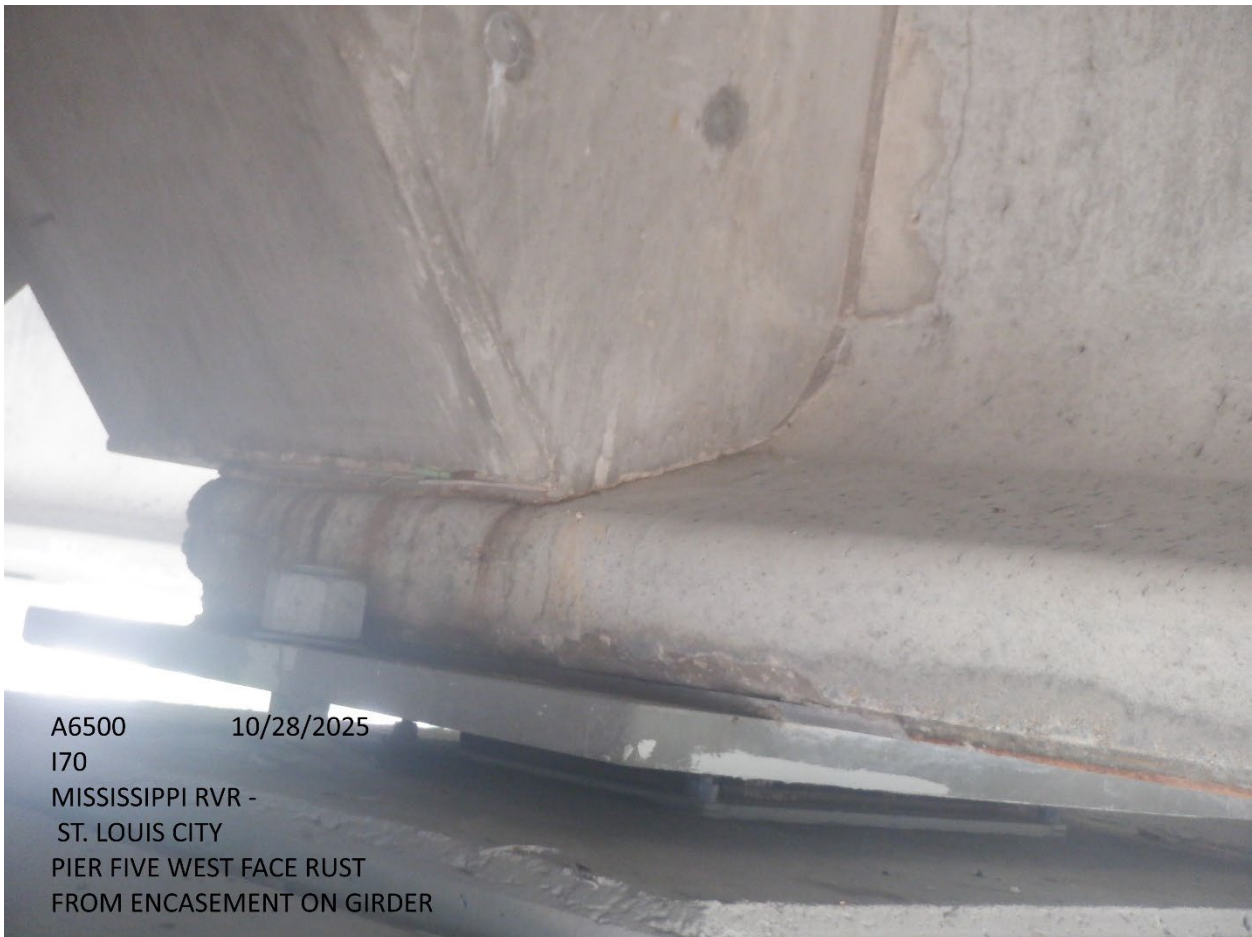
A6500 10/28/2025
170
MISSISSIPPI RVR -
ST. LOUIS CITY
PIER FIVE WEST FACE RUST
FROM ENCASEMENT ON GIRDER

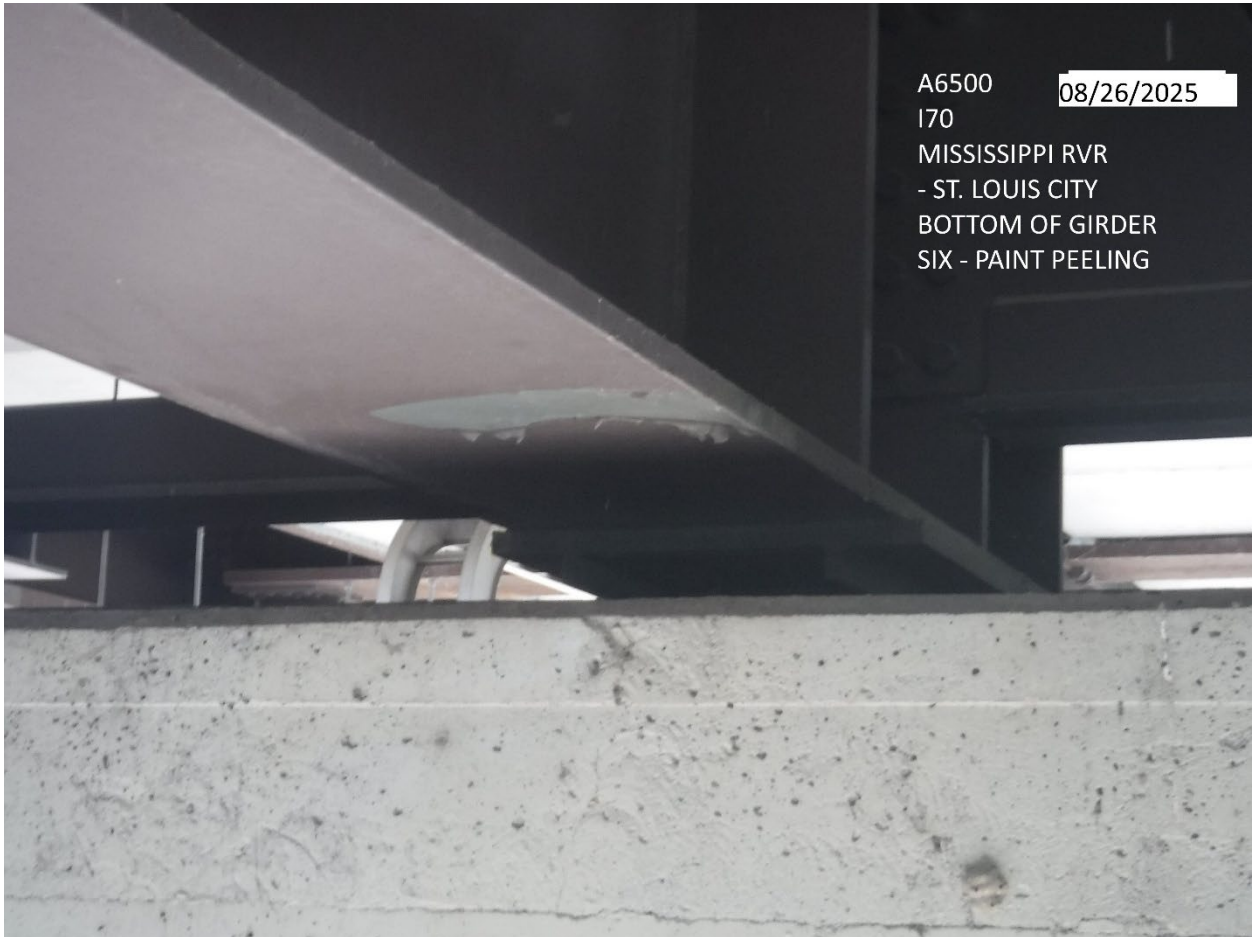
A6500 08/26/2025
170
MISSISSIPPI RVR
- ST. LOUIS CITY
BOTTOM OF GIRDER
SIX - PAINT PEELING

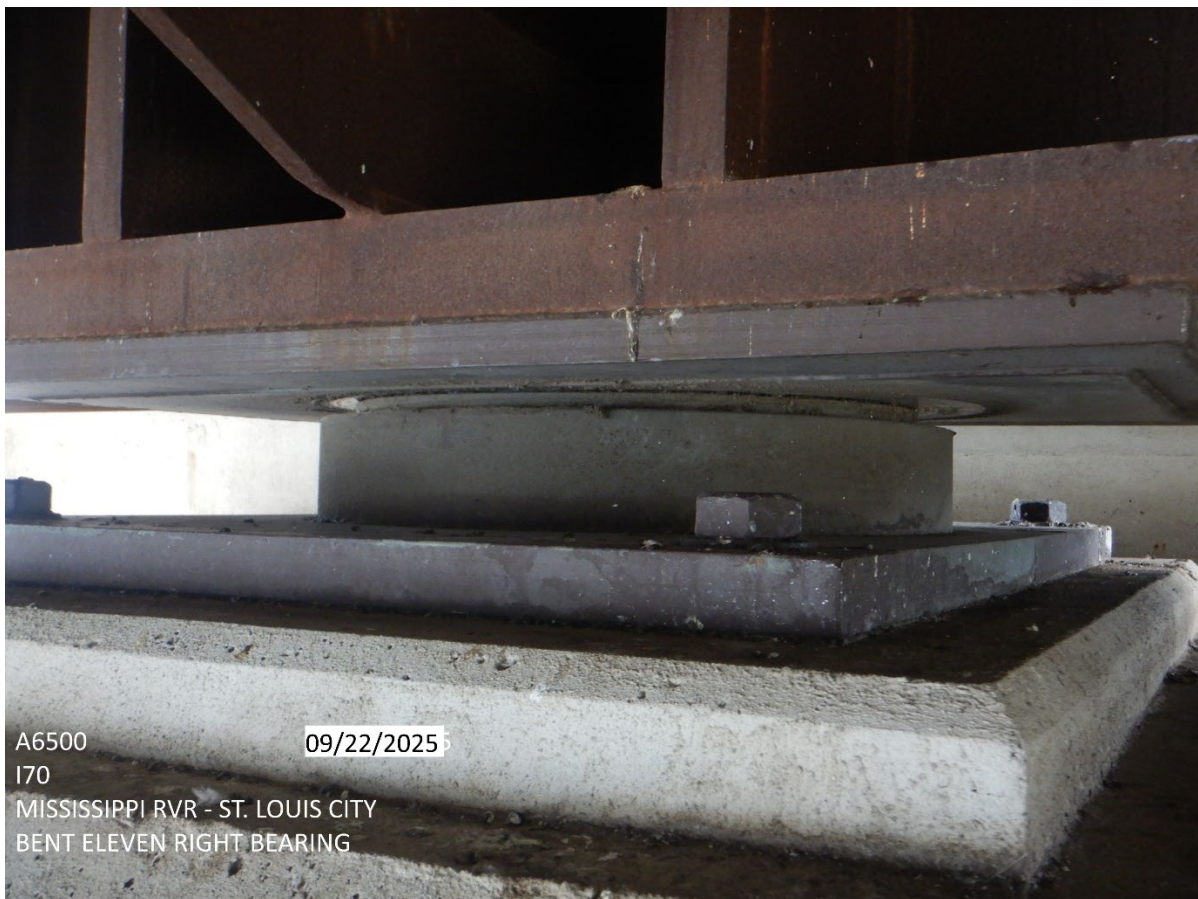
A6500 09/22/2025
I70
MISSISSIPPI RVR - ST. LOUIS CITY
BENT ELEVEN RIGHT BEARING

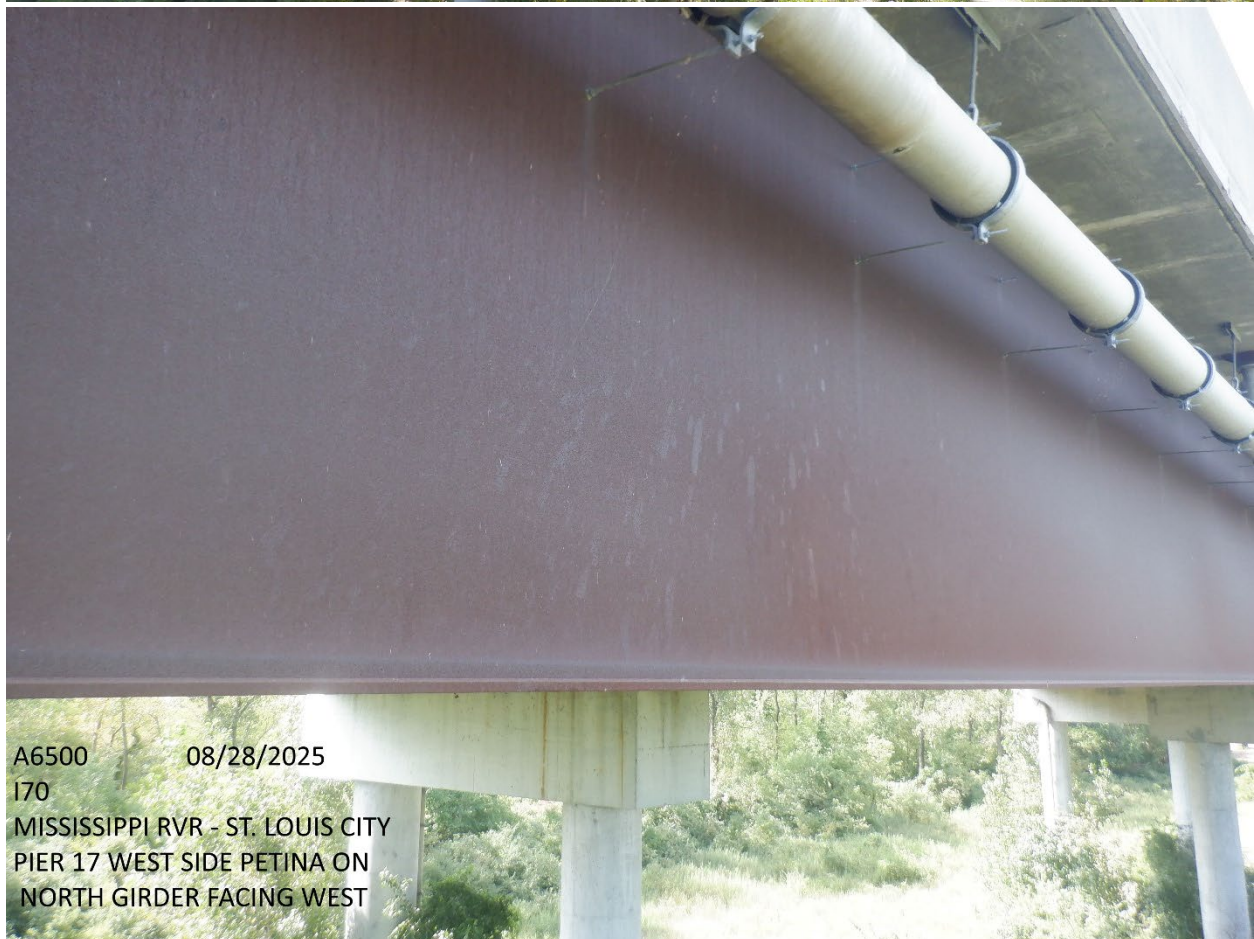
A6500 08/28/2025
170
MISSISSIPPI RVR - ST. LOUIS CITY
PIER 17 WEST SIDE PETINA ON
NORTH GIRDER FACING WEST

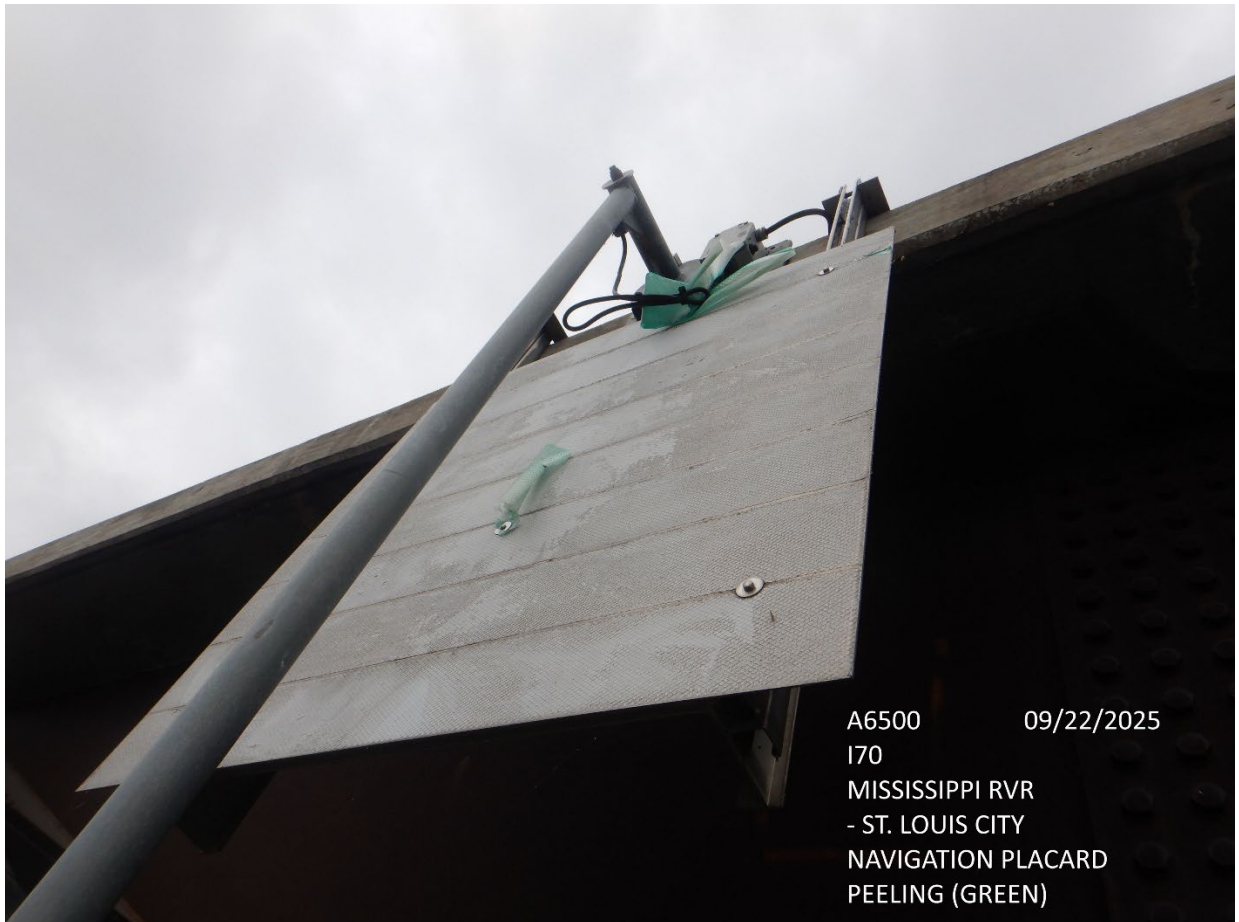
A6500 09/22/2025
I70
MISSISSIPPI RVR
- ST. LOUIS CITY
NAVIGATION PLACARD
PEELING (GREEN)

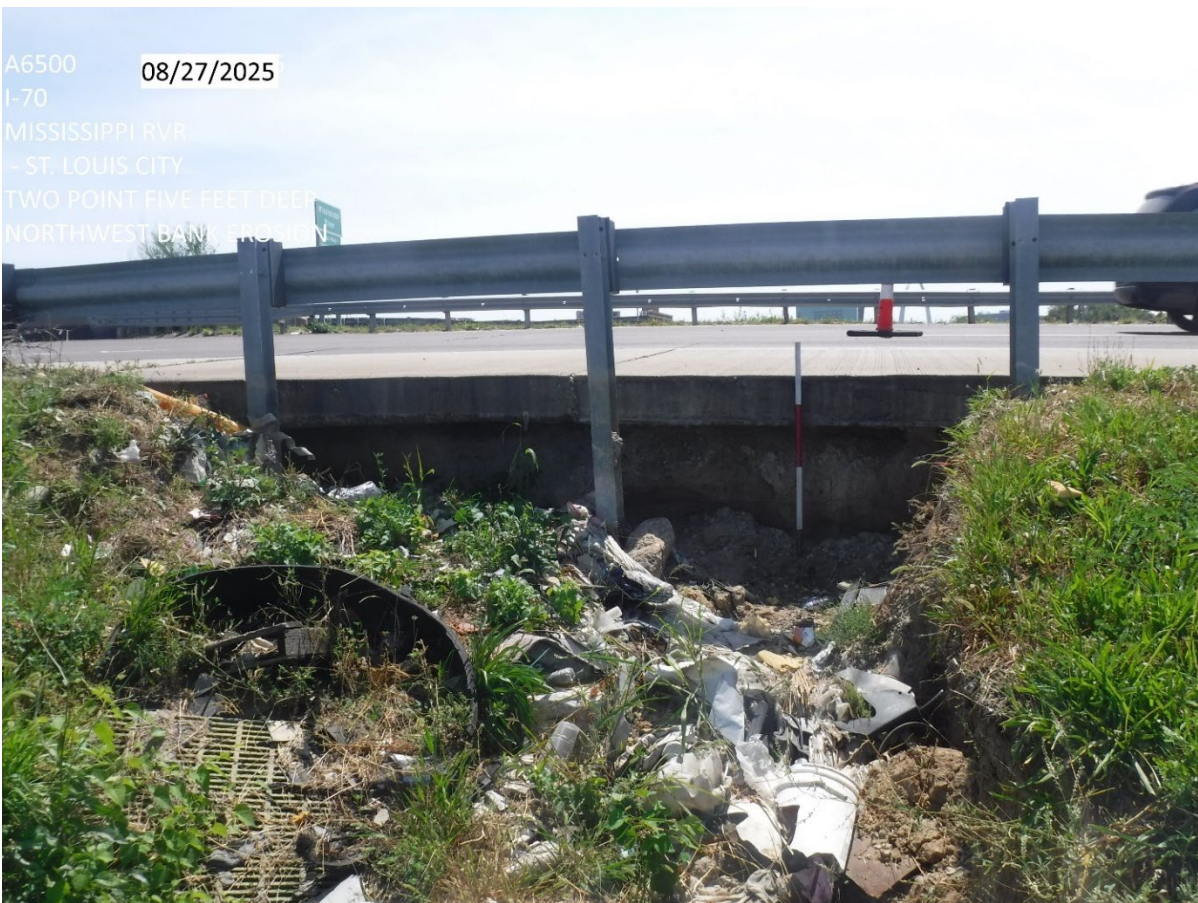
A6500 08/27/2025
I-70
MISSISSIPPI RVR
- ST. LOUIS CITY
TWO POINT FIVE FEET DEEP
NORTHWEST BANK EROSION
