# MISSOURI SCOUR ASSESSMENT FIELD FORM

Date: 2/14/94  
 Inspector: JAY BESTGEN, GARY BAKKE

District # 5  
 Bridge # W-559 BOONE

**SUBJECT:** Materials  
Asbestos Inspection & Heavy Metal Paint Survey  
Route 163  
Bridge W-0559  
Boone County

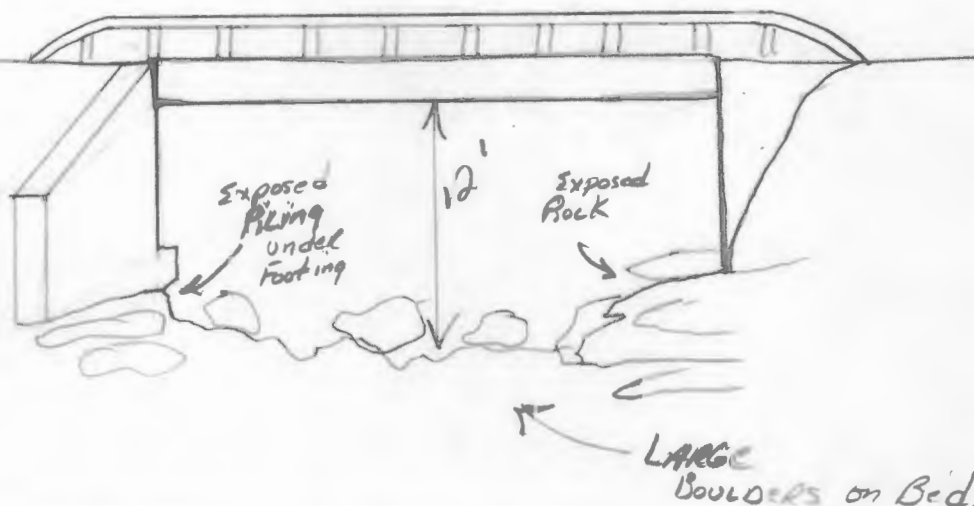
## Sketch of Bridge Opening/Channel Cross Section at Upstream Side of Bridge

Underclearance from channel Bed to Low Steel: 12 (ft) (999 if > 35) Water Depth in channel: 0 (ft)  
 Flow Deflected by Debris: 0 Impact Point: — Distance to Impact Point: — (ft)  
 0 = No 1 = Yes 1 = LB 2 = RB += US 0 = At Bridge -= DS
