Substructure Evaluation

Route 19 Bridges over Current River and Spring Valley

MoDOT Structure Nos.: G0804 / J0420

Inspection Report

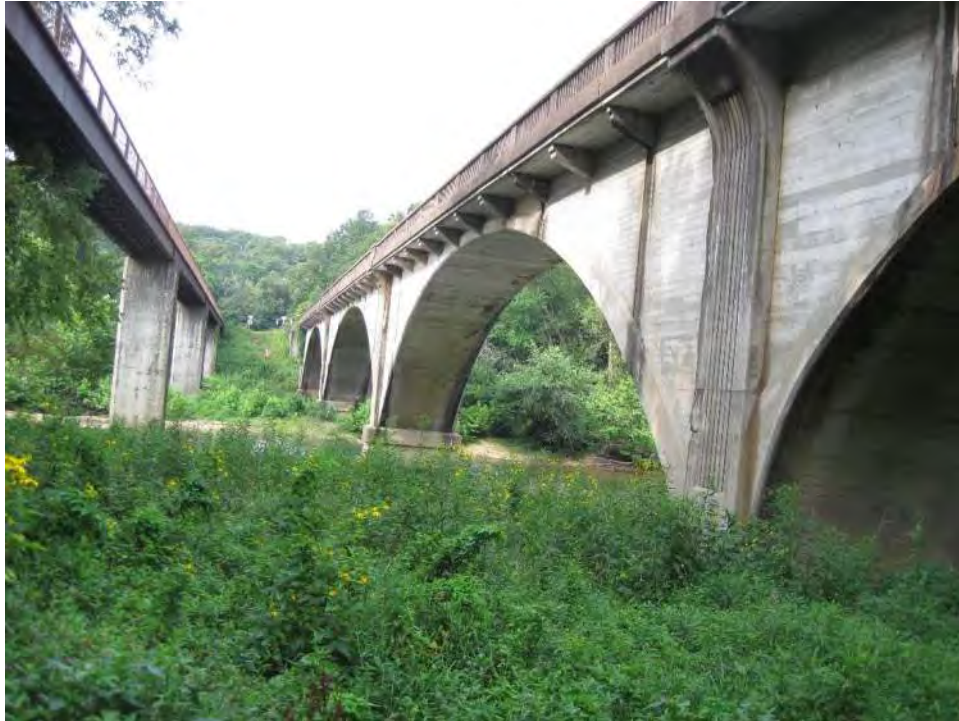
Photo 1: Current River Bridge, Downstream Fascia, looking south

The Route 19 Bridge over the Current River, shown in Photo 1, was originally constructed in 1924. The 5 span, filled spandrel arch structure has a length of 602 ft, comprised of three 130 ft arch spans, flanked on either end by 60 ft arch spans. An 18 ft wide roadway is carried across the bridge.

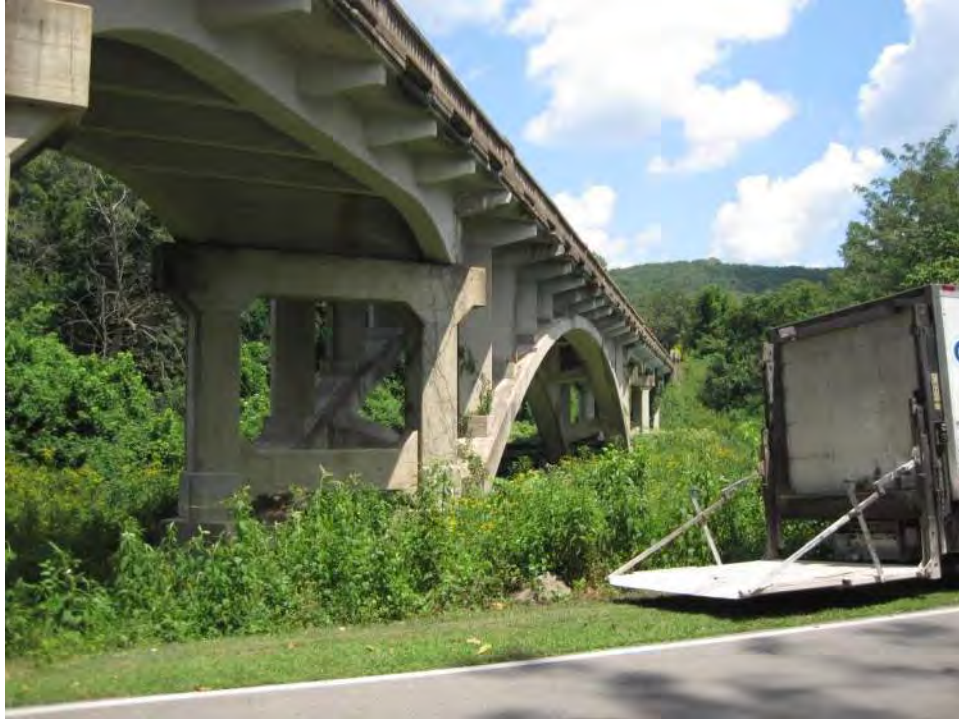
Photo 5: Spring Valley Bridge, East Fascia, looking north

The Route 19 Bridge over Spring Valley, shown in Photo 5, was originally constructed in 1930. The bridge is 523 ft long with a 20 ft wide deck, carrying two lanes of traffic. The 150 foot main span is supported by a two rib open spandrel arch with 3 concrete deck girder approach spans to the north of the main span and 4 to the south. The approach spans are supported by reinforced concrete piers.

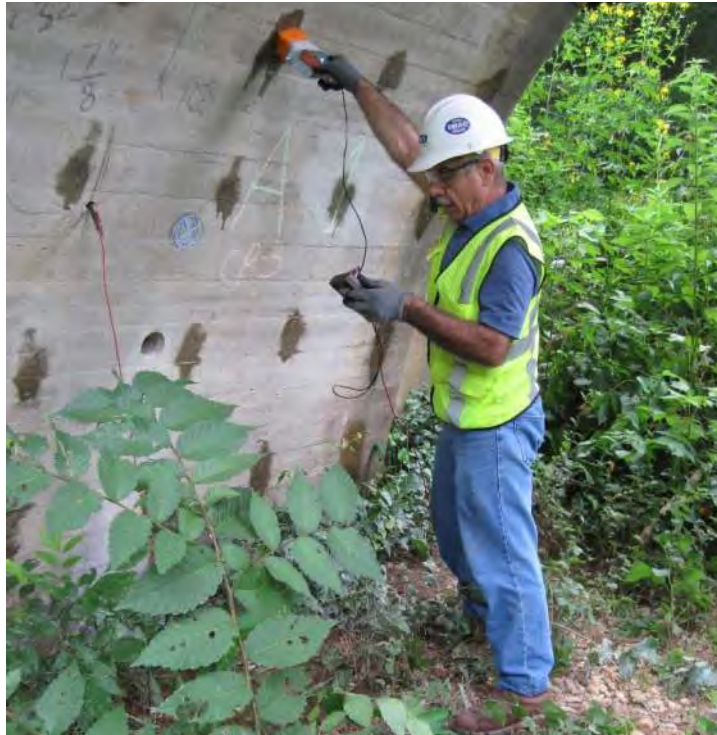
Photo 7: Half Cell Potential Testing

Half-cell potential measurements using a copper/copper sulfate reference half-cell were performed in accordance with ASTM C876-09, “Standard Test Method for Half-Cell Potentials of Uncoated Reinforcing Steel in Concrete.” Measurements were taken at select locations throughout both bridges, as shown in Photo 7.

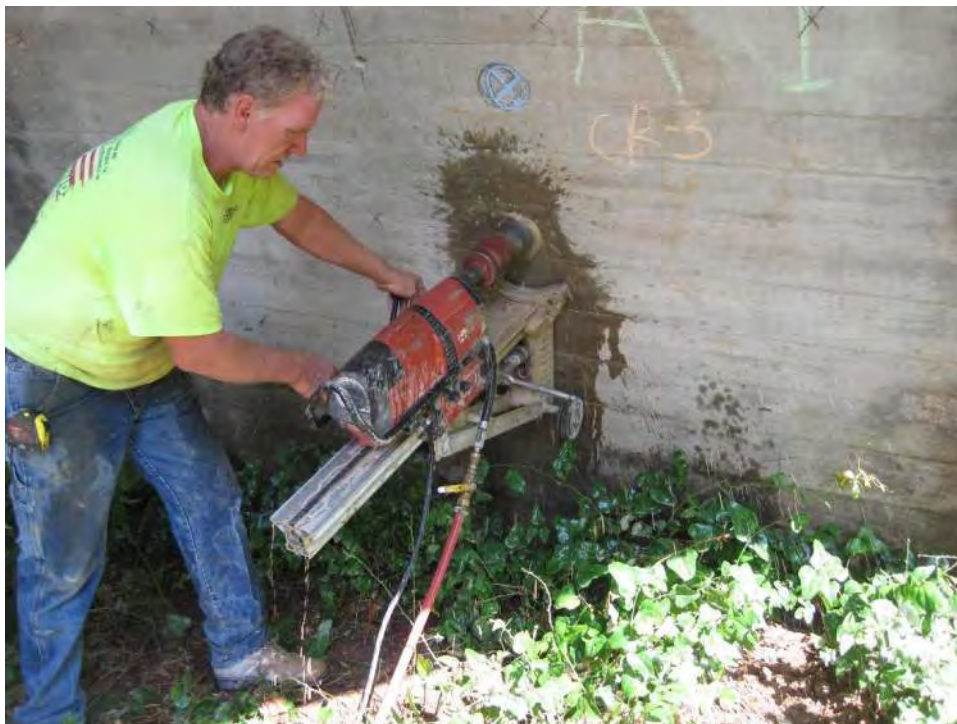
Photo 8: Concrete Coring

A total of seven, 4-inch diameter cores were removed from the bridges. Cores were extracted using a standard water-cooled core drill, as shown in Photo 8. Sample locations and observations are summarized in Table 3-4 below.

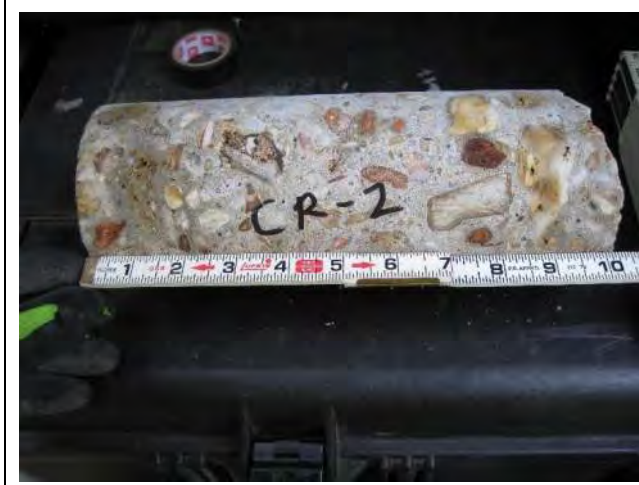
Core CR-2:

- East Face of Pier 2
- 4 x 10
- No delaminations noted
- Some cracking in Aggregates

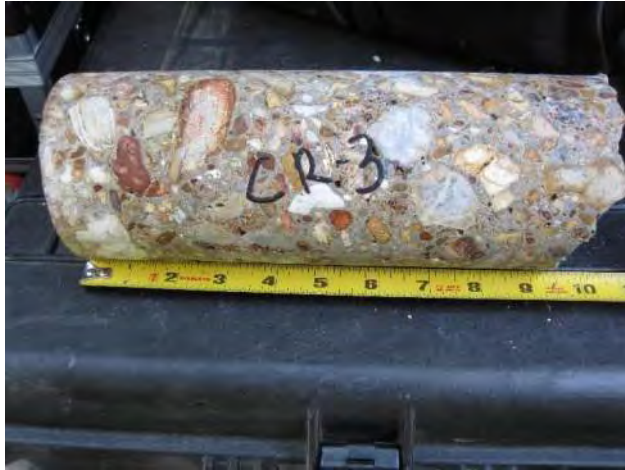
Core CR-3:

- Underside of Arch, Span A @ Abutment 1, near center of bridge
- South Exposure, under bridge
- 4 x 10
- No delaminations noted
- Some cracking in Aggregates

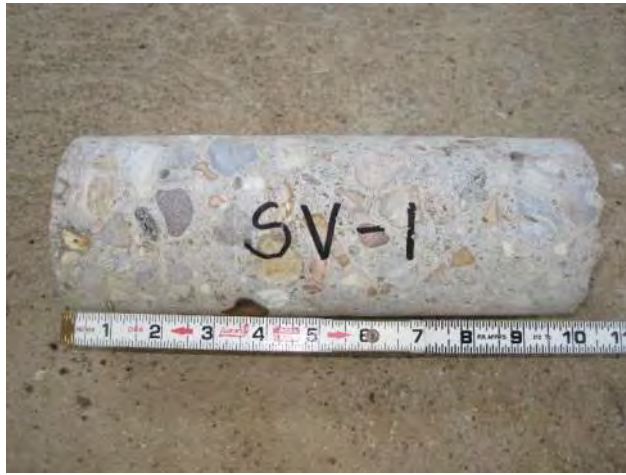
Core SV-1

- Pier 6, West Column, West Face
- 4 x 10
- No delaminations noted

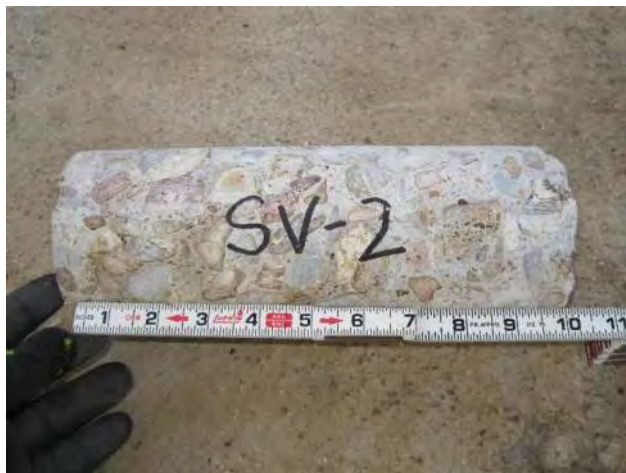
Core SV-2

- West Arch @ Pier 5, East Face
- 4 x 10
- No delaminations noted

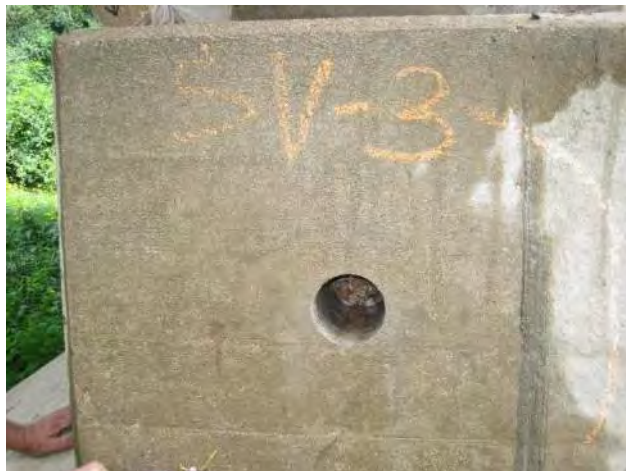
Core SV-3

- East Arch Abutment @ Pier 5, South Face
- 4 x 10
- No delaminations noted

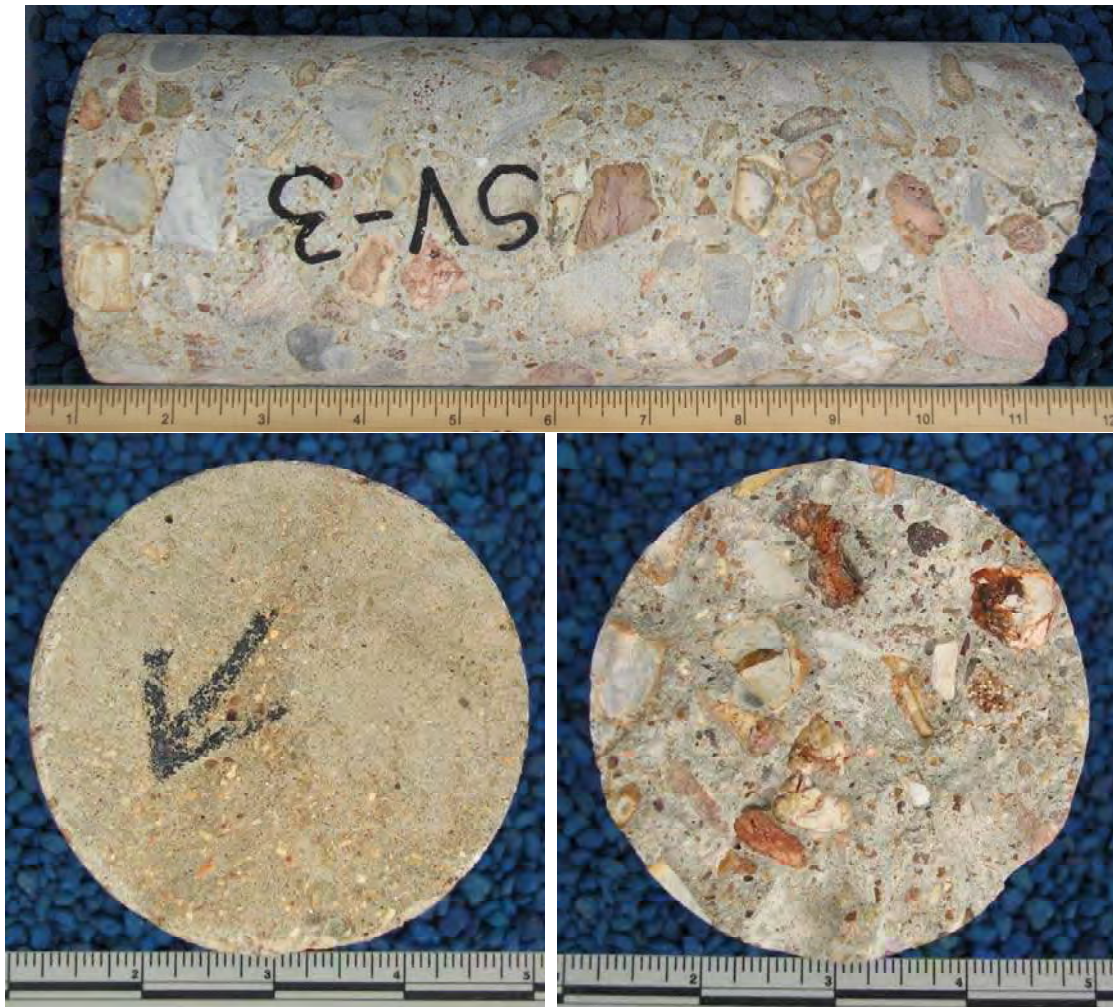
The core is 3.7-in. (95-mm) in diameter, 10.0-in. (254-mm) long and represents a partial member thickness (Figure 6). The outer surface has a smooth imprint of a formed surface (Figure 6). The inner surface is an irregular fracture surface (Figure 6). The concrete is well consolidated and shows no signs of segregation (Figure 7).

Figure 6: Top: Core SV-3 (outer surface oriented to the left). Bottom: Outer (left) and inner (right) surfaces of Core SV-3.

No cracks or microcracks are present in the core, as shown in Figure 7 below.
