MEMORANDUM

Missouri Department of Transportation Construction - Materials Central Laboratory

SUBJECT: Materials
Geotechnical Section
Foundation Investigation for
Vienna Maintenance Building
Job No. R35G-FI2292
Maries County

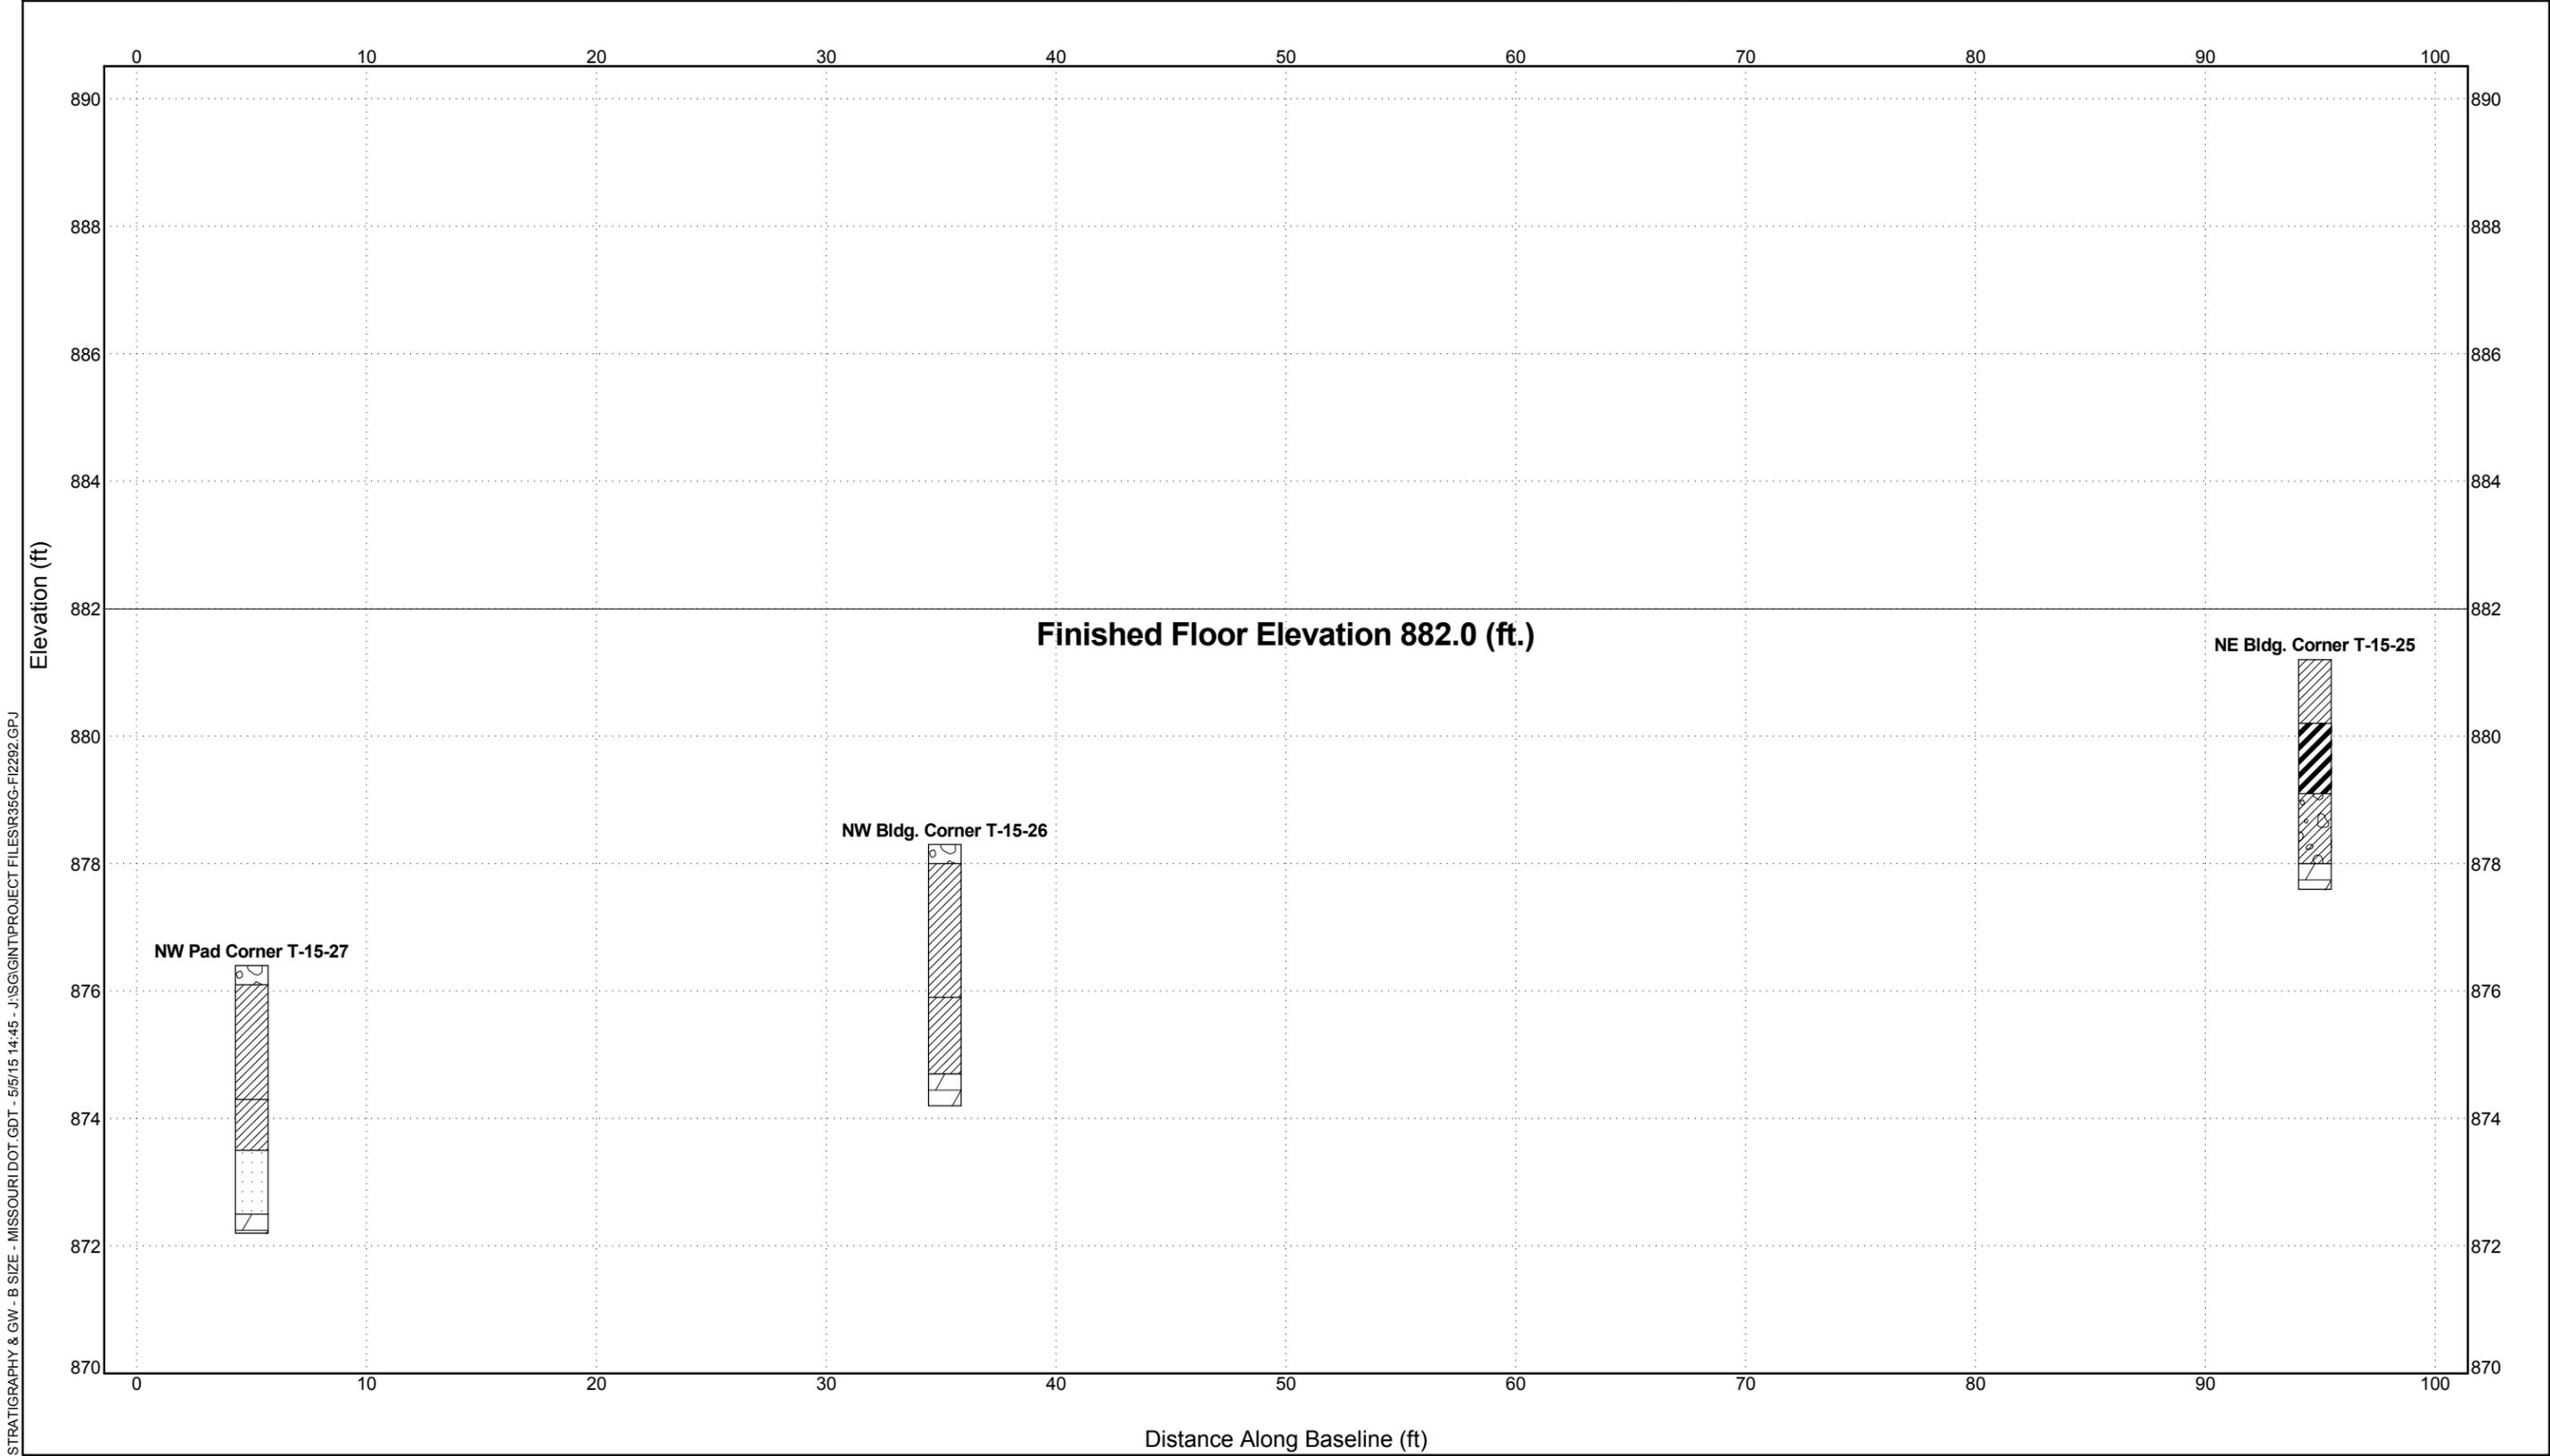
PROJECT NAME Vienna Maintenance Building

Six borings were drilled at the staked locations as indicated on Figure 2 - Boring Location Aerial. A subsurface diagram of the three borings at the north end of the proposed building is included as Figure 3 while a subsurface diagram of the three borings at the south end of the proposed building is included as Figure 4. Also attached are individual boring logs for each of the locations drilled.
