**TERMINAL BUILDING REHABILITATION PROJECT
&
TERMINAL ASBESTOS ABATEMENT PROJECT**

**MARSHALL MEMORIAL AIRPORT
STATE BLOCK GRANT NO. 13-018B-1
BMcD Project No. 76127**

ADDENDUM NO. 1

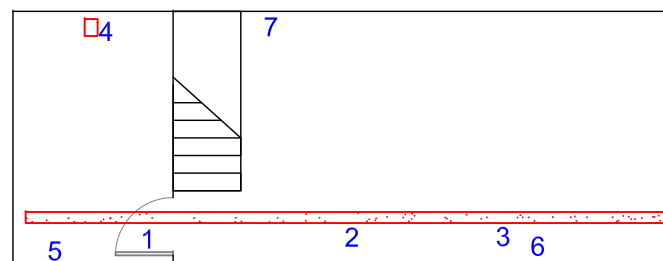
Figure 1
Asbestos Sample Locations
Marshall Municipal Airport
Terminal
Marshall, Missouri

MAIN FLOOR PLAN

APPROXIMATE BASEMENT FLOOR PLAN

A total of 29 bulk samples were collected from the Site. Sampled items include: floor tile with mastic, vinyl sheet flooring, ceiling tile, window glazing, roof materials, plaster, thermal systems insulations (TSI), fire brick, and fire brick mortar. Bulk sample locations for each floor of the Site building are illustrated on Figure 1.

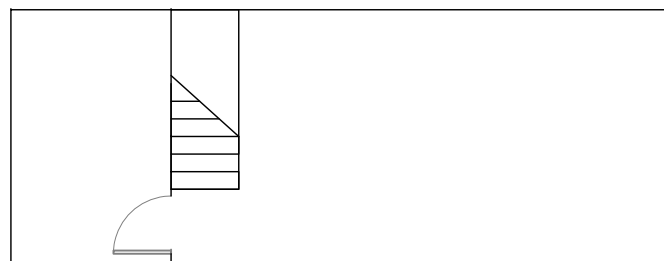
MAIN FLOOR PLAN

APPROXIMATE BASEMENT FLOOR PLAN
