#### BRIDGE OVER PINE CREEK

STATE ROAD FROM WILLOW SPRINGS TO ROUTE 17 ABOUT 6.5 MILES N.E. OF WILLOW SPRINGS

PROJECT NO. S.J.-S3

STA. 334 + 87. 5

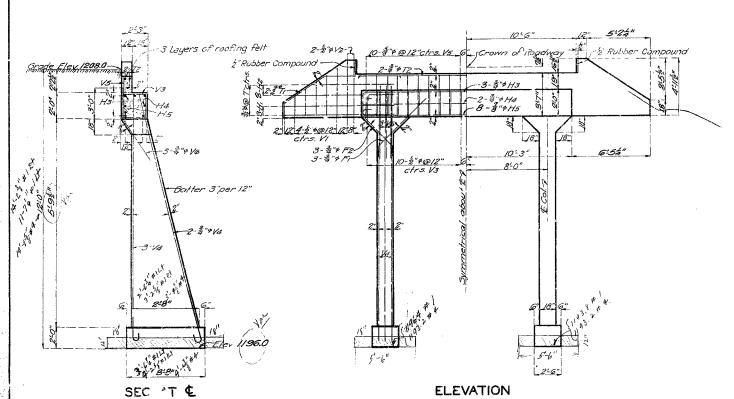
DETAILS OF BENTS NO. 1 &4

Note: This drawing is not to scale. Follow dimensions.
