BRIDGE OVER SALINE CREEK

STATE ROAD FROM PERRYVILLE TO SILVER LAKE
ABOUT 8 MILES S.W. OF PERRYVILLE
FINISHED

PROJECT NO. R.5IA-S.2 STA.4II+59

COUNTY: PERRY DISTRICT: SE CLASS: STATBR FED-ID: 8828 BRIDGE: S0734

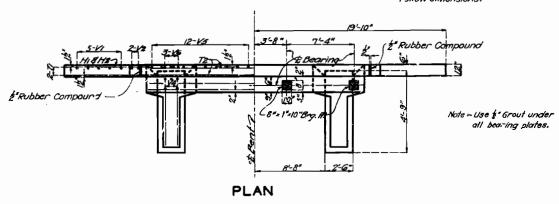
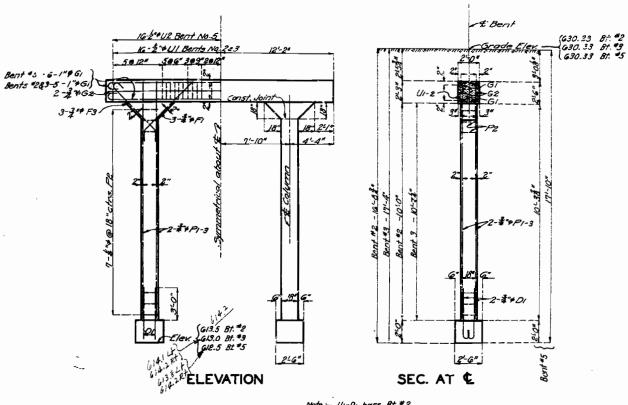
DETAILS OF BENT NO.1

Note:- Ui-Pi bars 8t. #2 Ui-P3 bars Et. #3 U2-P3 bars Bt. #5
