MoDO	r.			-	Fransportation	
				Bridge Inspect	-	
	COUNTY: OZARK	DISTRICT: SE		S: STATBR	FED-ID: 10065	BRIDGE: K08
		***GENERAL STRUCT				***BR
	US160E	# SPANS:			CODE: 36548 JASPER	DATE: 10/24
	BULL SHOALS LK	LANES ON: LANES UNDER:			NGTH: 1,817 FT 0 IN	FREQUENCY: 24
LOG MILE:	P-POSTLOAD	COMPASS DIRECTION:			I SPAN: 181 FT 8 IN DWAY: 24 FT 0 IN	TEAM LEADER: TERR
	: 54.00 MILES	DIRECTION OF TRAFFIC:			CURB: 22 FT 0 IN	INSPECTOR 2: BRAN INSPECTOR 3:
NHS:		FUNCTIONAL CLASS:			D OUT: 24 FT 8 IN	** When calculated interv
BUILT:	: 1951	NBI OWNER:	MODOT		AADT: 1453	G
REHAB:		NBI MAINTAINED:			YEAR: 2023	
	S 19 T 22 R 15 W	MAINTENANCE DISTRICT:			RUCK: 7.4%	
	: 36 34 40.05 (DMS)	MAINTENANCE COUNTY:			AADT: 3051	
LONGITUDE:	: 92 38 50.35 (DMS)	SUB AREA:	/H19	FUTURE AADT	YEAR: 2043	
	FRACTURE C	RITICAL INSPECTION INFO	DRMATION			***INDEPTH INSPECT
DATE:		ONSIBILITY: BRIDGEDIV	CATEGORY: THRU	TRUSS	DATE:	RESPONSIBILITY:

ROUTE 160 FROM ROUTE 5 TO ROUTE 95 ABOUT 2.9 MILES EAST OF ROUTE 95 BEGINNING STATION 375+98.00± (Match Existing)

Sheet No. 1 of 7

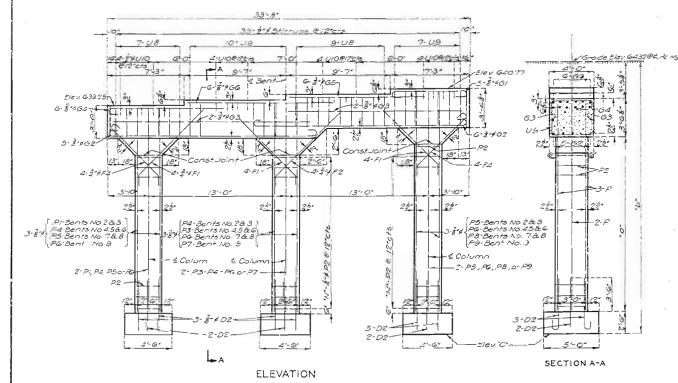
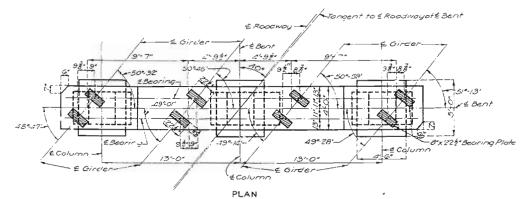
DETAILS OF INTERIOR BENTS NO. 2, 3.4, 5, 6, 7, 8 & 9

ny.									C	CMPLET	ΞB	ILL	OF RE	INF (PRCING	2
.9	NO.	size	Length	Mork	Location	NO.	Size	Length	Mork	Locotion	No.	size	Longin	Morik	location	Ĺ
		SUP	ERSTA	RUCT	URE	5	UPE	R STR.	(00	ntal	END	BE	V75 M	0.1 €	(control)	Į.
	4	2.0	12'-6"	RI	Roil	28	5-6	9'-6'	W5	Web	11	29	31-0	U4	Colismo	Ĺ
	416	2.4	5"	R2.	Roil	8	200	15'- 0"	WG	Web	G	24	30-6-	65	Column	Ĺ
	252	2.4	7-3-	R3	SUD PUSI	9		2:-6"	w9	W65	13	4%	32-0-	06	Coiumn	
	184	2."0	3'-9"	RØ	Post	9	8-4	3'-0"	WIO	Web	7	5.0	31-6-	07	Column	
Í	3200	3.0 p	18"	<i>R5</i>	Bolusters	1152	2"0	7:6"	BI	Girder	G	20	81.61	V8	Column	Ĺ
	1	źź	11'-3*	RG	Roil	.90	1200	29.3	<i>B2</i>	Circler	G	ŹŚ	10-5	Vg	Column	Ĺ
i	2	20	10'-3"	R7	Fioil	:08	12 0	50'-0"	83	Girder	6	2.4	11-00	210	Coiumn	
	8	Ź*\$	8-5-	R8	Roil	72	12"0	45-6	34	Girder	6	270	12:-6-	111	Column	Ĺ
	4	\$-\$	11-6	R9	Roit	.108	15-0	20-0-	35	Girder	ω	\$~¢	6-3-	D!	Fcotina	
i	4	\$°¢	9'-9"	RIO	.90,1	90	1200	29.9	56	Girder						1
	So	2"0	12400	RII	Reil						INTER		<i>BENTS</i> A	02,3	4,5.G,7,889

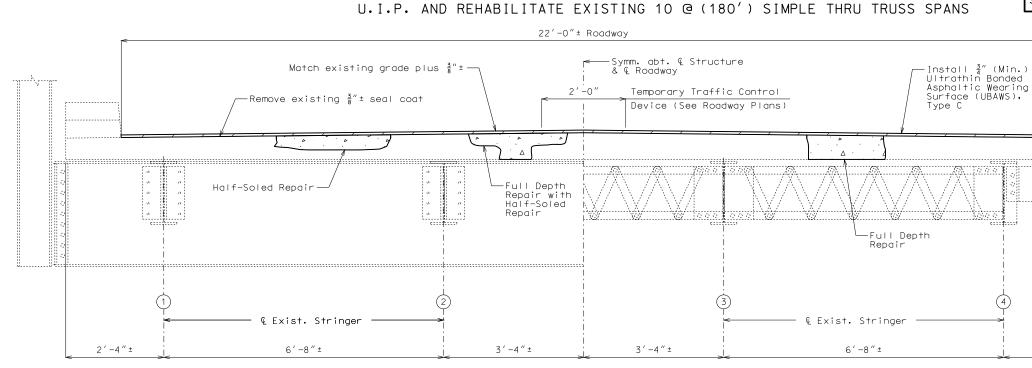
HALF SECTION NEAR PANEL POINT

HALF SECTION NEAR MID-PANEL POINT

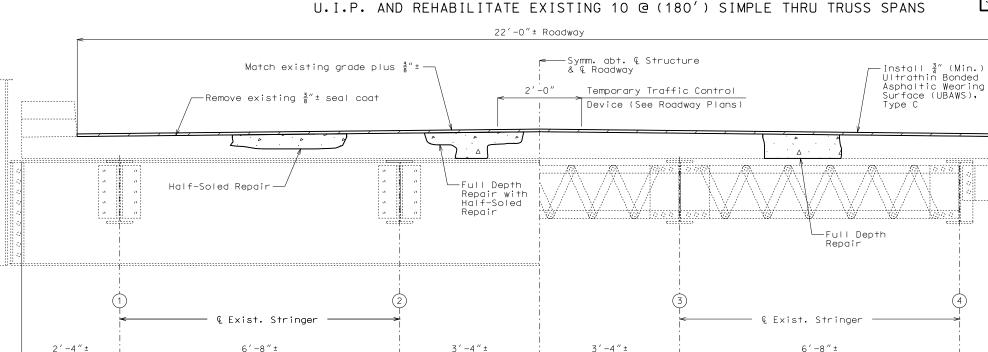
HALF SECTION NEAR PANEL POINT

HALF SECTION NEAR MID-PANEL POINT
