Missouri Department of Transportation State Bridge Inspection Report

COUNTY: BUTLER DISTRICT: SE CLASS: STATBR FED-ID: 4499 BRIDGE: F0665

GENERAL COMMENTS/MAJOR RATED ITEMS GENERAL COMMENTS: (BOWDEJ1, 09/05/2008)--(54') SMP WF GDR SPAN (WIDENED AND REDECKED)

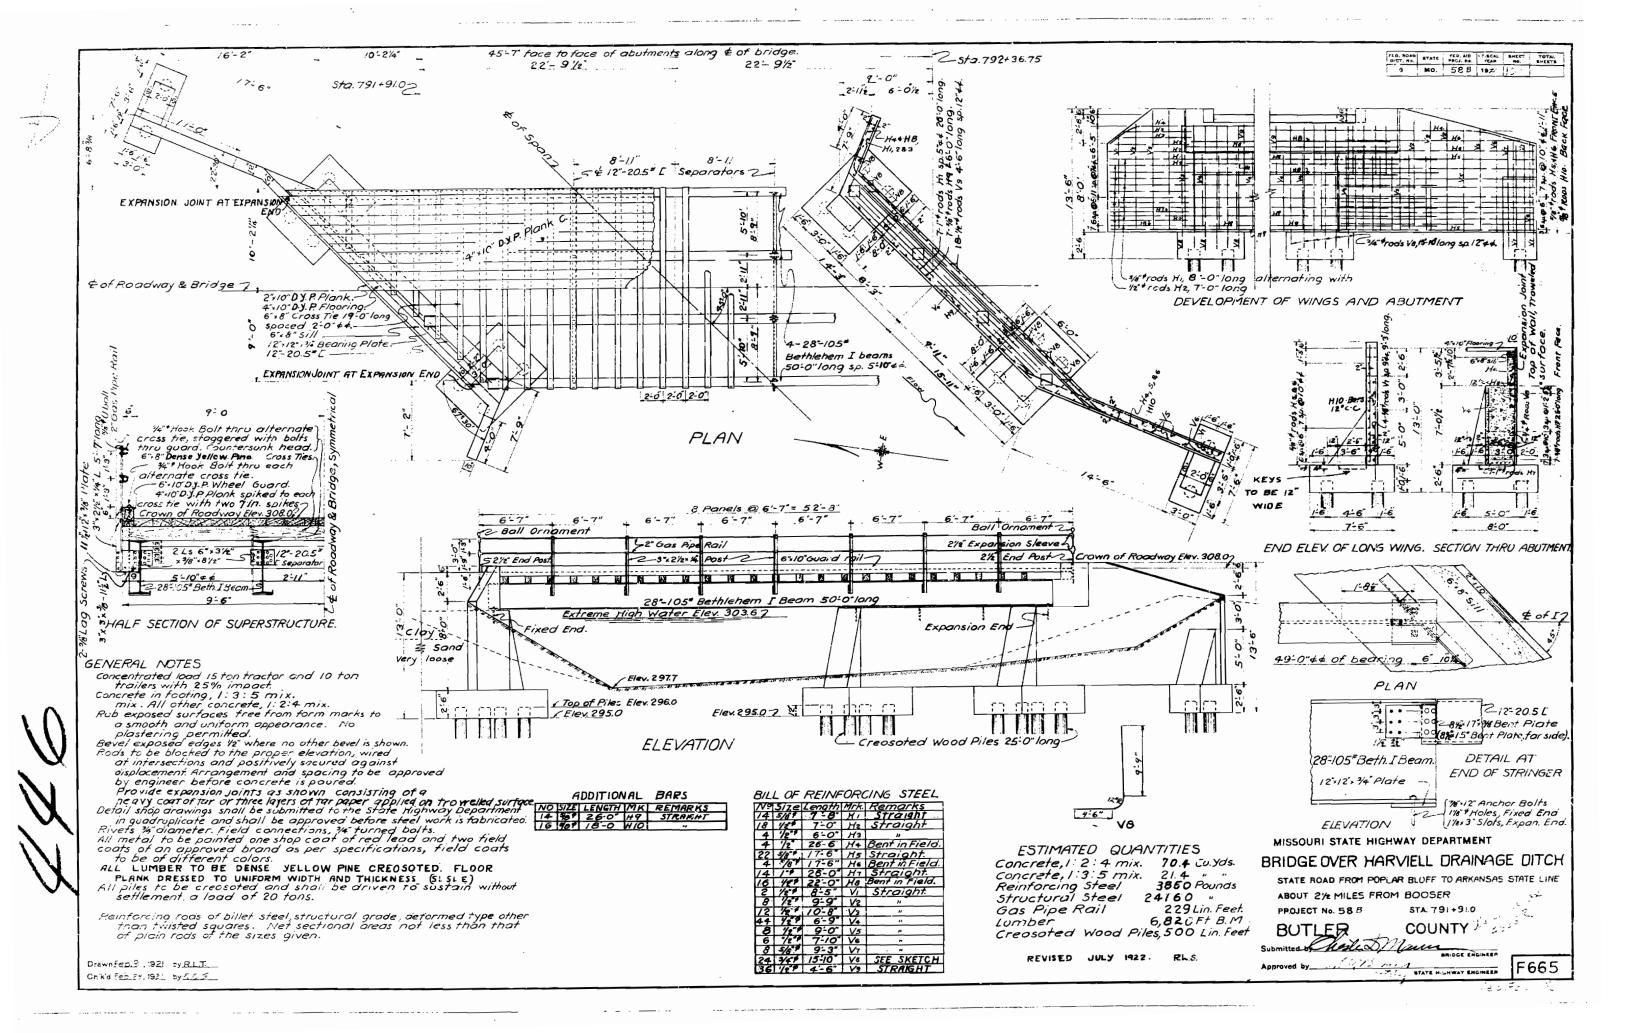
Sheet No. 1 of 5 .

COMPLETE BILL OF REINFORCING STEEL

Design Specifications A.A. 5.H 0.

Loading H-15 A.A.3.H.O.

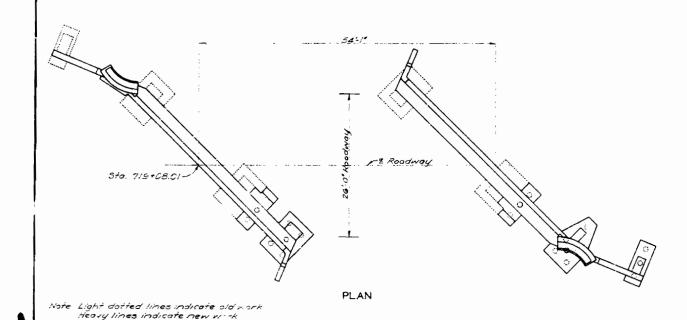
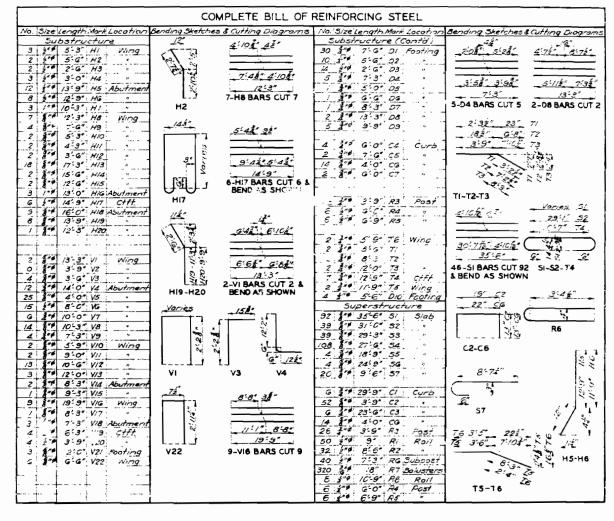
Sheet No 1375

Note: /// z. . s driven to susiain a load of at least 17 ton per pile.

EPPS DITCH

Droinage Area 3 50. Miles - Flat
