MISSOURI STATE HIGHWAY DEPARTMENT

STD. 702.02
STD. 706.30
A-2636

(57'-78'-57') Cont. W. Beams (Composite)

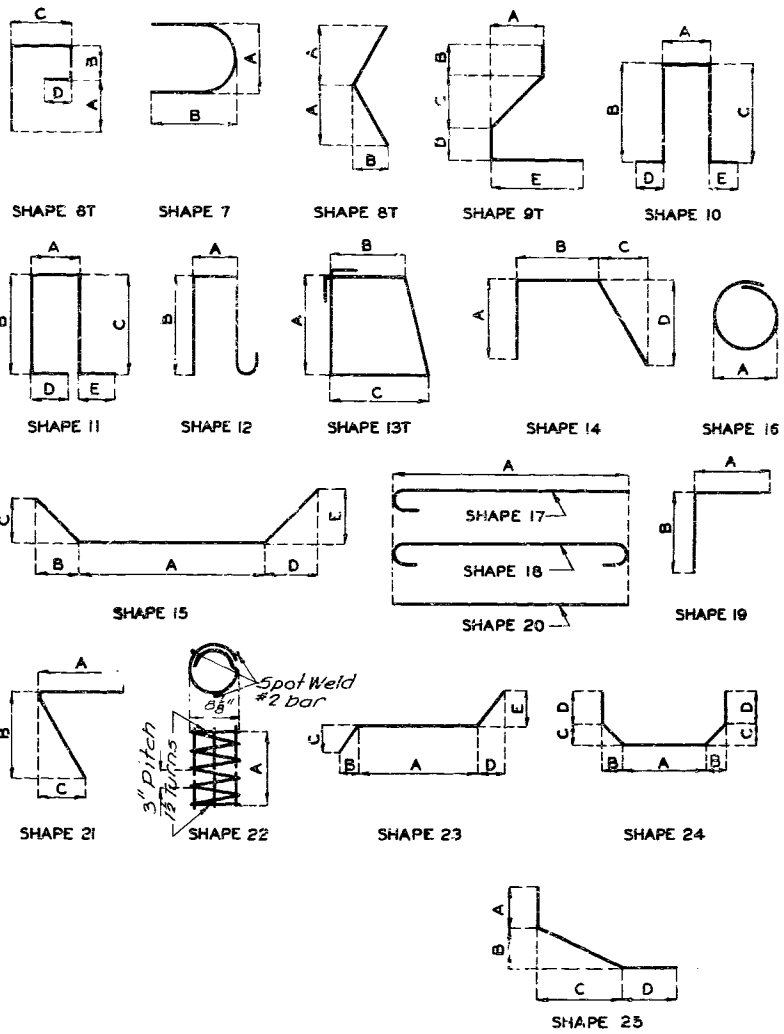
BENDING DIAGRAMS

Note: All bending dimensions are out to out.
Hooks and bends shall be in accordance with the CRSI Manual of Standard Practice for detailing reinforced concrete structures.

T - tie or stirrup
S - bar is included in substructure quantities.
Length - Total lengths are measured along centerline bar to the nearest inch.
V - bar dimensions vary in equal increments between dimensions shown on this line and the following line.
No. Ea. Number of bars of each length.

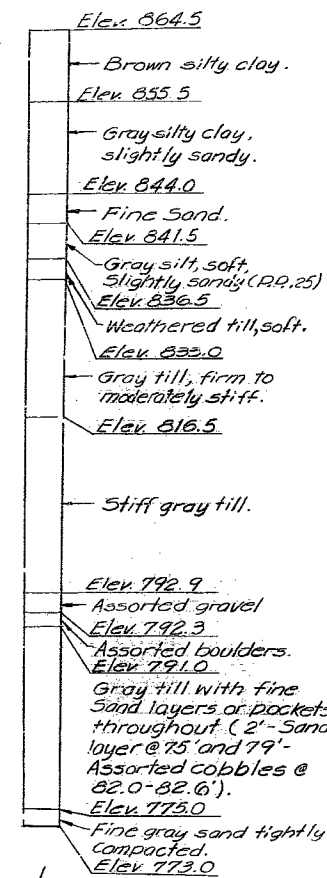
Standard Penetration Test
Depth Blows/6"

5'	2-3-5
10	1-2-4
15	2-4-10
20	6-8-10
25	5-2-1
30	6-4-7
35	7-9-14
40	4-5-3
45	5-6-10
50	14-18-23
55	17-14-19
60	7-7-12
65	7-9-12
70	14-26-36
75	100/7"
80	34-26-36
85	15-23-24
90	25-41-60

(Core)

Note: For location of borings see Sheet 1 of 7

Note: * Indicates location of borings. For boring data see sheet no. 4

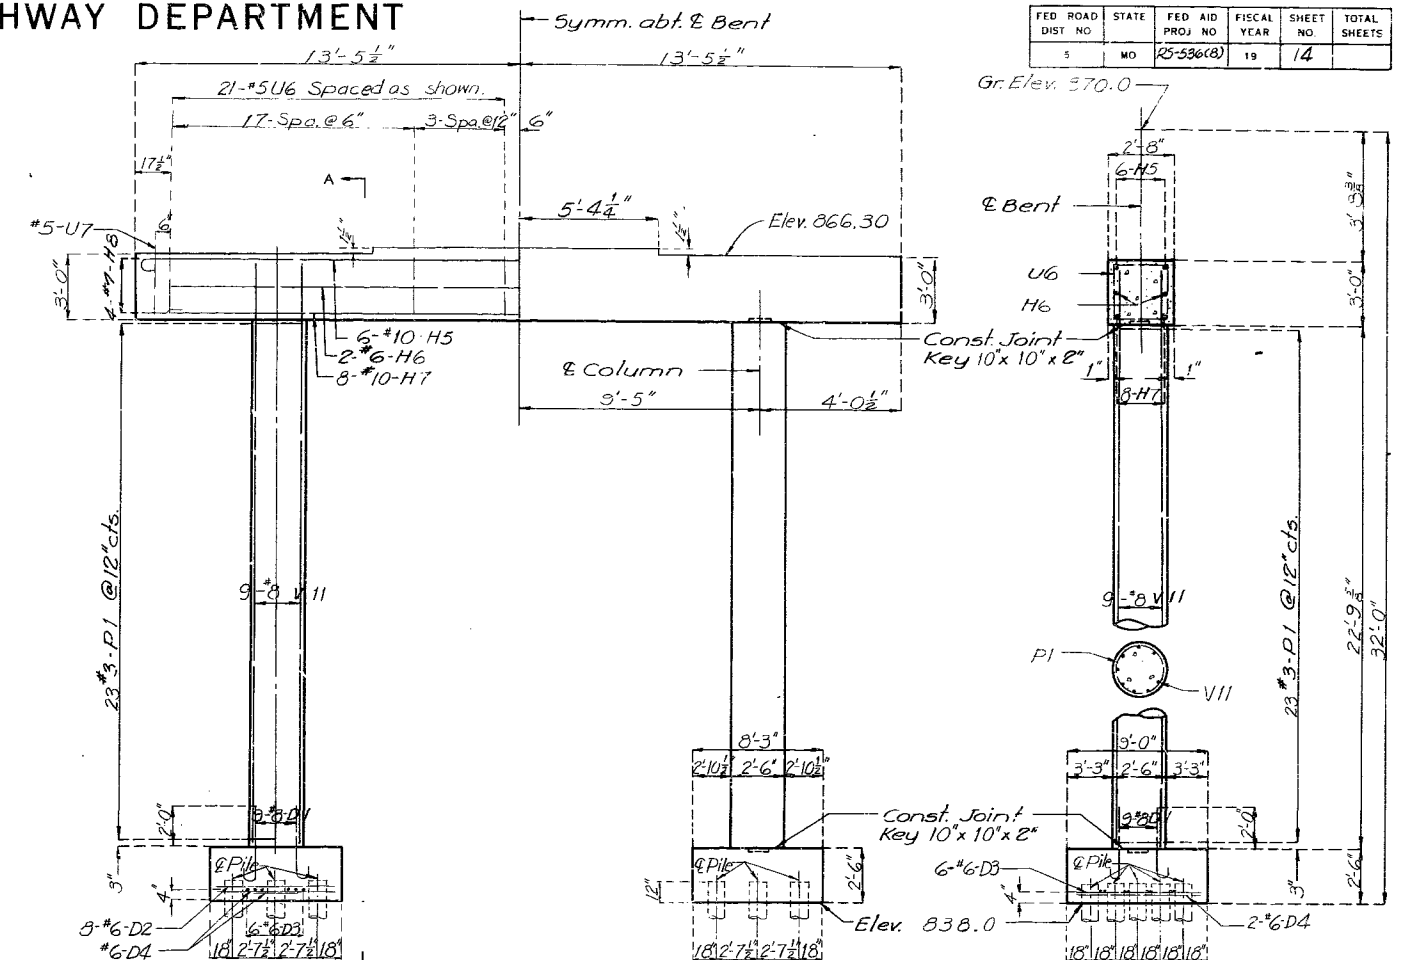
DETAILS OF INTERMEDIATE BENTS NO. 2 & 3

ELEVATION

SECTION A-A

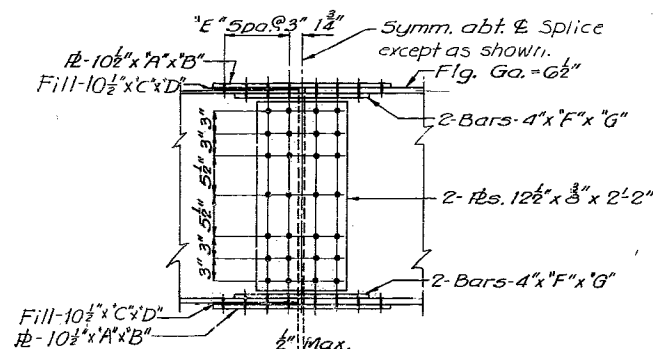
WF SIZE	"A"	"B"	"C"	"D"	"E"	"F"	"G"
30" WF 99" to 108"	7/16"	2'-0 1/2"	13 Ga.	12"	3	1/2"	18 1/2"
30" WF 108" to 108"	1/2"	2'-6 1/2"	-	-	4	1/2"	18 1/2"

Note: 15" ϕ reamed holes for 8" ϕ high strength bolts.
DETAIL OF 30" WF BEAM SPLICE

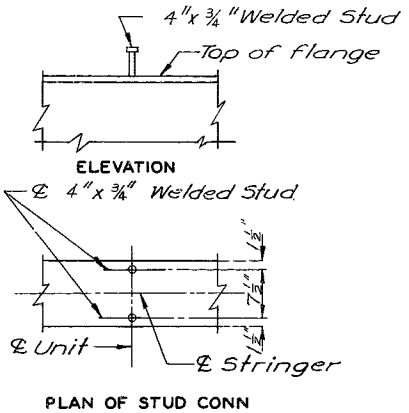
DETAILS OF SHEAR CONNECTORS

Note: Weight of 595 lbs. of shear connectors is included in weight of Fabricated Structural Carbon Steel.

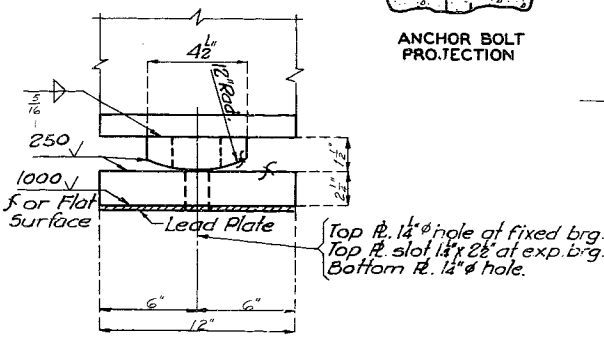
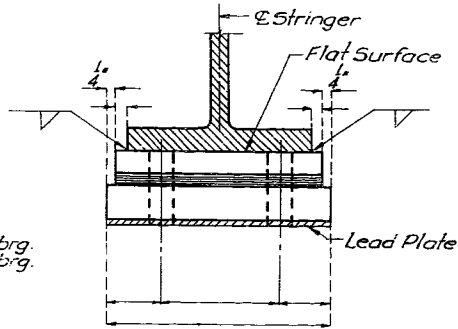
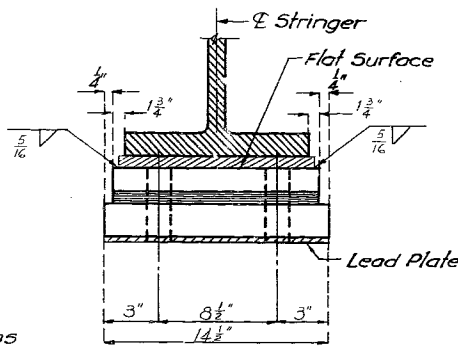
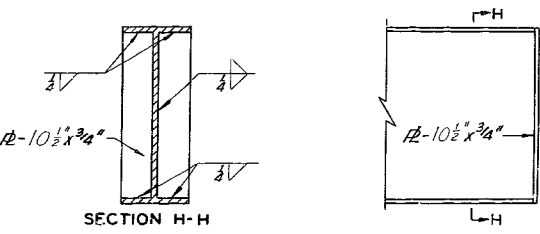
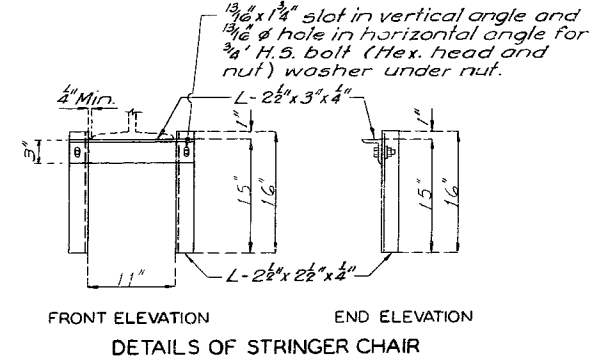
TYPE "C" BEARINGS
(Estimated Weight 1063 #)

NOTES: TYPE "C" BEARINGS
Lead plates under bearings shall be approximately 8" thickness and weigh 8# / sq. ft. Cost of lead plates shall be included in price bid for other items.
"Estimated weight" does not include weight of anchor bolts.
Anchor Bolts for Type "C" Bearings shall be 1" ϕ swaged bolts 10" long with no heads or nuts.
Top of Anchor Bolts shall be set approximately 1/4" below top of bearing.

Required: 0 - Fixed Bearings
8 - Expansion Bearings

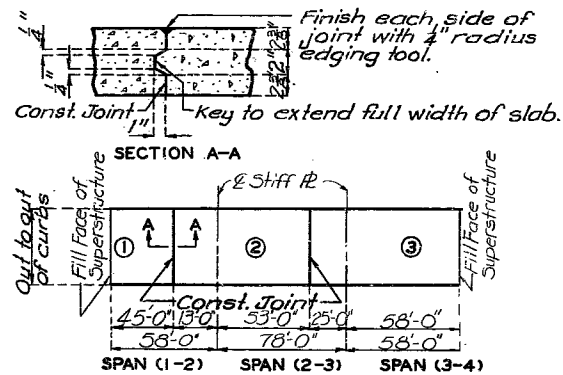
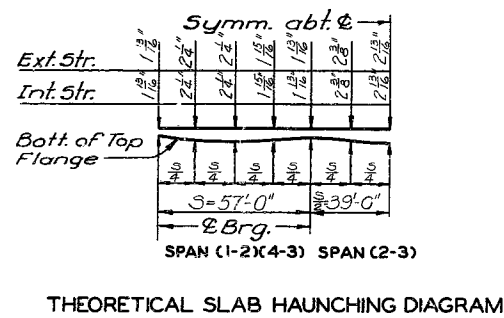
SLAB POURING SEQUENCE

Sequence of Pours		
	Direction		
Basic Sequence	1	2	3
Alternate "A" Pours	End to 2	1 to 3	2 to End
Alternate "B" Pours	1+2	3	2 to End
Alternate "C" Pours	End to 3	2 to End	
Alternate "D" Pours	1+2+3	End to End

Note: The contractor shall pour and satisfactorily finish the slab pours at a rate of not less than 25 cubic yards per hour.
