Missouri Department of Transportation State Bridge Inspection Report

COUNTY: OREGON DISTRICT: SE CLASS: STATBR FED-ID: 5778 BRIDGE: K0344

BRIDGE OVER ELEVEN FOINTS RIVER

STATE ROAD FROM SHANNON CO. LINE TO ALTON ABOUT 25.5 MILES NORTH OF THAYER PROJECT NO.PWA76,58-53A STA 401410

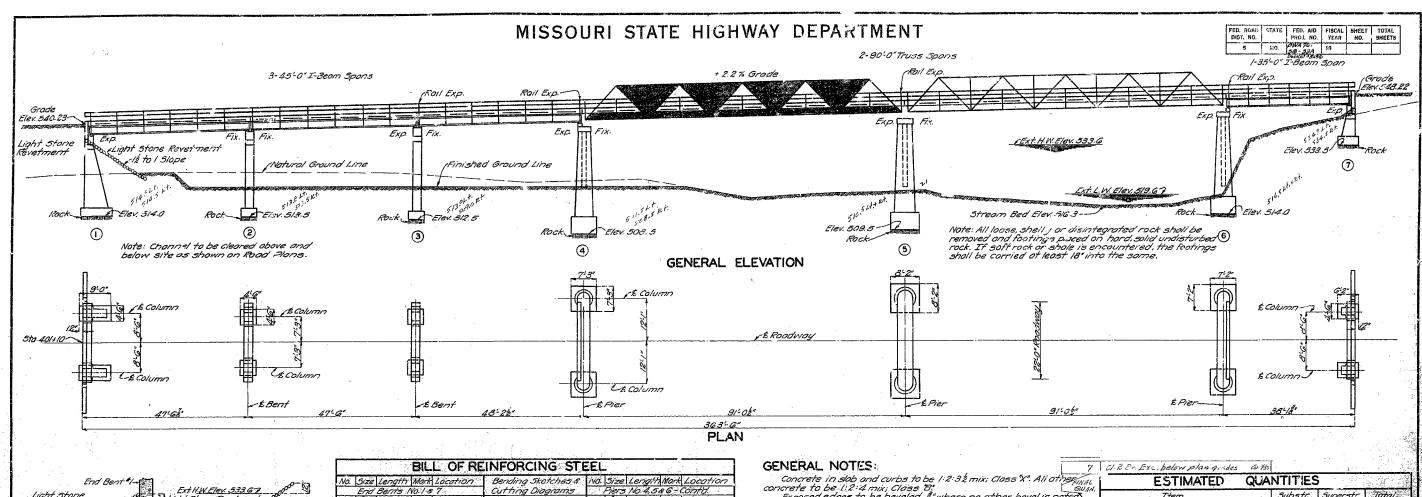
REVETMENT SKETCHES

Ext. H.<u>W. Elev. 533.67</u> ight, Stone Revetment-_% Light Stone Iztol Slope of Fill under and in front of end bent No. 1 to be Natura Ground Line FRONT OF END BENT SIDE SLOPES OF FILL BENT NO.1

Note: Light stone revetment to be placed on fills at end bent No. I as shown in sketches. Approximately 280 sq.yds. of light stone revetment work included in road contract:
