PED AND STATE FED NO FISCAL SHEET TOTAL DISTING STATE PROLING YEAR NO. SHEETS S MA. NESSEL 49 MISSOURI STATE HIGHWAY DEPARTMENT 9 5 6 @ 18 clis. St in top 35-1 09'clis. \$3 Top and bottom 4-118 Alt. witt. 4- 8 + 0 18 cfrs.53 10 2 10 18 ctrs. 59 9 2 to 18 cirs 510 98 & Roadway 5-8 10 18 clts SI in lop 38 35-8" a9 ctrs 58 Top and Bolton All with 4 & all clis.53 PLAN OF SLAB AND DECK GIRDER SHOWING REINFORCING 62 26 62 SKETCHES SHOWING LOCATION 7 Salusters 10 Balusters 10 Salusiers 7 jalusters 7 Saissfers OF END POSTS OF HANDRAIL 2. 2 BR Evenly Spoced 1 4 Gas Pipe It long, plugged end, with \$ 4 Bar Re 2-0" long extending to within 2" of end of plug 2-\$ 4 Rs 3-3-4 Ch 2-2"RO 2-C3-ELEVATION OF HANDRAIL 2-5" + C3 1 3 layers of tar paper 3 Bituminous Fel 20'-0' Roodway 10'-0" Note: - Partition joint at fixed end Curbs to be cast independently of slab is same as expansion joint except. 2 layers of for paper instead DETAILS OF EXPANSION JOINT of \$ bituminous felt. Curbs to be cast Const. Joint -to Bars (Dowels) between # + Bars (Dowels) be sen BRIDGE OVER DITCH NO.25 Crown of Roadwa Notch to extend from curb to curb 4" 0-B5 A WALL FORM COST CON grans C3 | Zat each end of pullets . R25-S32

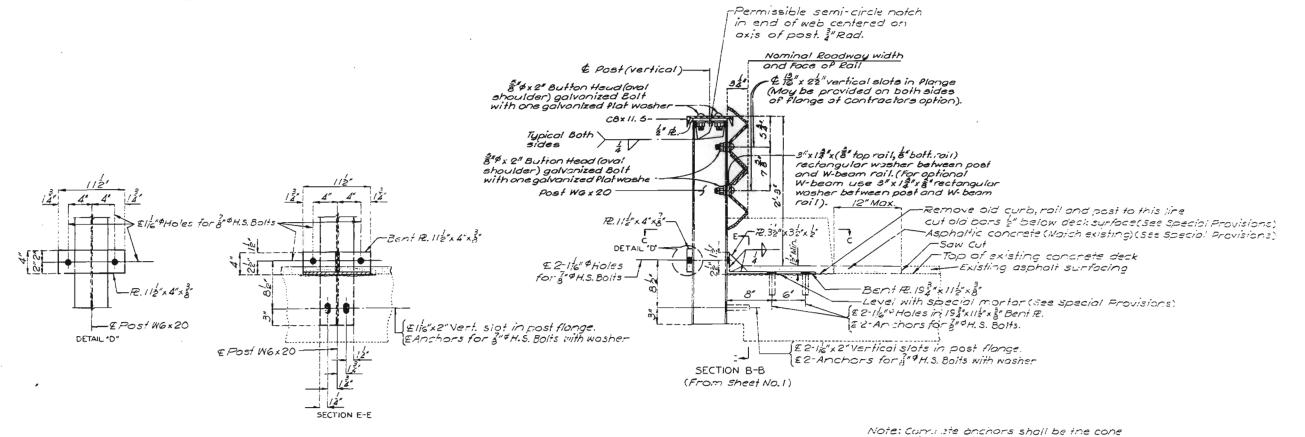
DETAIL OF POST 'M'
(From Sheet No. 1)

DETAIL OF SHIM PLATES

Note: Shim plates 6"x6"x16" may be used between post W6x20 and old concrete and shim plates 1"b"x4"x16" may be used between post W6x20 and 19\$"x115"x8" bent plate as required for horizontal alignment.
