ADDENDUM NO. 2

**HUNNING ROAD SAFETY IMPROVEMENTS
STP-5403 (696)**

Geotechnical Report

Hunning Road Improvements
Jefferson County, Missouri

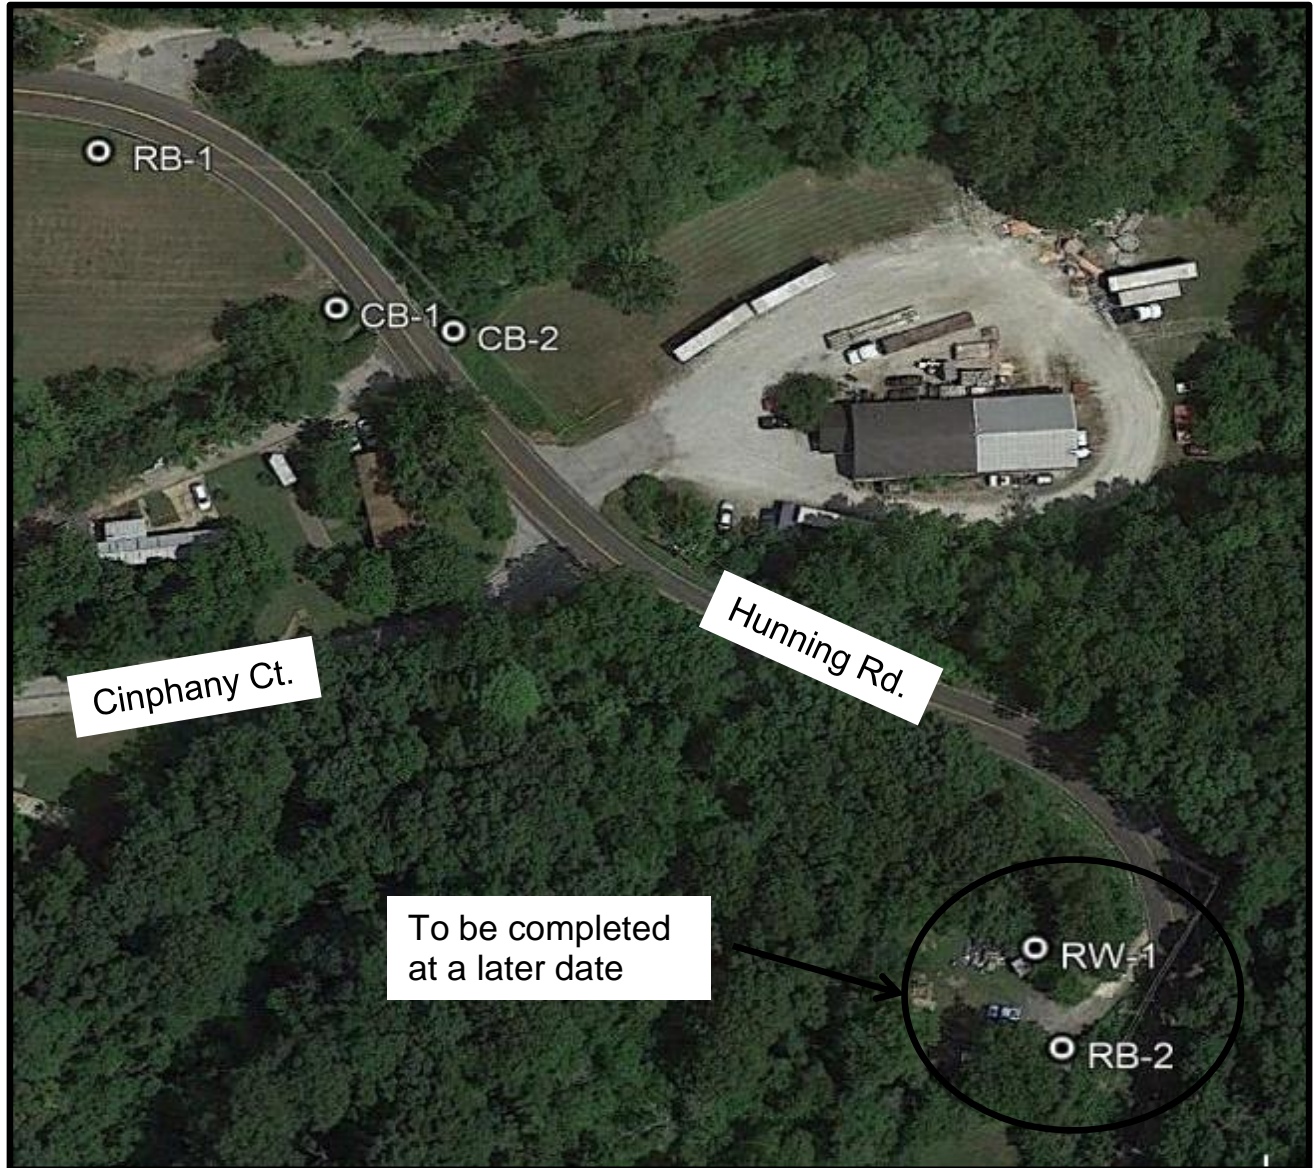
FIGURE 2: BORING LOCATION PLAN

The general site area is presented in the Vicinity Map (Figure 1) in Appendix A. The approximate locations of the borings performed for this study are presented in the Boring Location Plan (Figure 2) in Appendix A.

On January 10, 2022, Millennia conducted a subsurface exploration at the site consisting of three borings. Two borings were drilled for the culvert replacement, designated as CB-1 and CB-2. One boring was drilled for the realignment curves for the new roadway, designated as RB-1. The realignment boring RB-1 was advanced to a depth of five feet in order to sample the underlying soils. The two culvert borings CB-1 and CB-2 were advanced to depths of approximately 13.3 feet and 20 feet, respectively. The borings were drilled with all-terrain mounted drill rigs using either hollow stem auger method. The approximate locations of the borings are indicated on the Boring Location Plans in Appendix A.

The general site area is presented in the Vicinity Map (Figure 1) in Appendix A. The approximate locations of the borings performed for this study are presented in the Boring Location Plan (Figure 2) in Appendix A.
