MISSCURI STATE HIGHWAY DEPARTMENT Note: For details of handrail see "35H", "358" and "356" on 5td.0-6501R2 and "458" on 5td.0-6502R2 and madify as shown and noted on 5heet No.5 of 5. 1-47-5" (Overall) Dack Girder 2-35' Deck Girders 2-35' Deck Girders Elev. 452.65 Elev. 456.0 Elev. 452.01 All 11 25-0 Creos. Timber Piles (5) 35-0" Creos. Timber Piles 20-0"Creos. Timber Piles Elev. 452.0 Note:-See Special Provisions in regard to ordering pilling. All pilling to be creosoted timber and ordered in the following lengths: 15 & 15-0", 27 @ 20-0", 15 @ 25-0", and 27 @ 35-0". Alle lengths include 5-0" cut-offs. | W 20-0"Creos. Timber Piles 15-0"Creos. Timber Piles **(4**) GENERAL ELEVATION A- & Bent E RODOWAY -> Sta. 150+54.12 Sta. 150+91.80 Sia. 15/+ 39.20 -Sta. 151+70.88-Sta. 152+ 14.38 -Grade Elev. 478.8/ Grade Elev. 478.81 Grade Elev. 478.07 Grade Elev. 478,55 Sta. 150+16.62 Grade Elev. 473.55 Grade Ele 478.07 --47- 3" 37-841 3748**\$**" 19759 PLAN GENERAL NOTES:~ NEARL NOTES:"

BRIDGE OVER CHICAGO & ALTON R.R.

STATE ROAD FROM GLASGOW TO FAYETTE ABOUT 3 MILES EAST OF GLASGOW

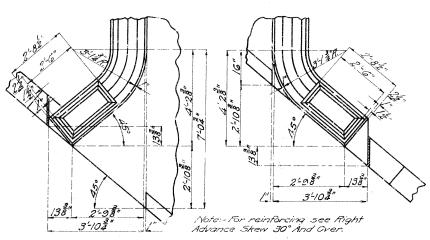
TYPICAL END ELEVATIONS

SQUARE END BENT
