BRIDGE OVER CANE CREEK STATE ROAD FROM RIE SE AT OAK RIDGE S TO JACKSON ABOUT 3.6 MILES N.W. OF JACKSON PROJECT NO. S-187(1) SEC B(SD)STA 397126

CAPE GIRARDEAU COUNTY

FINAL PLANS

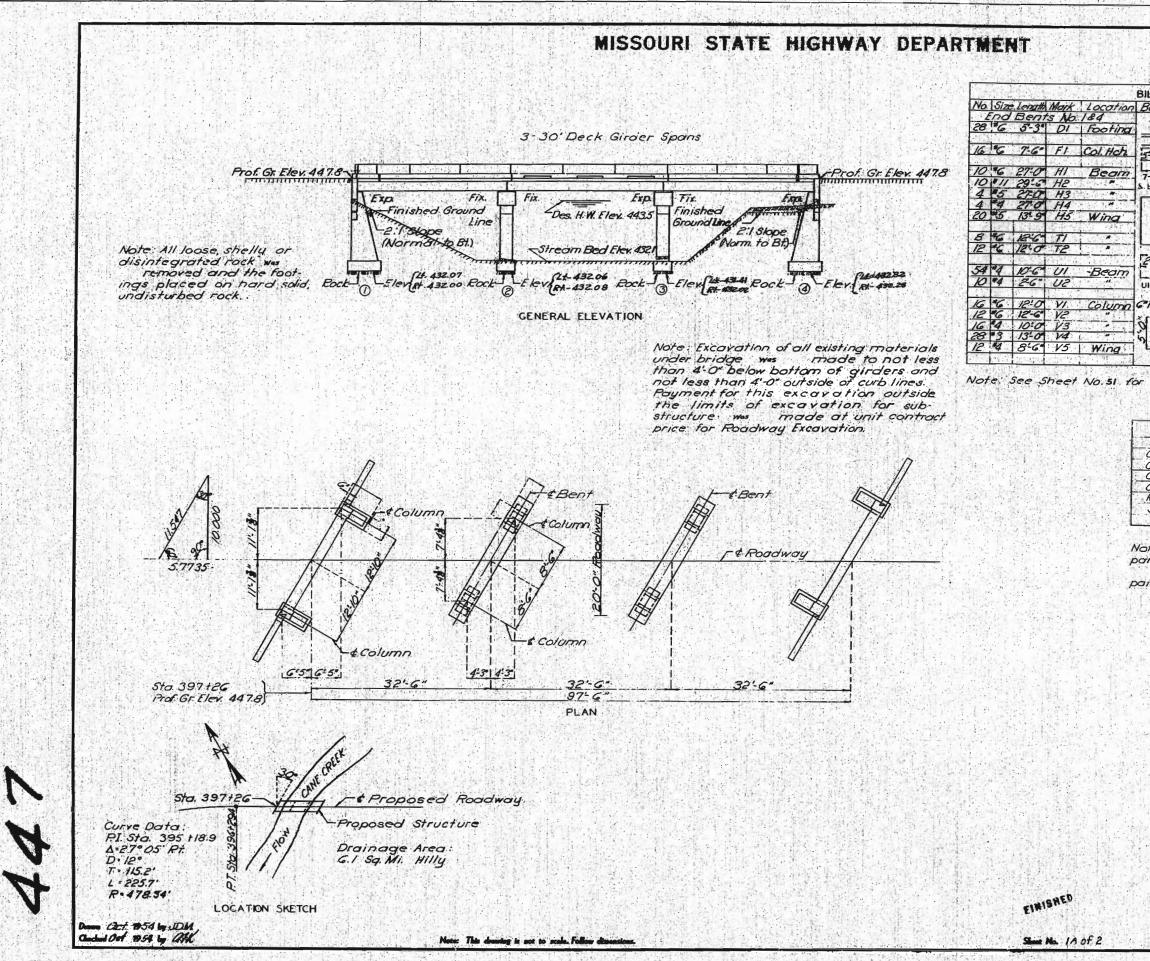
STATE FER. AD FRICAL SERIES 1000. CHER. MOL · · 49 6 FINAL PLANS BILL OF REINFORCING STEEL - SUBSTRUCTURE Bending Sketches & Cutting Diagrams No. Size english Mart Location 6-V5 CUT 12. 7-14 CUT . 8 U2-114-V4 Seam BELLE A HOWN Columo 50 = 4 11=3 U3 20 = 4 4:0 U4 Beam 238 P UP UB .FI 23-11"GI 3-112 26-12 H2 DI GI-H2 6-6-7-3 TI FIFZ Note: See Sheet No. 51 for Bill of Reinforcing Steel for Superstructure. FINAL QUANTITIES Substr. Supers Class | Excavation for Structures Cuide 645 Class 2 Excavation for Structures. CuYds 25.5 Class B'Concrete (Handrail) Curks Class B'Concrete (Except Handrail)Curks 564 83.3 Reinforcing Steel 162 7750 23 2M Structural Steel Bearing Plates ibs. TEST Holes Note: Excavation for bridge made above fley. 434.0 mis poid for as Class I Excavation for. Structures. Excavation for bridge made below Elex 434.0 +++ paid for as Class 2 Excavation for Structures GENERAL NOTES: Design Specifications: A.A.S.H.O. 1953. Looding: HIO-44. Reinforcing Steel Stress. 18,000 "/" Class 'B" Concrete Stress: 1.000 #/** All concrete shall be Class 'B'. Where joint filler is specified on the plans it shall conform with the requirements for Premoulded Material for Filler as given in Section 38-19A0)h of the Standard Specifications. BM # 32 Fley 447.71 H an Lt Wing So End of Bridge Sta. 397+26

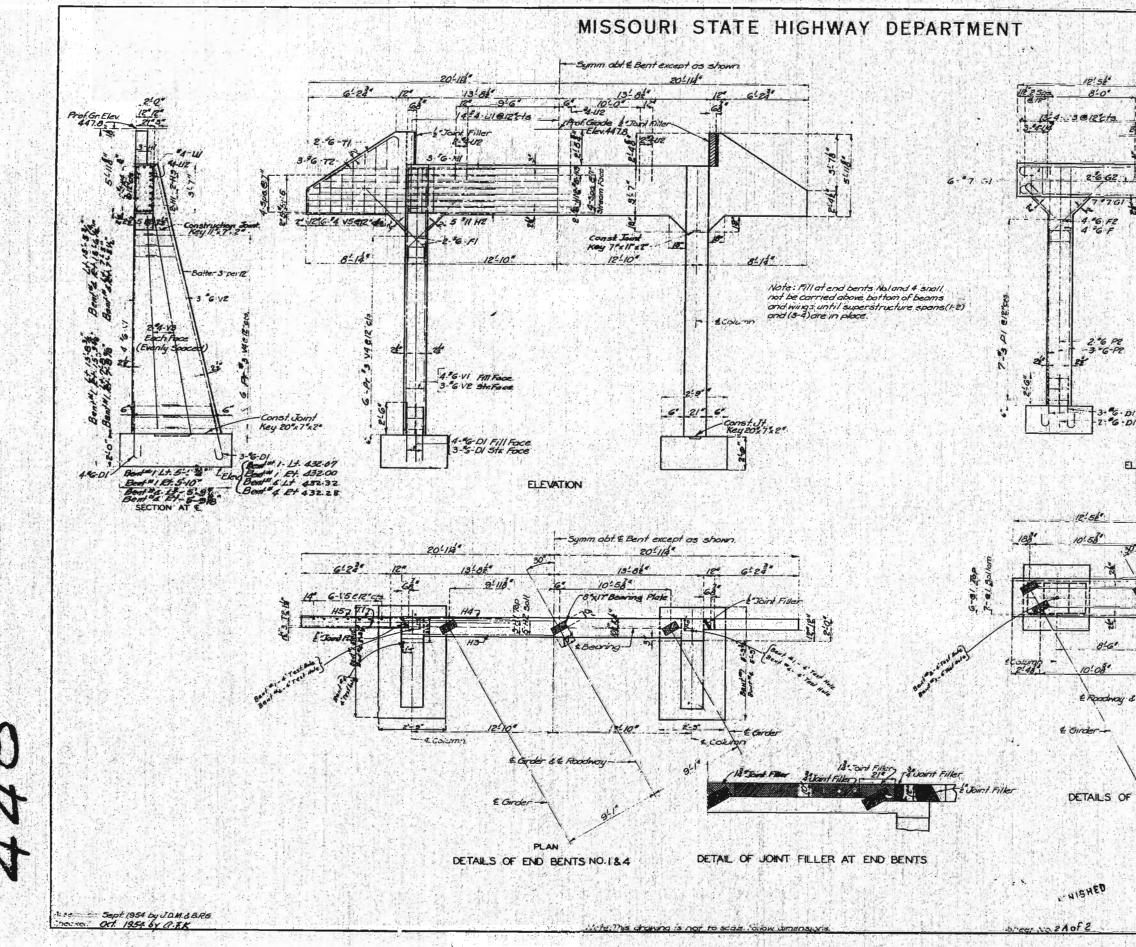
FINAL PLANS 50 61 Symmable Bent except as shown 12:52 - E Bent 343" 22 6-61 22 Virol Gr Elev 4428 Prof Gr. Elev 447.8 19:3 8:6" 3-112 Const Jom Key 9'x 9'x2 Key 9 x 9 x 2" 143.1 ELEVATION SECTION AT & -Symmable Bent except as shown it 12-52 10-00 resering "117" Bearing Plate 3-64 - Ecolumn - & Gurter 54 180 PLAN DETAILS OF INTERMEDIATE BENTS NC. 283 BRIDGE OVER CANE CREEK STATE ROAD FROM RTE. S.E. AT OAK RIDGE SOUTH TO JACKSON AROUT 3.6 MILES N.W. OF JACKSON PROJECT NO S-W7(D SEC.B (SD) STA. 397+26 CAPE GIRARDEAU COUNTY TINISHEC FINISHED P-714
