DECK REPAIR WITH VOID TUBE REPLACEMENT

SUPERSTRUCTURE REPAIR (UNFORMED)

REPAIRING CONCRETE DECK (HALF-SOLING)

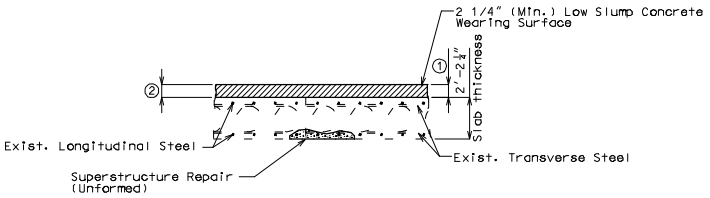
① 2 1/4" (min.) Low Slump Concrete Wearing Surface ② Existing 2" Low Slump Concrete Wearing Surface
