# Highway-Rail Grade Crossing Safety Study

## Texas Eagle

July 14, 2023

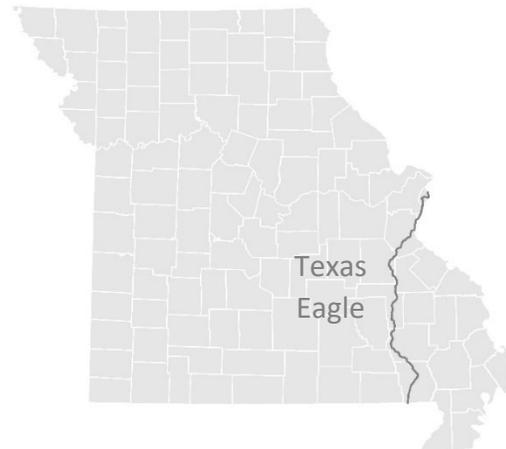
Within the state of Missouri, the Texas Eagle (see graphic at right) extends north-south in Missouri for approximately 185 of its total 1,306 miles from St. Louis to the southern border with Arkansas. The route provides service of one (1) train daily in either direction. Pre-pandemic ridership averaged nearly 325,000 riders annually but fell to an average of 175,000 in 2020 and 2021<sup>1</sup>. The full extents of this route connect Chicago with Los Angeles, providing service within the states of Illinois, Missouri, Arkansas, Texas, New Mexico, Arizona, and California.

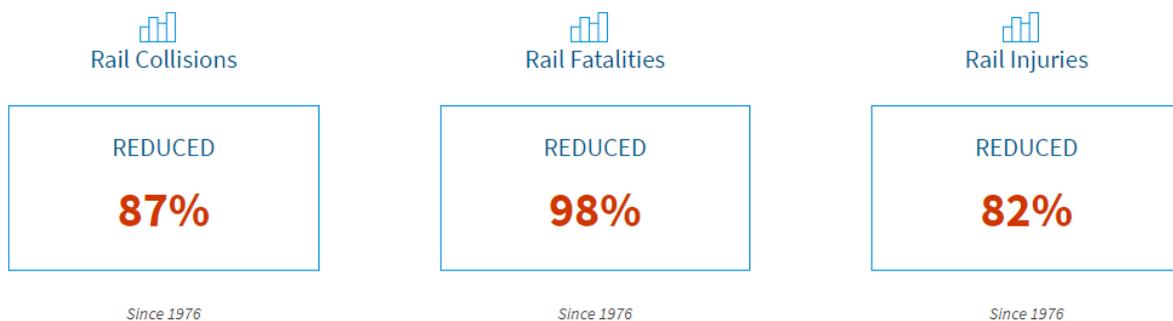
**Figure 1. Missouri Rail Crossing Progress Since 1976**

Over the last few decades, Missouri has made great strides in improving highway-rail grade crossings safety throughout the state. Between 1976 and the present day, Missouri has reduced the number of annual rail collisions by 87 percent, reduced rail fatalities by 98 percent, and reduced rail injuries by 82 percent (Figure 1).

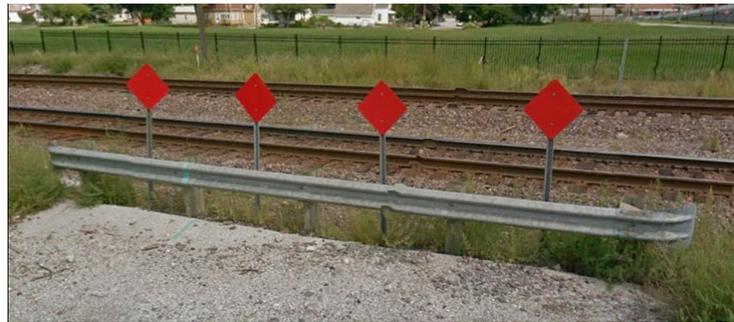
**Figure 4. Standard Closure Barrier**

The cost to close a crossing has a wide range, dependent on the scope of associated roadway work, but basic closures identified in this study can typically be implemented for less than \$30,000. In the case of any crossing necessitating roadway modifications, the cost to close a crossing could increase to millions of dollars. Specific information on the types of proposed roadway modifications and costs are given in subsection “Major Roadway Improvements.”

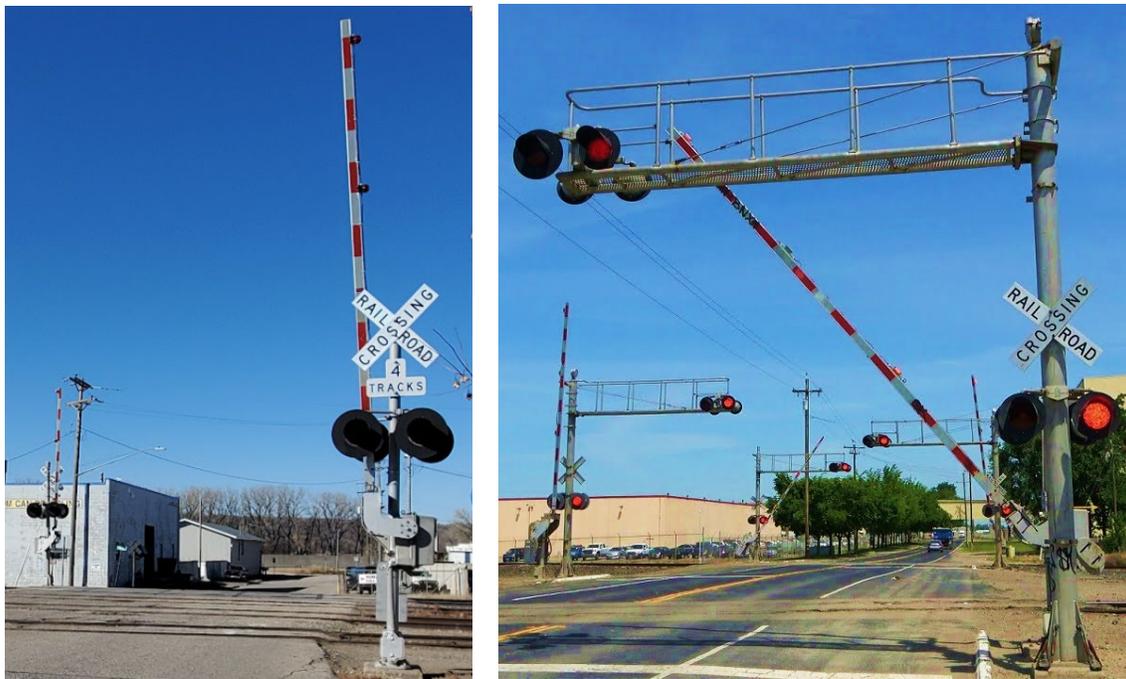
**Figure 6. Automatic Gates and Flashing Lights, Standard and Cantilevered Examples**

Found at many railroad-roadway crossings, gates and flashing lights are active traffic control devices that include components to detect trains approaching the crossing. If a crossing includes automatic gates and flashing lights, it is said to be an “actively” controlled crossing. When a train has been detected, lights will begin to flash and bells will begin to sound for a predetermined interval prior to the arrival of a train, warning drivers that a train is approaching. A motorized drive will lower a retroreflectorized red-and-white gate with lights to a horizontal position at a shorter predetermined interval before the arrival of the train, physically restricting vehicular and pedestrian access. For multi-lane or profile-restricted roadways, an overhead metal-frame cantilever element is often used to support a second set of flashing lights for added emphasis or to improve visibility to those in the middle lane. Missouri Statute 304.035 regulates drivers approaching automatic gates and flashing lights under penalty of a Class C misdemeanor for failure to comply.

Per the stated study goals (see the “Project Scope” section), active warning devices such as automatic gates and flashing lights are recommended for all public passenger rail crossings in Missouri that are currently controlled by non-active traffic controls and are not being recommended for closure. For this study, the cost for a system of automatic gates and flashing lights controlling two roadway approaches is estimated to be \$400,000. This cost can be impacted by factors including the availability of power, the proximity of adjacent crossings, and the number of tracks at the crossing. Costs will be further refined as projects advance in planning and design.

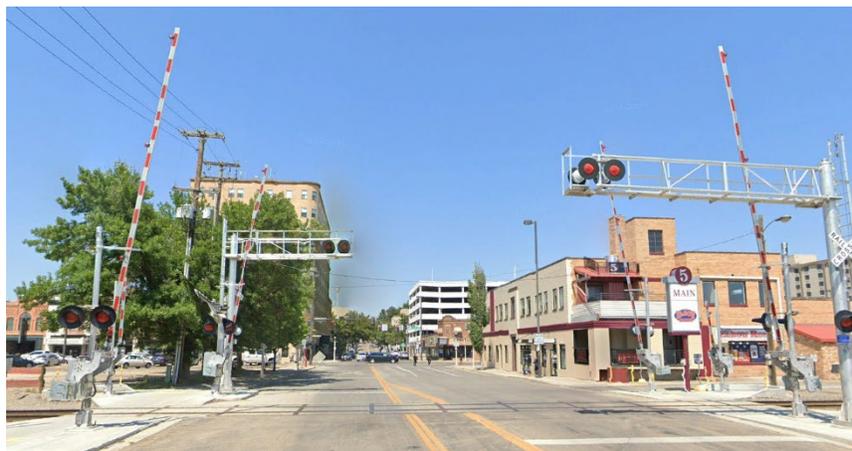
**Figure 7. Four-Quadrant Gates**

Four quadrant gates function similarly to the standard automatic gates and flashing lights described above. However, these systems include two additional gates which fully block access to the crossing when in the lowered position. These systems are useful in cases where motorists have historically been recorded circumventing the gates. However, they are also substantially more expensive to install and maintain, require more complex infrastructure, and increase delays due to added warning times need to successfully activate. Much of the increased installation and maintenance costs is related to the in-pavement vehicle detection systems that are typically used to determine whether the exit gates can be lowered without trapping highway users on the crossing surface. Due to these concerns, no four-quadrant gates systems have been recommended at any Texas Eagle crossing. However, other engineered systems can be employed to help channelize and direct vehicular traffic, such as non-mountable curb islands or non-traversable medians. These systems are much more cost-effective and have been included in some crossing recommendations.

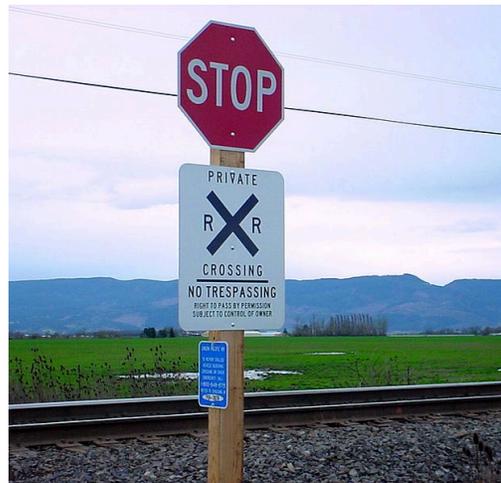
Figure 9. Private Crossing Signage

Private crossings are intended for use only by property owner(s) and provide access only to privately-owned locations or facilities. As opposed to public crossings, private crossings are not maintained by MoDOT or local road authorities. There are a number of locations in this corridor that are categorized as public crossings – because they are located on publicly maintained roadways – but in practice they function more like private crossings (e.g., providing access to a single house, or providing access to agricultural areas with no outlet). At locations like these where average daily traffic is very low and public use is limited, the installation of active warning devices may not be warranted.

An approach proposed by this study is to consider the conversion of these crossings to the private crossing category. This would require signed agreements between the railroads and the local property owner(s) served by the crossing. In many cases, this would also include the jurisdictional transfer of roadway segments to private ownership. While this approach may not always be feasible given the complexity of negotiating between multiple agencies and property owners, it should be pursued before defaulting to the more costly options of gate and flashing light installation. At crossings where public-to-private conversion is implemented, appropriate signage, meeting MUTCD and FRA requirements, must be installed, an example of which is shown in Figure 9.

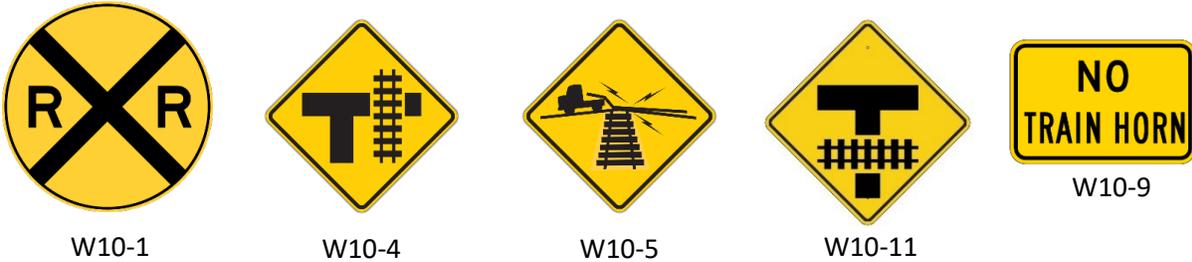
**Figure 10. Examples of Advance Warning Signs used in Corridor Safety Improvement Plan**

*Advance Warning Signs (AWS):* Advance warning signs are used to convey information to drivers. Figure 10 shows AWS commonly recommended in this Corridor Safety Improvement Plan. A W10-1 is required to warn drivers that they are approaching a crossing and is placed at a distance determined by the posted speed limit of the road. A W10-4 is used on a roadway that runs parallel to track(s). A W10-5 is used to inform larger vehicles of a humped crossing, which may pose a risk of high-centering. A W10-11

is used to inform drivers of limited storage space between an intersecting roadway and the track. A W10-9 is used to supplement a W10-1 within quiet zones where there is authorization for trains to not sound a horn – typically implemented in dense, urban environments. This list and descriptions of signage reflects the most common signage recommended and is not intended to be comprehensive of all signage recommended in this study. The cost of AWS is estimated to be \$500 per sign.

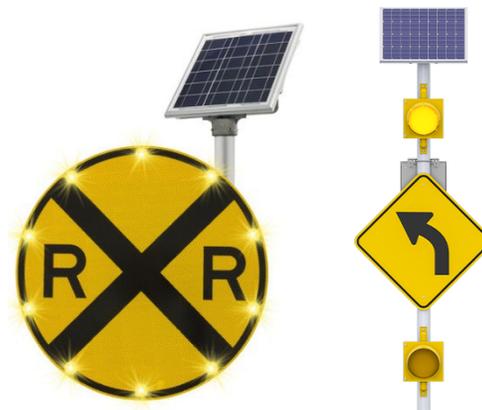
**Figure 11. Examples of Advance Warning Signs with Flashers**

*Advance Warning Flashing Signs (AWFS):* These enhanced signs are most often used in rural areas with little to no illumination along the roadway. Especially on gravel roads with no pavement markings, W-10 series advance warning signs equipped with flashers have generally been found to improve performance compared to signs alone. There are two common methods of adding flashers to an advance warning sign: placing LEDs around the edge of the sign or utilizing a flashing beacon. The lights have the potential to be powered by an attached solar panel, so a nearby power source may not be required. Both types are shown in Figure 11. The cost of AWFS is estimated to be \$2,000 per sign.

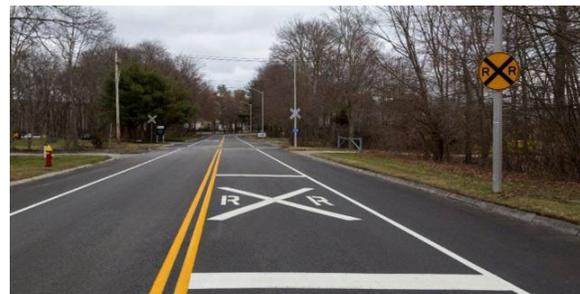
**Figure 12. Pavement Markings**

*Pavement Markings:* White retroreflectorized pavement markings are required in advance of gated highway-rail grade crossings and consist of an “X”, the letters RR, a no-passing marking (typically centerline markings), and transverse lines. Pavement markings should be placed directly adjacent to advance warning signs, as shown in Figure 12. The cost of pavement markings is estimated to be \$2,000 per approach.

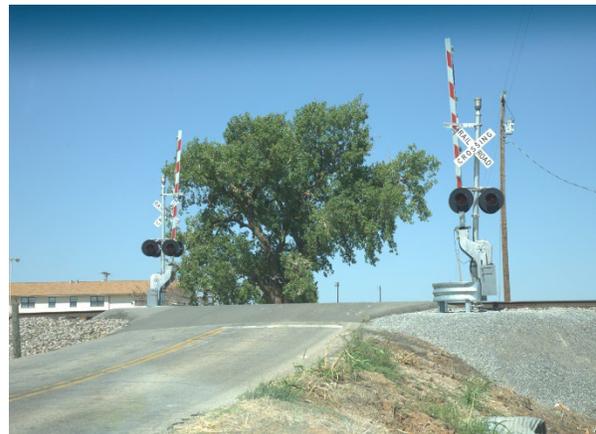
**Figure 13. Example of a Humped Crossing**

*Vertical Re-Profiling:* Humped crossings exist when the elevation of the track creates a steep grade on an approach. Humped crossings present a very serious risk, as low trailers or heavy-duty vehicles may become immobilized at the crossing. The American Railway Engineering and Maintenance-of-Way Association (AREMA) *Manual for Railway Engineering* recommends that the crossing surface be in the same plane as the top of rails for two (2) feet on either side of the edge-of-track and the surface of the roadway be not more than three (3) inches higher or lower than the top of the rails at any point from 30 feet from the edge-of-track.

The cost to reprofile vertical grades is estimated to be \$50,000 per crossing at a conceptual level, though further study and detailed engineering analysis is required to refine costs for roadway re-profiling.

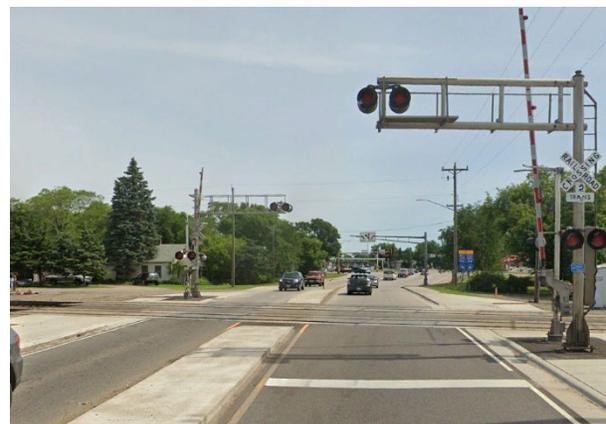
**Figure 14. Non-Traversable Median**

*Non-Traversable Medians:* While driving around gates is illegal, according to FRA incident data, this infraction represented nearly 10 percent of Missouri grade crossing incidents from 2016-2020. Non-traversable medians are one method of physically preventing drivers from driving around gates. For this study, medians have only been recommended in urban environments. The cost to add medians is estimated to be \$300 per linear foot at a conceptual level.

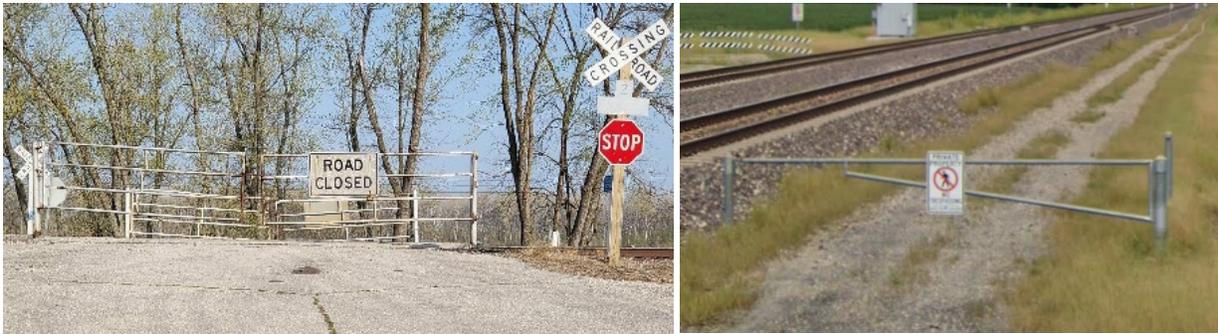
Figure 15. Security Gates

Security gates act as quasi-closures. In cases where security gates are presented as an option, crossing infrastructure is assumed to be retained and maintained. Security gates allow for flexible roadway access in cases where full closure of a crossing could introduce safety concerns, such as eliminating a secondary access point to properties during extreme weather events. The cost to install a security gate is estimated to be \$5,000 to \$10,000, based on UP standards.
