J6I3290
BRIDGE REHABILITATION
I-55 OVER MERAMEC RIVER
2026-2027

STAGE 1

STAGE 1 - DESCRIPTION OF WORK

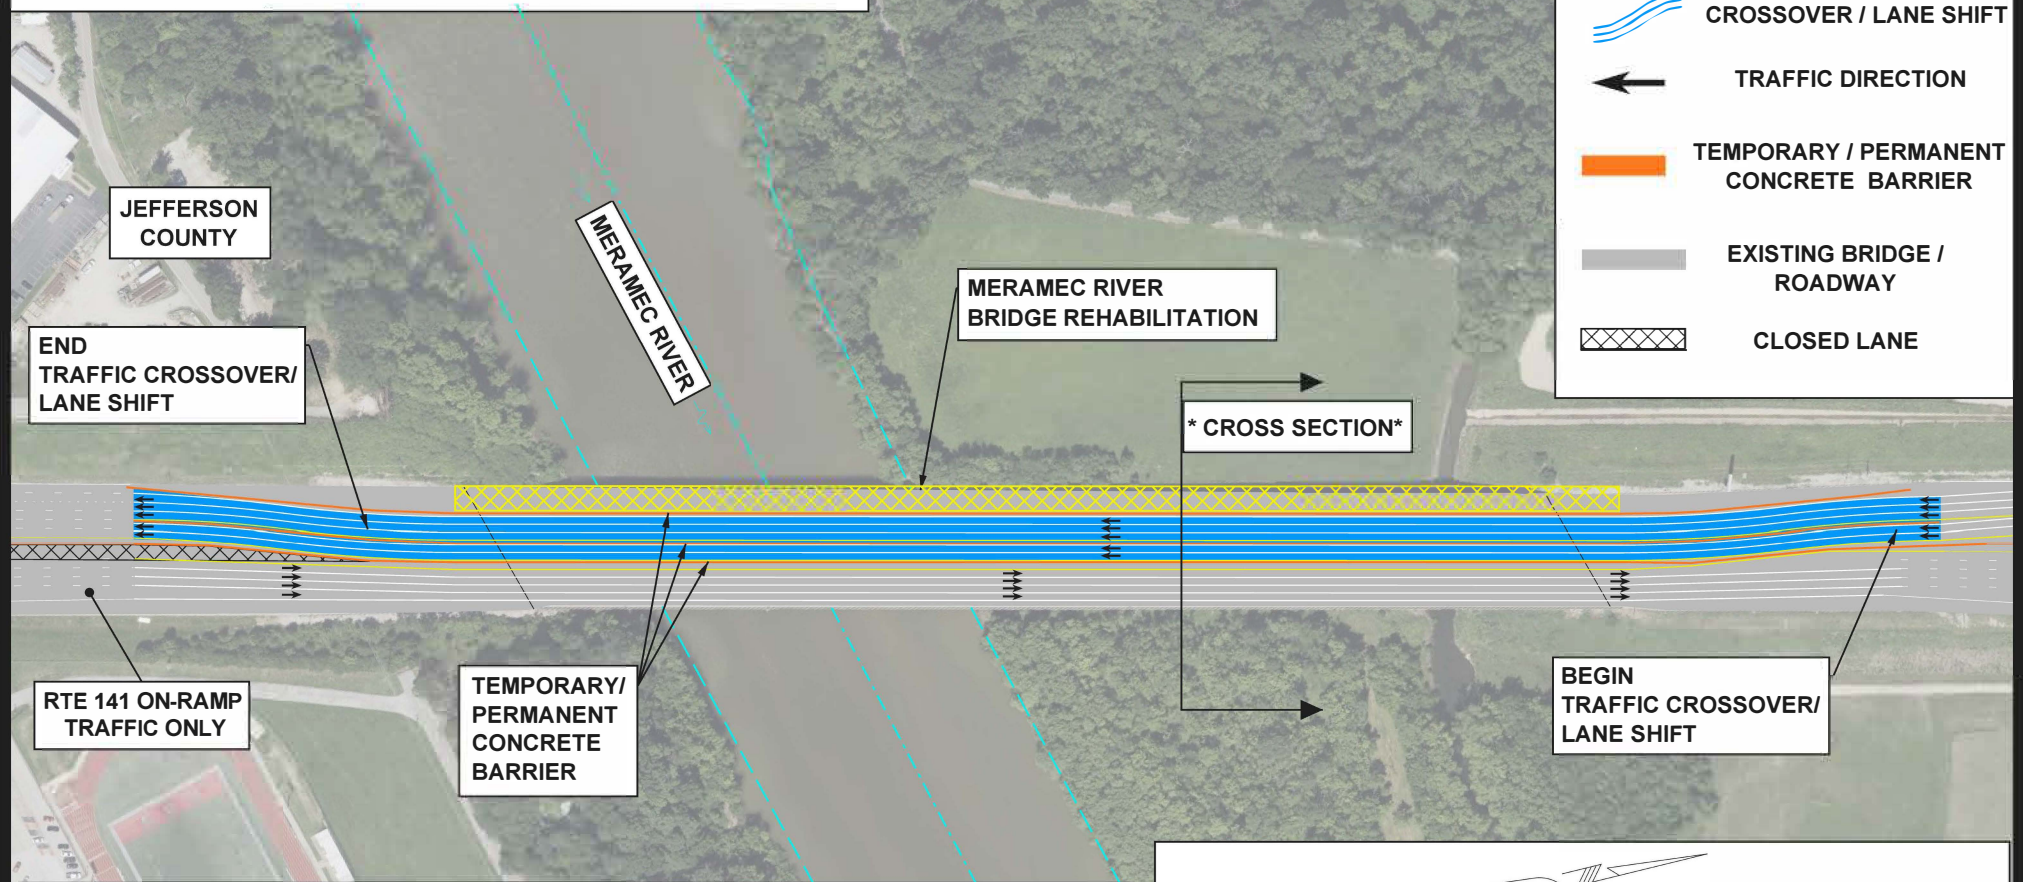
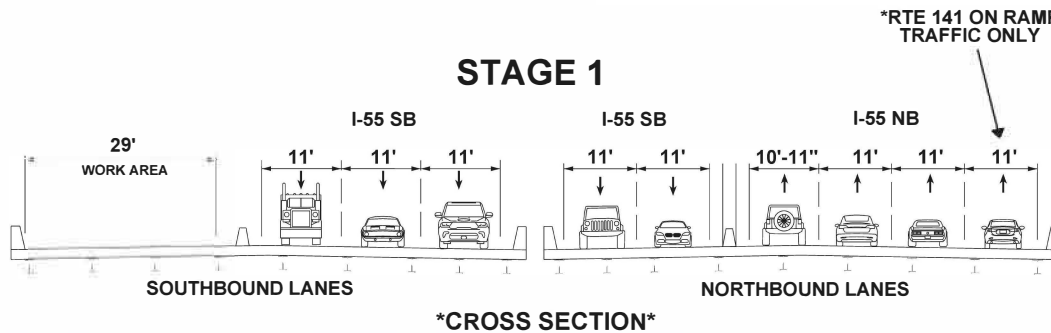
STAGE 1

DURING THE WEST PORTION OF THE MERAMEC RIVER BRIDGE CLOSURE:

- THREE (3) SOUTHBOUND LANES WILL REMAIN ON THE WESTERN SECTION OF THE BRIDGE
- AN ADDITIONAL TWO (2) SOUTHBOUND LANES WILL CROSS OVER ONTO THE NORTHBOUND MERAMEC RIVER BRIDGE
- FOUR (4) NORTHBOUND LANES WILL REMAIN OPEN ON THE BRIDGE
