INTERSECTION COLLISION DIAGRAM

INTERSECTION: U.S. 54 AND KEY LARGO

COUNTY: CAMDEN

TIME PERIOD COVERED: FROM 7/8/2014 TO 7/18/2017 (3.0 YEARS)

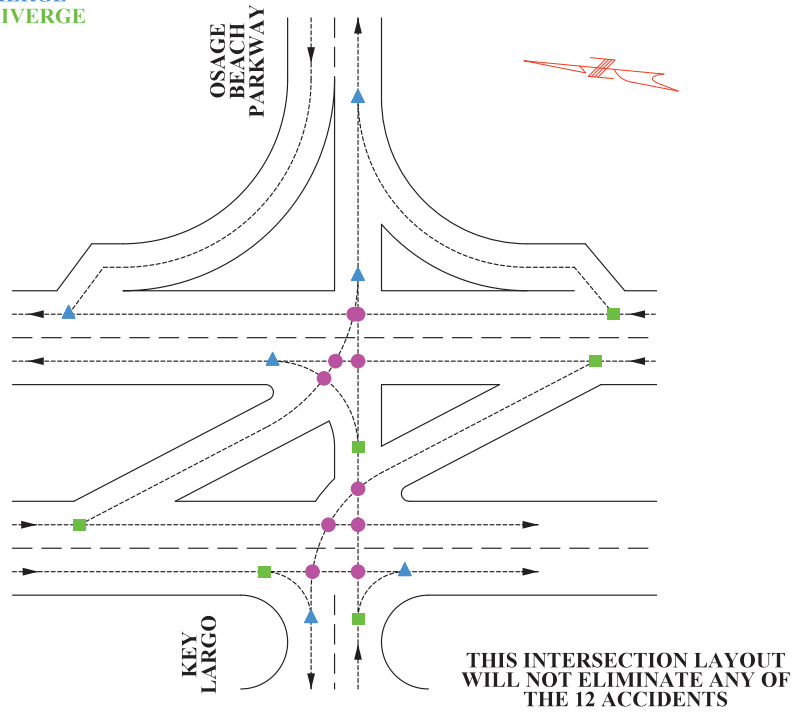
EXISTING INTERSECTION LAYOUT

26 TOTAL CONFLICT POINTS

- 13 CROSSING
- ▲ 7 MERGE
- 6 DIVERGE

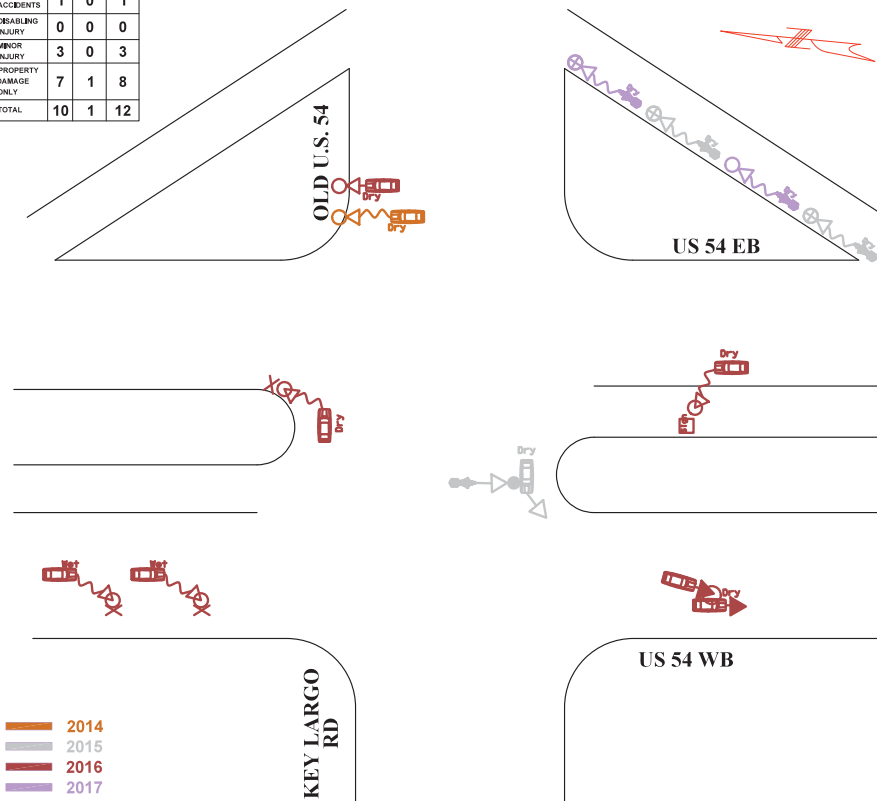
ACCIDENT SUMMARY			
SEVERITY	DAY	NIGHT	TOTAL
FATAL ACCIDENTS	1	0	1
DISABLING INJURY	0	0	0
MINOR INJURY	3	0	3
PROPERTY DAMAGE ONLY	7	1	8
TOTAL	10	1	12
